Chesapeake Bay Breakwater Database Project, Section 227 Demonstration Site: Hurricane Isabel Impacts to Four Breakwater Systems

July 2006

Final Report

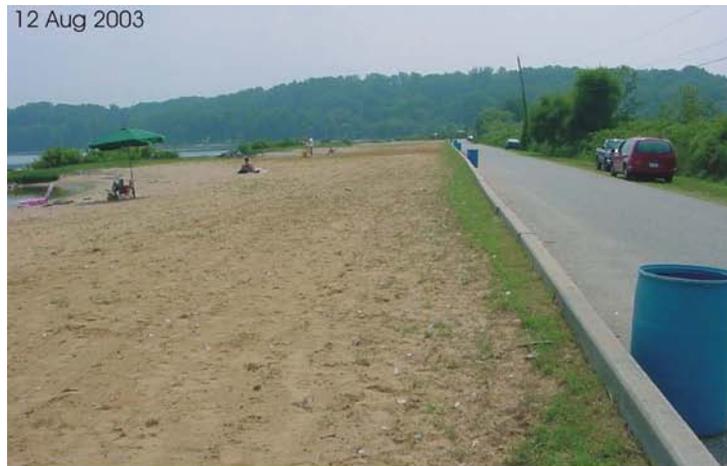
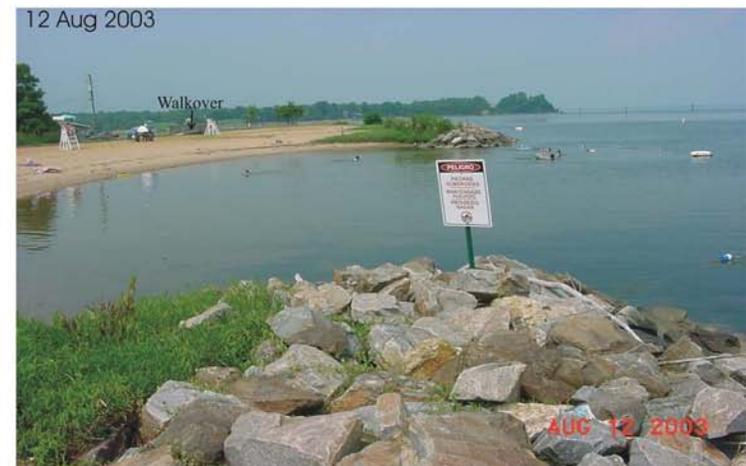
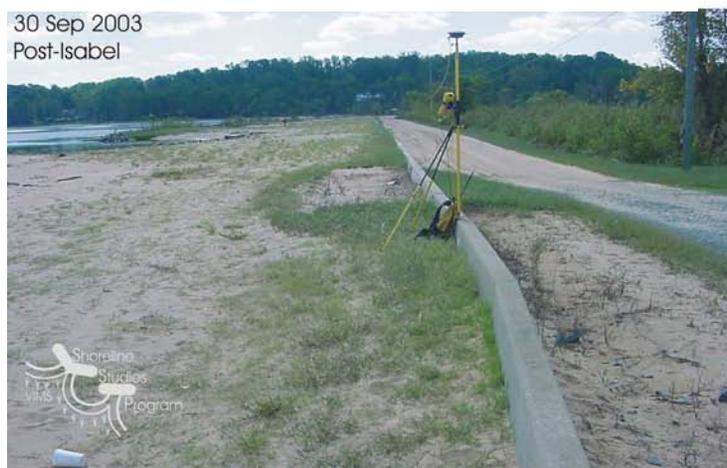
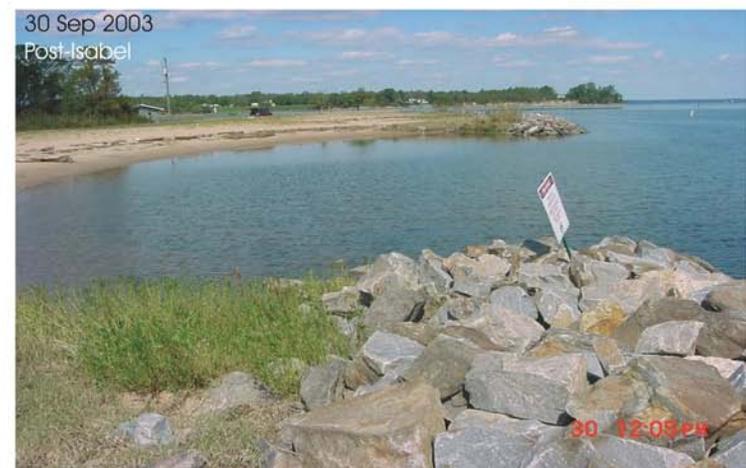
Figure 17. Aquia Landing ground photographs pre- and post-Hurricane Isabel

Aquia Landing was the least impacted by Hurricane Isabel of the four sites discussed in this report. It had the least storm surge and it was not directly impacted by wave attack. Nevertheless, the storm impacts were enough to carry sand into the access road due to the low backshore and the absence of an upland bank. However, no significant infrastructure was damaged at the site. Overall, this site fared well with little or no impact.

a. Looking south along Jersey wall and access road

b. Looking north from BW 2

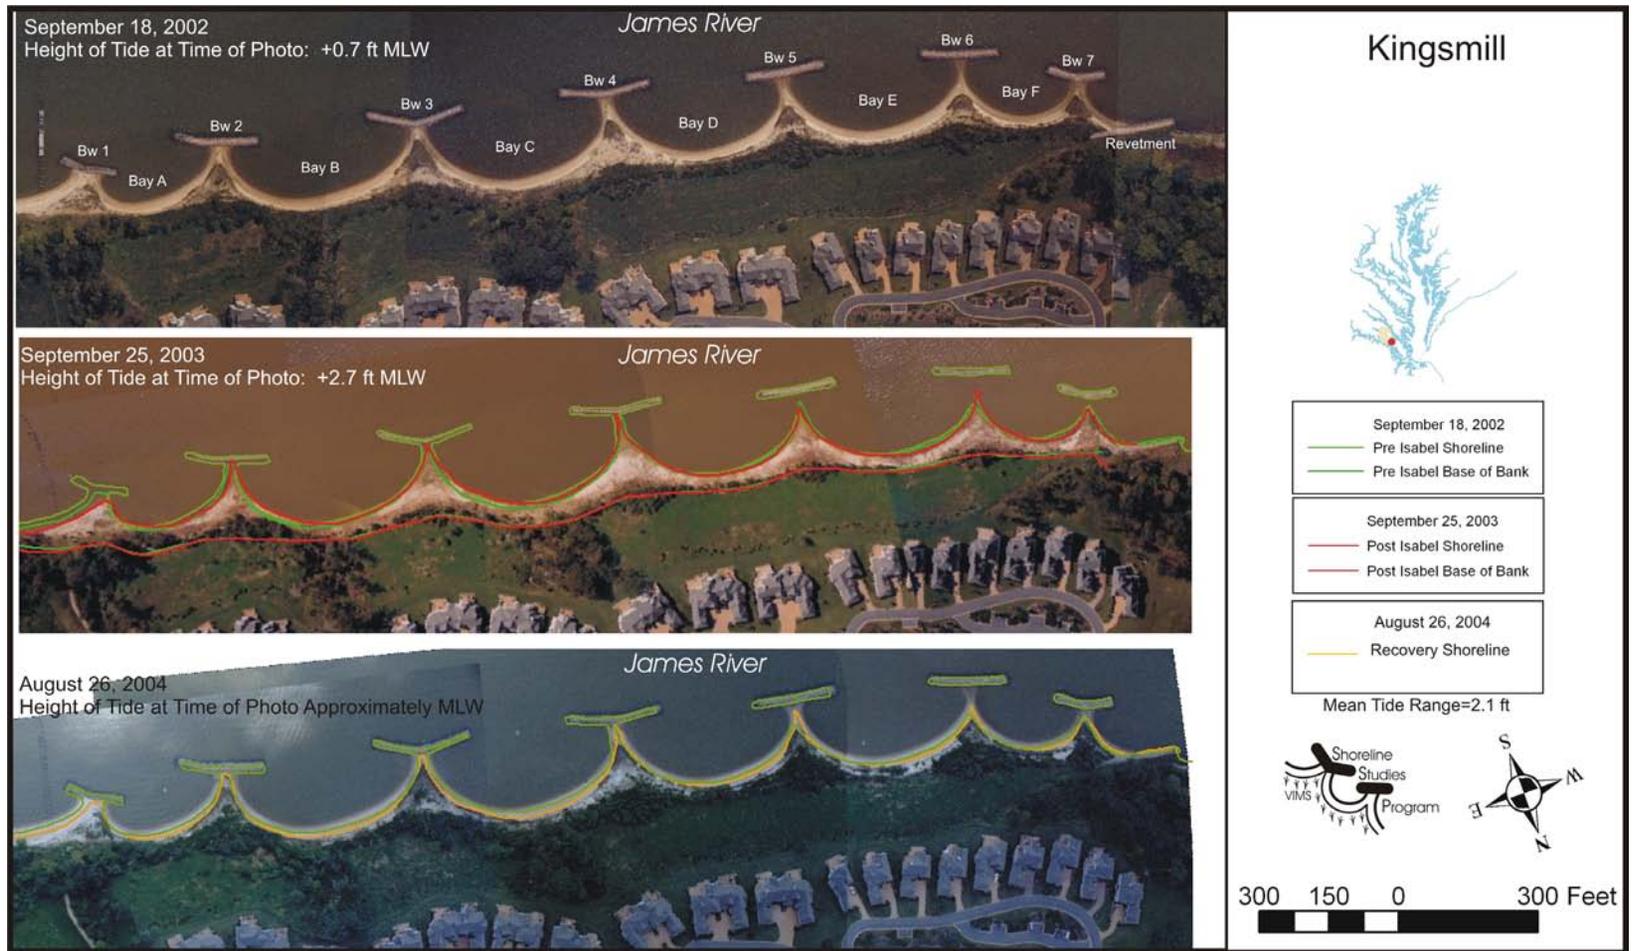
Figure 19. Kingsmill low-level pre- and post-Hurricane Isabel and recovery ortho-rectified aerial photographs

Pre- and post-Isabel aerial imagery of the site show slight changes in shore position (Figure 19). Each tombolo apex had a tendency to shift upriver. Measurable base of bank recession occurred along much of the project, but it was particularly prevalent adjacent to each embayment. These changes are illustrated in the typical bay and breakwater profiles in Figure 20. The combination of storm surge and wave runup limits was measured in the field and are shown for each typical profile at just over el 10. This was a significant event for the site, yet overall damage was minimized by the heavily vegetated backshore/base of bank (Figure 21). Post-Isabel recovery is shown in Figure 19; the beach planforms have returned to approximately their pre-storm positions.

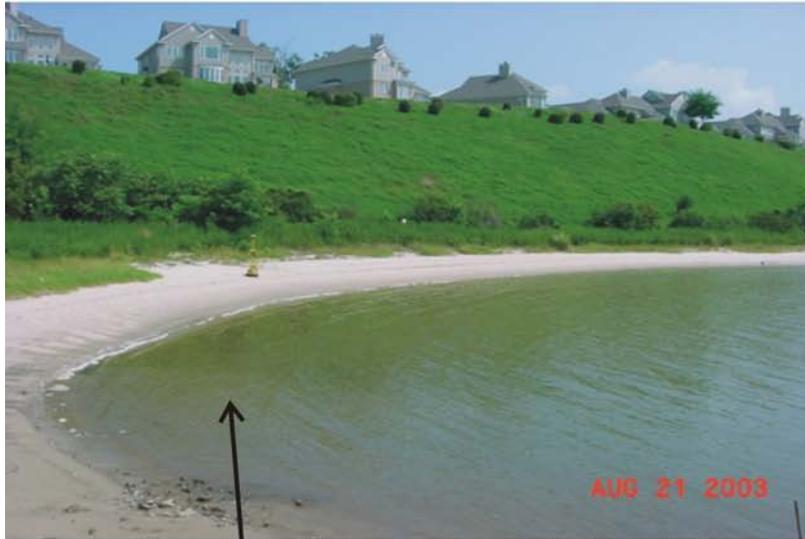
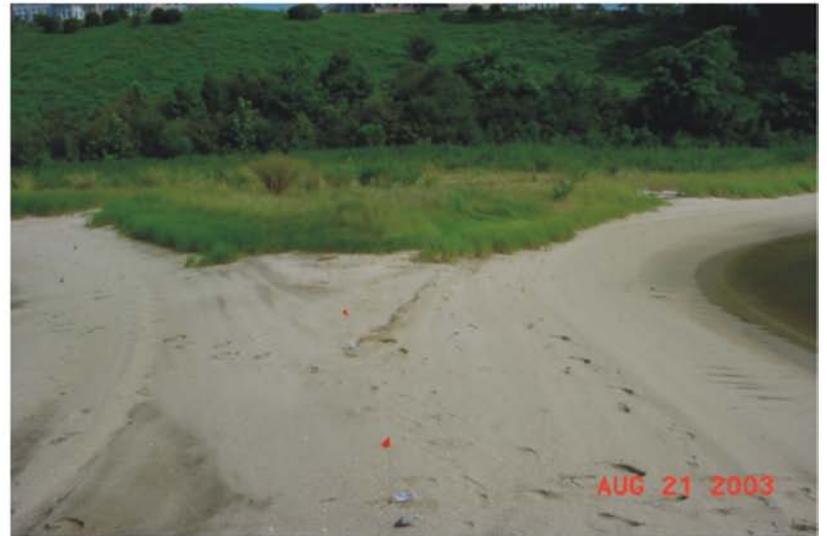
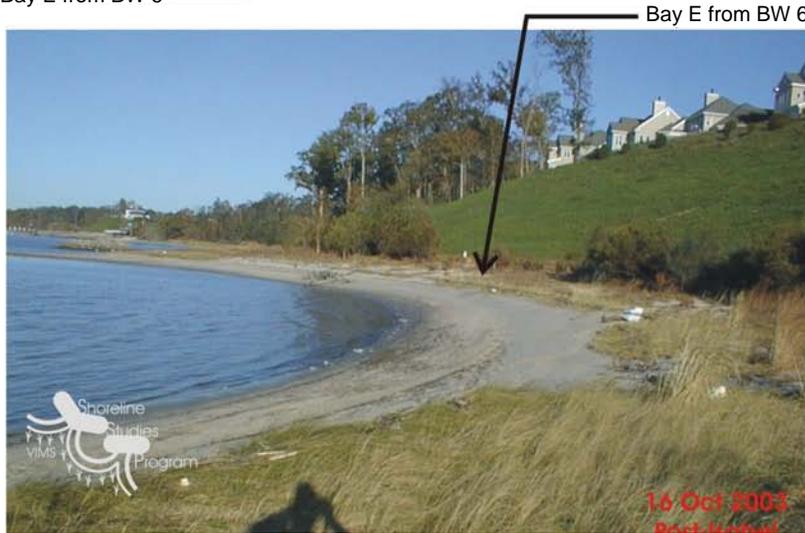
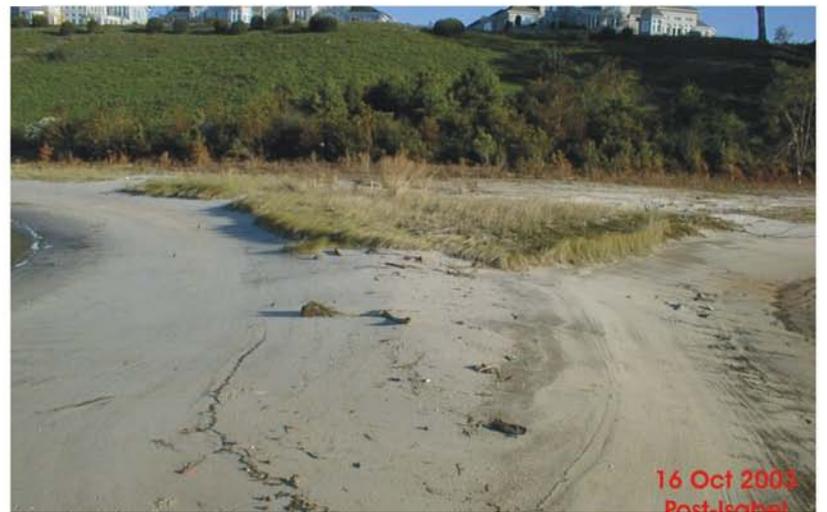
Figure 21. Kingsmill ground photographs before and after Hurricane Isabel

Hurricane Isabel exceeded the design conditions at the site, but it is difficult to accurately quantify its hydrodynamic forces. All of the piers along the shore sustained significant damage, and although the base of the bank was cut along

most of the site, no banks failed or incurred significant damage. The banks will be regraded and a wider backshore will provide a larger buffer between the banks and storm waves once the vegetation is restored. No significant alteration in beach planform or loss of sand from the system occurred. The breakwater system is stable.

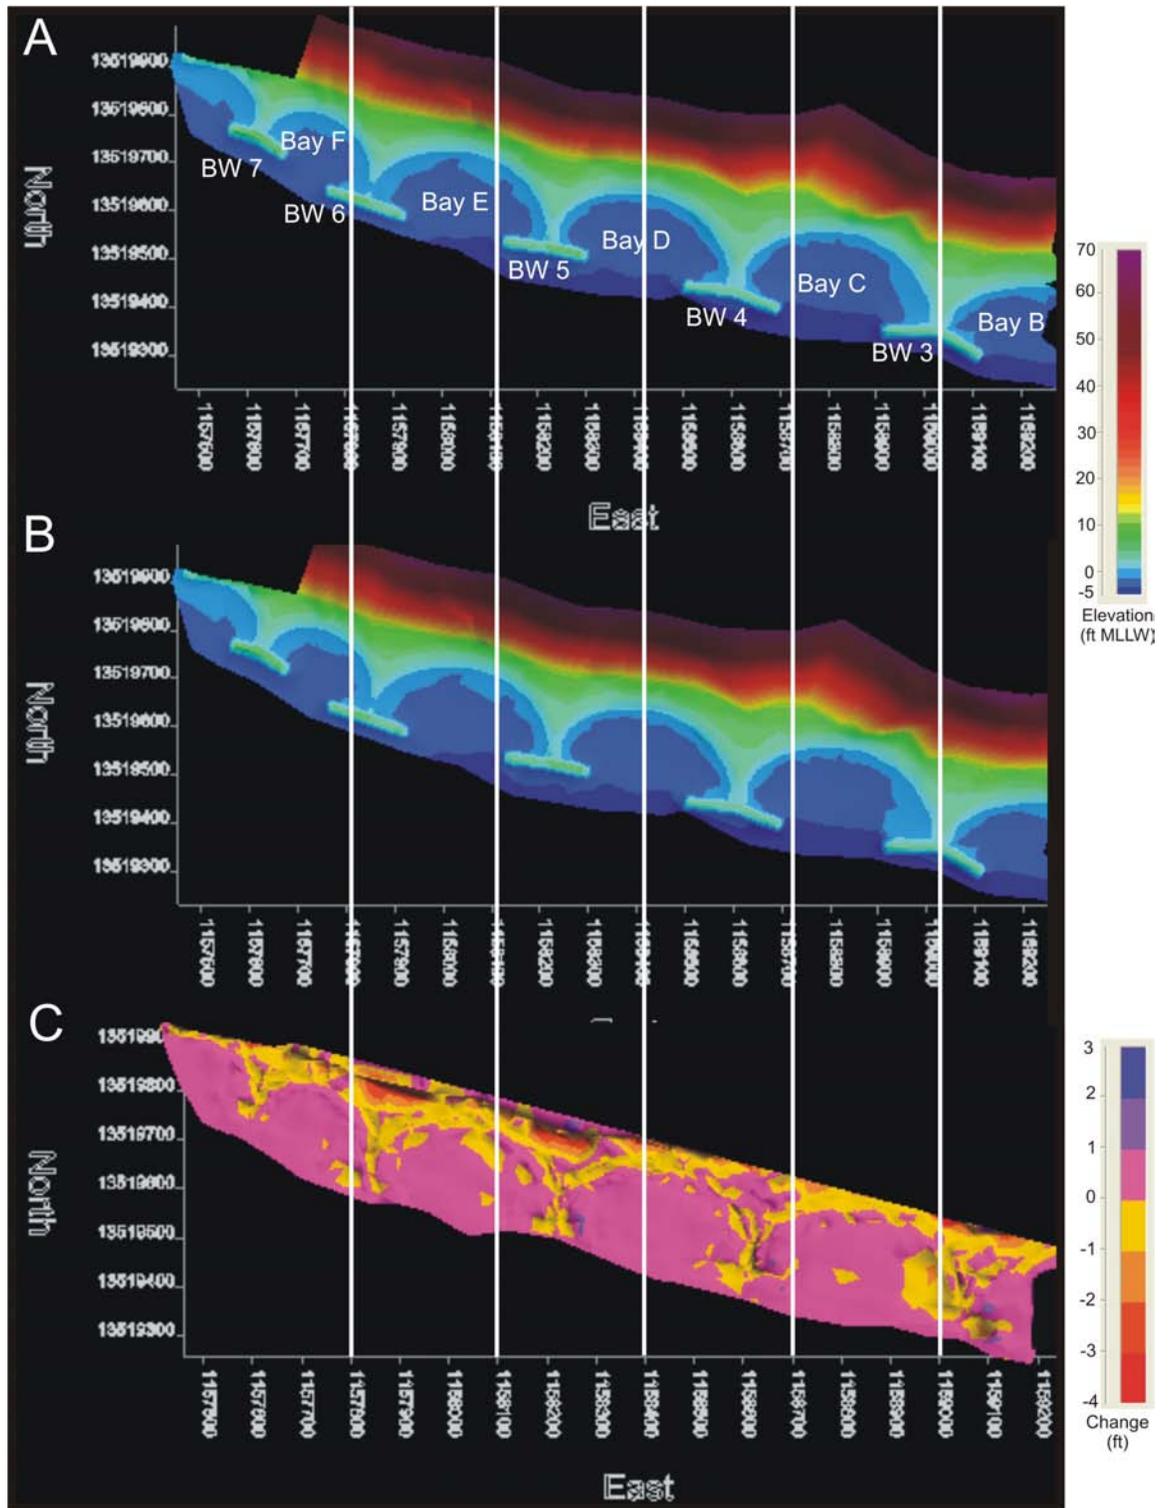
Figure 22. Kingsmill color contour maps for: (a) pre- and (b) post-storm conditions, and (c) isopach map showing elevation changes between surveys

Topographic changes along the site between breakwater (BW) 3 and BW7 are shown in Figure 22. The isopach map that indicates a general pattern of reduction in elevation occurred along the beach, backshore, base of bank, and around each breakwater unit. Most increases in elevation were in the nearshore and in small pockets in the lee of each breakwater unit. The most severe scour occurred along the base of the bank (BOB) between BW5 and BW6. However, the damage did not endanger the integrity of the bank face. No slumping or failure was noted or has occurred since. Just upriver, extensive damage (more than \$3 million) occurred at the adjacent marina, which only had a timber pile breakwater for protection.

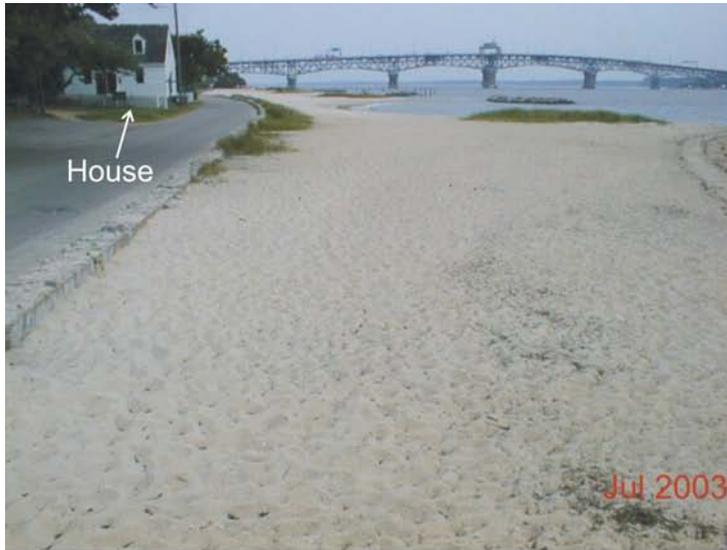
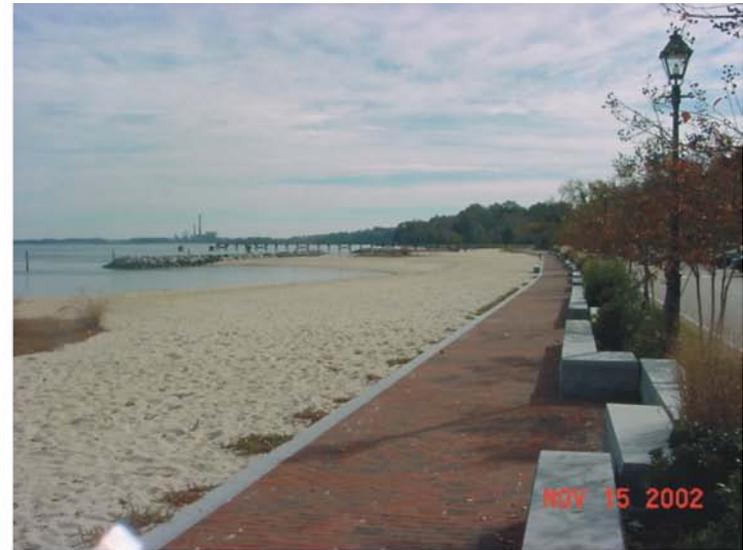
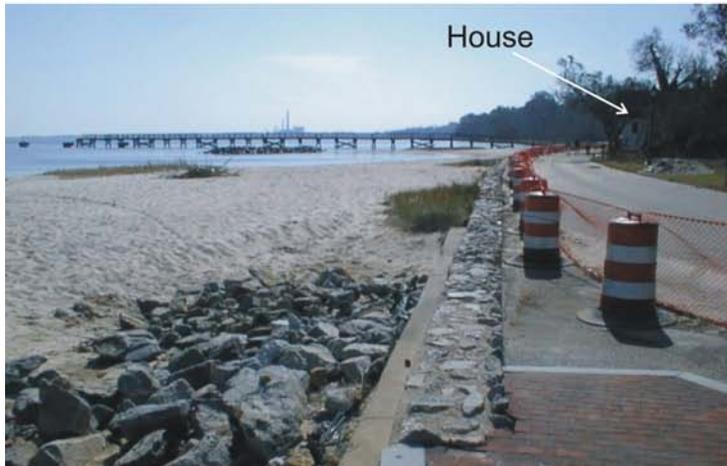
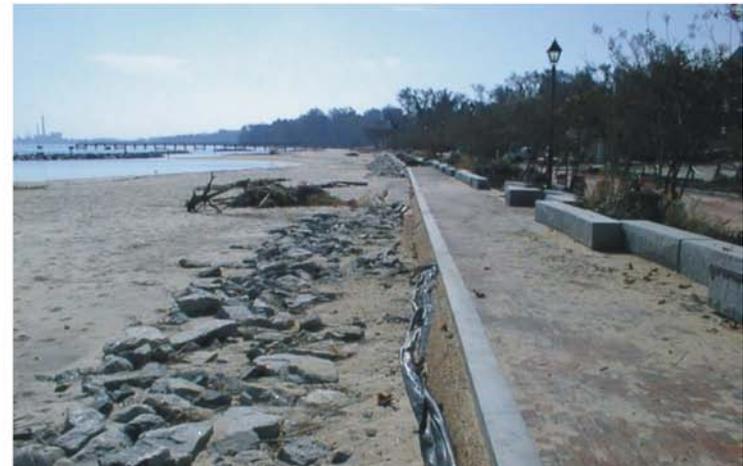
Figure 29. Yorktown ground photographs before and after Hurricane Isabel

Sand was carried into the adjacent street, but recent granite block backstops helped reduce this tendency. These blocks measuring about 0.3 m (1 ft) square, 1.5 m (5 ft) long, and weighing about 907.2 kg (1 ton) were easily shifted around by the storm waves. Several areas of scour occurred along the backshore/sidewalk/road juncture (Figure 29), but post-storm cleanup and added fill restored the public beach to use by late October 2003. The businesses along the waterfront were severely damaged. It took several months for their rehabilitation due to water damage, but they are presently operating. Figure 30 shows a low backshore along Water Street in Yorktown as well as the storm wrack lines, which are the floating debris accumulated at the limit of high water. At Colonial National Historical Park, just downriver from Yorktown, small rocks from the revetment along the shoreline were scattered on the road, and the adjacent upland bank was severely scarped.

The waterfront at Yorktown was severely damaged by Hurricane Isabel. The low backshore and adjacent low bank allowed the storm surge to inundate the structures protected by the project. However, the wave action was significantly reduced by the public beach's breakwater system, which may have spared the structural integrity of the buildings located along Water Street. This system experienced sand losses and local scour but maintained its overall integrity and performed above expectations; the system was designed for a 50-year event and sustained what many consider a 100-year event in this part of the bay.

a. View along downriver portion of Water Street

b. View along upriver portion of Water Street at main recreational area

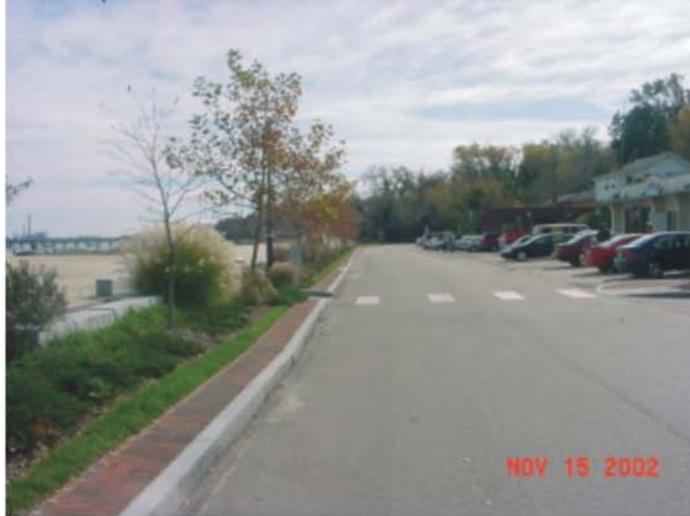
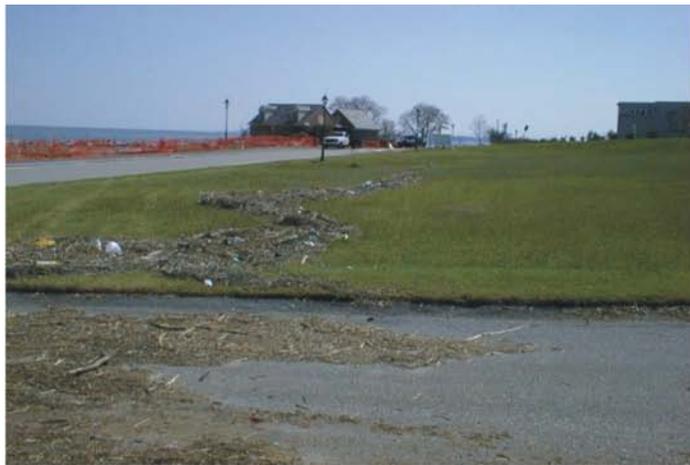
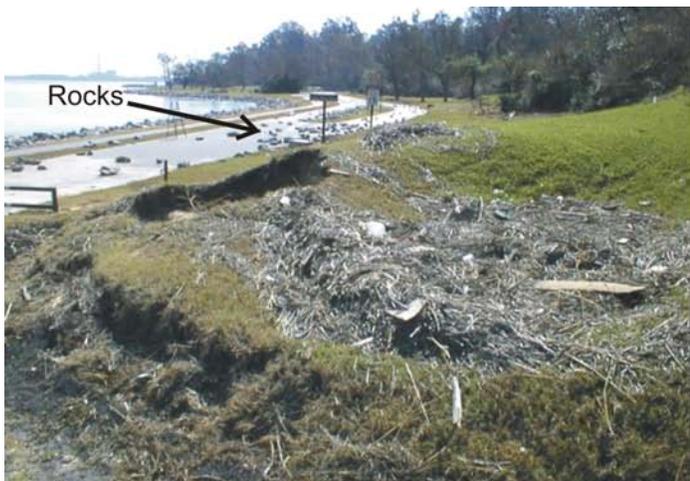
Figure 30. Yorktown

a. Pre-storm low backshore

b. Post-storm wrack line

c. Post-storm wrack line downriver

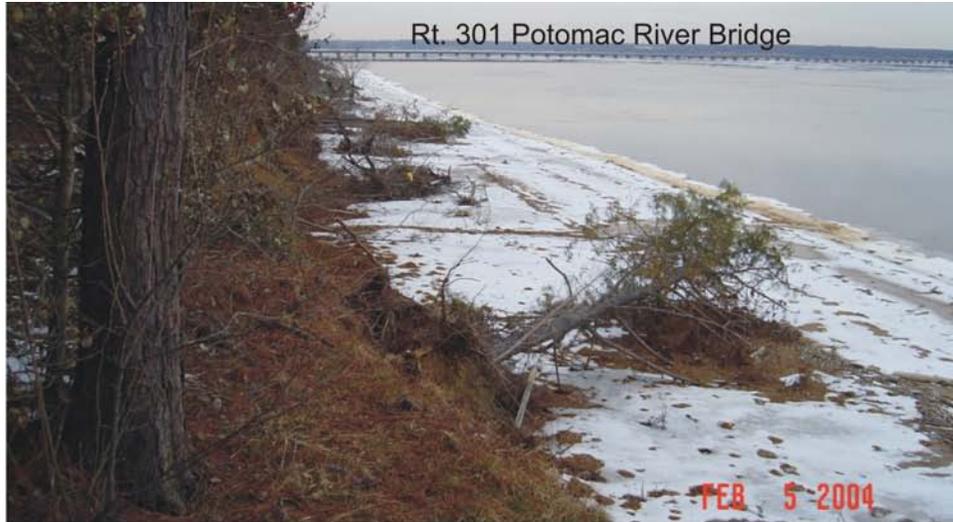
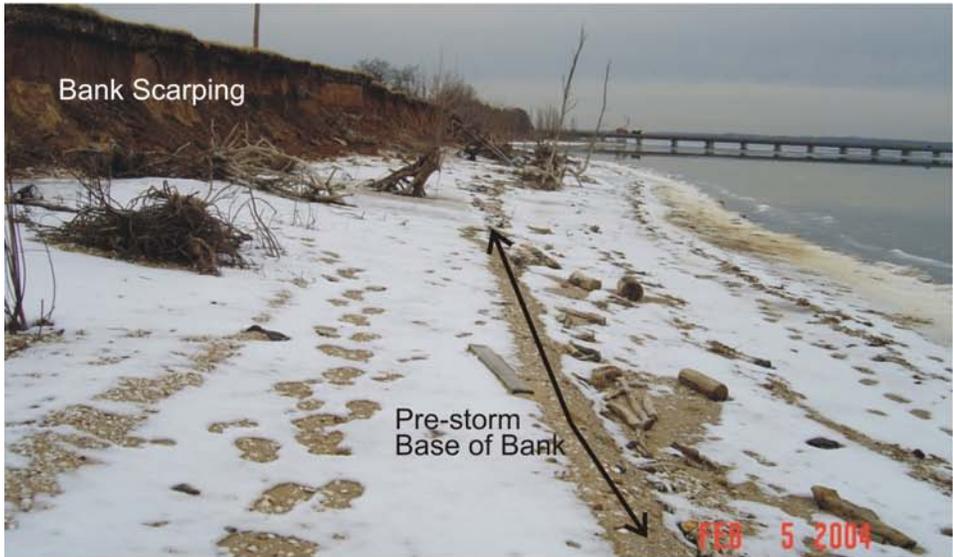
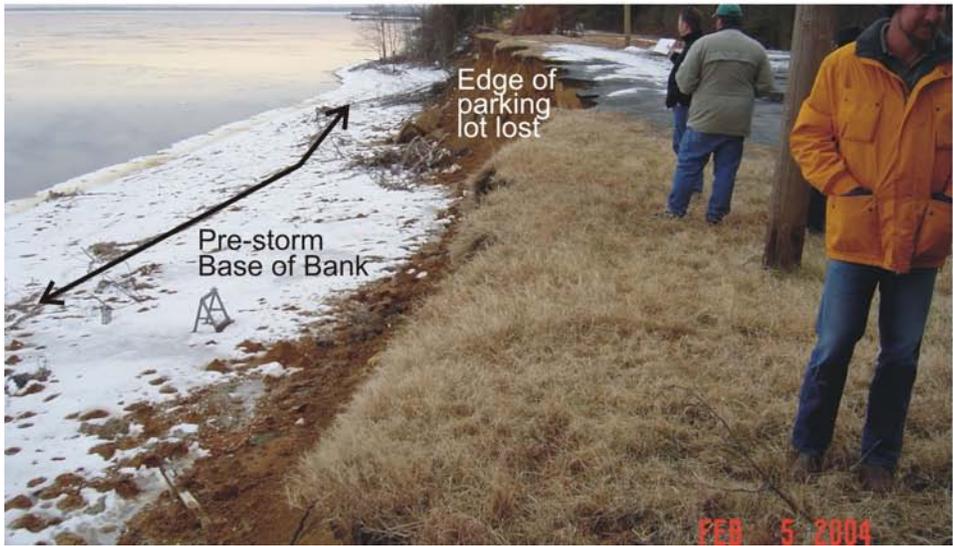
Figure 32. Impacts to unprotected shore at Dahlgren due to Hurricane Isabel

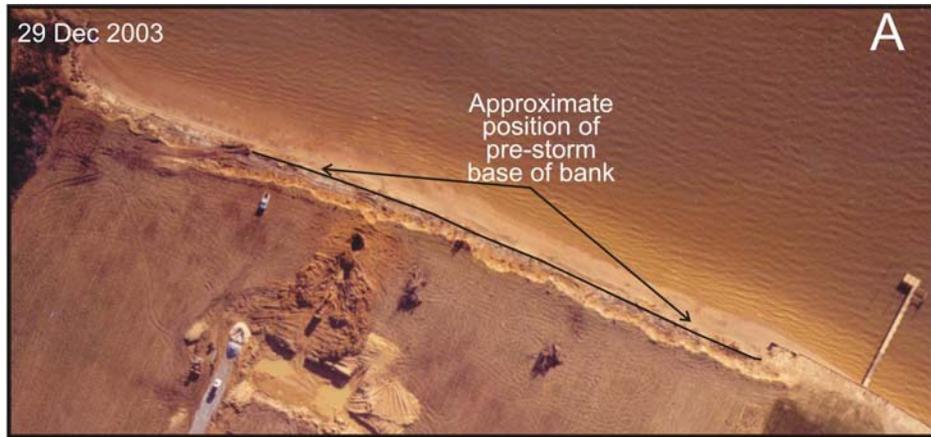
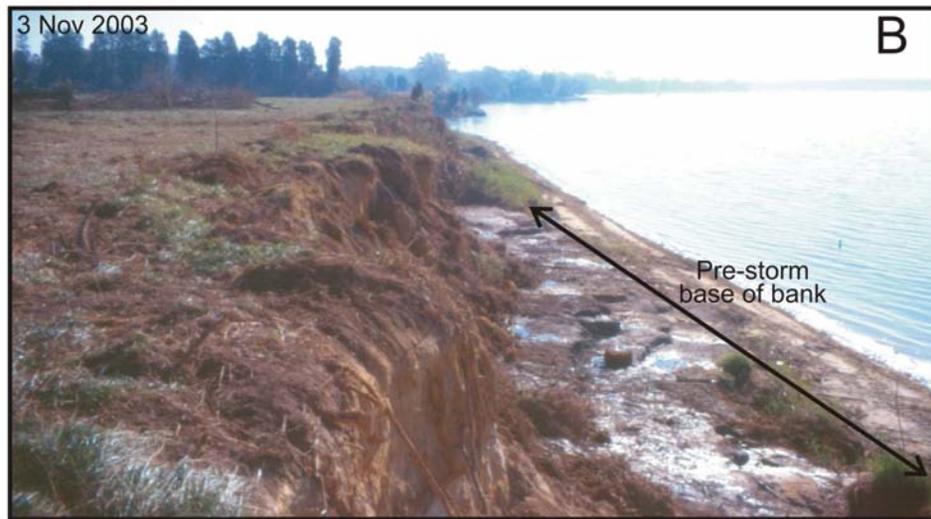
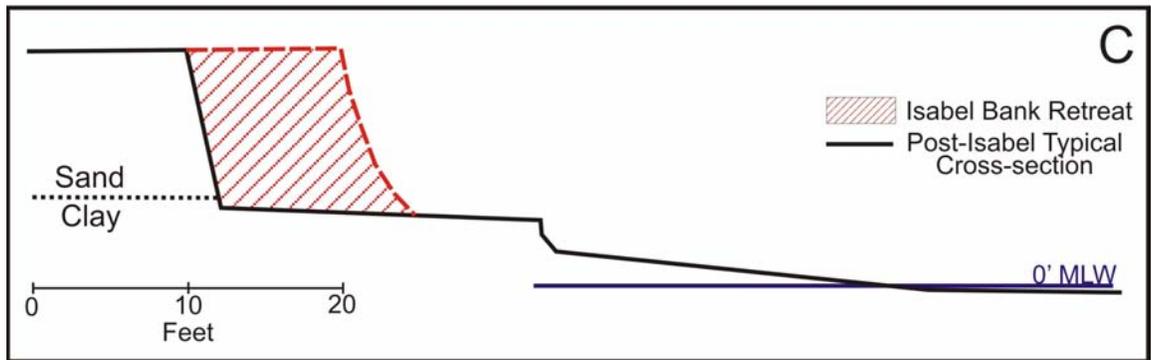
Figure 33. Impacts to unprotected shore at Lenhart due to Hurricane Isabel

a. Nonrectified aerial photograph

c. Typical post-storm cross section

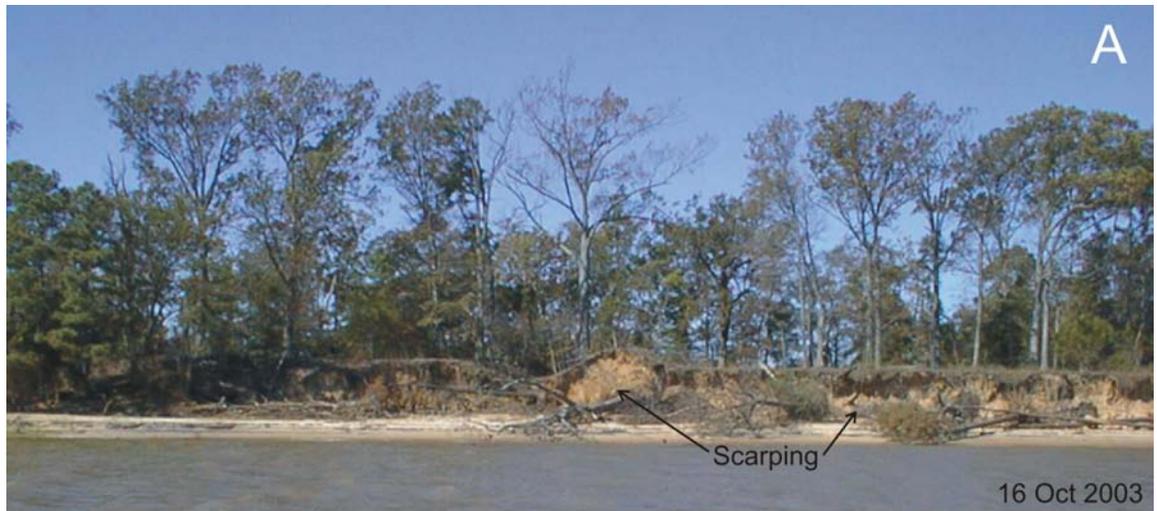
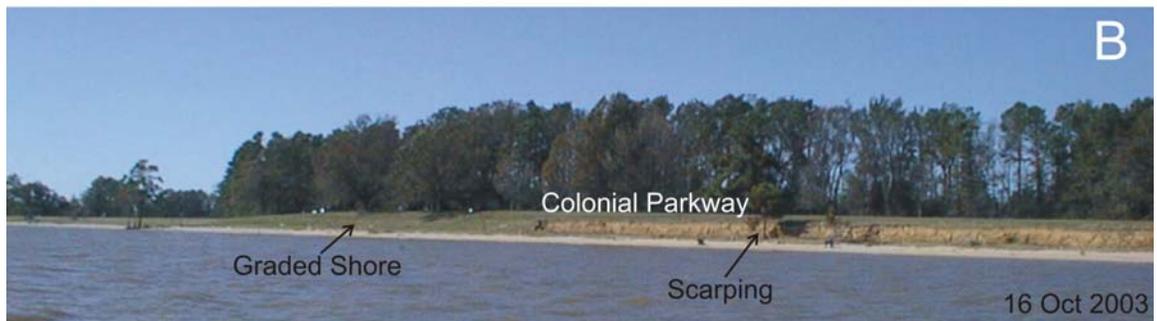
Figure 34. Impact to unprotected shores on James River due to Hurricane Isabel

a. At Confederate Fort

b. Along Colonial Parkway

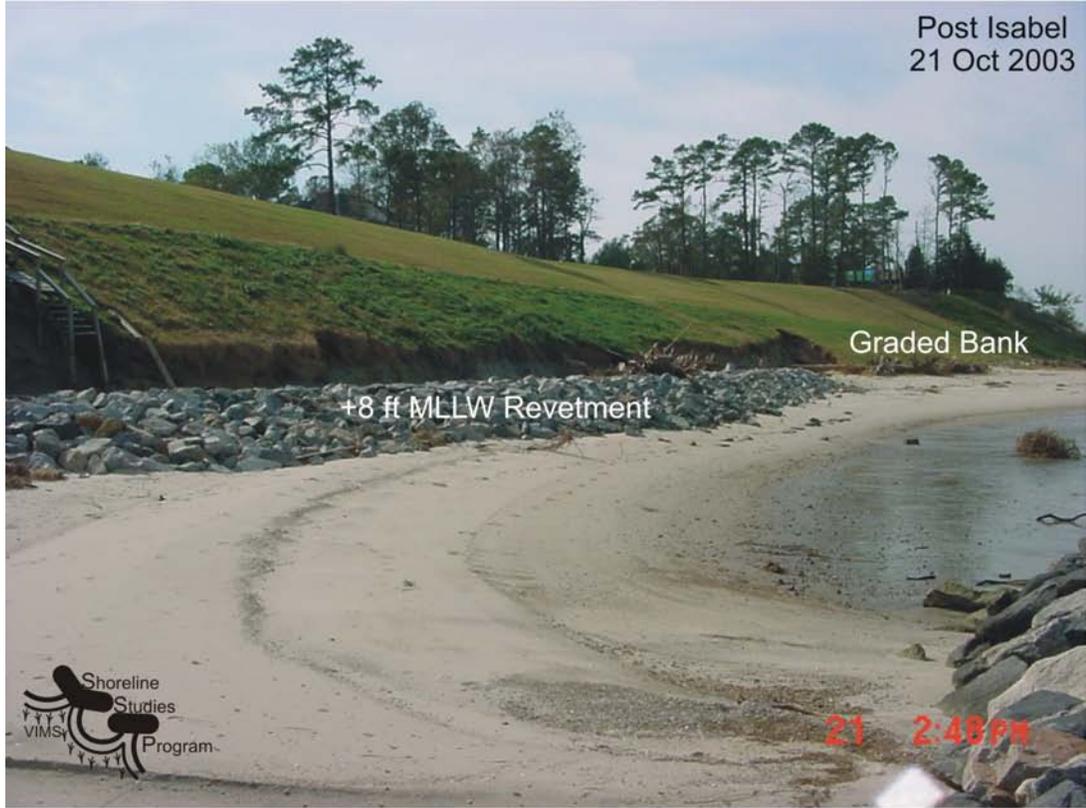
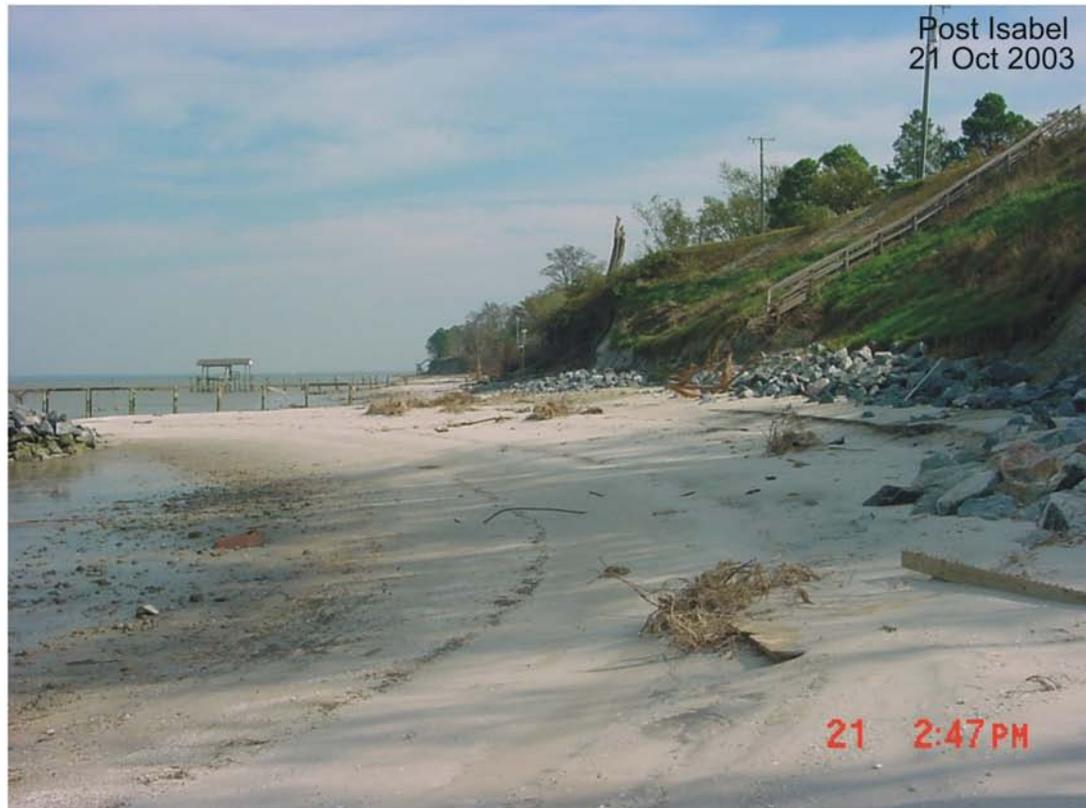
Figure 35. Impacts at downriver end of Van Dyke where shore is protected by a revetment

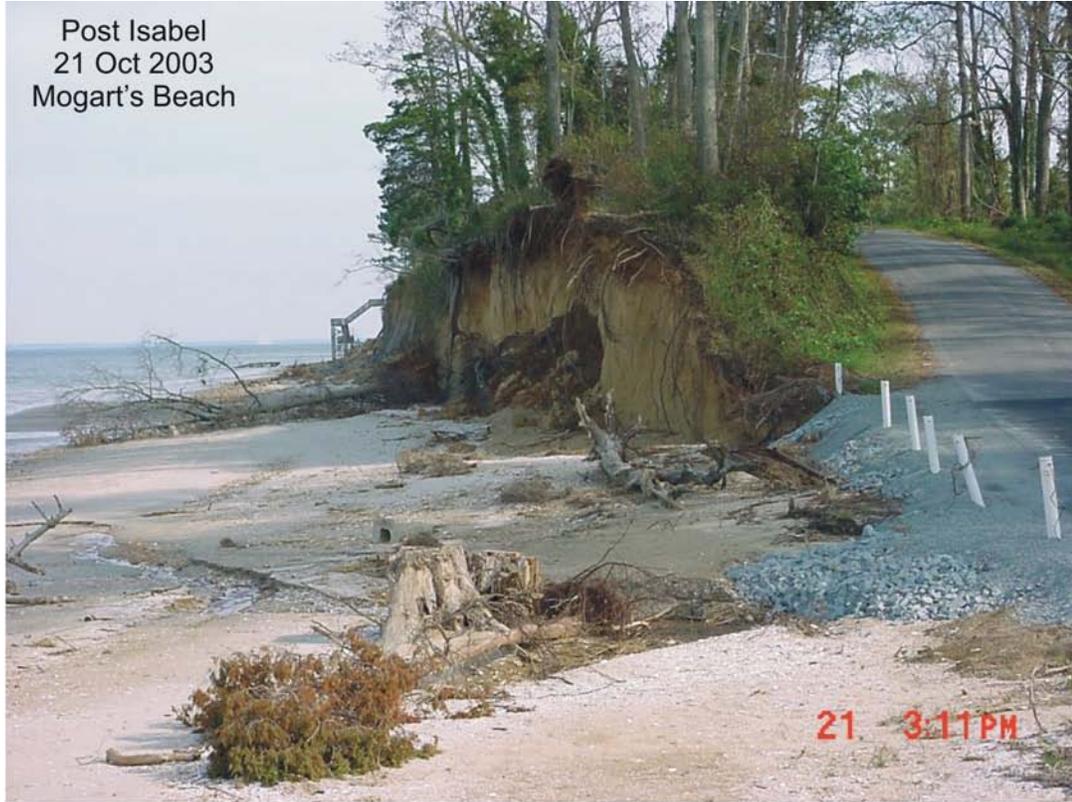
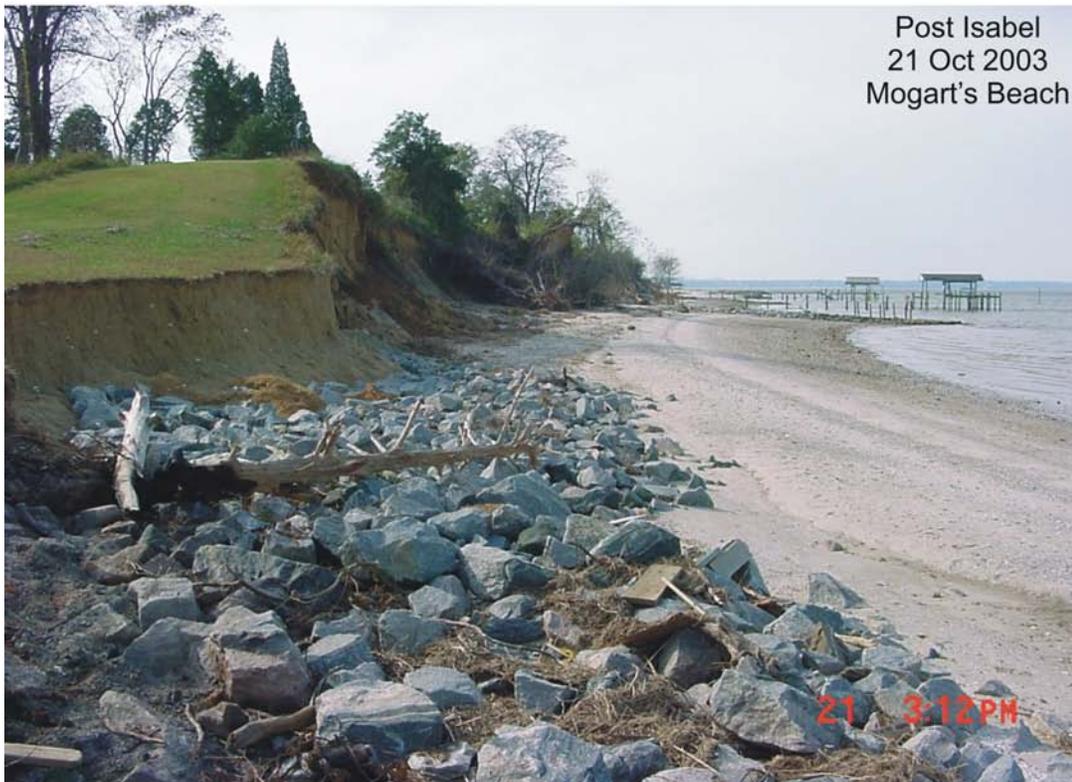
Figure 36. Impacts to shore downriver from Van Dyke at Mogarats Beach

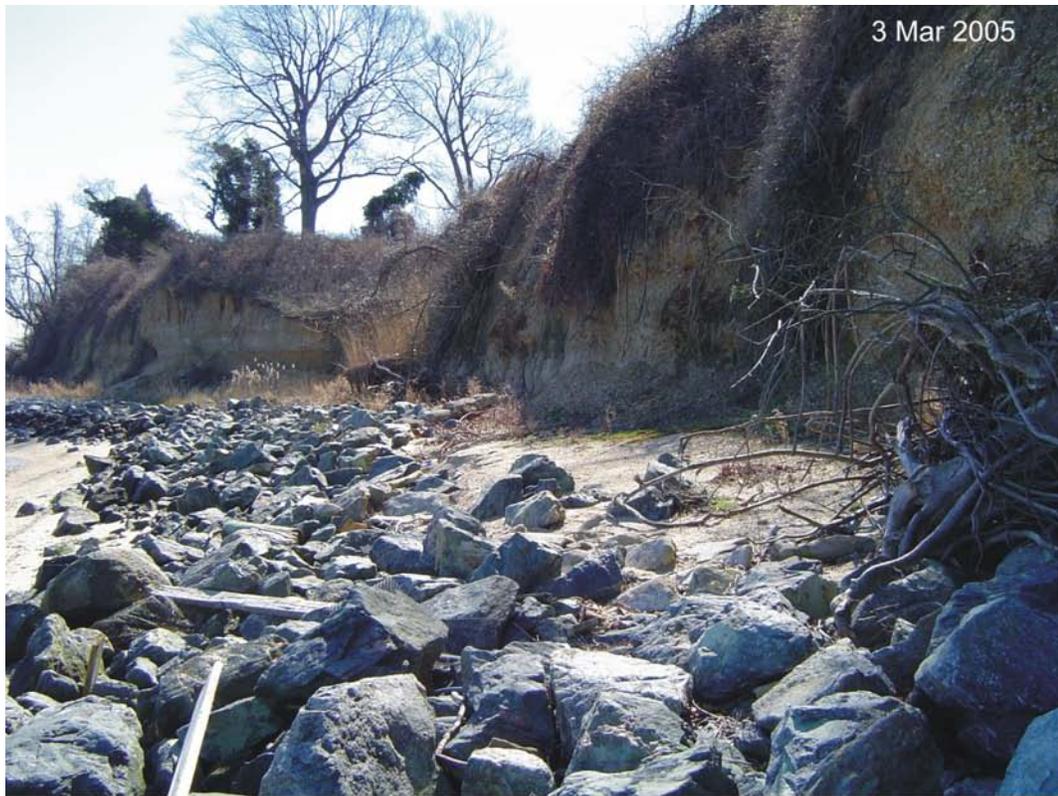
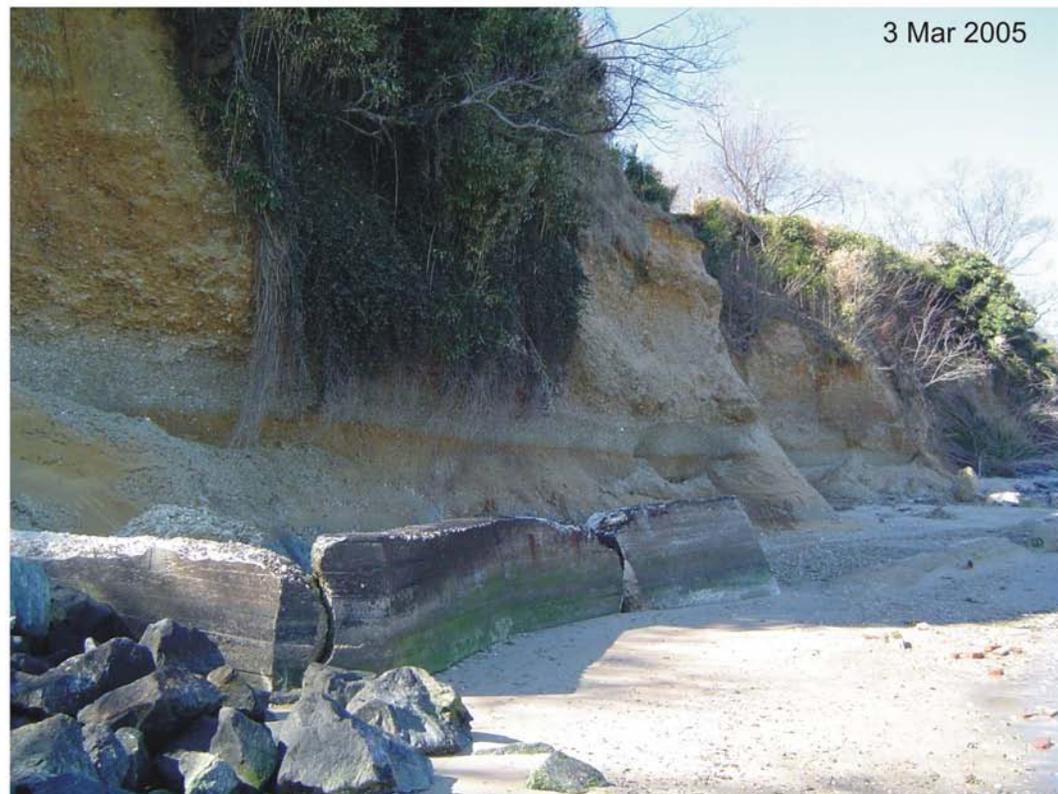
Figure 37. Impacts to shoreline downriver from Yorktown Beach at National Park Service's Moore's House
