TECHNICAL REPORT 1943
July 2006

**Impulse Flashover Tests at
Edgar Beauchamp High Voltage
Test Facility, Dixon, California**
In Support of Cutler Insulator Failure Investigation

P. M. Hansen
SSC San Diego

G. Dann
Naval Facilities Engineering Service Center

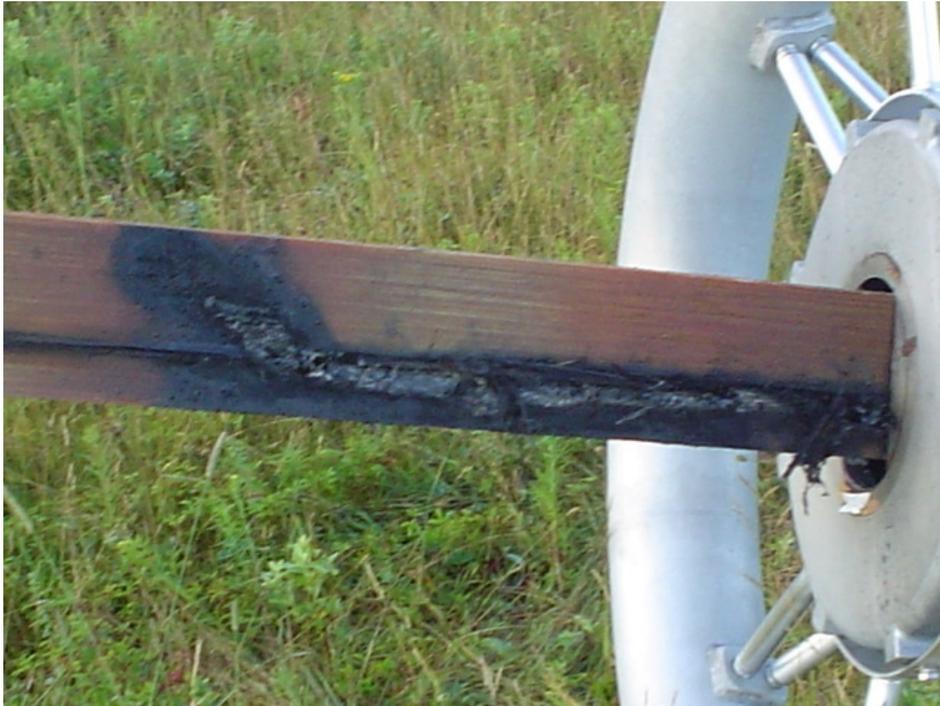
The fourth failure occurred in conjunction with a rare, very large, lightning strike (100-kAmp peak current [3]), which shattered the porcelain tube and heavily tracked the fiberglass belt but left the belt intact structurally (Figure 1).

Figure 1. Cutler safety core insulator failure #4.

The pressure relief diaphragm was intact following the fourth failure. That fact and other analysis reported by Zueck [4] indicated the porcelain was shattered from the outside, by either thermal stress or the shock wave from the high-current lightning bolt.

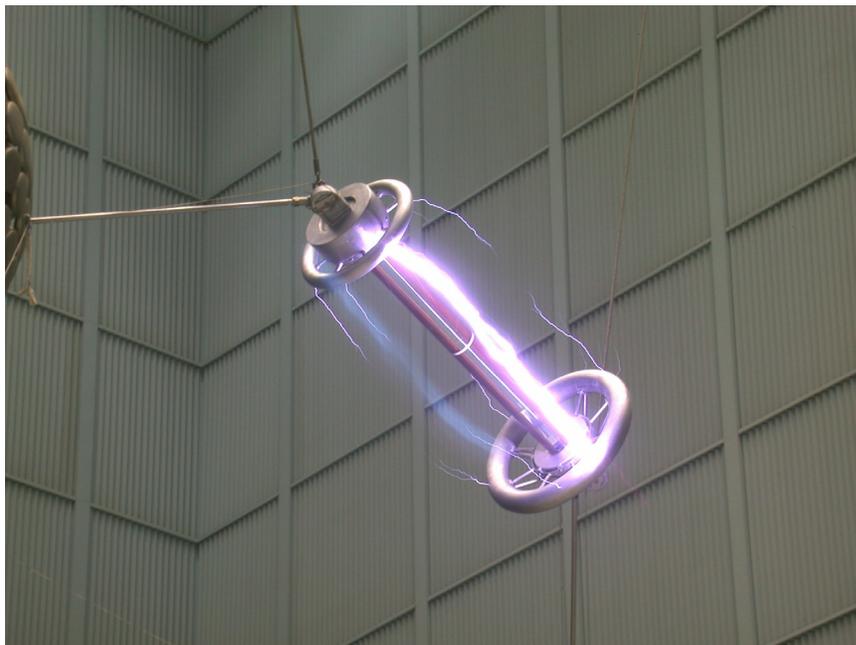
Careful analysis of the test data in the report, especially examination of the pictures, revealed that there was a dV/dt threshold below which flashover occurred in the air and above which the flashover occurred along the surface of the insulator. The threshold for the insulator tested was about $7 \text{ MV}/\mu\text{s}$ (7×10^{12} volts/second). Figure 2 shows the flashover for a voltage waveform with a magnitude of dV/dt above the threshold.

In Figure 2, note that the streamers in the air from ring-to-ring have not quite made connection, while the flashover path down the surface of the insulator has been completed. Also, note that the surface flashover path appears to terminate at the porcelain metal interface of the smaller corona ring (upper end). Lightning simulators of the type used at Hydro Quebec simulate the full threat voltage waveform that might be generated by a lightning strike, but they do not provide the full threat current. Consequently, the flashovers along the surface did not cause any damage inside or outside the insulator.

Figure 2. Cutler safety core test at Hydro Quebec.

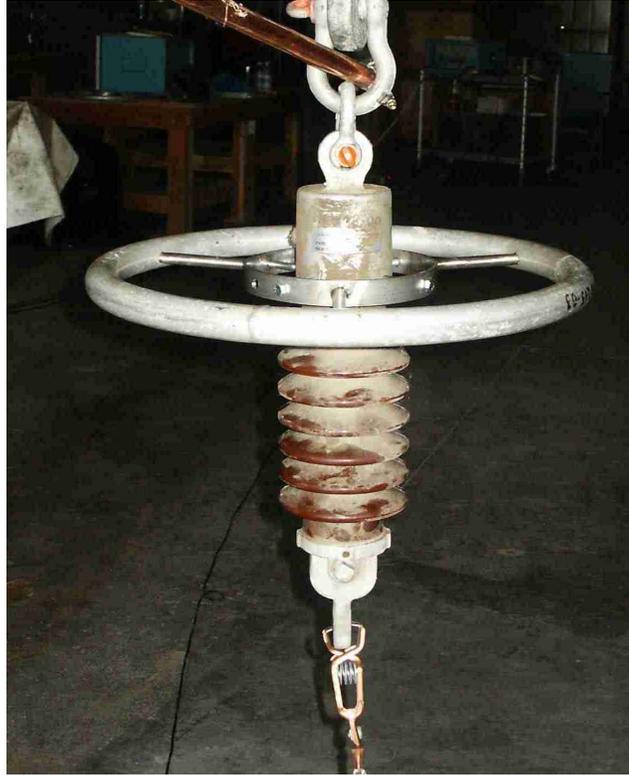
Figure 8. Insulator with bottom ring removed.

This configuration was hit with pulses starting with 10 kV/stage charging voltage and ending with 80 kV/stage. At 30 kV/stage (~ 200 kV peak), the insulator flashed over on roughly half the pulses, and it flashed over consistently at 35 kV/stage (~ 230 kV peak). When the voltage reached 50 kV/stage (~ 333 kV peak) and above, the flashover appeared to be along the insulator's surface.

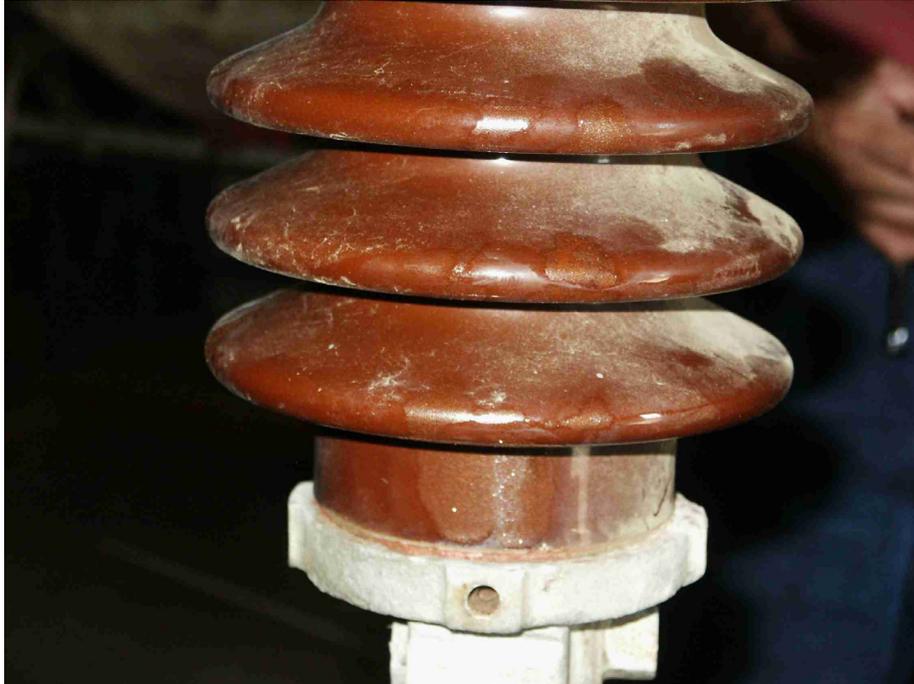
After shutting down and grounding the apparatus, we inspected and found the flat area near the lower end casting and a fingertip-sized area on the tip of each rain shed where the porcelain's glaze appeared to have melted and re-solidified. This is shown as slightly lighter-colored brown areas on the right-hand side of the bottom sheds shown in Figure 9.

Figure 9. Insulator showing damage to glaze.

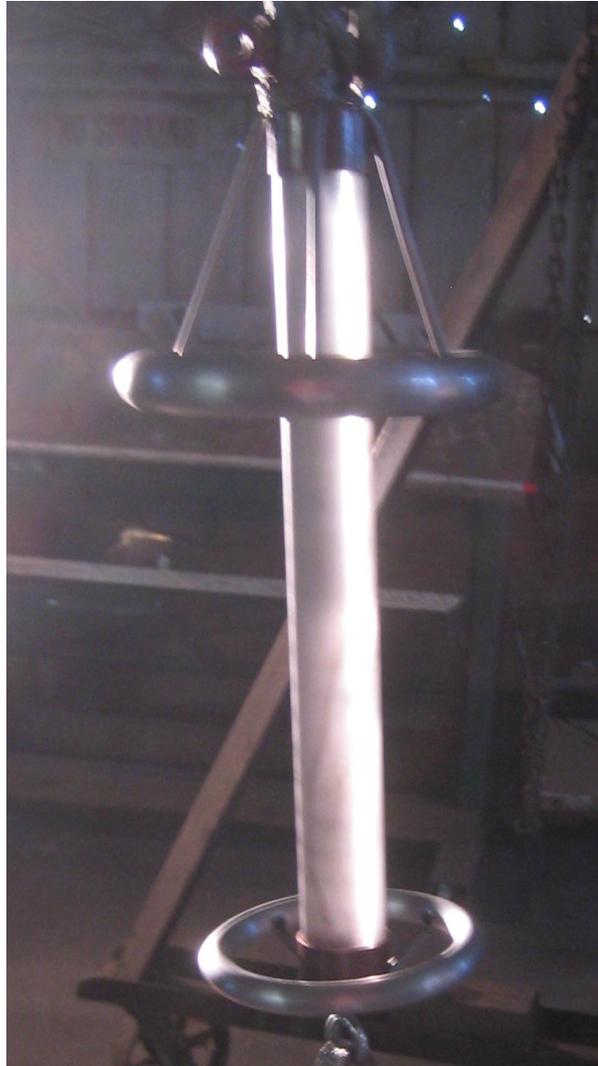
Figure 13. Configuration 5 showing the effect of surface flashover.

By serendipity, we discovered there was a slight modification of the surface of the plastic when flashover occurred along the surface. This was not a carbon track but a slight distortion of the surface, probably caused by surface melting that could be seen upon close examination of the polycarbonate plastic. The surface distortion was apparent when the polycarbonate rod was viewed up close with the back lighting in the test cell, and it can be seen by close examination of Figure 13. The test procedure was modified after this was discovered.

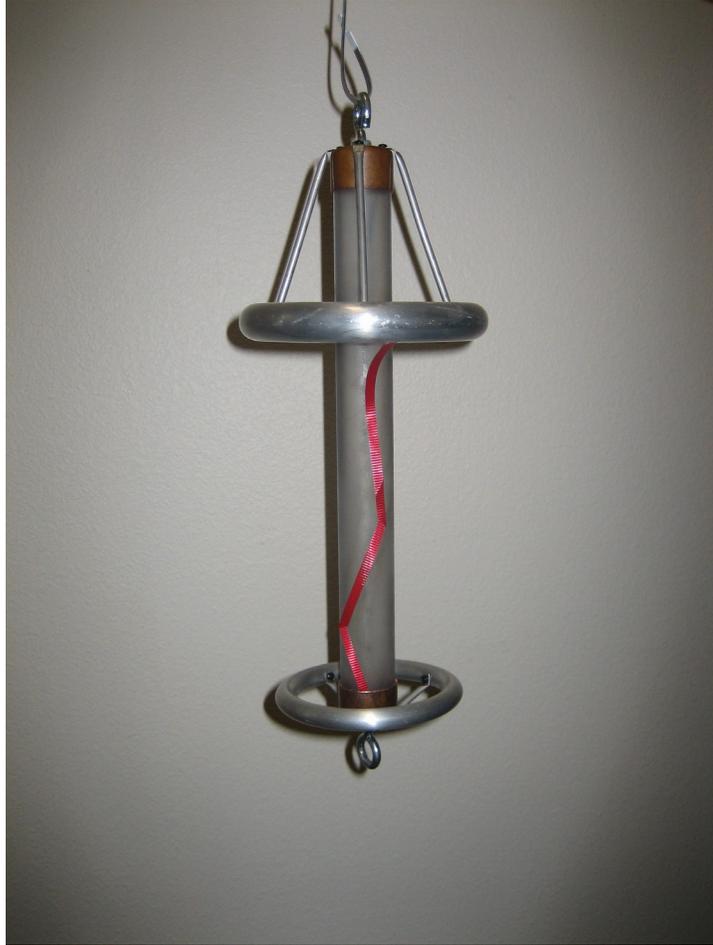
The flashover path for this insulator started on the large ring and went from there through the air to the surface of the polycarbonate rod and then down the rod to the grounded end, terminating at the triple point formed by the edge of the copper end-cap. The lower portion of the surface flashover path can be seen on the insulator surface in Figure 13. Figure 15 shows the model insulator with the flashover path highlighted by a ribbon.

Figure 15. Configuration 5 insulator model with highlighted flashover path.

Note that on the high-voltage end the arc starts on the ring and then goes to the insulator surface, terminating on the triple point at the low-voltage end of the insulator. This same type of behavior was observed in the full-scale testing at Hydro Quebec. During that test, at dV/dt levels where the flashover path was transitioning from being in the air to going completely along the surface, some flashovers seemed to start from the big ring and then dive down to the surface of the insulator body. An example of this is shown in Figure 16.

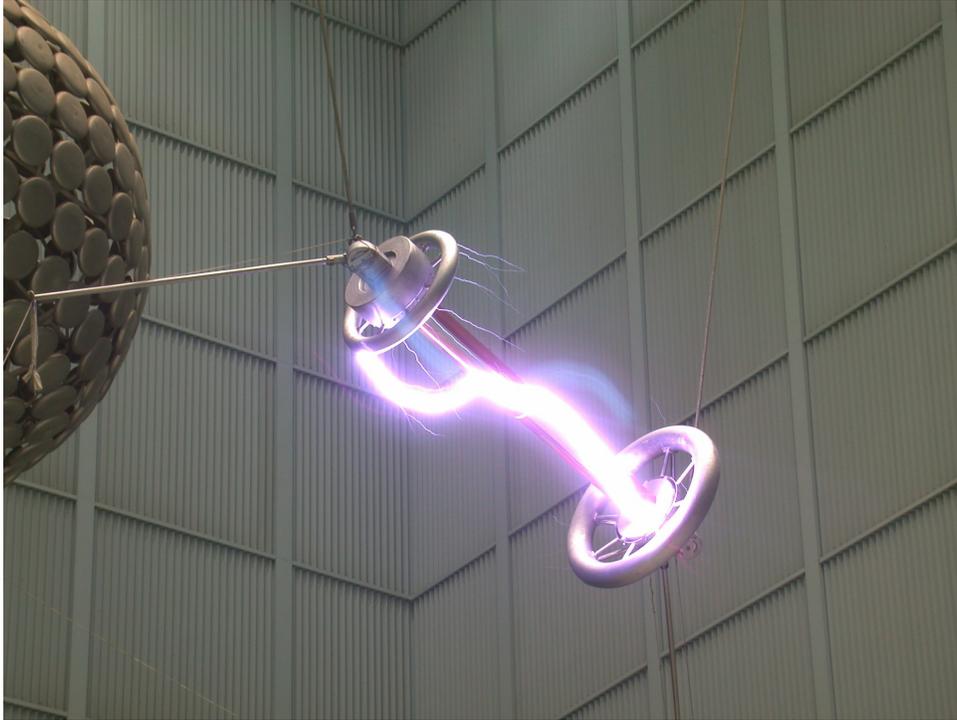
Figure 16. Cutler insulator at Hydro Quebec showing partial surface flashover.

It is interesting to note in Figure 16 that the surface termination point of the arc is at the triple point on the high-voltage (large ring) end of the insulator.
