THE NATIONAL SHIPBUILDING RESEARCH PROGRAM

**1991 Ship Production Symposium
Proceedings:
Paper No. IIIB-2
Permanent Composite Cladding of
Deteriorating Steel Hulls**

Permanent Composite Cladding of Deteriorating Steel Hulls

Albert W. Horsmon, Jr., Visitor, University of Michigan Transportation Research Institute

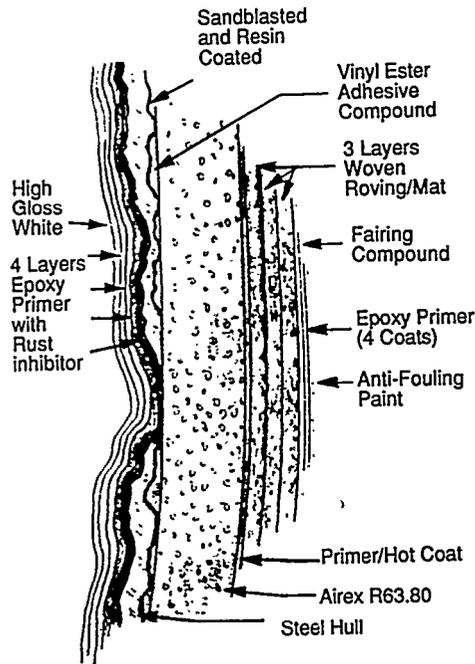
Figure 1
FRP CLADDING

The basics of the FRP cladding are shown in Figure 1 (6). The MEDEA's steel hull was blasted to white metal and given a thin coat of vinyl ester resin to quickly seal the bare steel. A linear polyvinyl chloride (PVC) foam was vacuum bonded to the hull with a putty resin and faired, and three layers of woven glass fibers alternating with chopped strand mat (CSM) were bonded to the foam. Finally the FRP was faired, then painted
