Laboratory and Field Investigations of Small Crater Repair Technologies

Lucy P. Priddy, Jeb S. Tingle, Timothy J. McCaffrey,
and Ray S. Rollings

September 2007

Final report

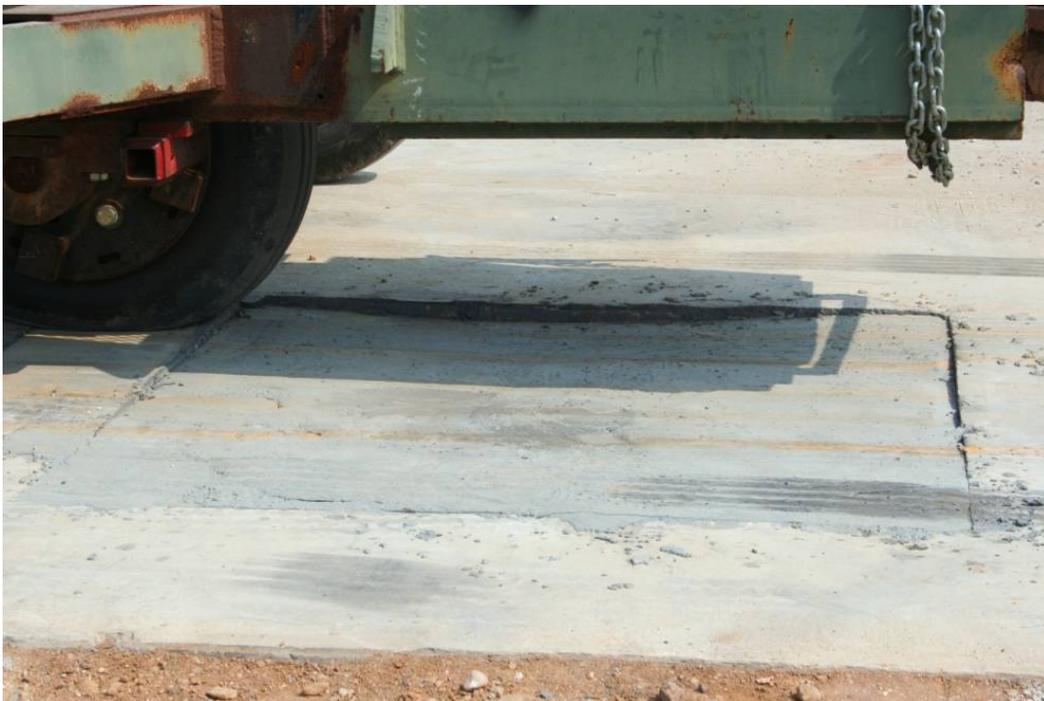
HWD and roughness measurements were performed prior to traffic. Due to load cart problems, tests could not be performed until 3 hr after the repair was completed. After the completion of one pass, the pressure cell measuring capacity was over ranged by the load cart. The patch deformed under the tire load but remained elastic until 10 passes. After this time, deformation became permanent, and after 30 passes, no more traffic could be applied to lane 5 due to complete loss of bond of the patch to the edge receiving loading (Figure 101). After 62 passes, the 1.25-in. roughness criteria were exceeded with maximum deformation on the repair edges reaching 1.56 in. The east edge experienced 3/16-in. separation. In addition, 1.5-ft and 5-ft low severity cracks were noticed near the northwest and southeast corners, respectively (Figure 102). Trafficking was discontinued on this repair, and the product was not recommended for Series 2 testing.

Figure 101. Crater A: Debonding of repair to slab on the south and west edges.

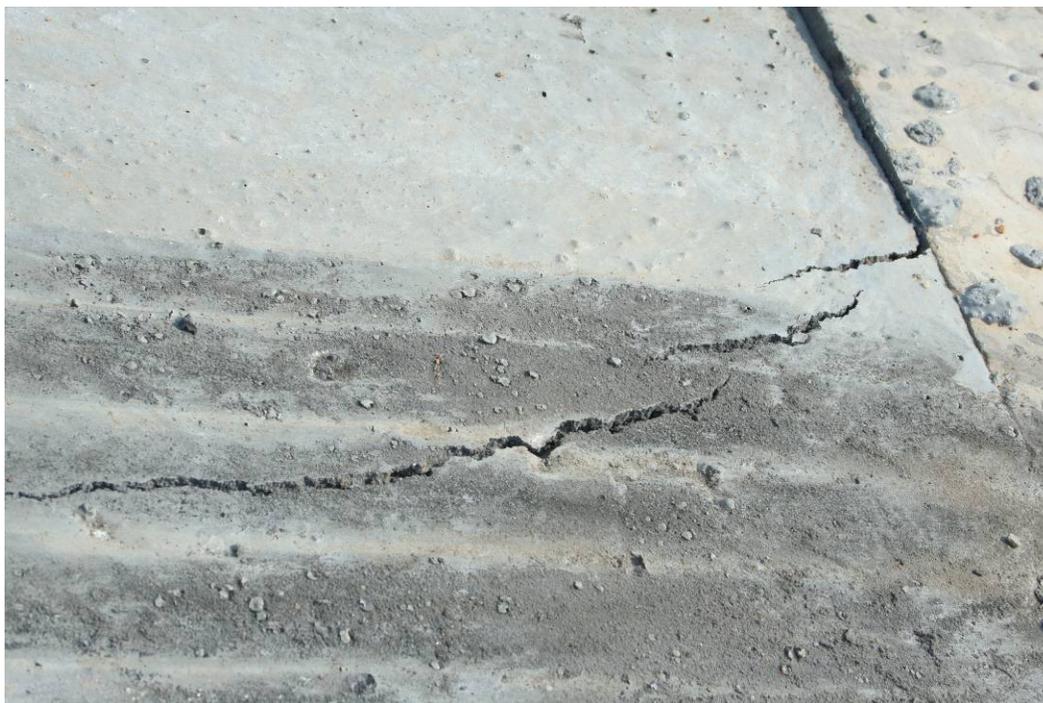
Figure 102. Crater A: Cracking and debonding of repair on west edge.

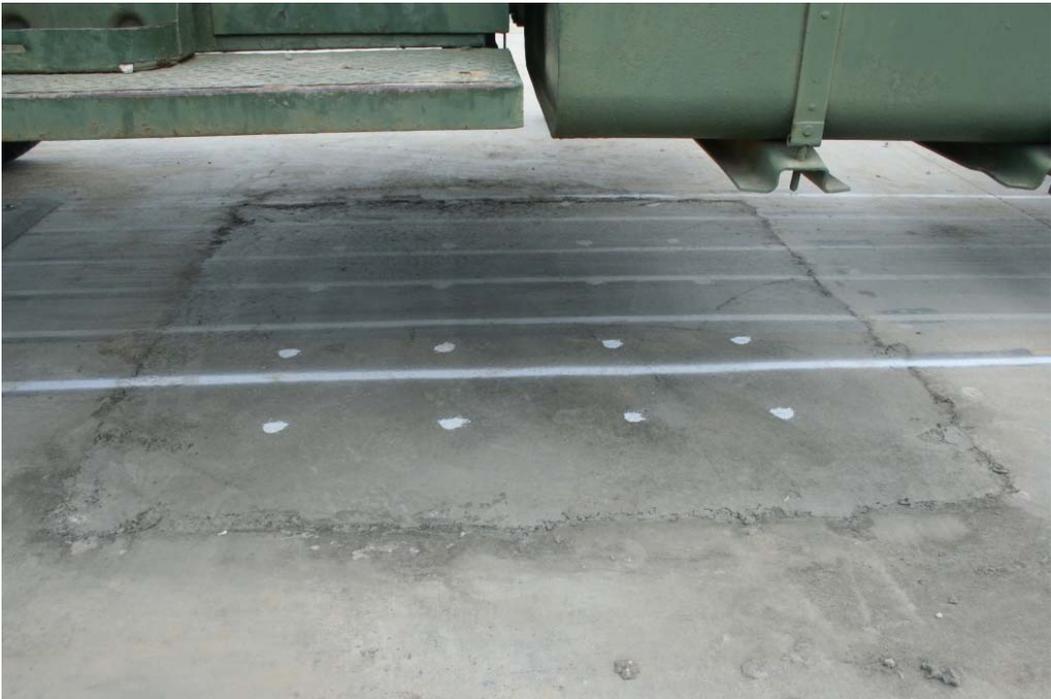
HWD and roughness measurements were performed prior to traffic. After 80 passes, minor spalling was noticed on the northwest edge as shown in Figure 109. The spalling did not progress significantly and a total of 112 passes were applied with the load cart with no cracking, noticeable deformation, or additional FOD. Expedient criteria were met with this repair. Figure 110 shows the crater spalling on the northwest edge.

Figure 109. Crater C-2. Under traffic.

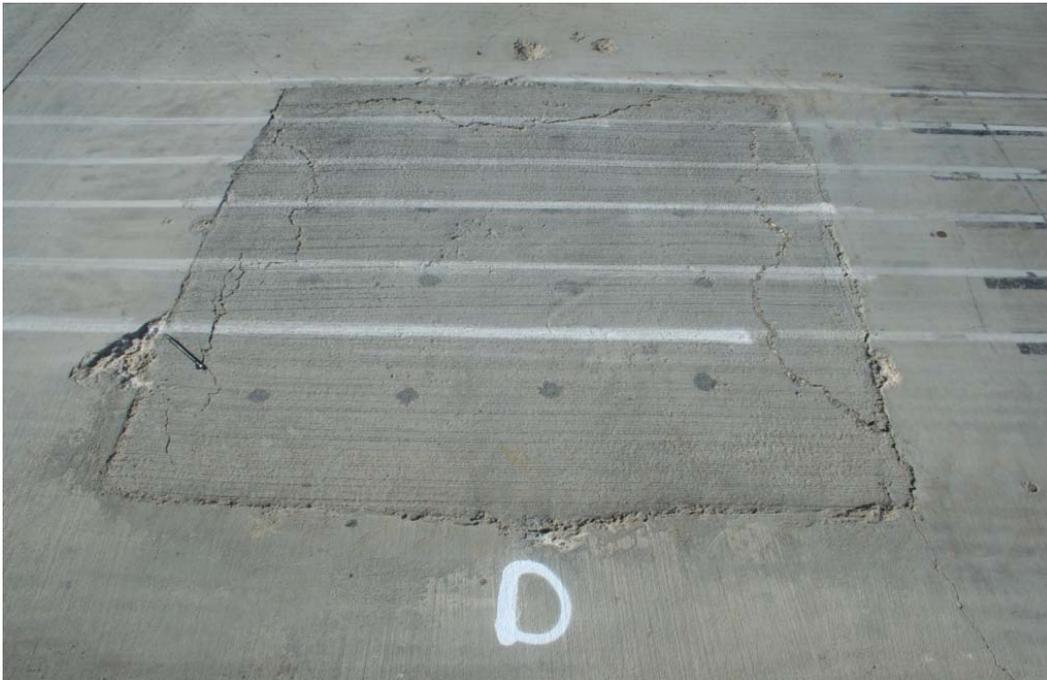
Figure 111. Crater D. Cracking and spalling of the south, east, and west edges after 320 passes.

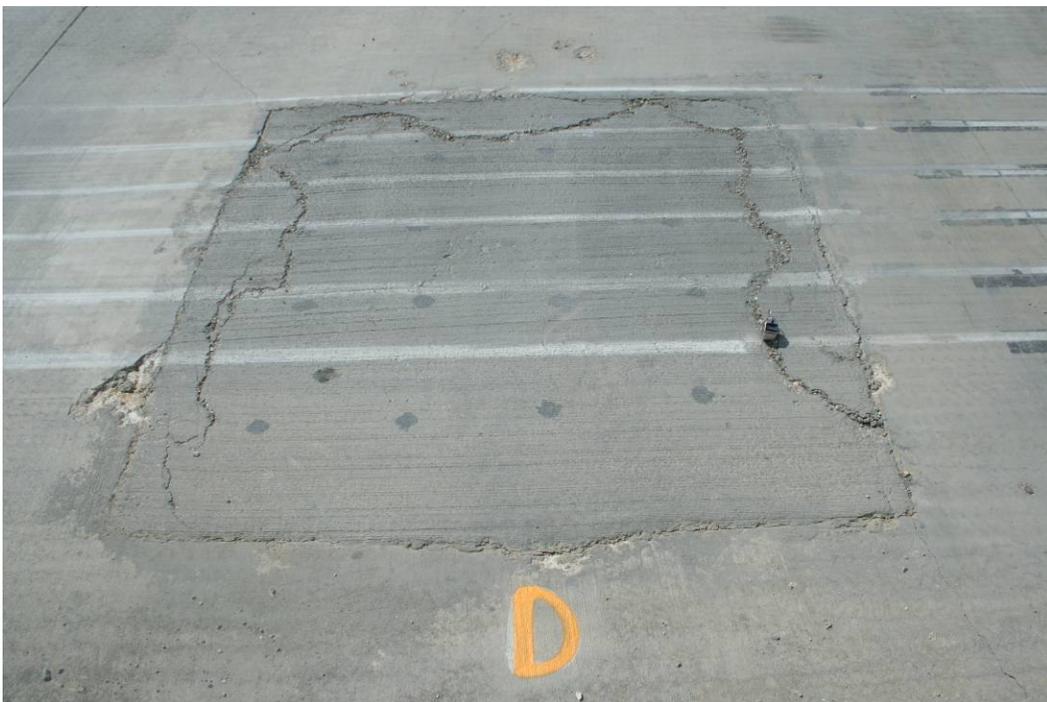
Figure 112. Crater D. Cracking and spalling of the south, east, and west edges after 688 passes.

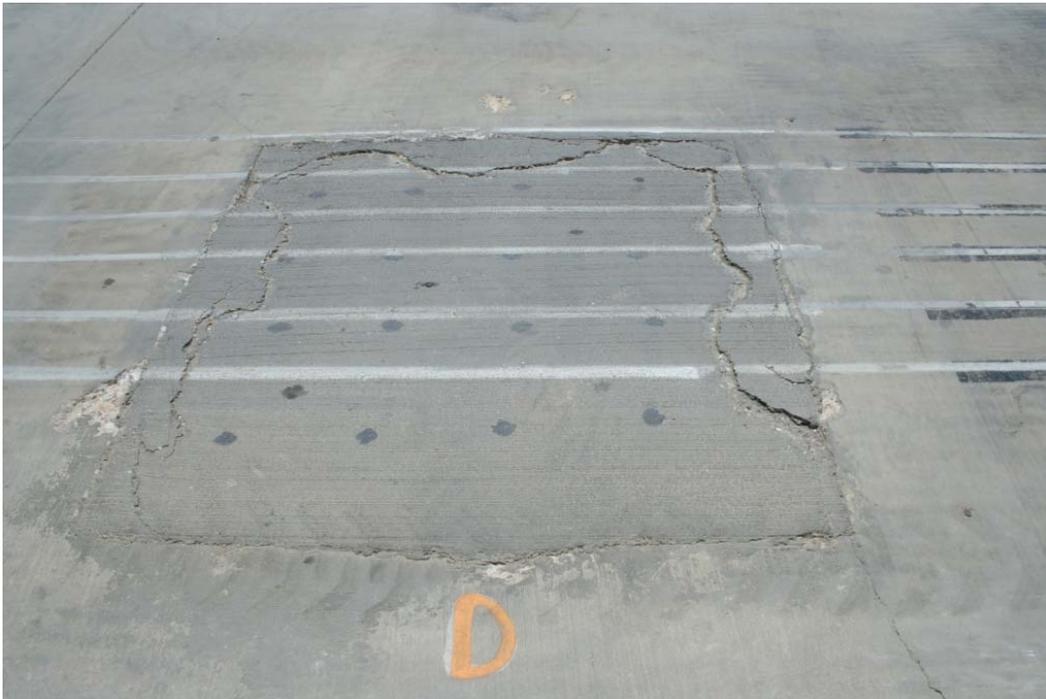
Figure 113. Crater D. Cracking and spalling - south, east, and west edges after 720 passes.

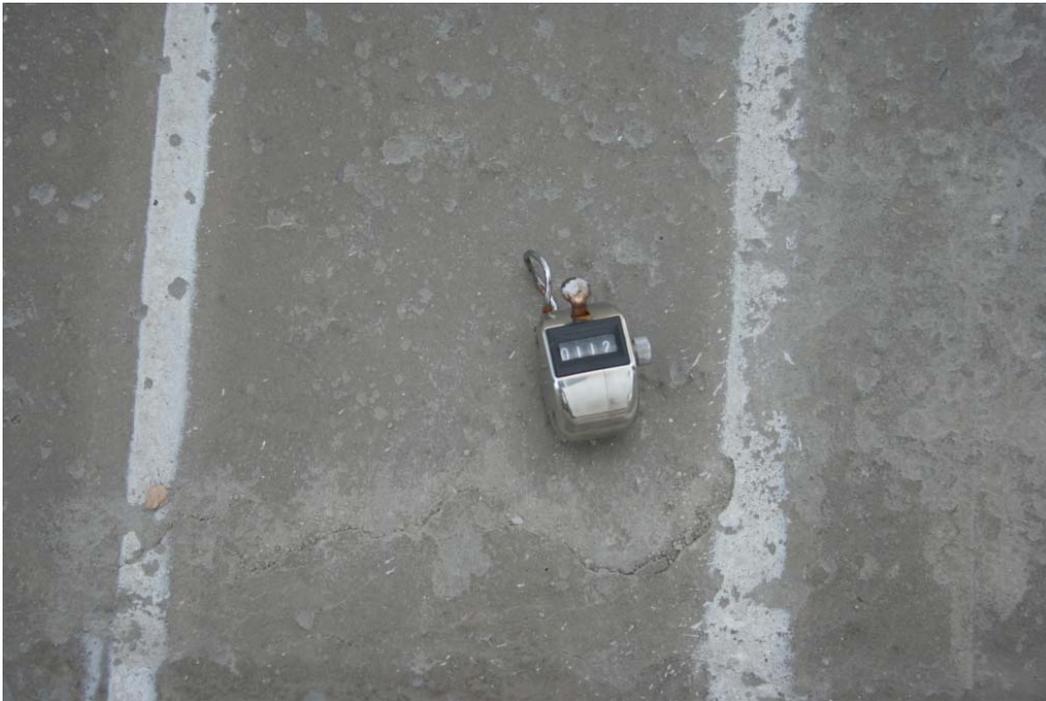
HWD and roughness measurements were performed prior to traffic. After 32 passes, minor spalling was noticed along the south joint (Figure 114). Popping noises accompanied this spalling. The spalling did not progress significantly, and a total of 112 passes were completed by the load cart with no cracking, noticeable deformation, or additional FOD. Expedient criteria were met with this repair.

Figure 114. Crater E. Cracking along the south joint.

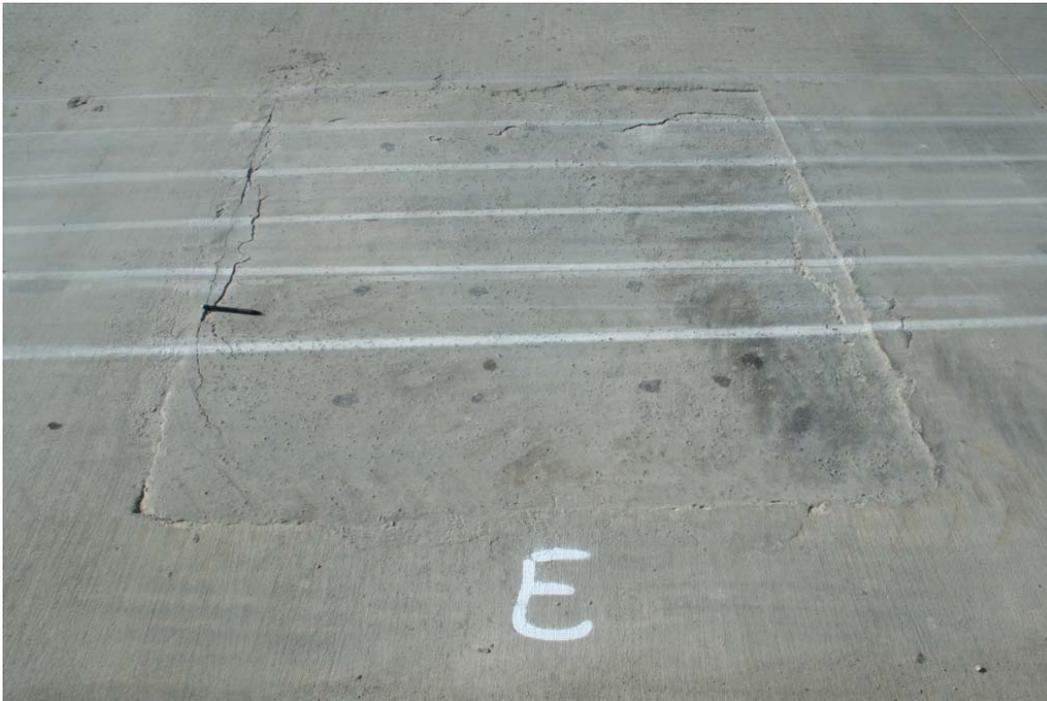
Figure 115. Crater E. Cracking and spalling along the south, east, and west edges after 182 passes.

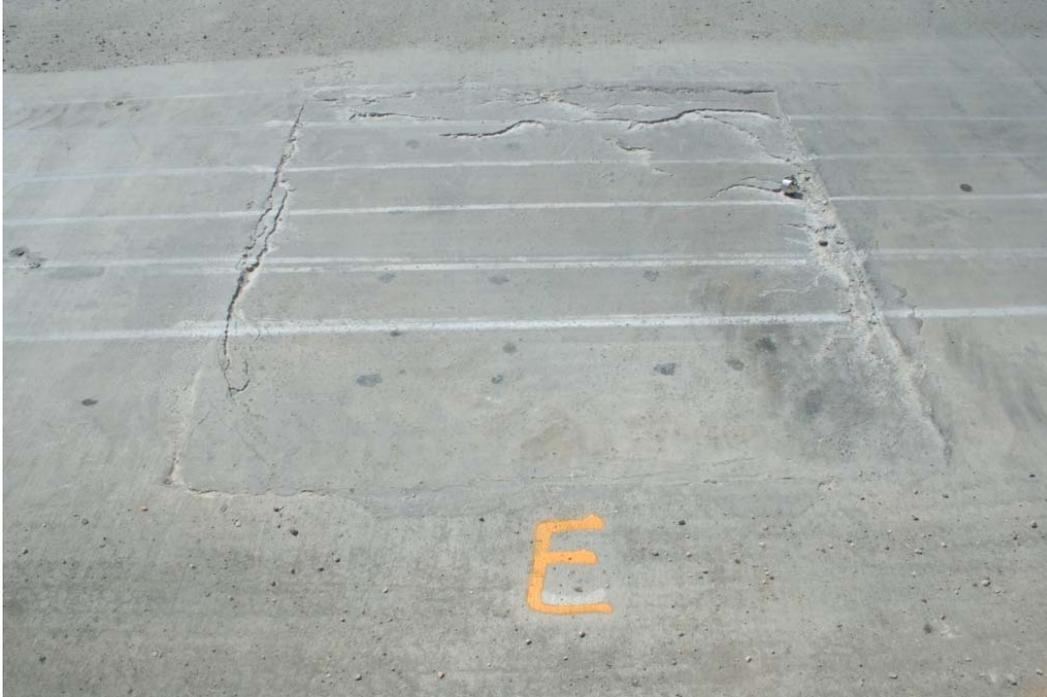
Figure 116. Crater E. Spalling along the south, east, and west edges after 688 passes.

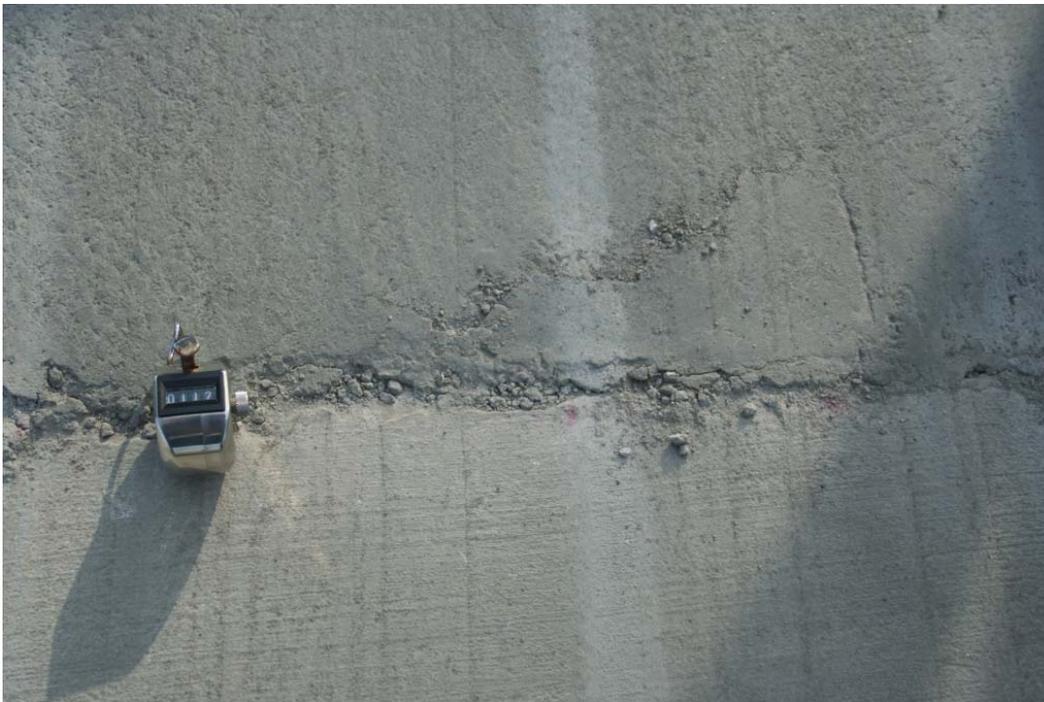
Figure 117. Crater F. Cracking on northeast corner after 112 passes.

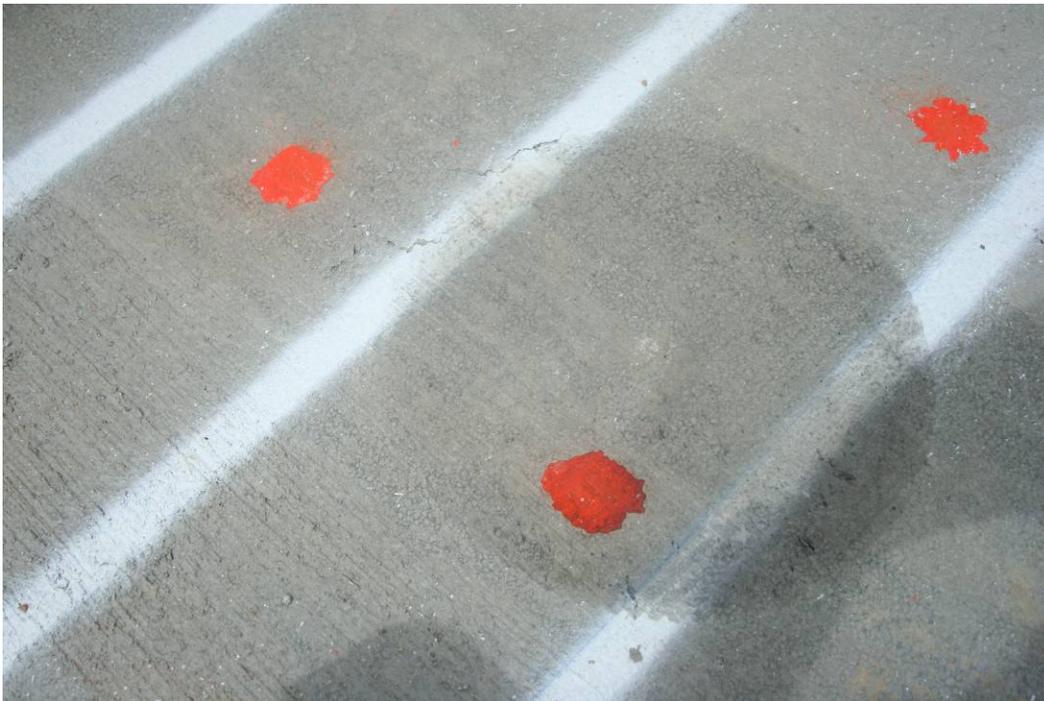
Figure 120. Crater G-1. Cracking caused by HWD testing.

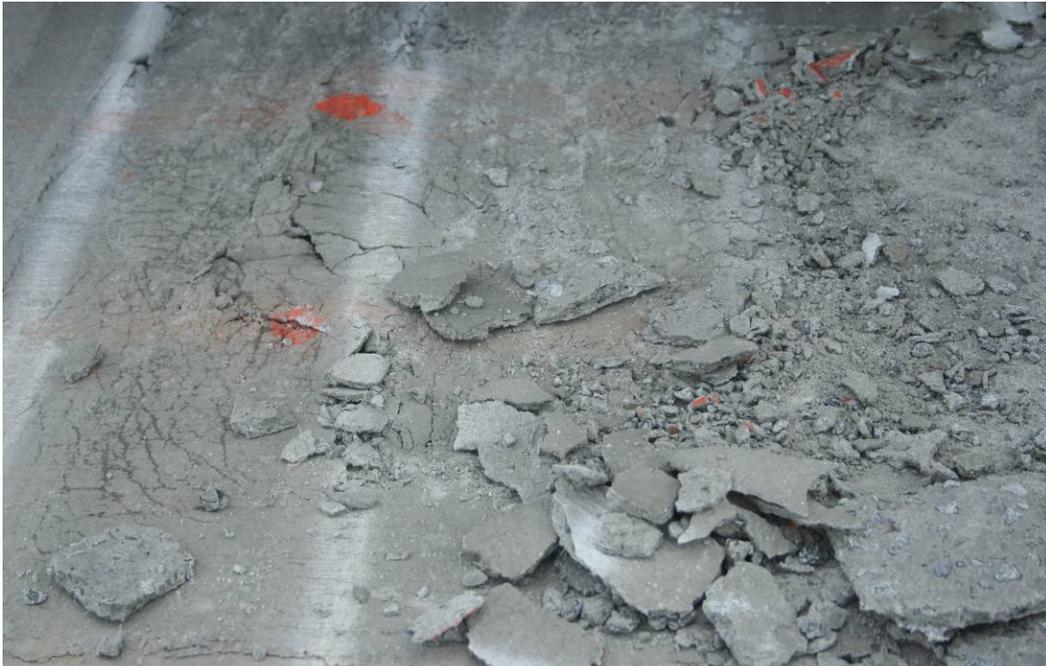
Figure 121. Crater G-1. Failure after 16 passes.

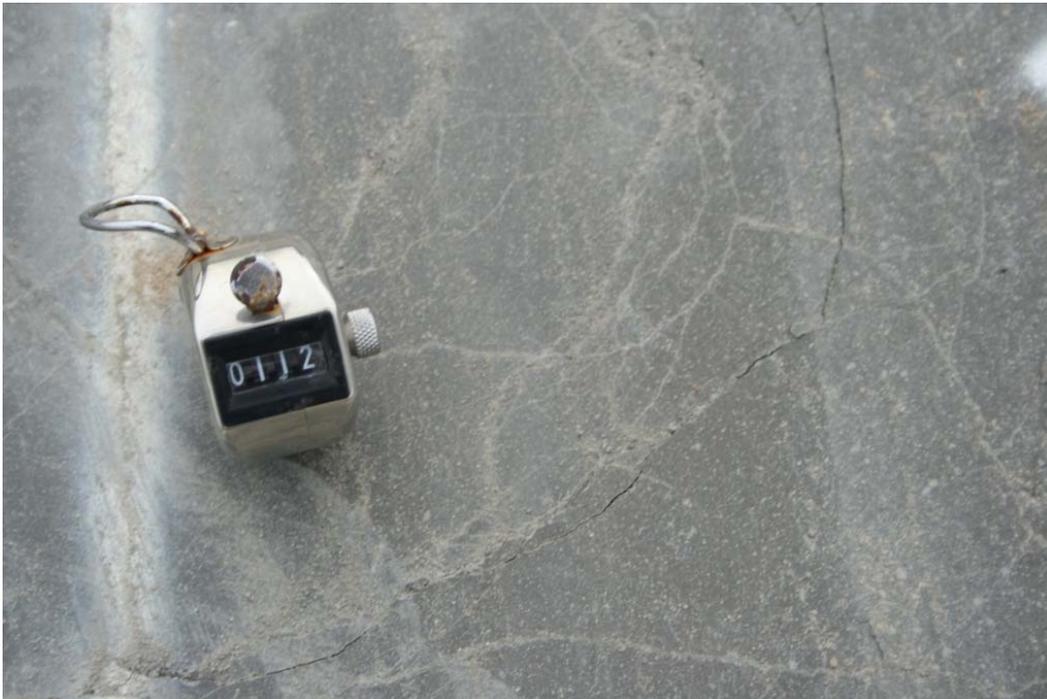
Figure 123. Crater G-2. Map cracking after 112 passes.

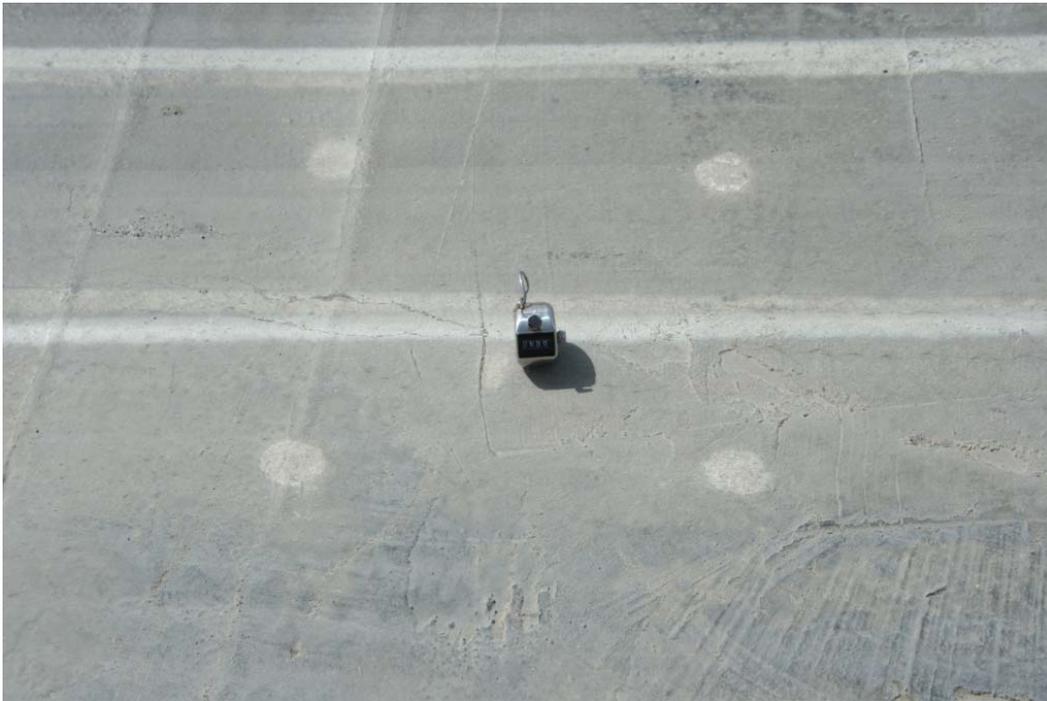
Figure 127. Crater H. Cracks in center of crater after 320 passes.

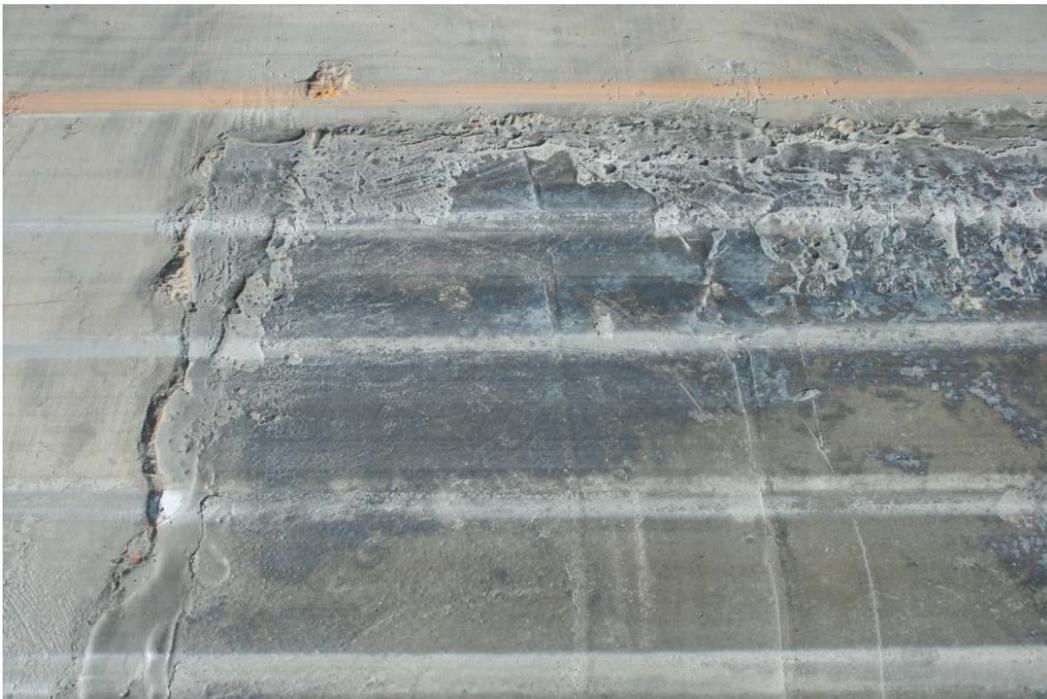
Figure 128. Crater H. Cracking along east and south edges after 920 passes.

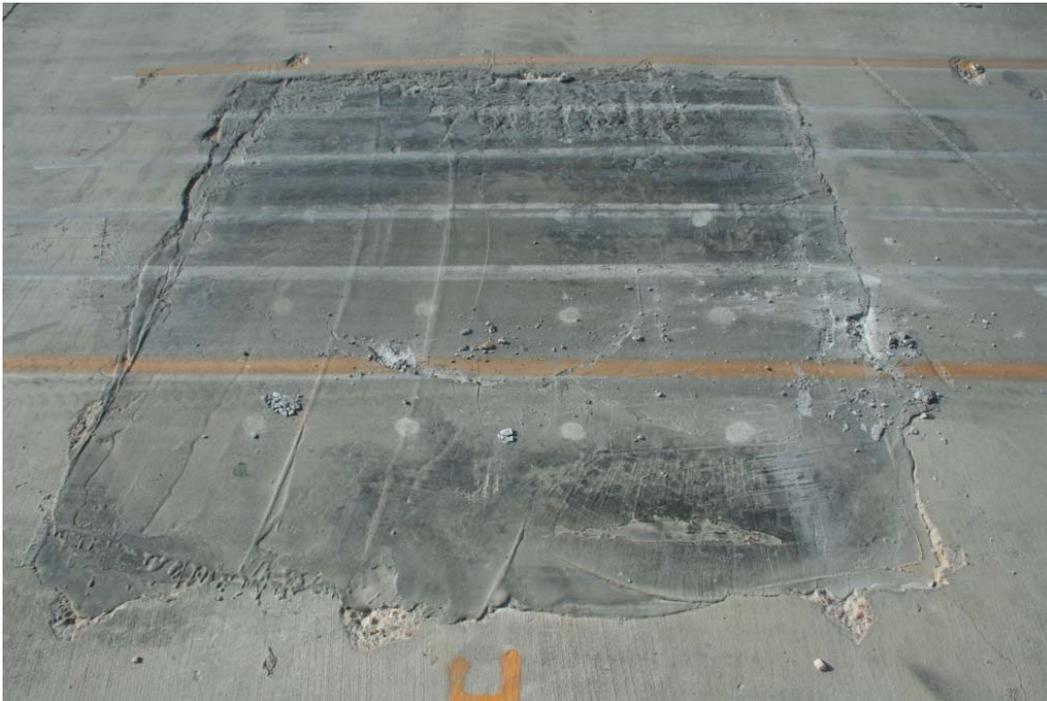
Figure 129. Crater H. Cracking after 1,344 passes.

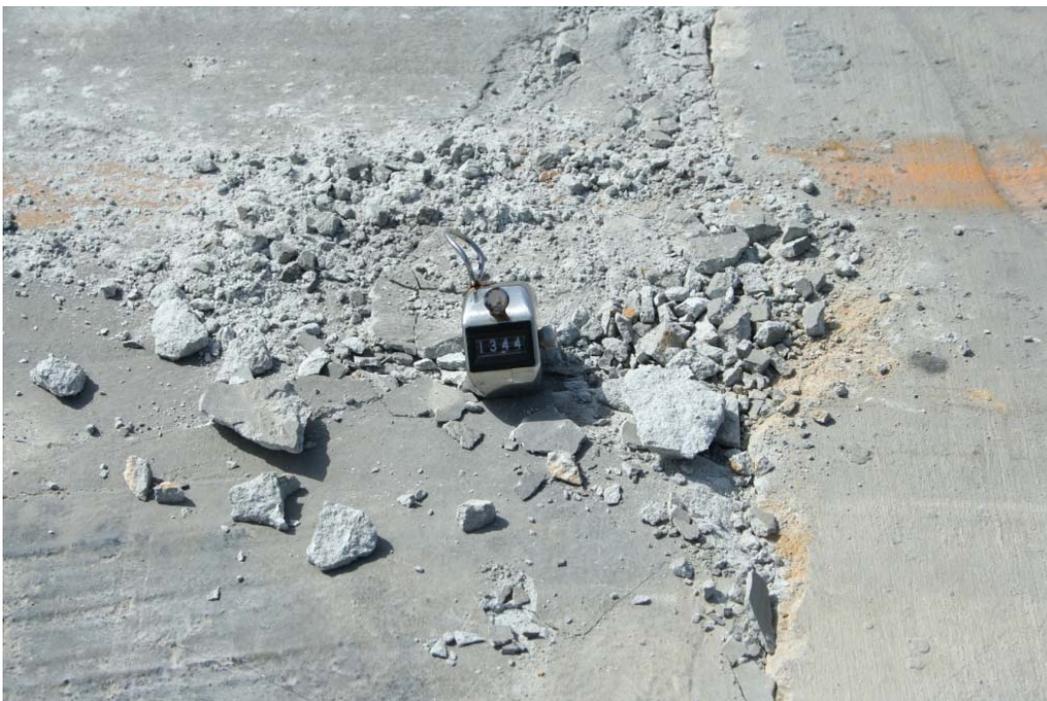
Figure 130. Crater H. High severity joint spall after 1,344 passes.

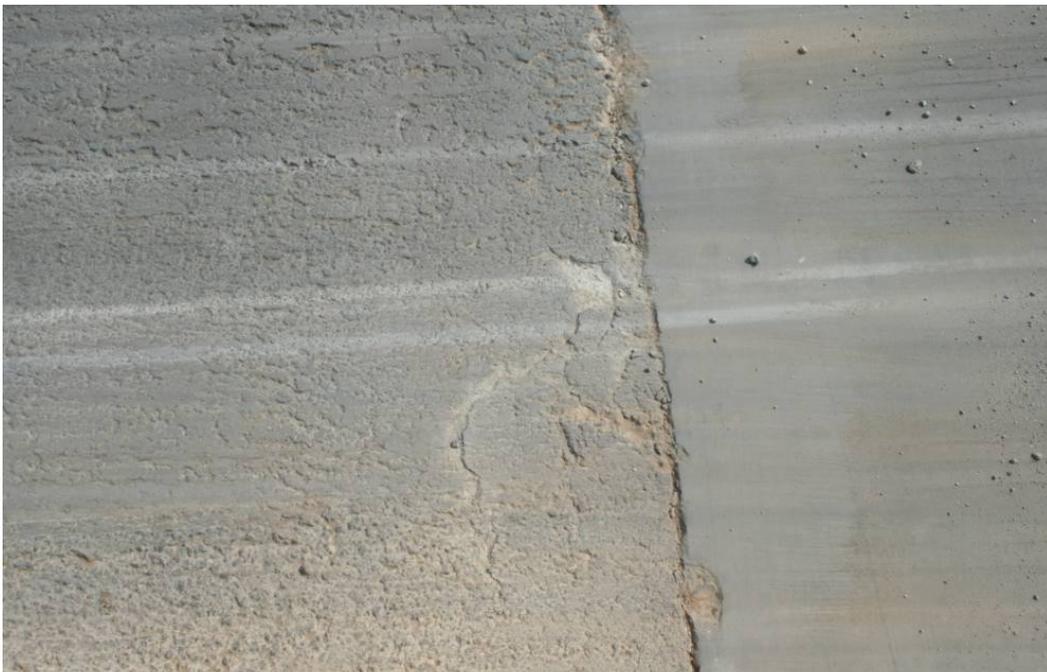
Figure 134. Crater J. Spalling on the south edge after 1,008 passes.

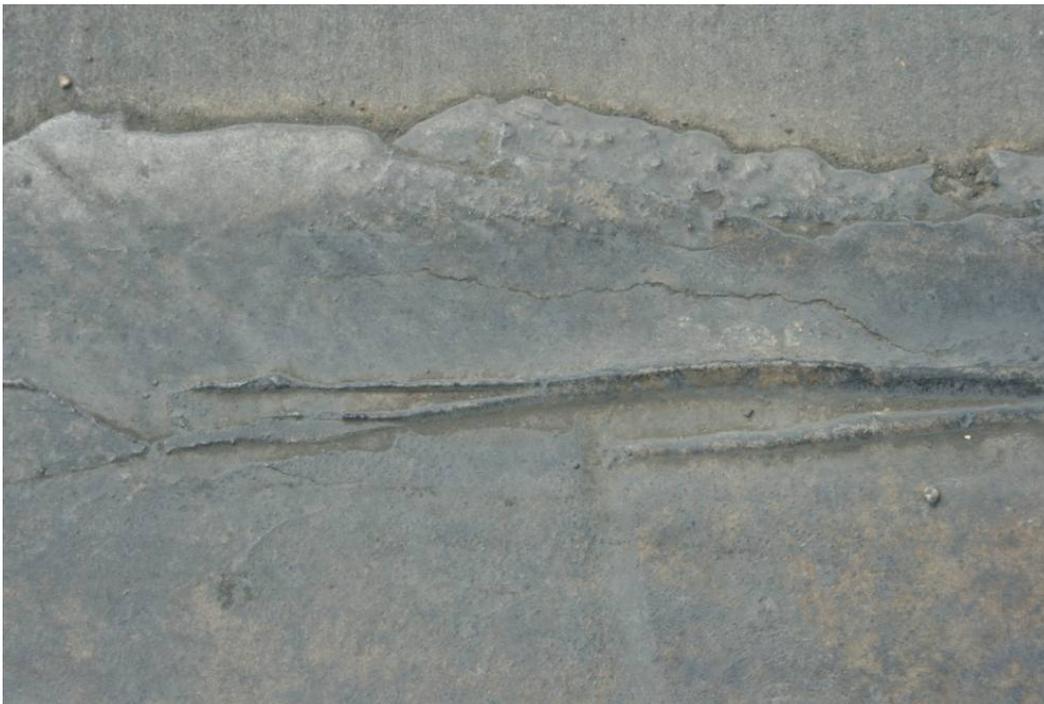
Figure 137. Crater K. Hairline crack after 5,000 passes.

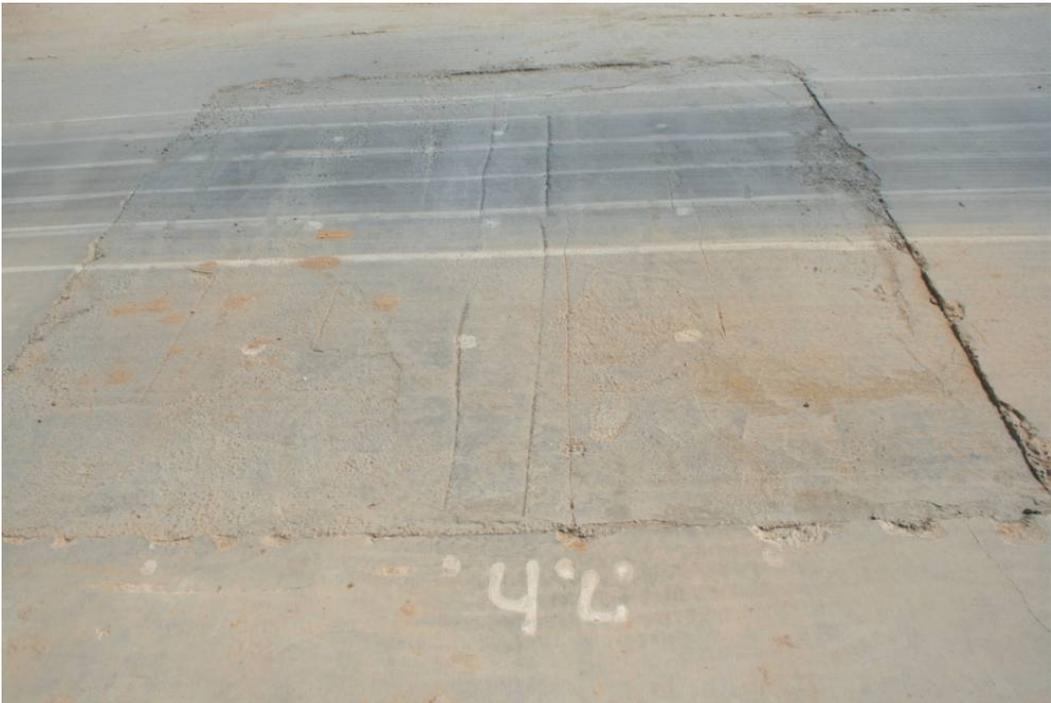
Figure 138. Crater L. Spalling and edge cracking on loaded edges after 336 passes.

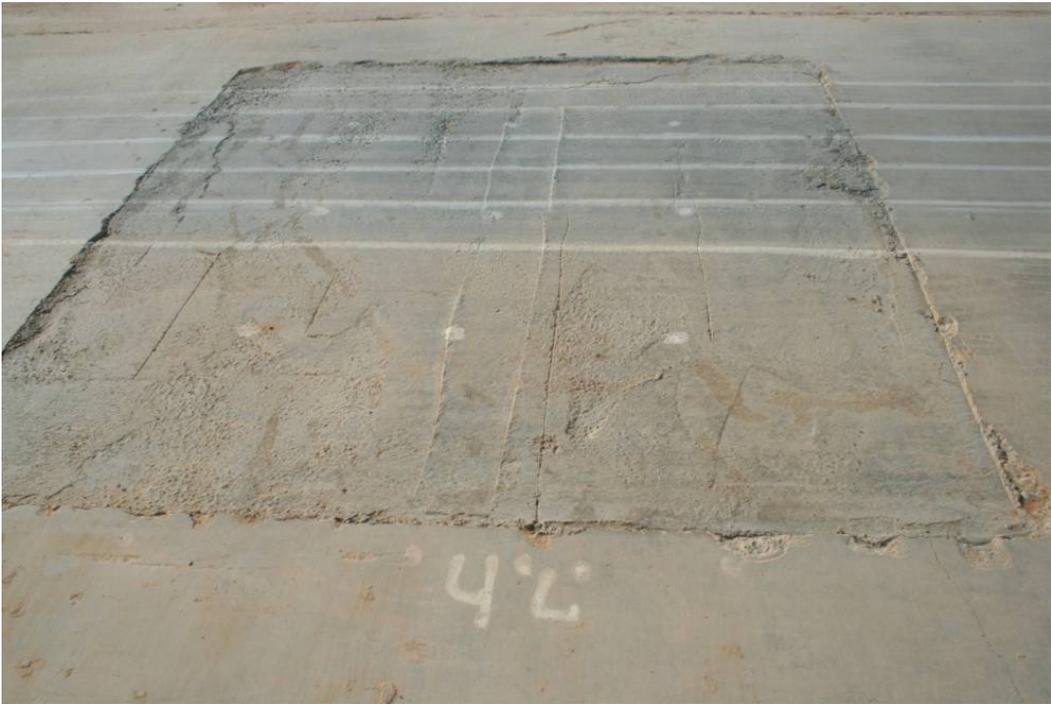
Figure 139. Crater L. Spalling and edge cracking on loaded edges after 1,008 passes.

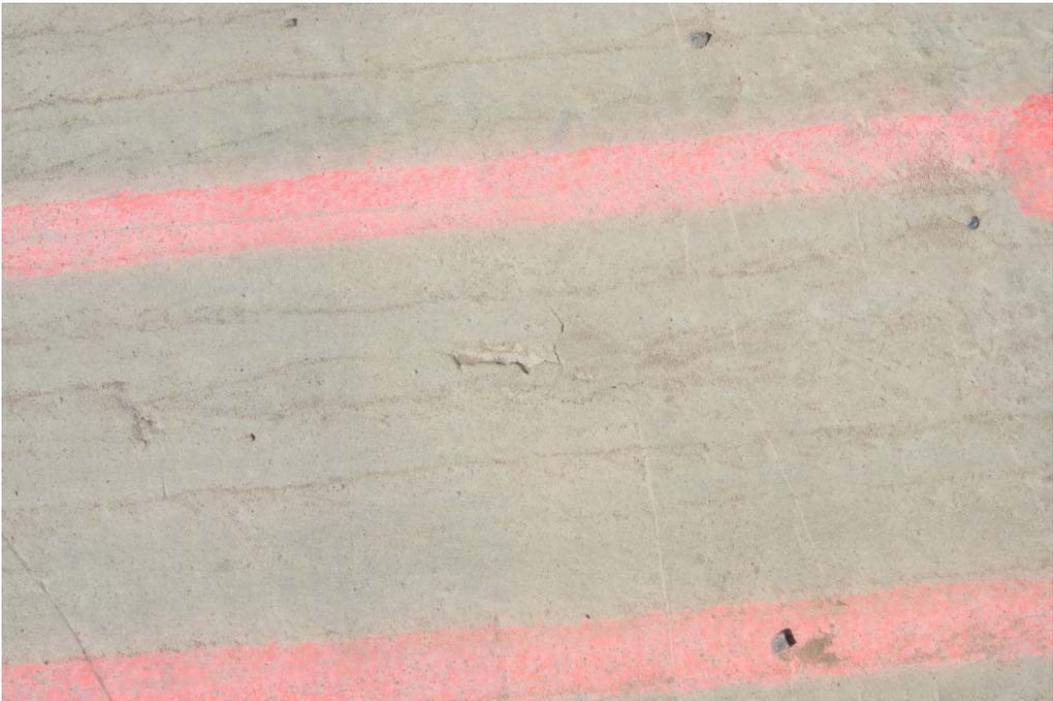
Figure 141. Crater Q. Rapid Set shrinkage cracking pre-traffic.

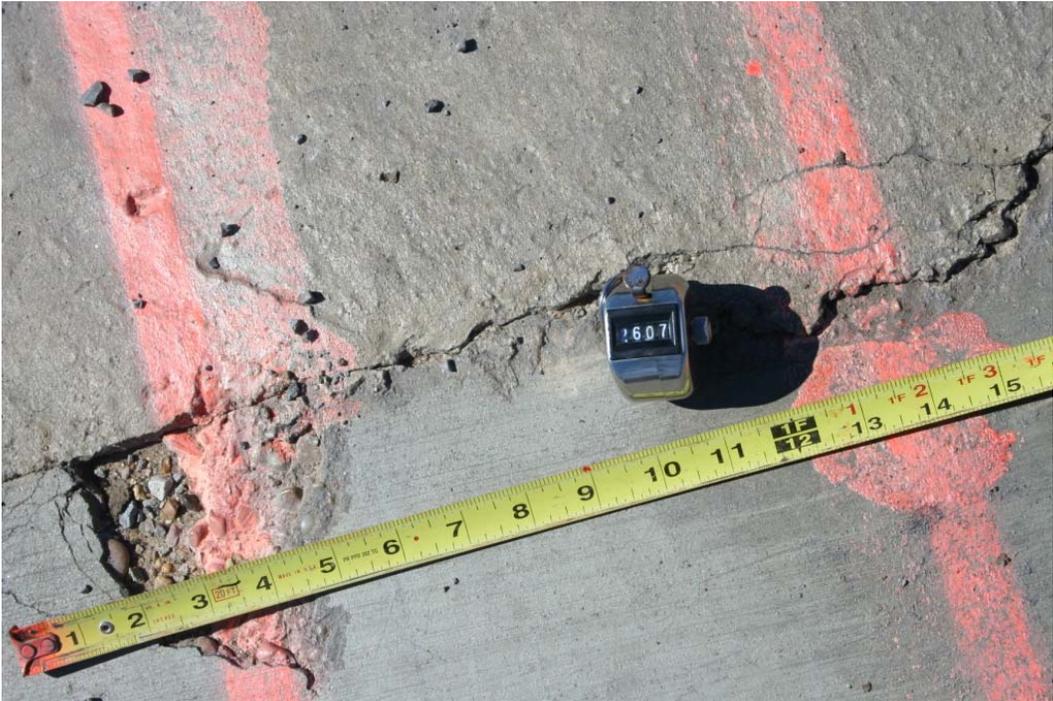
Figure 142. Crater Q. Rapid Set cracking on the south edge after 2,000 passes.

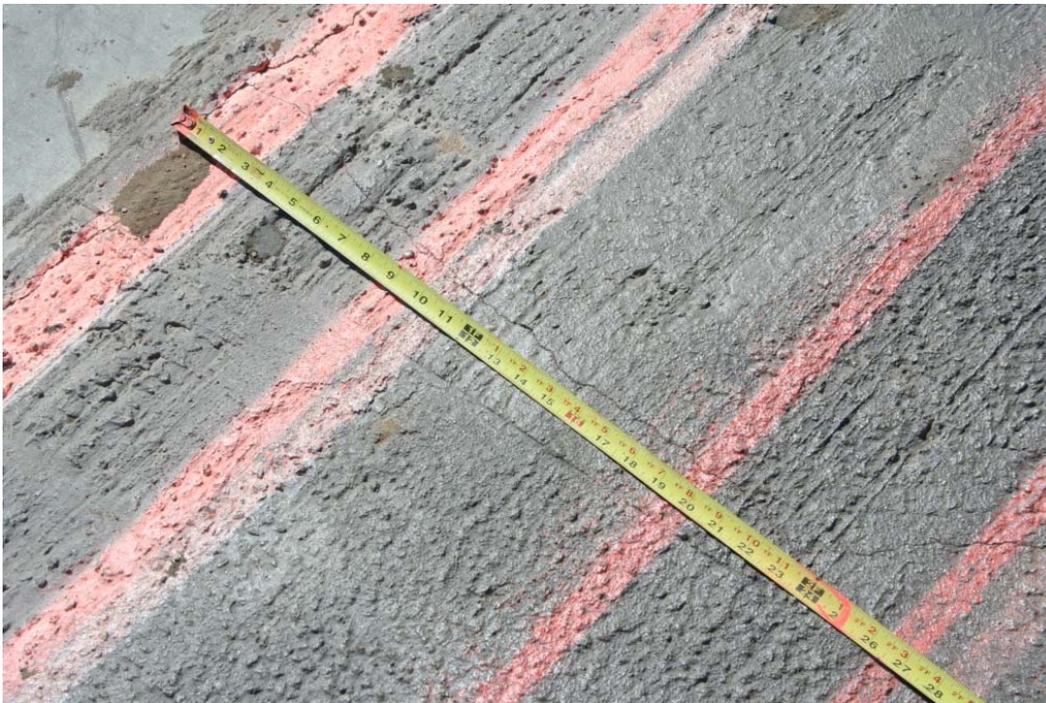
Figure 145. Crater T. Ultimax repair crack after 3,000 passes.
