U.S. Army Corrosion Prevention and Control Program

Innovative Corrosion-Resistant Coatings for Heat Distribution Piping at Fort Jackson

Final report

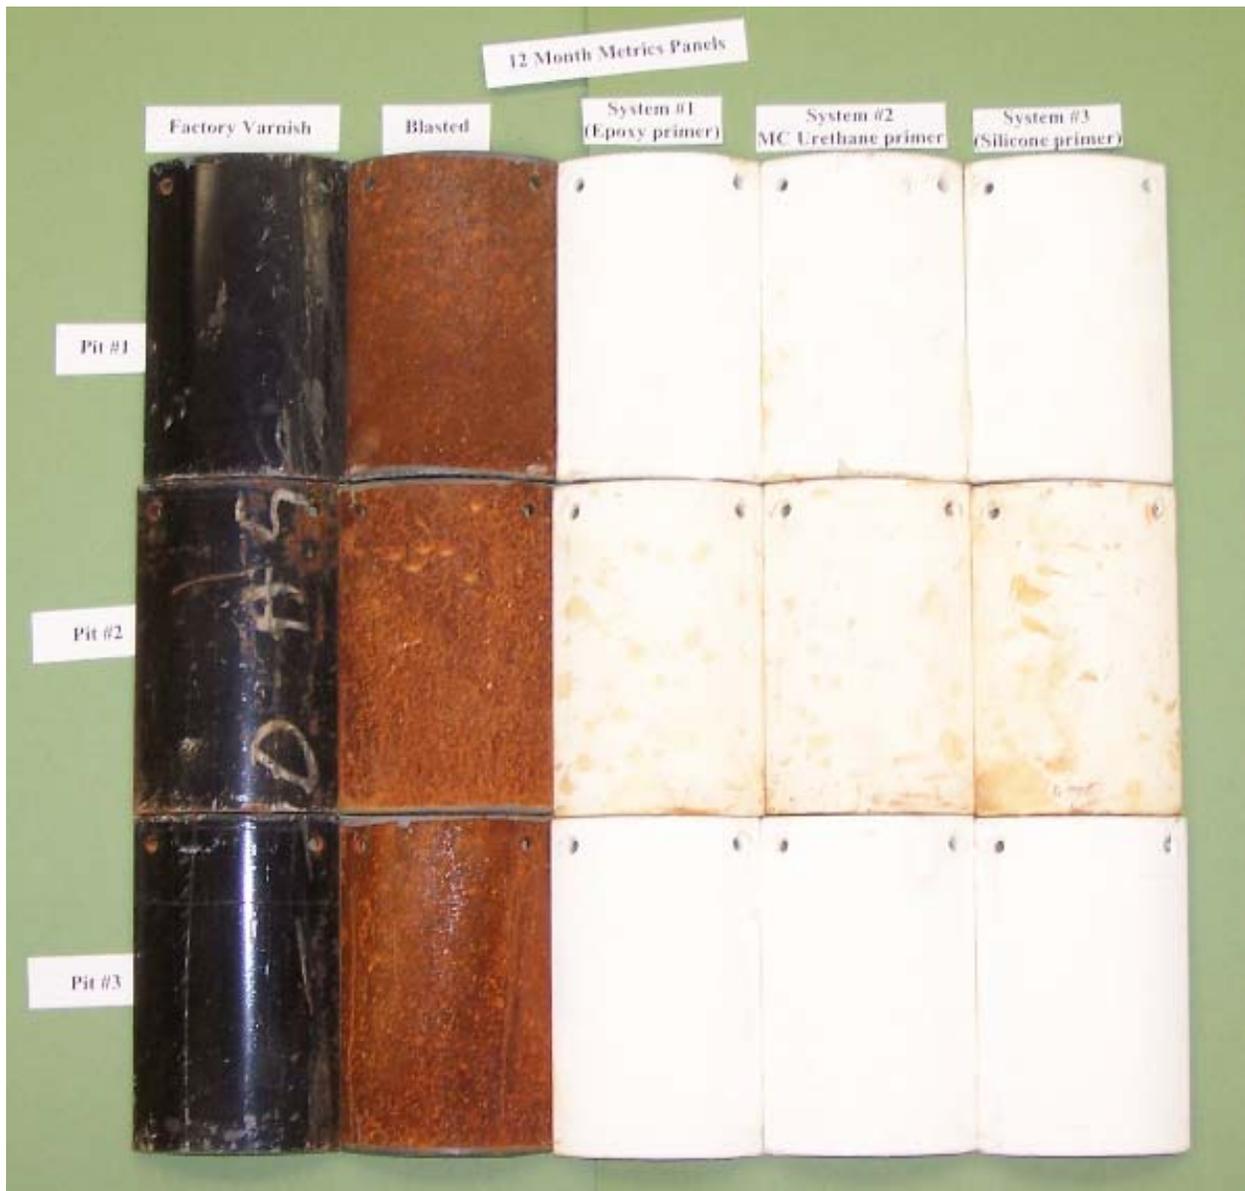
Figure 1 shows all three sets of test panels, and two control sets, after 12 months of exposure. Details about each panel and more photos are presented in Appendix B. In brief, however, it was determined that little to no coating degradation had occurred during the period of exposure. Some staining of the coating was observed in the site 2 specimens, but the coating integrity was unaffected.

Figure 1. Samples showing test panel results after 12 months of exposure in three separate pits. The vertical columns, left to right, are factory varnish, blasted, system 1 (epoxy primer), system #2 (MC urethane primer), and system 3 (silicone primer).

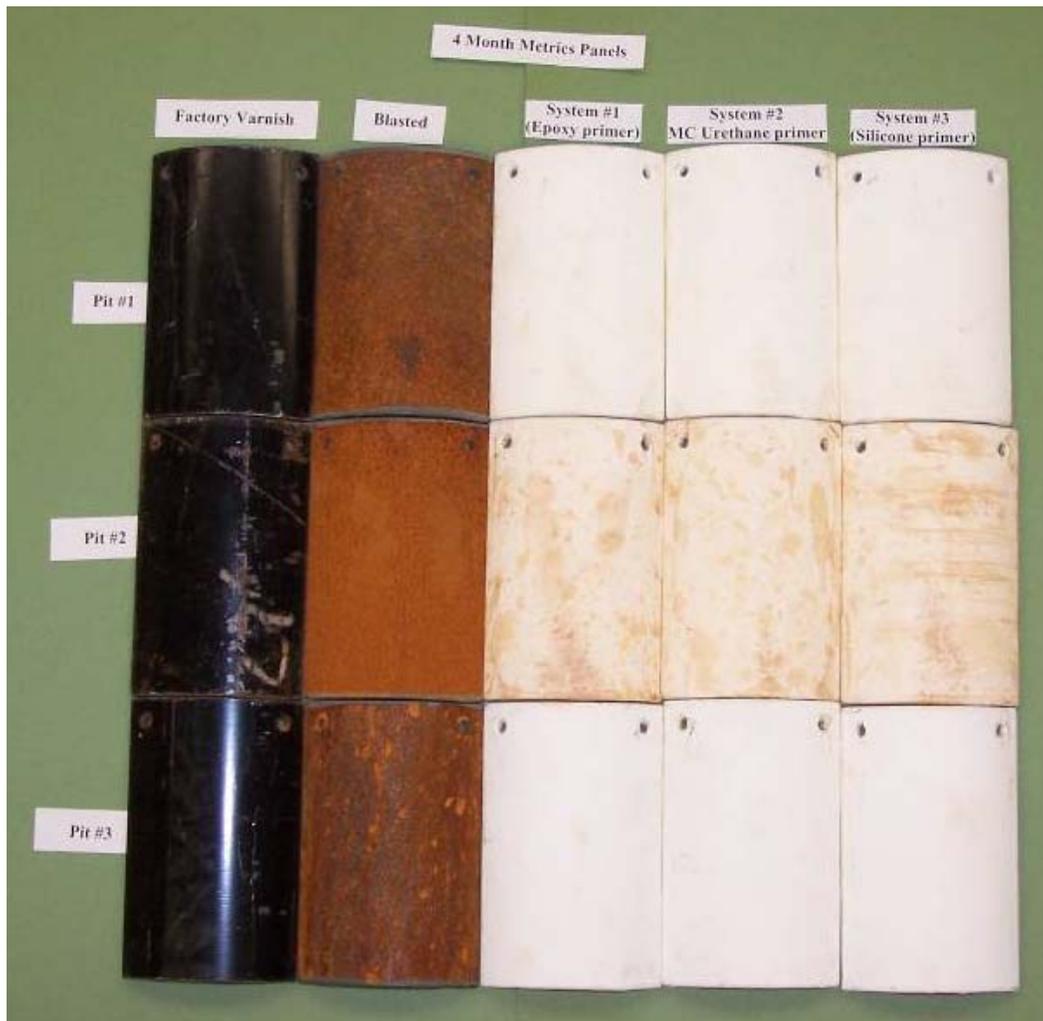
Figure B1. Samples showing results after 4 months of exposure in three separate pits. The vertical columns, left to right, are factory varnish, blasted, System #1 (Epoxy primer), System #2 (MC Urethane primer), and, System #3 (Silicone primer).

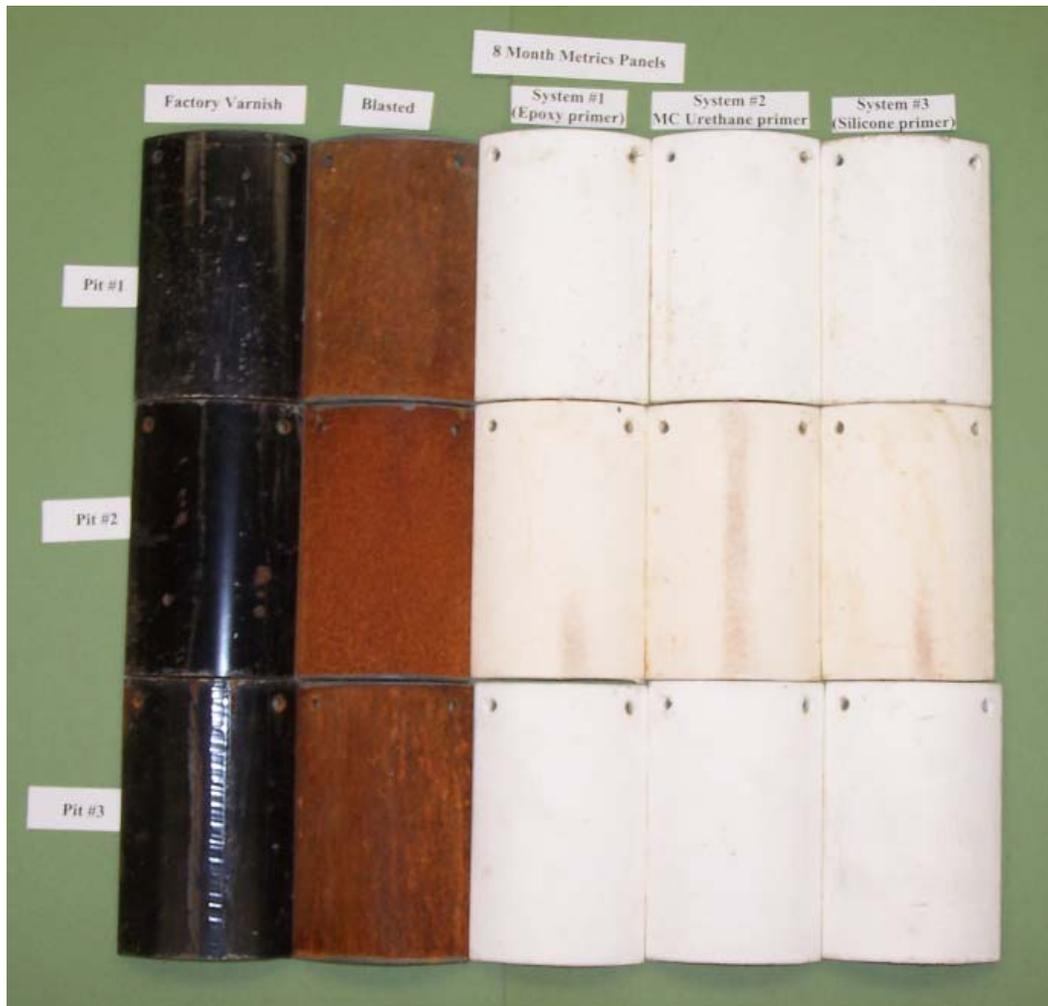
Figure B2. Samples showing results after 8 months of exposure in three separate pits. The vertical columns, left to right, are factory varnish, blasted, System #1 (Epoxy primer), System #2 (MC Urethane primer), and, System #3 (Silicone primer).

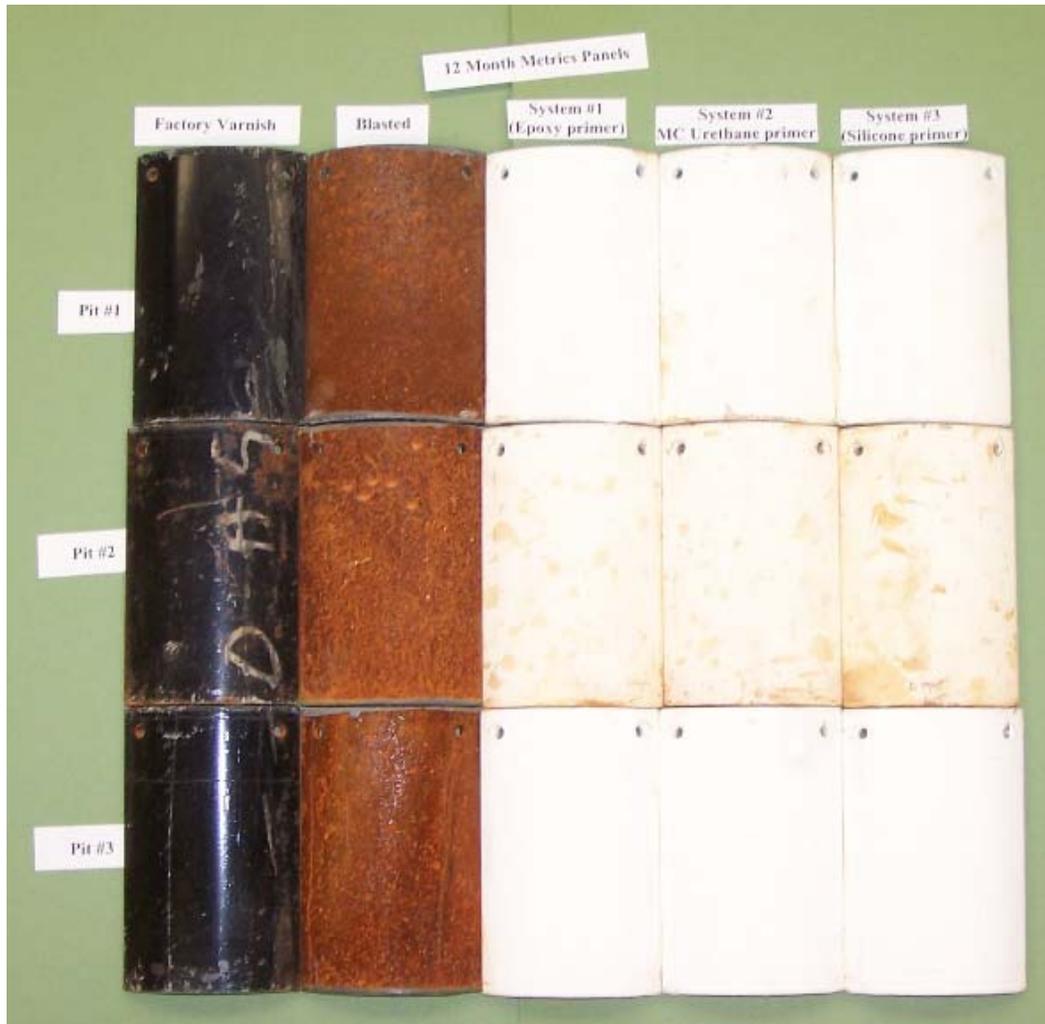
Figure B3. Samples showing results after 12 months of exposure in three separate pits. The vertical columns, left to right, are factory varnish, blasted, System #1 (Epoxy primer), System #2 (MC Urethane primer), and, System #3 (Silicone primer).
