FIGHTING VEHICLES RESEARCH AND DEVELOPMENT ESTABLISHMENT

REPORT NO: FT 2239

DEVELOPMENT TRIALS 'A' VEHICLES REPORT

MINE DAMAGED TRACK

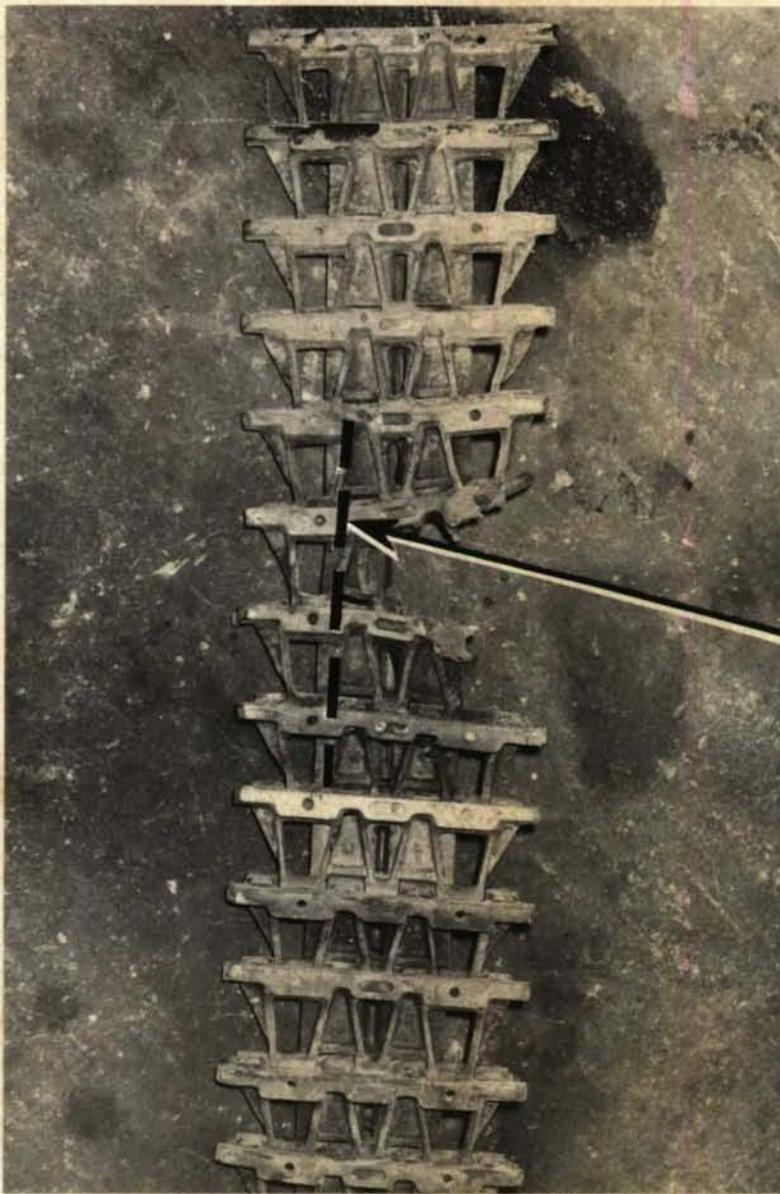
SECTION AA

- 3.2. For this light track assembly No. FV.337635 the following design criteria were determined based on the arbitrary conditions given in 2.4.
  - 3.2.1. When track is not severed beyond section 'AA' indicated in the figure attached to this cover sheet No 'kill' will be recorded.

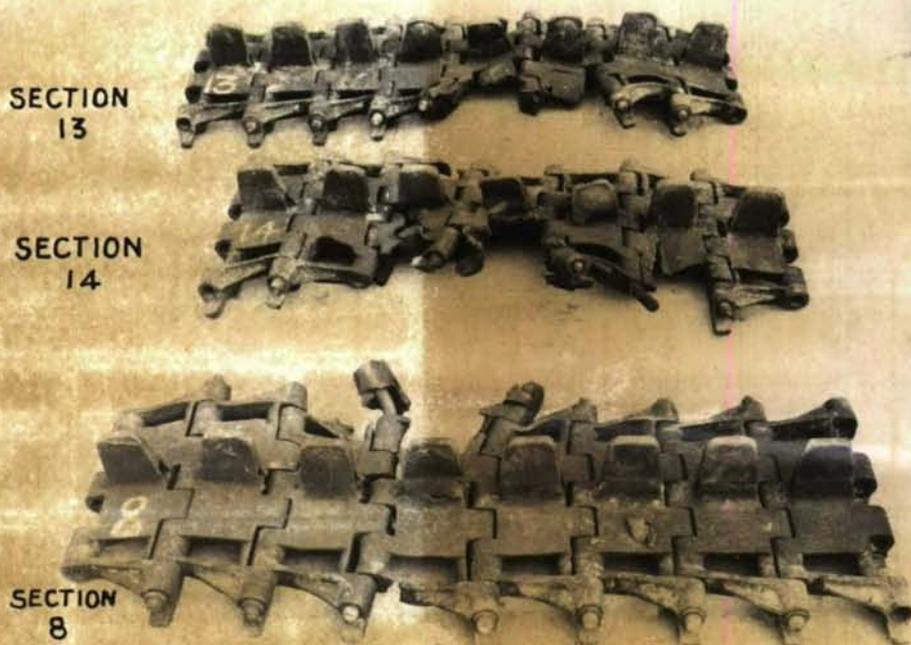
FIG. 1

3.2 Track Sections. Ten sections of dry pin metal tracks, as received from R.A.R.D.E. are shown in Fig. 1-3. These sections were each identified by the number painted on them by R.A.R.D.E. (Ref. report SXR/457/01). Drawing No. of link FV.351283.

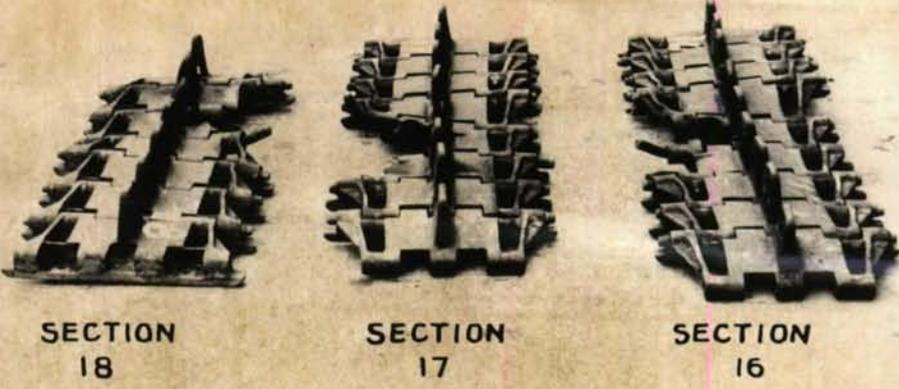
FIG. 7

6.1 The condition of the track sections after removal is shown at (Fig. 7-9).
