Technical Findings, Lessons Learned, and Recommendations Resulting from the Helios Prototype Vehicle Mishap

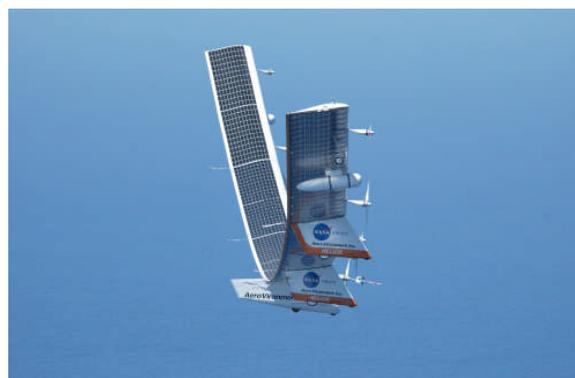
At 10:19am, the Stationary Pilot (SP), located in a trailer near the runway, noted that instrumentation and the aircraft were behaving as though it was in turbulence (noted later as the 1st encounter with turbulence). At 10:22am and again at 10:24am the aircraft again encounter some turbulence. The aircraft's wing dihedral became larger than normal and mild pitch oscillations occurred; the wing dihedral during both events returned to normal without any pilot inputs, and the oscillation damped out. These events both occurred during the time when the Stationary and Mobil crews were focused on the handoff procedure. Neither crew was aware of the high wing dihedral or the pitch oscillations. At 10:35am, at approximately 2,800 feet altitude, the aircraft began experiencing airspeed excursions of around ± 2 ft/sec. The persistent high wing dihedral (Figure 5) and the subsequent loss of pitch control, the aircraft became very unstable in a highly divergent pitch mode in which the airspeed excursions from the nominal flight speed about doubled every cycle of the oscillation. During the final nose down dive (approaching 90°) the aircraft exceeded the maximum allowable speed by over a factor of two. The resulting high dynamic pressures caused progressive failure of the wing leading edge secondary structure on the outer wing panels. Soon thereafter, the solar cells and skin on the upper surface of the wing began to rip off. These failures destroyed the aircraft's ability to generate lift and sustain flight; as a result, the aircraft fell into the ocean (Figure 6). The aircraft impacted the ocean within the confines of the PMRF test range and was destroyed.

Figure 5: HP03-2 with high wing dihedral

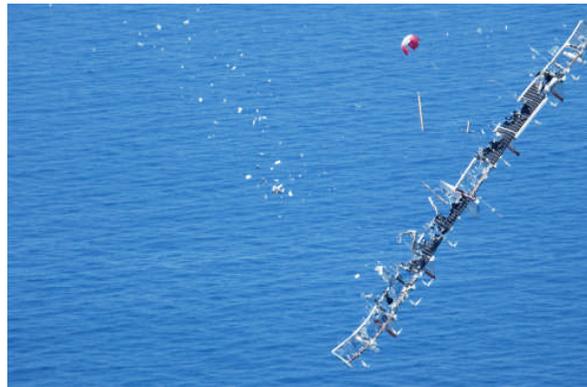
Figure 6: HP03-2 falling towards the Pacific Ocean

The aircraft impacted the ocean in mile-deep water 10 miles off the coast of Kauai. The vehicle structure including the main load carrying composite wing spars were severely damaged. The elapsed time from the first effort to diagnose and correct the high wing dihedral condition to the point at which the airplane began to break up in the air was 91 seconds. Figure 7 provides time histories of the aircraft's pitch rate and airspeed, and the wing dihedral for the 30-minute flight.
