Lipari Landfill Piping Network Corrosion Condition Assessment and Service Life Prediction Analysis

Charles P. Marsh, Thomas A. Carlson, Robert A. Weber,
Carl A. Feickert, and Peter B. Stynoski

December 2008

Final report

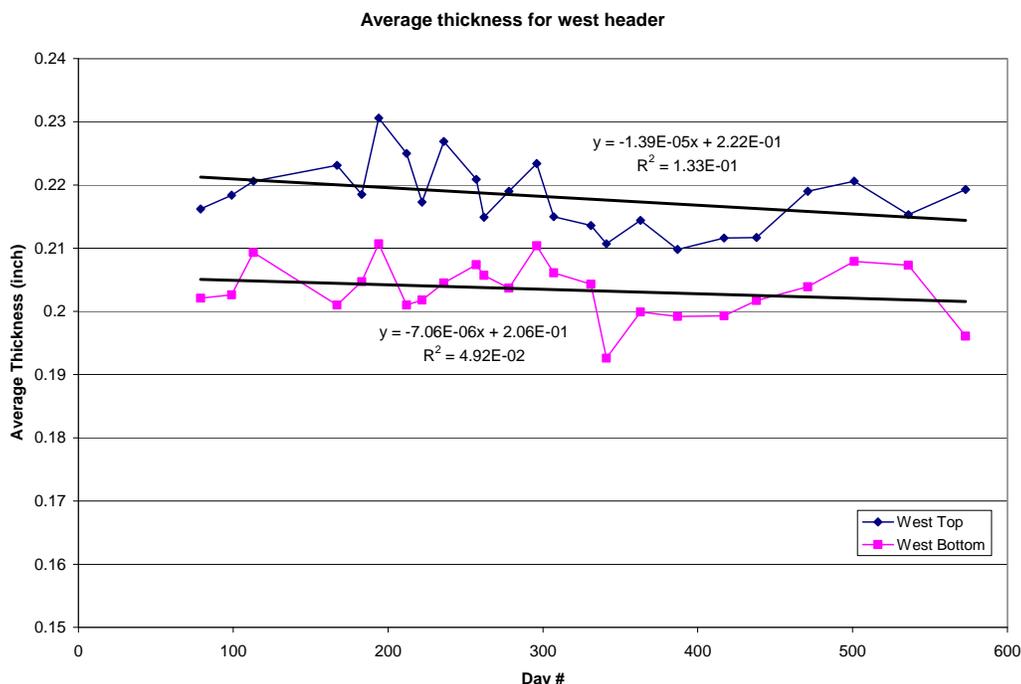
Figure 4. Average thickness measurements for west header during 15-month current condition assessment.

The data show some interesting trends. For the west header, both top and bottom thickness measurements show a decreasing trend. This would indicate a wall thickness that is thinning during the measurement period. For the central header, the top measurements show a decreasing trend, while the bottom measurements show a very slight increasing trend. This might indicate a loss of wall material near the top of the pipe and an accumulation of corrosion products at the bottom of the pipe. For the east header, both top and bottom measurements show an increasing trend. This might be due to an accumulation of corrosion products on the entire inside surface of the pipe. While this last trend may be an indication of the most excessive corrosion of the three pipes, we have to use the decreasing trend lines as an indication of material loss and hence a corrosion rate. The corrosion rates based on the decreasing trend lines are given in Table 2.

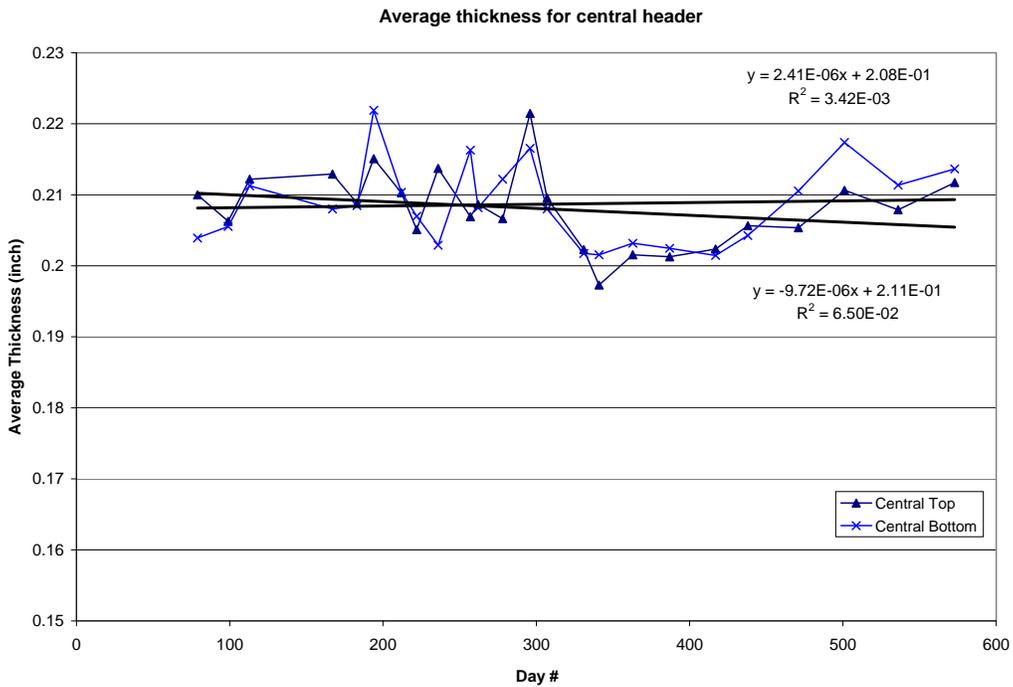
Figure 5. Average thickness measurements for central header during 15-month current condition assessment.

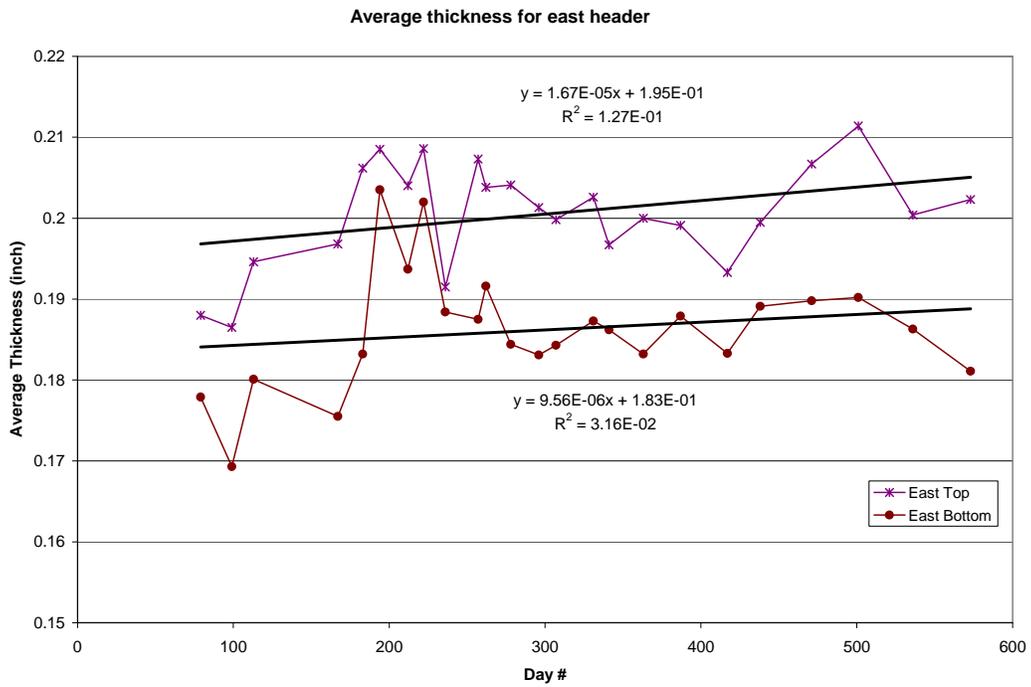
Figure 6. Average thickness measurements for east header during 15-month current condition assessment.

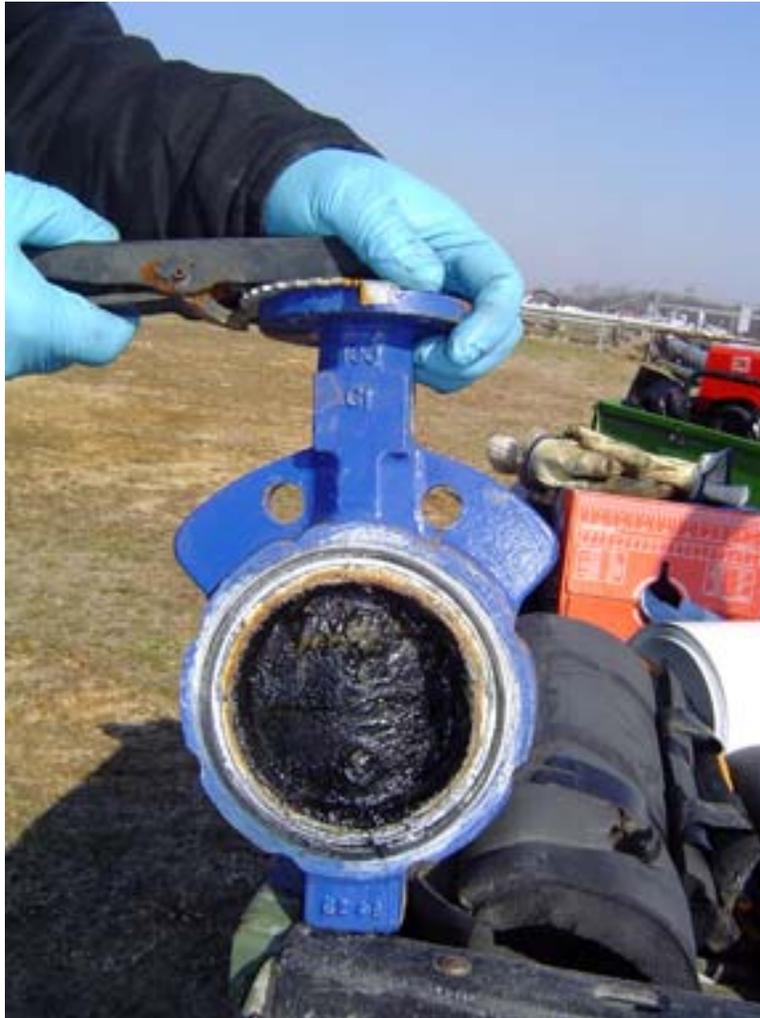
Figure 23. Photograph of the test coupon after 6 months in the west header.

The corrosion product on the coupon when removed from the pipe was black, as shown in Figure 23 and Figure C12 (see Appendix C). By the time the coupon reached the lab, the corrosion product was the common hematite rust color, as shown in Figures C13 and C14, which is typical of aerobic corrosion. This indicates that the pumped water had minimal dissolved oxygen to support complete corrosion. The corrosion product was loosely attached to the surface of the steel and was easily washed away. This may have allowed for fresh coupon material to be exposed to the corrosive action of the water while in the pipe and caused an accelerated corrosion rate.

Using the ASM (2003) standard method of calculating the corrosion rate from test coupon data, the corrosion rate was calculated to be 9.57 mpy. Additionally, a corrosion rate calculation based on initial and final average thickness measurements returned a value of 15.07 mpy.

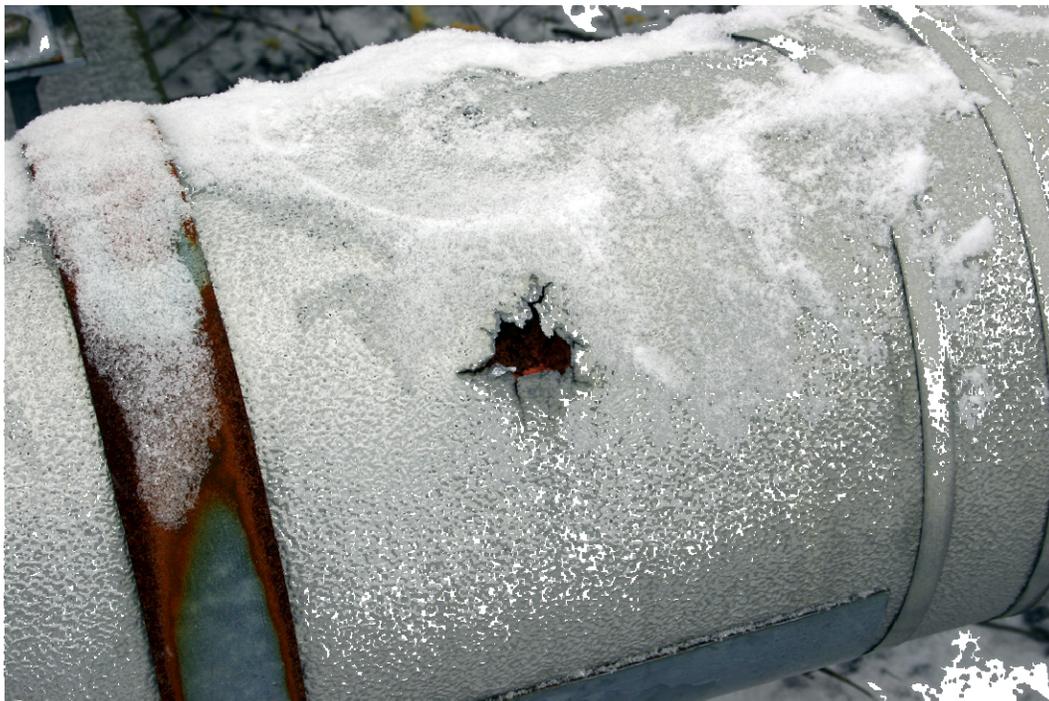
Figure C4. Photograph of the aluminum weather cover on header showing a hole possibly caused by general corrosion.

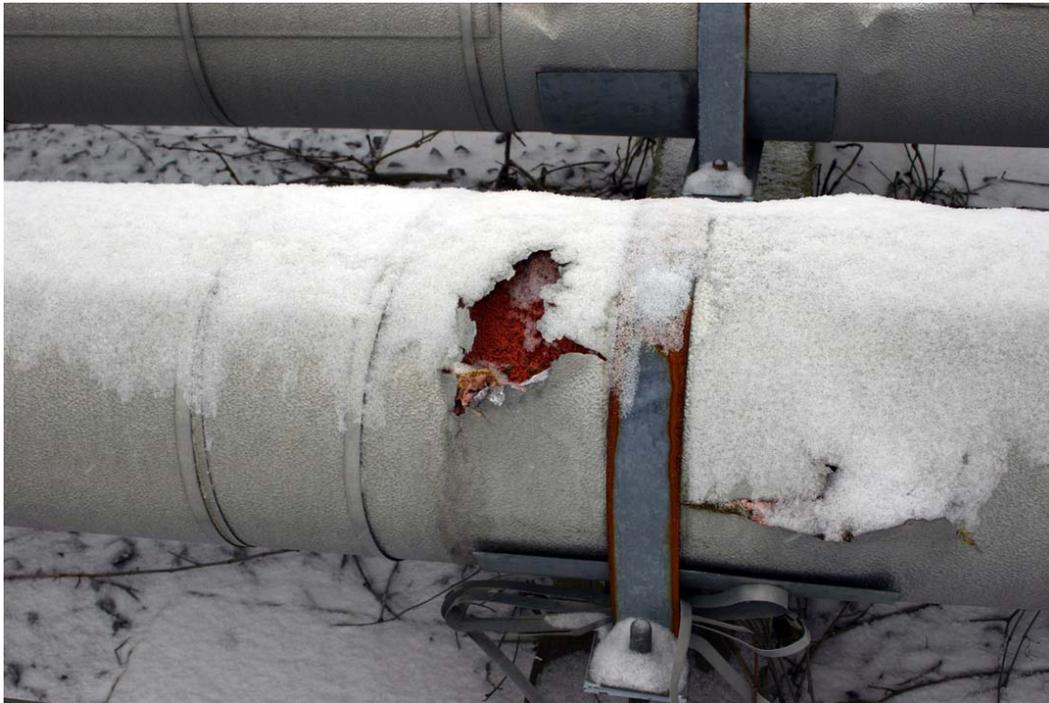
Figure C5. Photograph of another hole in aluminum weather cover.

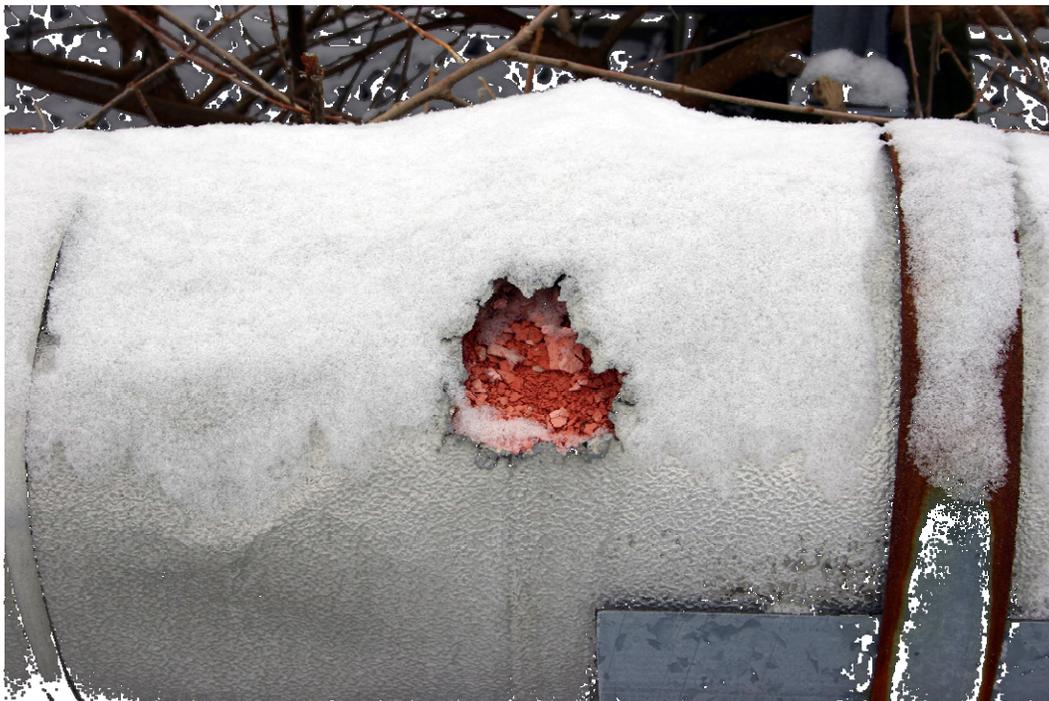
Figure C6. Photograph of another hole in aluminum weather cover on the header.

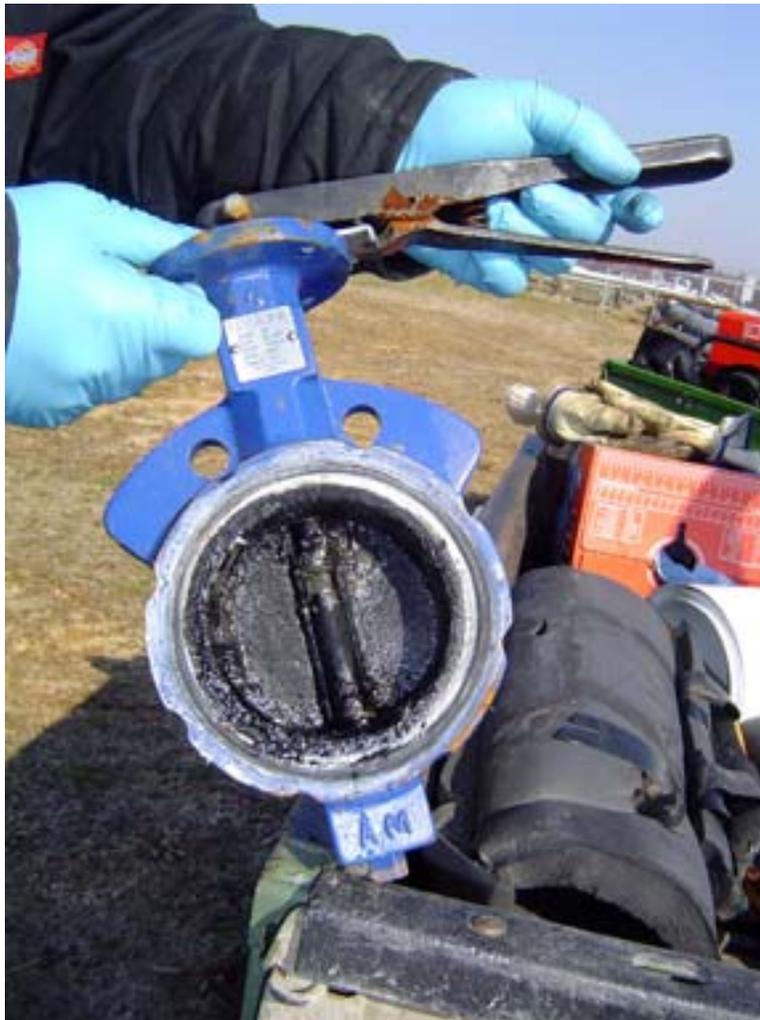
Figure C12. Photograph of the test coupon valve stem side after 6 months in the west header.

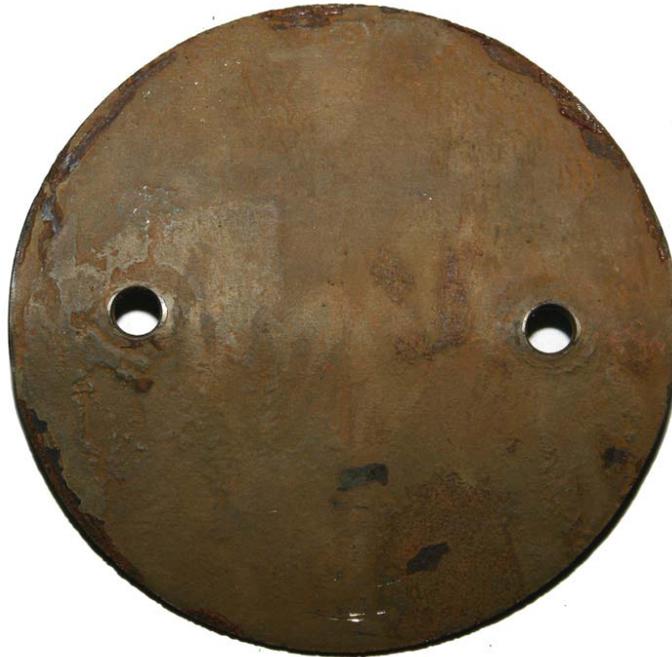
After cleaning the surface down to bare metal (see Figures C13 and C14) the weight and thickness were again measured. The final weight was determined to be 180.415 grams. The final average thickness was determined to be 0.274 cm (0.108 in.), with actual thickness values ranging from 0.267 to 0.282 cm (0.105 to 0.111 in.). Initial and final measurements of the corrosion coupon are recorded in Table 5.

Figure C13. Test coupon after cleanup, showing the extent of general surface corrosion.

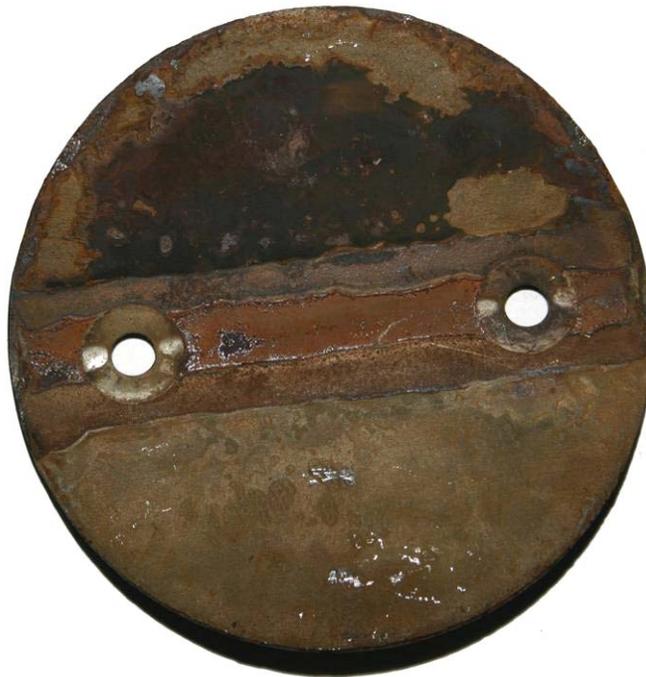
Figure C14. Test coupon stem side after cleanup, showing the extent of general corrosion.
