SOME REMARKS on a 100 Tons ACCIDENTAL EXPLOSION in
TUNNEL SYSTEMS in 1965

Seppo Tuokko

Ministry of Defence, Helsinki Finland

TWENTY-FIFTH DOD EXPLOSIVES SAFETY SEMINAR

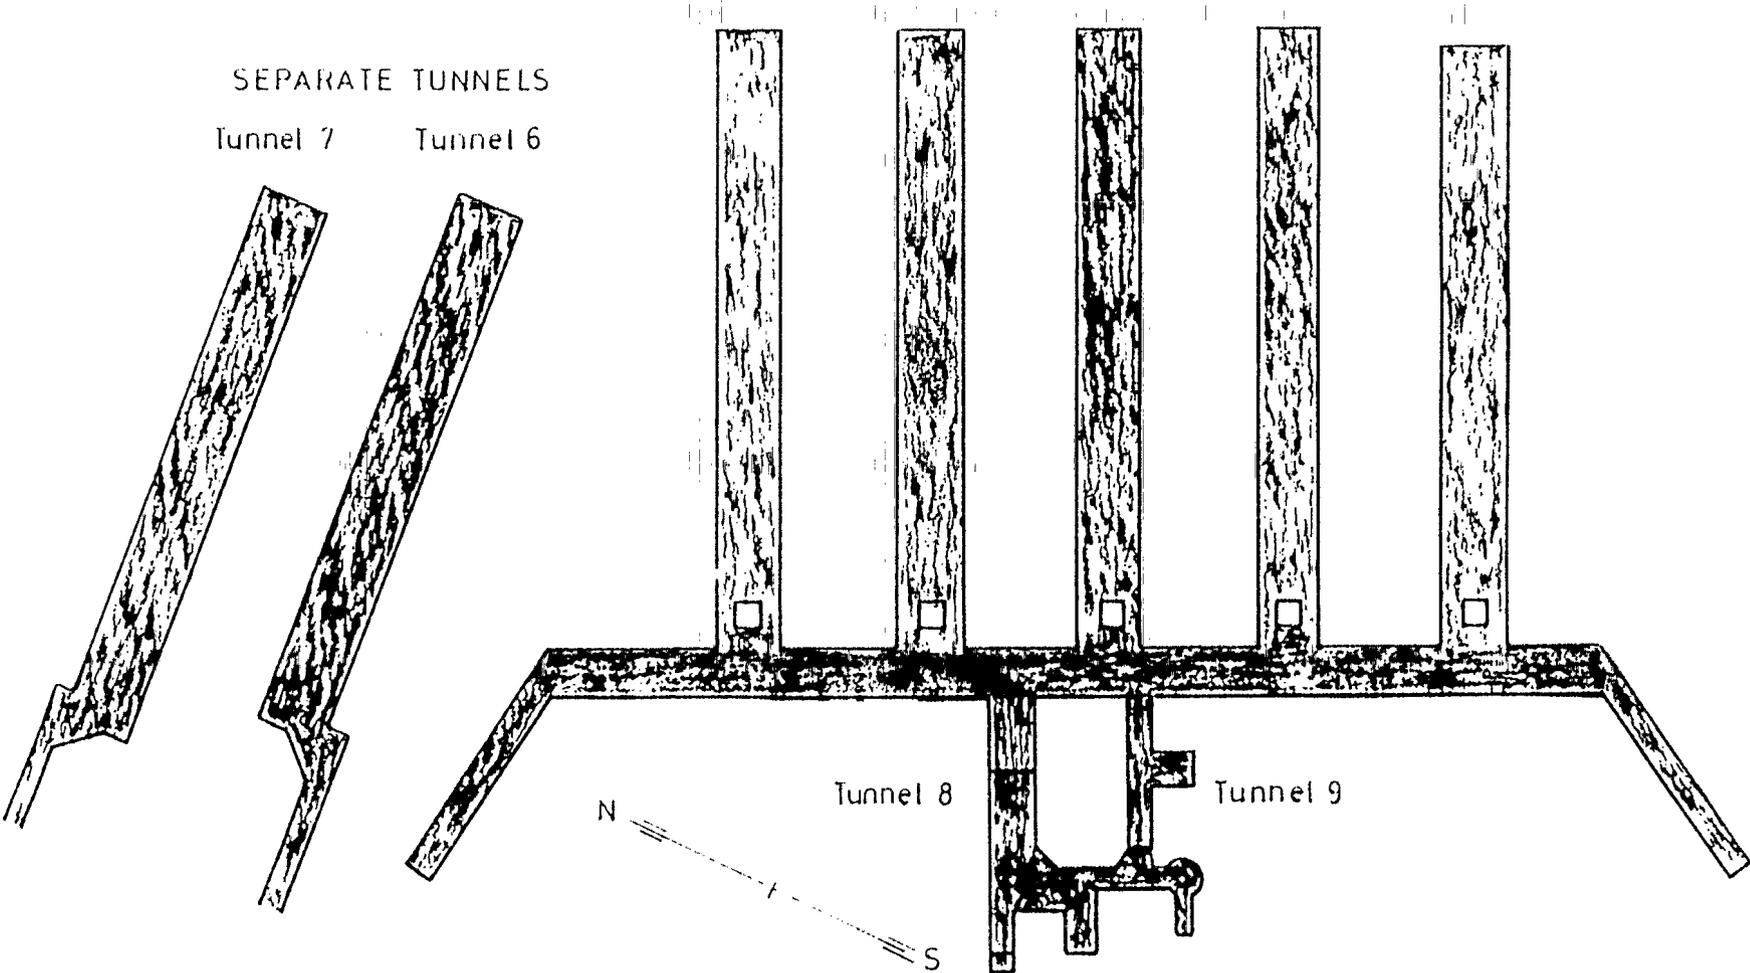
Figure 1

The plan of the underground storage is to be seen in Fig 1. The underground storage was only a part of the whole Depot. On the ground there were many workshops, barracks and different kind of storages.

This Tunnel System was consisted of the (so called) main part, of tunnels 1-5 and of two separate-Tunnels numbers 6 and 7. Each one had volyme of 2700 m³.

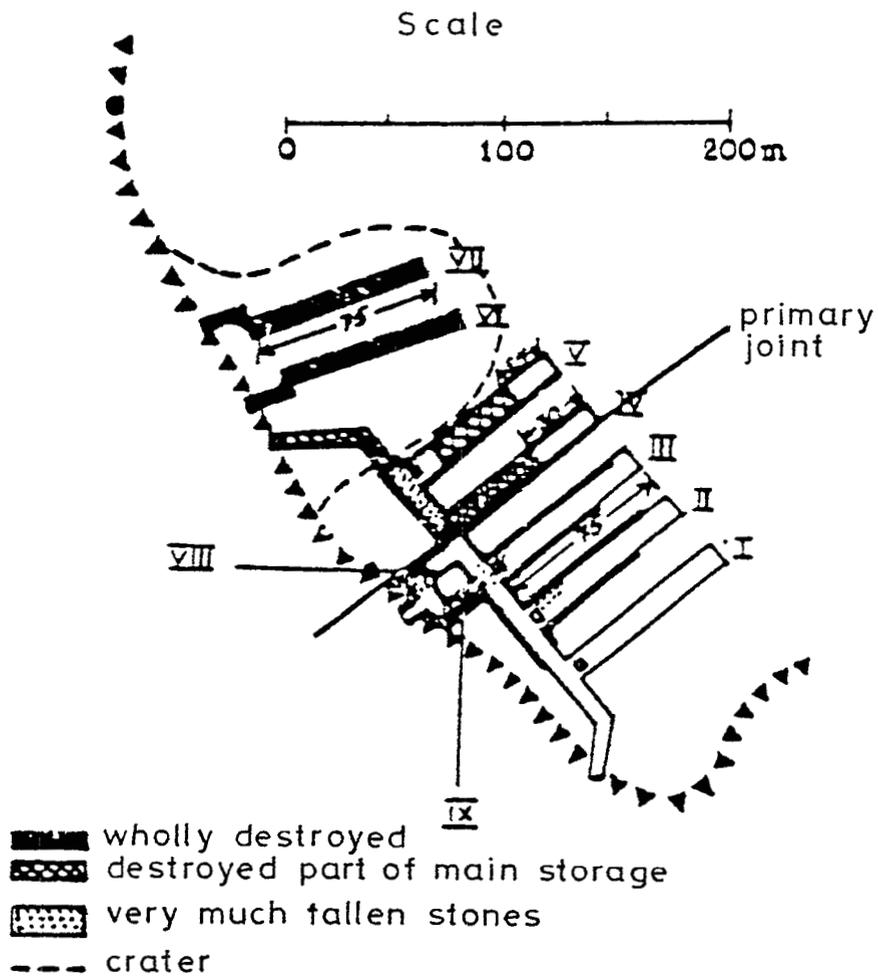
Fig. 2

Figure 2 shows the situation in the Tunnels after explosions. Tunnels 6 and 7 are wholly destroyed, there is only a crater. The deepest part of the crater is in the middle between the Tunnels. Figure 3 shows the ground profile before and after the explosion.

Tunnels 4 and 5 are only partly destroyed, the rears are damaged only a little.

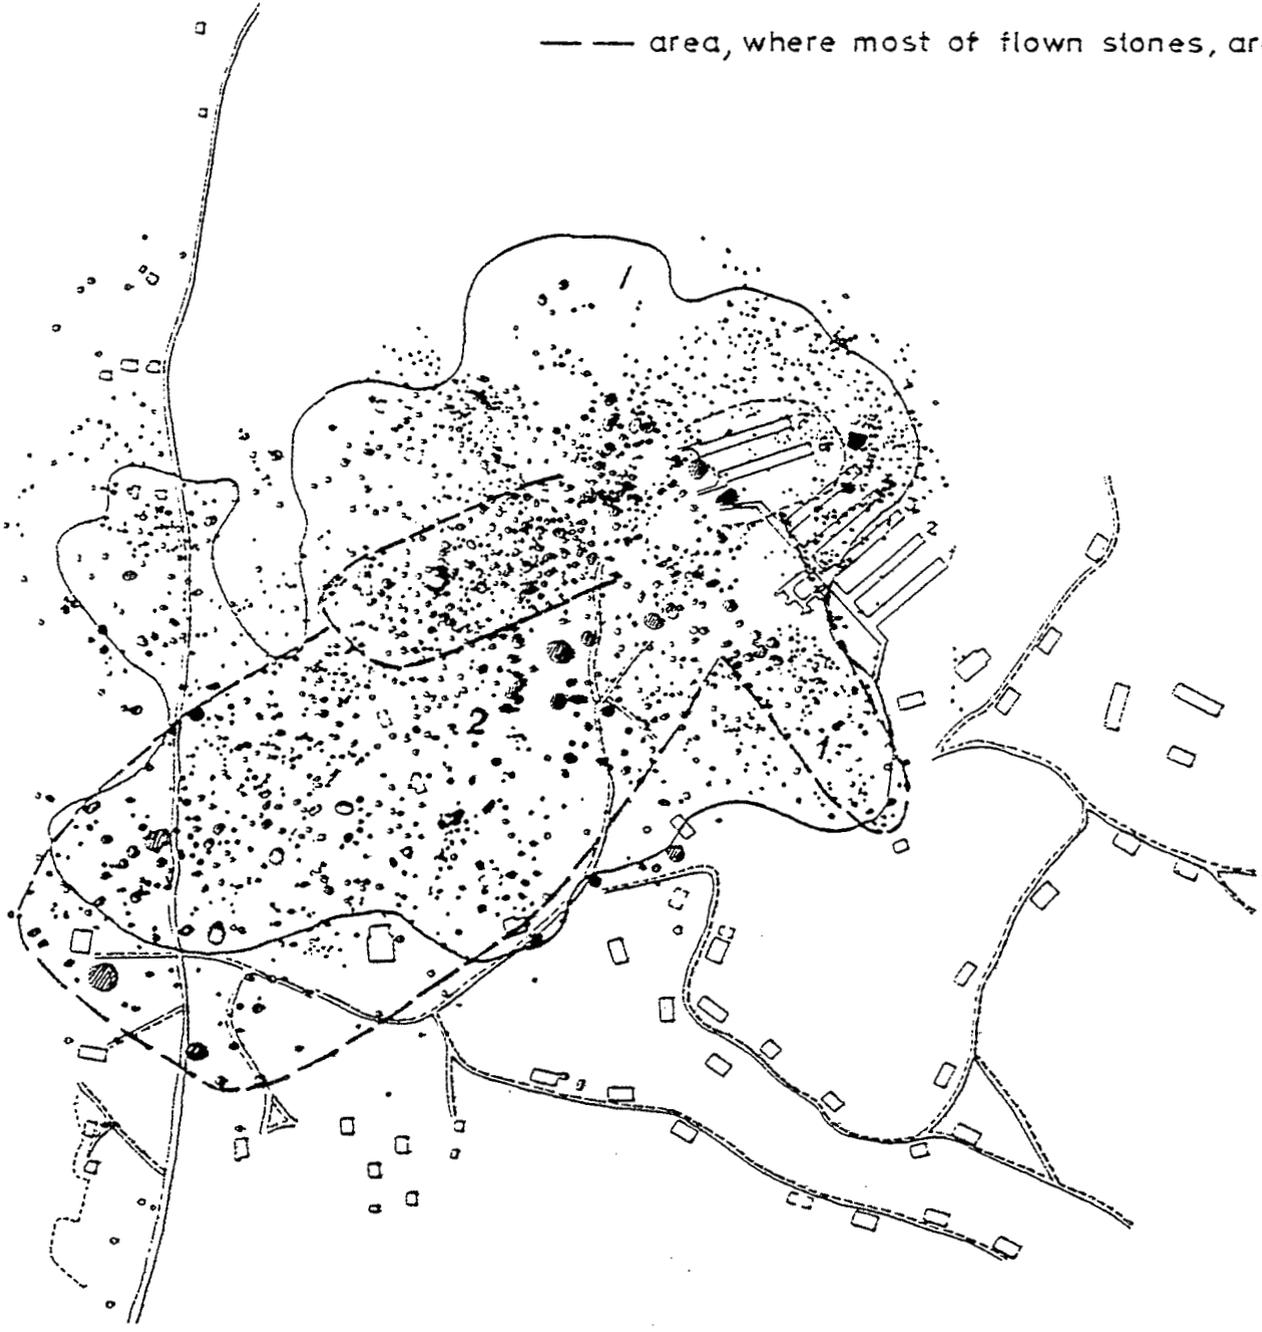
Fig. 4

In Fig 4 there can be seen areas, where most of the flown blocks were found. Typically, they have been directed mostly southwest. Also very many windows were broken, the longest distance was 7 km. There were some astonishing features in the effects, for example a brick chimney is almost undamaged although it is near the opening of the Tunnel System.

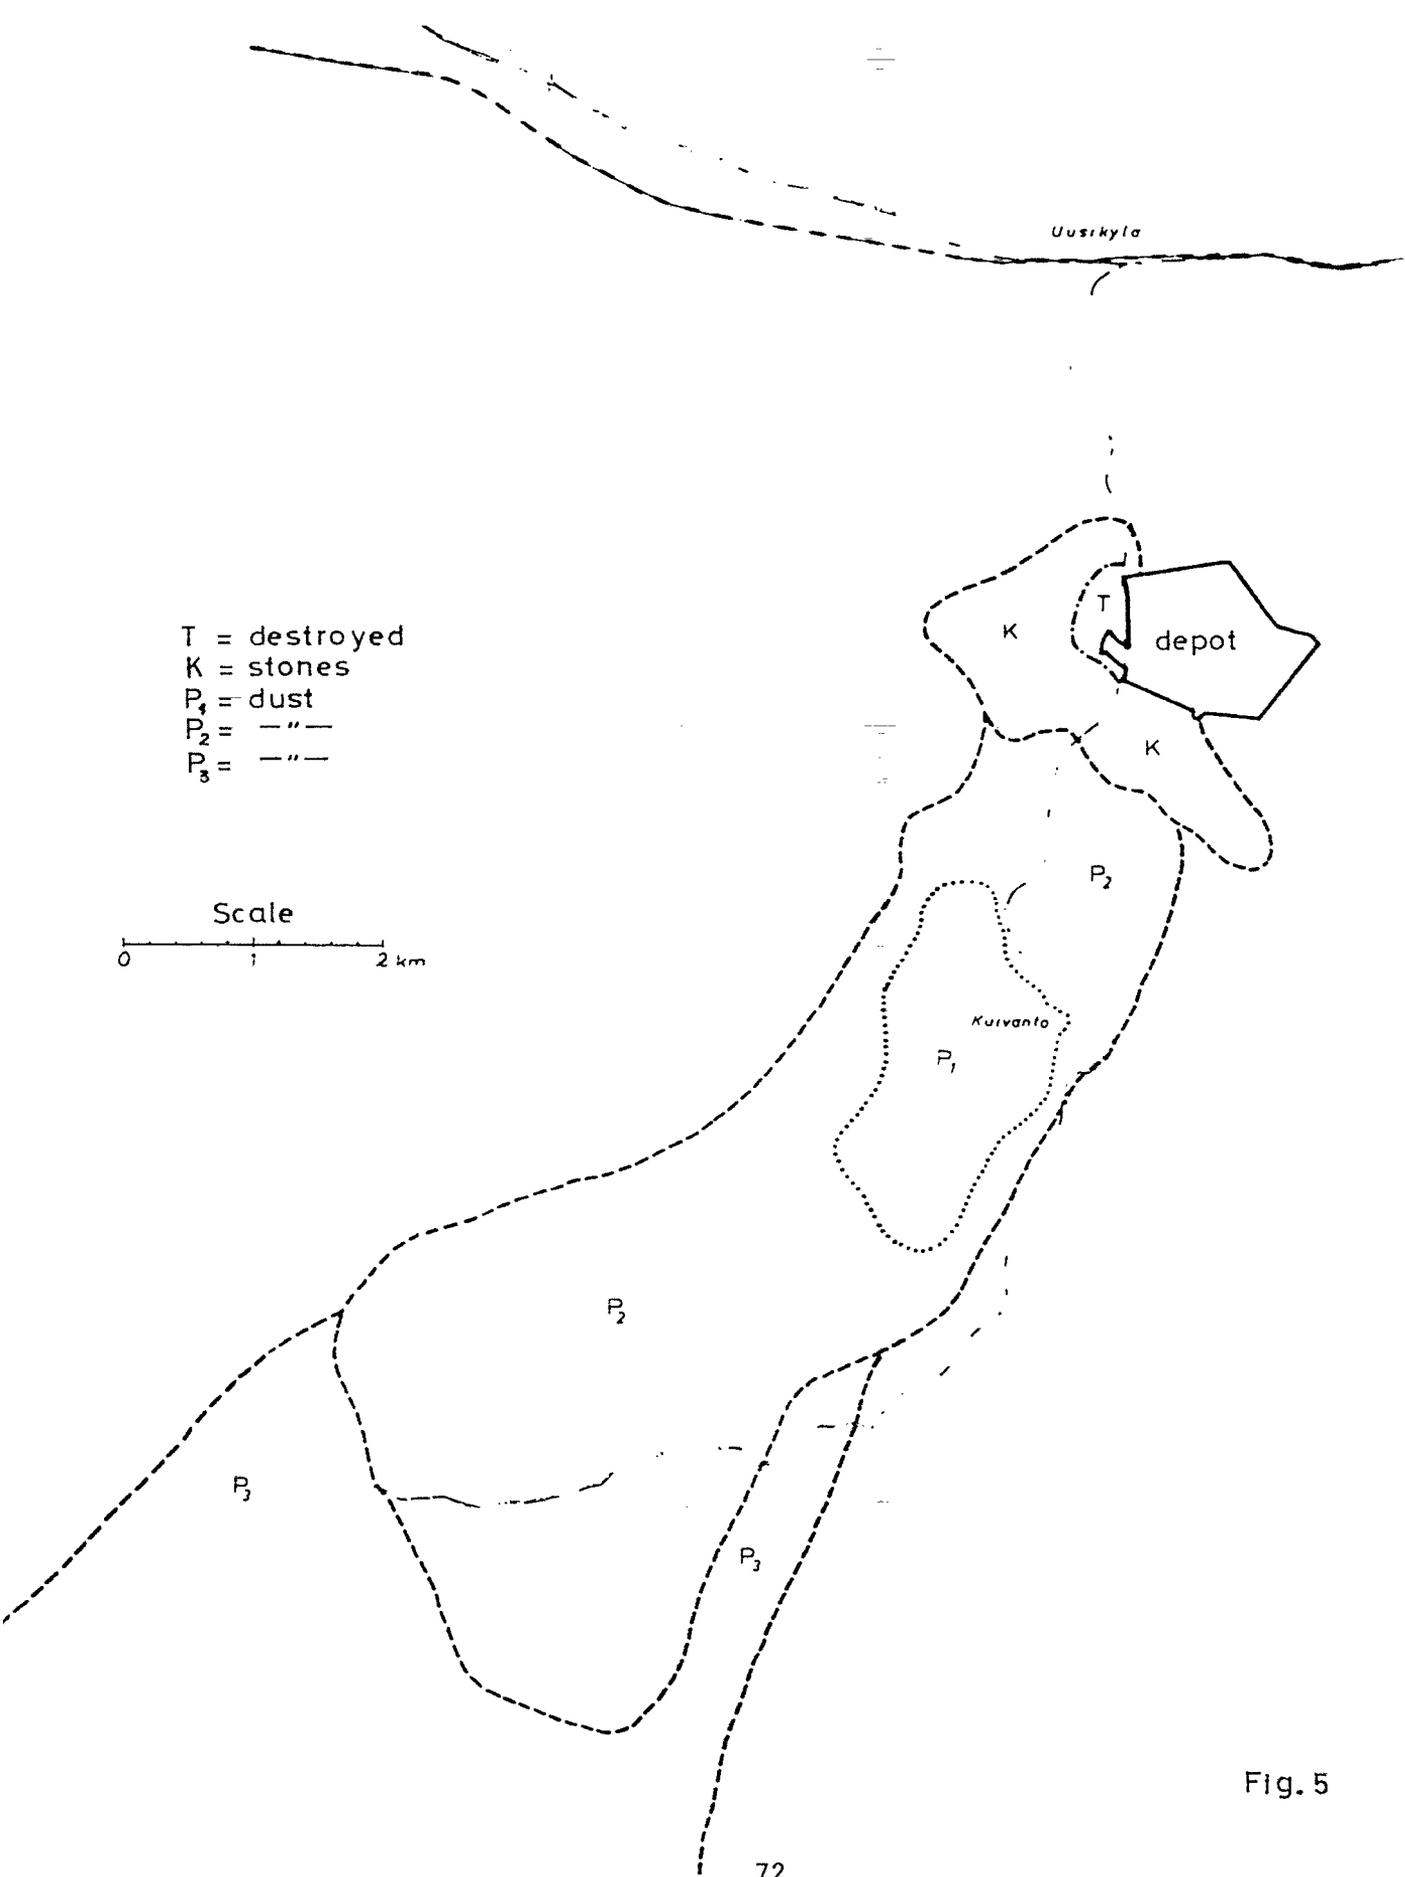
Fig. 5

In the pictures there are shown the effects of the rock shower to the buildings and surroundings. Specially in this accident the effects of flying stones, blocks and dust were typical effects to surroundings. For example there were hay and berries spoiled by dust in large areas (Fig. 5).

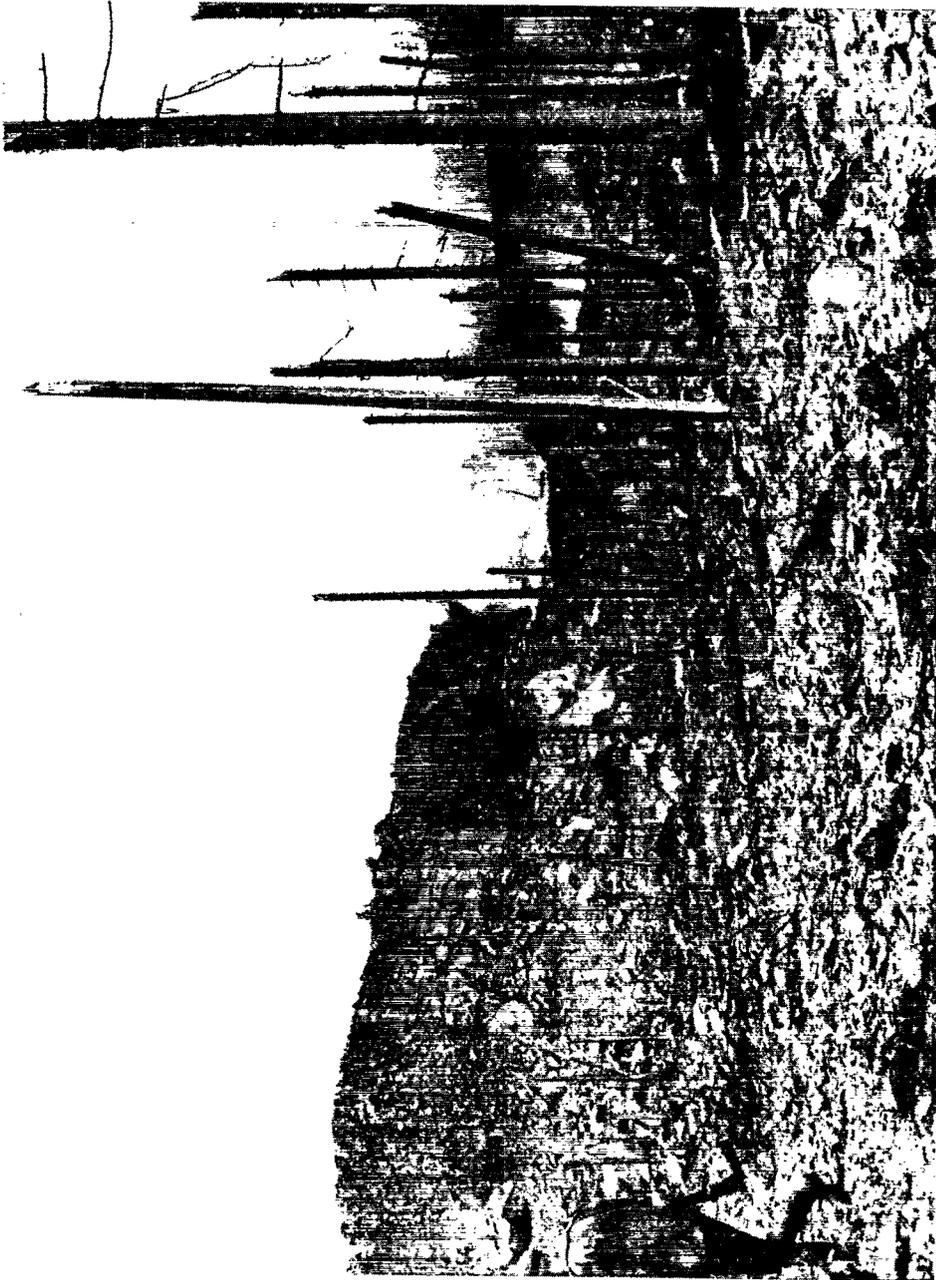
PICTURE 1

Near the crater. Something is still burning.

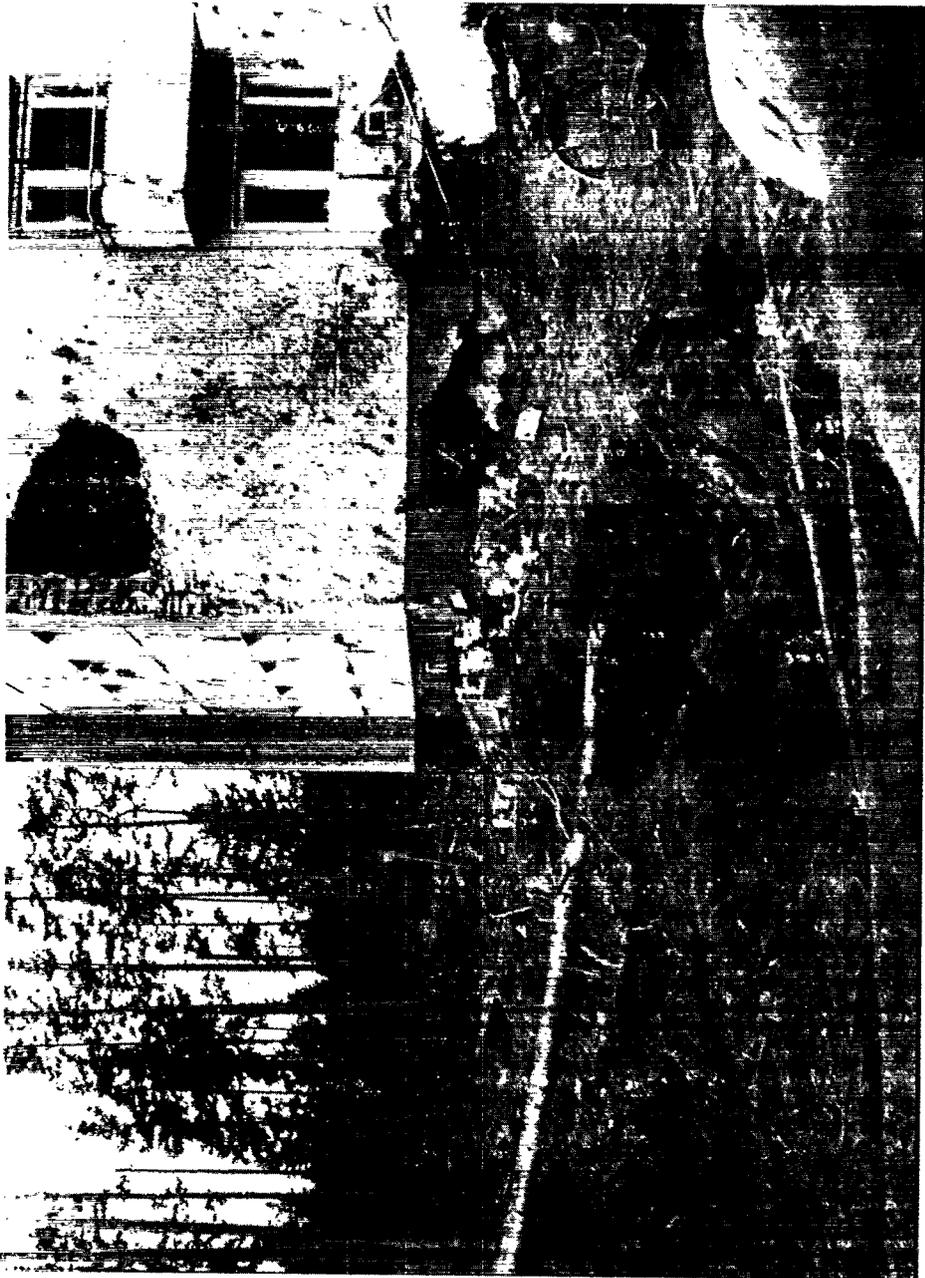
PICTURE 7

The Living house, 650 m from
the Explosion.
