MJU-8 IR FLARE MIX FIRE AT LONGHORN AAP, 28 SEPT 91

RALPH A. KNAPE

U.S. ARMY ARMAMENT
MUNITIONS AND CHEMICAL COMMAND

25th DEPARTMENT OF DEFENSE
EXPLOSIVES SAFETY SEMINAR
18-20 AUGUST 1992

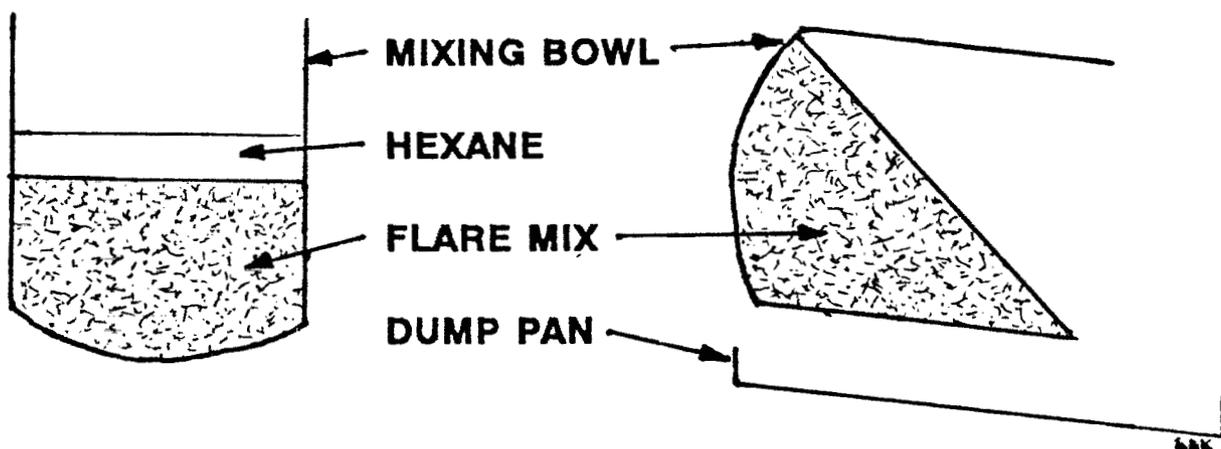
DIAGRAM 1

Diagram 1 cross-sections the mixing bowl in upright and dump positions. In the first case, the MJU-8 mix is shown covered by a layer of hexane liquid as the mix precipitates out in the absence of agitation. The second illustration shows the mixing bowl as pouring off of hexane liquid is completed. (Actually, the liquid is about 93 percent hexane and 7 percent acetone at the time of dumping.) The second illustration shows the mixing bowl in the position it was in at the time of the incident. The fact that the side of the bowl is turned about five or ten degrees past horizontal is significant.

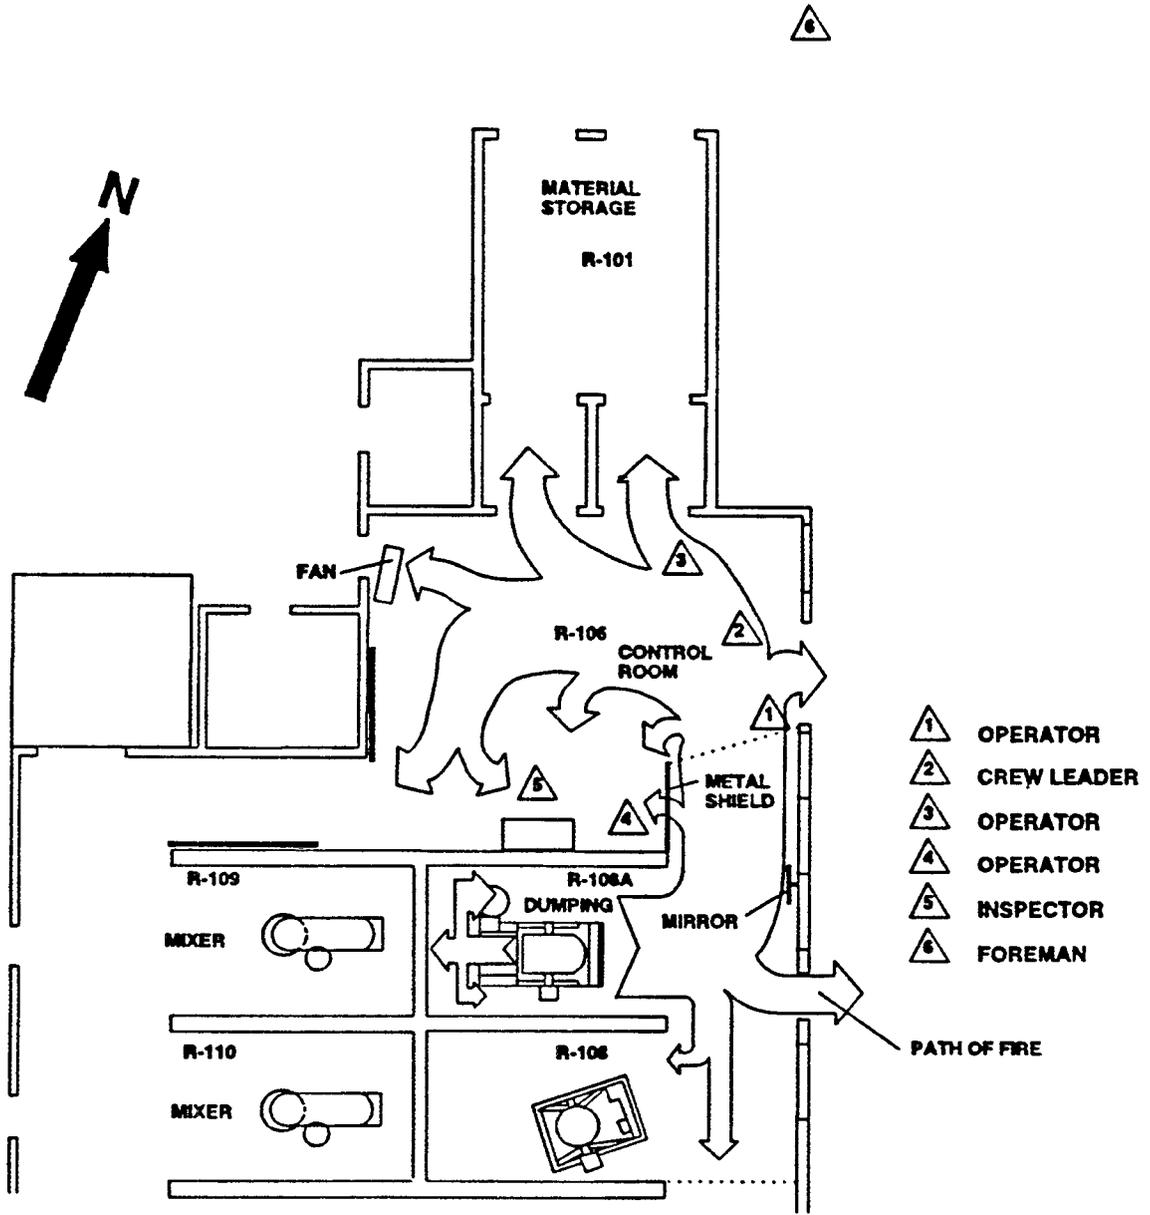
DIAGRAM 2

Investigation after the incident located the point of ignition of the fire as the area of hexane dumping and collection and tracked the path of the fire as it spread. The path and speed of fire spread during the incident was determined by a number of factors, including the presence of hexane vapor, the type and amount of mix in the bowl, the building construction and wind direction. Diagram 2 shows the path of the fire and indicates the location of the personnel in the building at the time of the fire. Evidence in the building indicted that the expanding fireball carried particles of burning mix as it bounced off the dump bay wall and swept out into other building areas. Size of the arrows is used to denote the relative amount of flame and heat as the fireball expanded.

Personnel at locations one through three were near exits and exited immediately as the fire initiated in the dumping bay, before the fireball could spread completely into the control room. Personnel at locations four and five were not in positions to immediately exit and had to fight their way through the fireball and burning mix in the control bay to exit. Both were severely burned and one subsequently died.

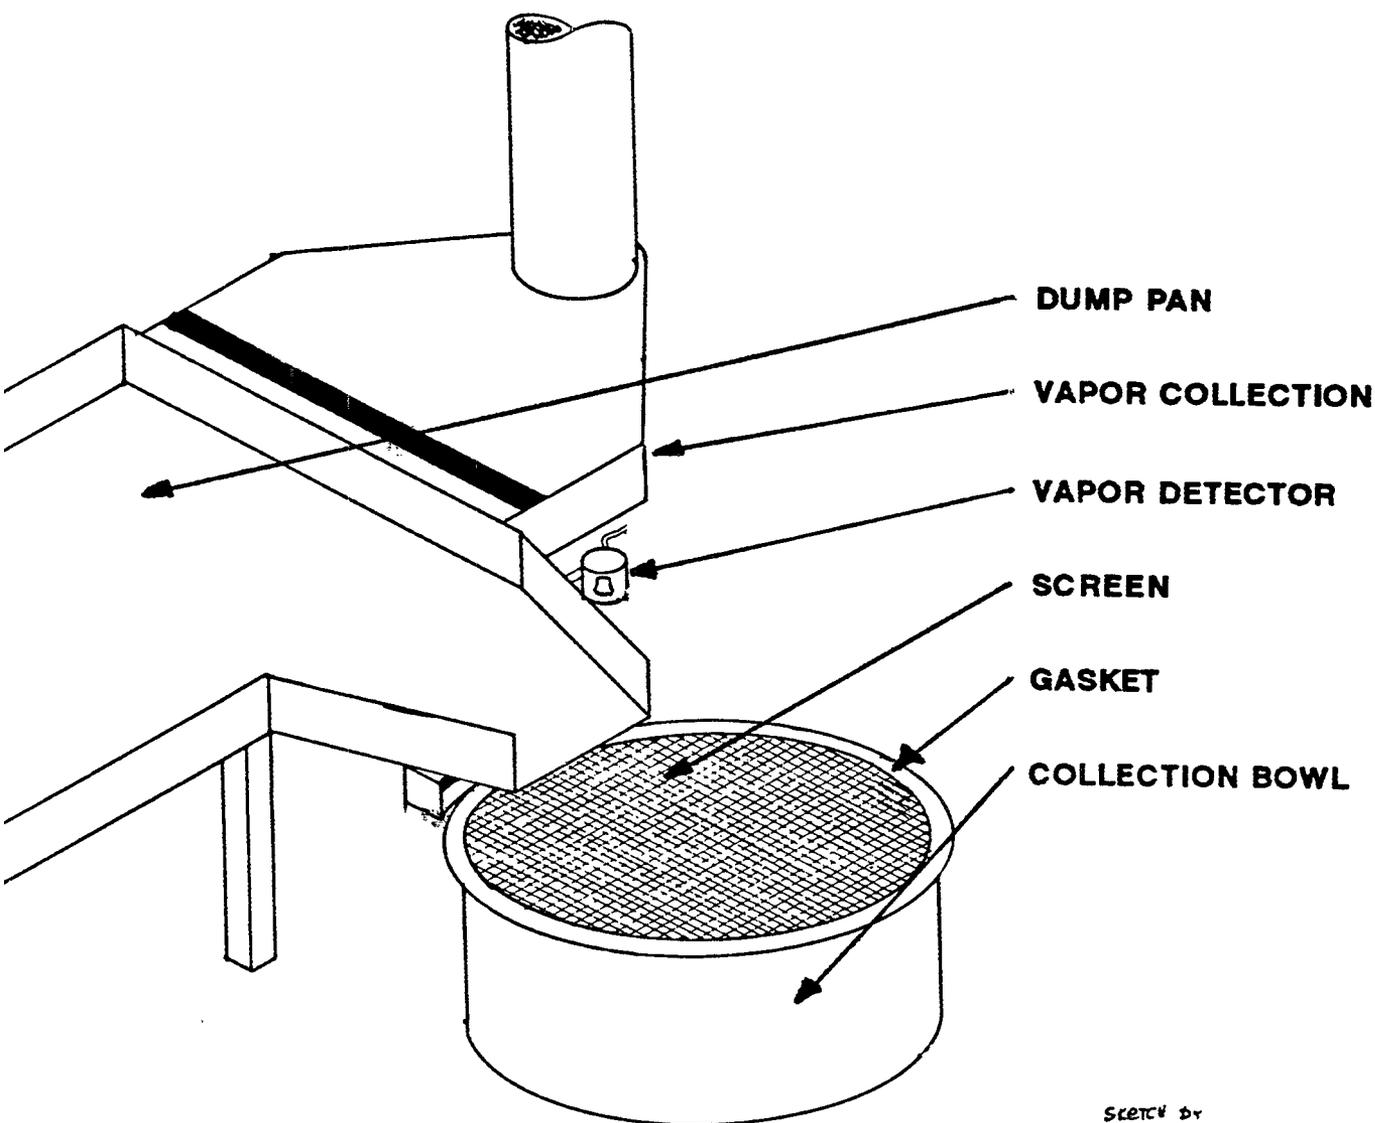
DIAGRAM 3

All permanently installed equipment in the dump bay had been bonded and grounded, and had undergone periodic testing. However, the BOI identified a screen that the hexane flowed through which was electrically isolated due to the addition of a nonconductive rubber gasket. The circular metal screen had not been tested when other equipment was tested. It was determined by the BOI that, most likely, a static spark from the screen ignited the surrounding hexane vapor which in turn ignited the MJU-8 mix.

The conclusion reached by the BOI was that the static spark was the root cause in the incident. The day that the incident occurred was the first very low humidity, low temperature day since adding the rubber gasket to the screen, creating a high static environment. A new dump operator, less experienced at the dumping operation was at the controls, possibly causing less smooth flow of hexane compared to operators more practiced at dumping, raising the potential for static generation and discharge. These factors combined to provide the opportunity for the spark. Testing after the incident proved that the dump pan above the screen and the collection bowl below the screen were

grounded, so two possible directions existed for the spark to jump. Both possible locations were known to contain hexane vapor even though both were covered by ventilation systems. A direct trail of hexane/hexane vapor led from the collection bowl through the area of the screen and to the mix in the dumping bowl. The entire hexane collection system quickly became involved and immediately ignited the mix in the mix bowl. Once ignited, the mix burned violently, blowing particles of mix out of the bowl, through the dump bay and into the hallway where those burning particles could be pushed by gas pressure into the control bay to surround the two operators.
