ERDC/CERL TR-07-23

Corrosion-Resistant Materials for Water and Wastewater Treatment Plants at Fort Bragg

Final Report on Project AR-F-319 for FY05

June 2007

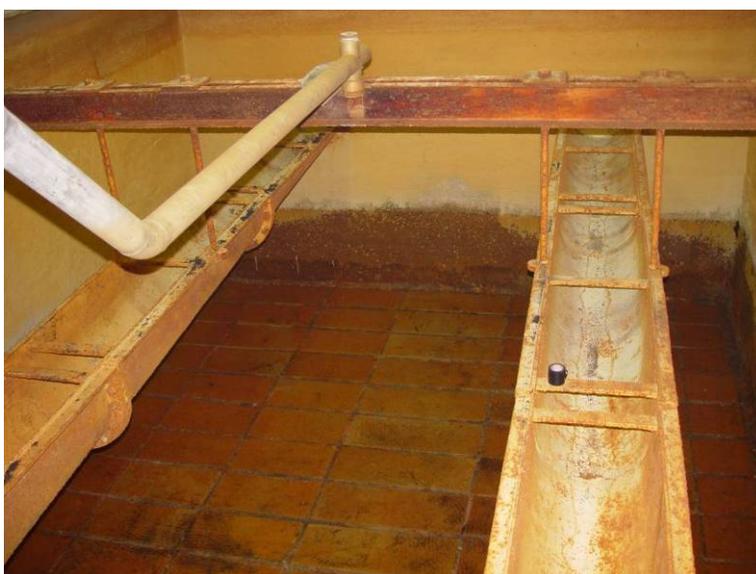
In WTPs, the concrete surfaces of the single and dual water filters deteriorate over time. This deterioration occurs primarily due to chlorine attack on the concrete mortar. This is evidenced by exposed aggregate in the surface of the concrete.

Chloride attack of the concrete's reinforcement steel is also a problem. This is evidenced by cracks forming in the concrete walls with reddish brown stains forming on the concrete surface. The reddish brown stains are nothing more than iron oxide (rust). When steel corrodes, it expands approximately seven times its original volume. Consequently, when steel reinforcement bar (rebar) corrodes, something has to give and it is always the concrete. The extreme high forces developed by the corroding rebar are too great for the concrete, which cracks.

Figure 1a. Concrete surface in single cell water filter before refurbishment.

1. *Refurbish the concrete wall coating in the single filters.* These tasks involved the rehabilitation of the concrete walls in single cell filters No. 1 through 10. All deteriorated concrete and coatings were removed, and the walls were cleaned down to the sound coated concrete surfaces. Mainstay ML-72 Microsilica Restoration Mortar was then applied over those exposed concrete surfaces and troweled smooth (at +/- 1/2-in. thickness) to restore the concrete walls to their original thickness. The ML-72 mortar was then coated with 20 to 25 mils of Madewell 1103 Epoxy Coal Tar coating and top-coated with 16 mils of Mainstay DS-4 epoxy. Mainstay ML-72 Sprayable Microsilica Cement Mortar is a restoration mortar that forms a

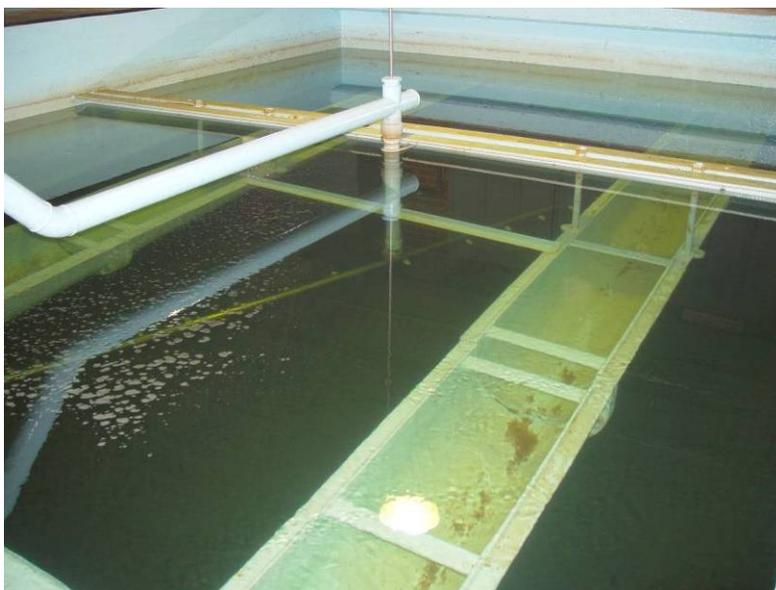
Figure 1b. Concrete surfaces in single cell water filter after refurbishment.

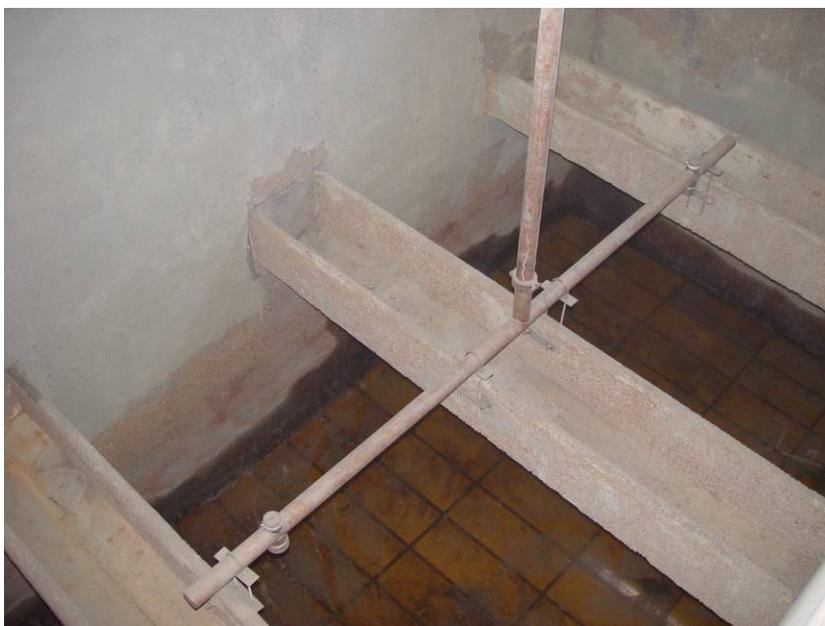
Figure 2a. Concrete surface in dual cell water filter before refurbishment.

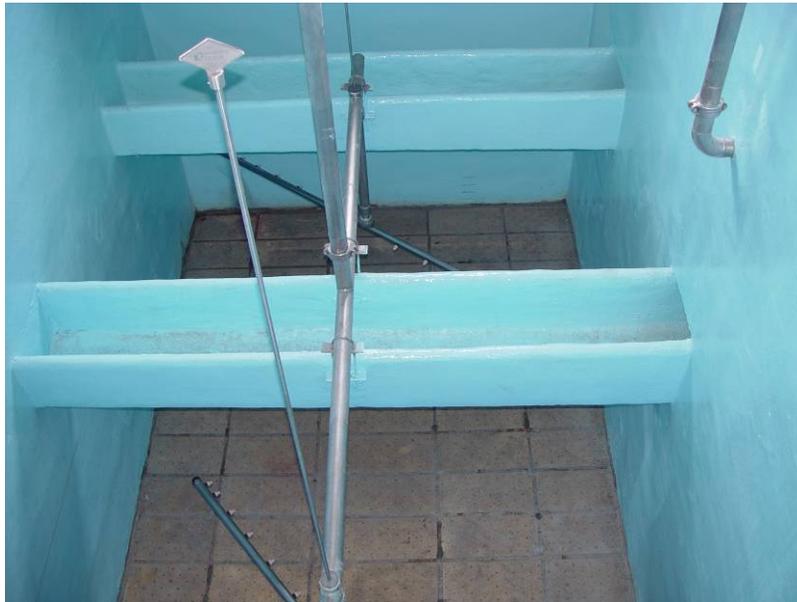
Figure 2b. Concrete surface in dual cell water filter after refurbishment.

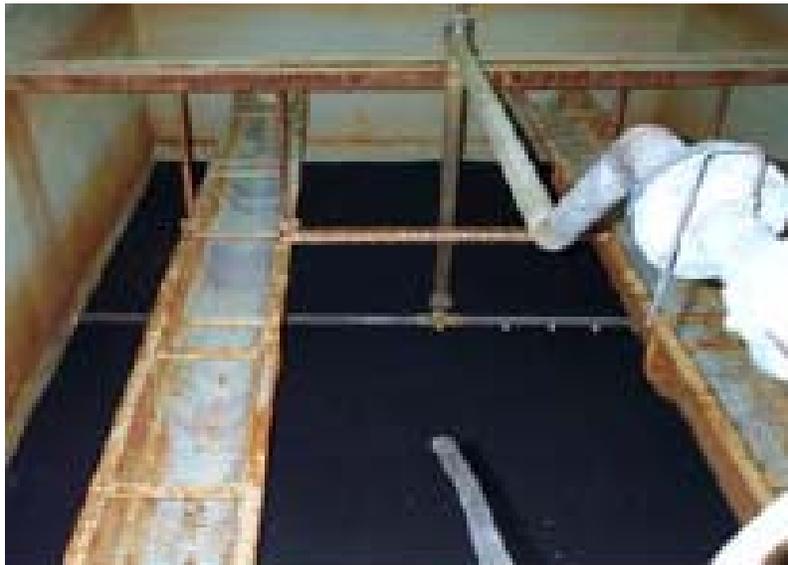
Figure 3a. Metal troughs and wash piping in single filter cells before coating refurbishment.

Before and after photographs are shown as Figure 3a and Figure 3b, respectively in the water treatment plant photographic journal section (Appendix 2). Additional specification information may be found on the PDS for these materials, as given in Appendix 3. Certain unforeseen field conditions ultimately led to premature corrosion in some areas (estimated to be less than 1% of the total trough surface area). The problem areas were all concentrated in tight, difficult to access spots, such as segments of angle iron mounted back-to-back, bearing plates attached directly to (and in in-

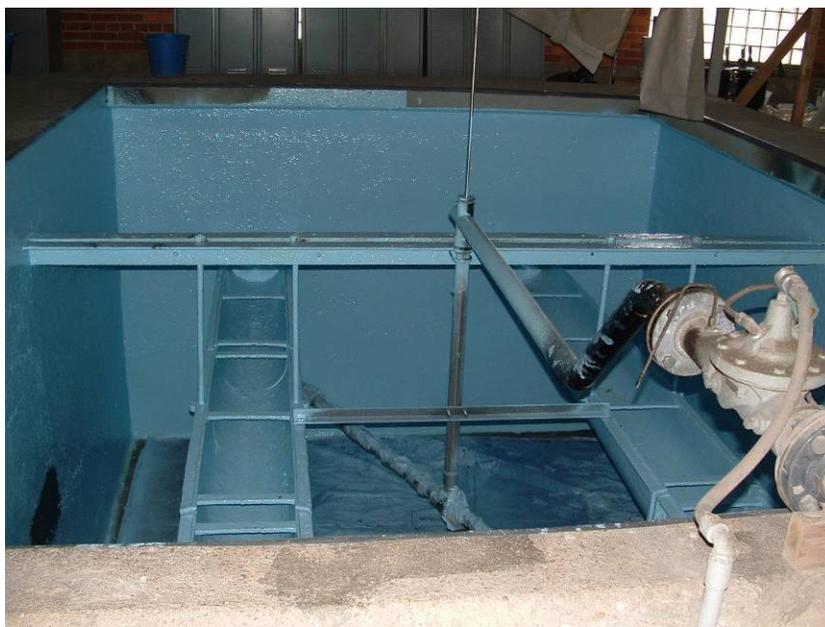
Figure 3b. Metal troughs and wash piping in single filter cells after coating refurbishment.

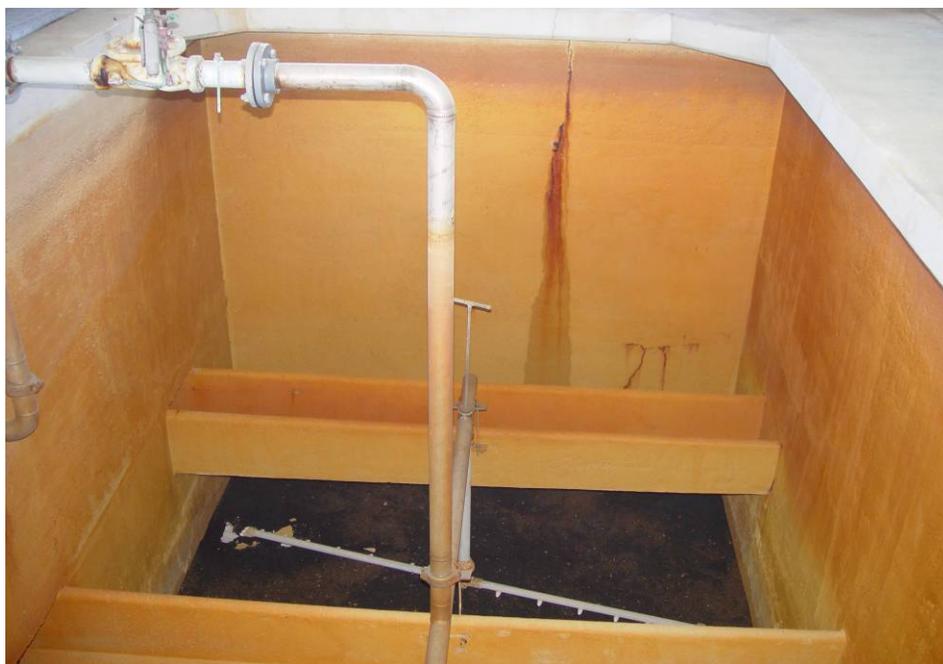
Figure 4a. Newly installed wash piping in dual filter cells before refurbishment.

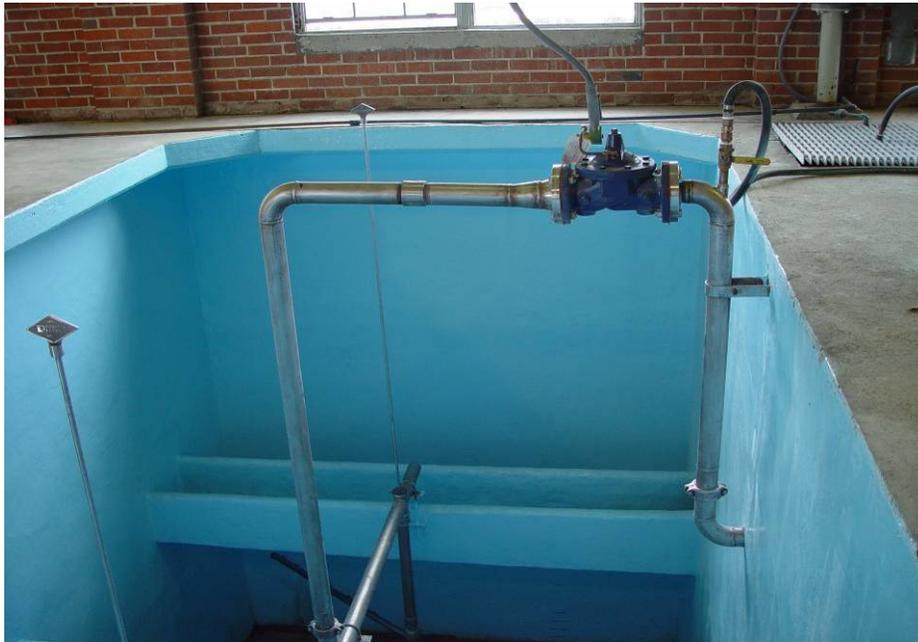
Figure 4b. Newly installed wash piping in dual filter cells after refurbishment.

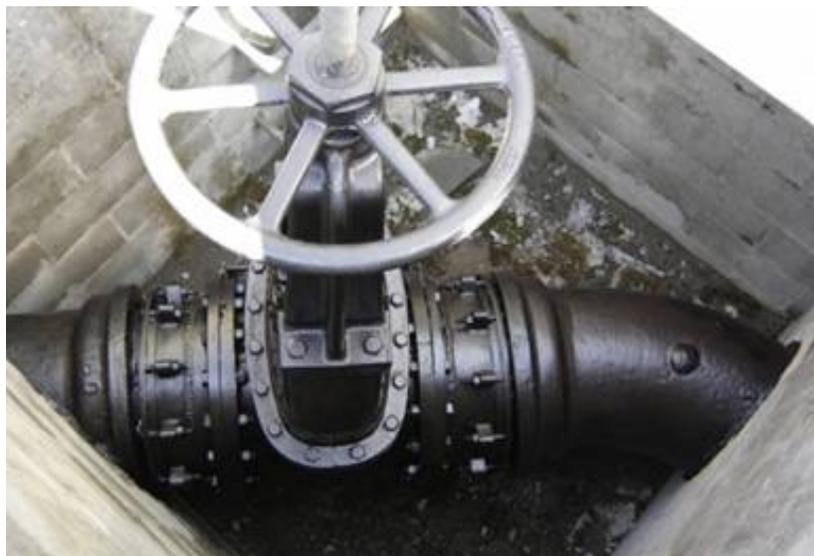
Figure 5. New coating system on one of nineteen underground valve pits.

5. Refurbish the coating on the piping and valves in below ground pits. This task involved repairing the coatings on the water pipes and associated valves within 19 underground valve pits in the fresh water plant. The pipes, valves, and fittings were sandblasted to near white metal (SP-10). The contractor then applied 20 to 25 mils of 1103 coal tar epoxy. Figure 5 is a photograph of one of the newly coated valve pits (Appendix 2).

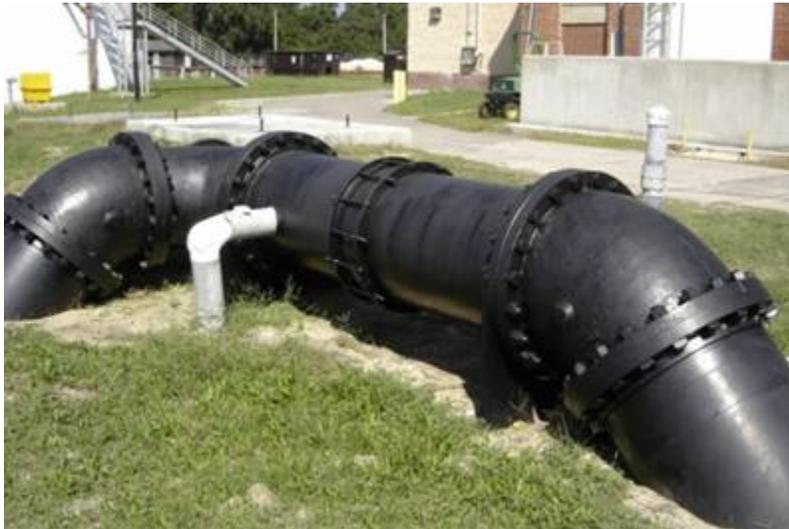
Figure 6. New coating system on above-ground manifold.

6. *Refurbish the coating on large, above ground piping manifold.* This task involved the repair of coatings on the 20-in. ϕ manifold piping behind the filter building in the fresh water plant. The piping was abrasively blasted to near white metal (SSPC-SP 10), and then 20 to 25 mils of Madewell 1103 epoxy were applied. Figure 6 is a photograph of the newly coated piping manifold (Appendix 2).

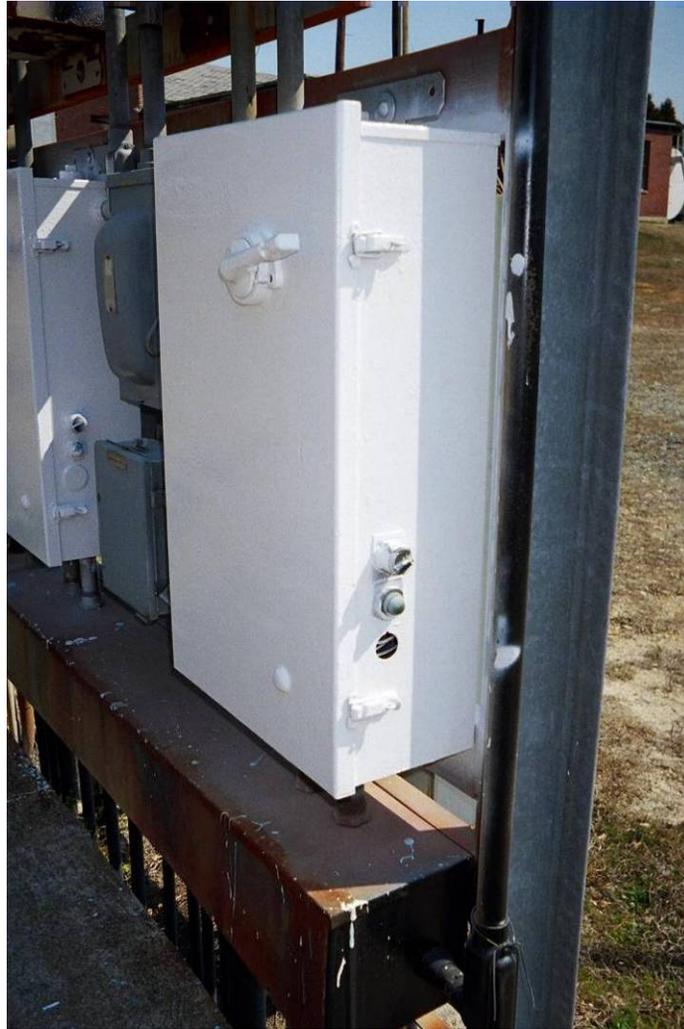
Figure 7. Electrical boxes at water treatment plant after refurbishment.

7. *Refurbish the coating on electrical panel box.* This task involved the repair of two electrical panel boxes in the water plant that service recirculation pumps No. 1 and 2. The boxes were abrasively blasted to near white metal (SSPC-SP 10). Then 10 mils of Madewell 1312S epoxy were applied and top coated with 2 to 3 mils of Madewell 1450 urethane. Madewell® 1312S is a heavy duty, 100% solids two component epoxy coating product. It is used for both new construction and maintenance of steel and concrete surfaces in tanks, sumps, trenches, decks, and pipe interiors and other process equipment and structures in chemical processing, power, refining, mining, pulp/paper and oil refining industries. Madewell 1312S may be used as a topcoat for other Madewell 1312 series coating systems to add color and/or seal the surface.

Madewell 1312S protects surfaces against chemical attack under immersion, spill, and splash conditions and impact and abrasion damage by rough use or heavy traffic. It is normally applied at a nominal thickness of 10 to 25 mils in two coats. Being attractive and easy to clean, its monolithic construction resists moisture, chemical, and bacterial penetration. Its free spreading characteristics, fast set time, and easy cleanup help to minimize labor costs and down time. Additional specifications may be found on the PDS for these materials, as given in Appendix 3. Figure 7 presents a view of a typical electrical panel box after refurbishment in the photographic journal section (Appendix 2).

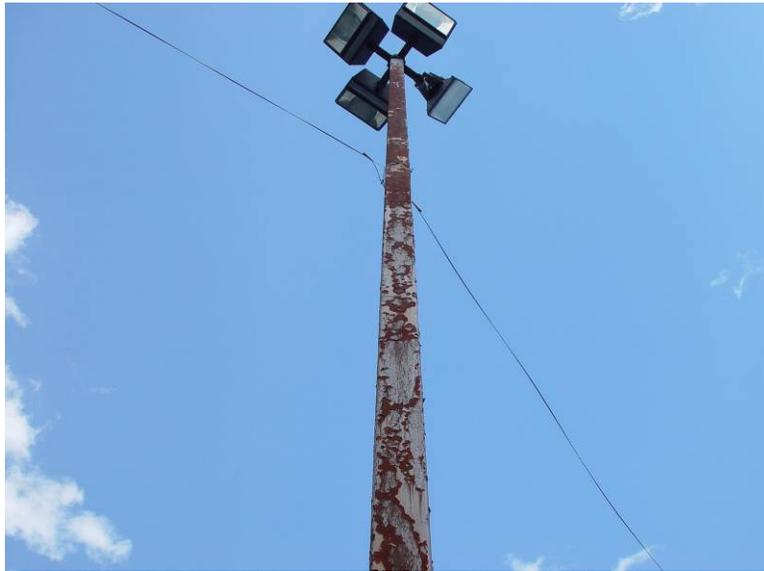
Figure 8a. Typical steel light pole at wastewater treatment plant before refurbishment.

1. *Refurbish the coating on 40-ft tall yard light poles.* This task involved repairs to 17 light posts within the wastewater treatment plant. The contractor wet blasted the square metal posts, including the base plates, to white metal (SSPC-SP 10). A 20 to 25 mil coat of 1103 coal tar epoxy was applied, followed by 2-3 mils of urethane 1450. Before and after photographs are shown as Figures 8a and 8b, respectively, in the wastewater photographic journal section (Appendix 2). Additional specifications may be found on the PDS for these materials, as given in Appendix 3.

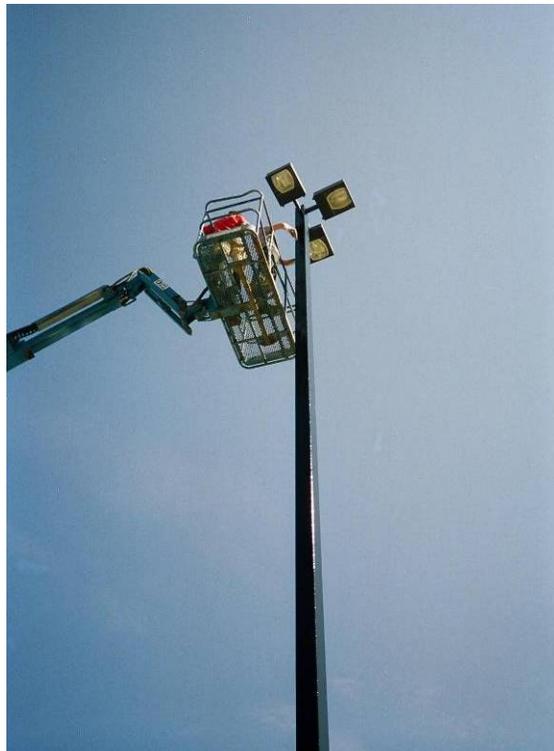
Figure 8b. Typical steel light pole at wastewater treatment plant after refurbishment.

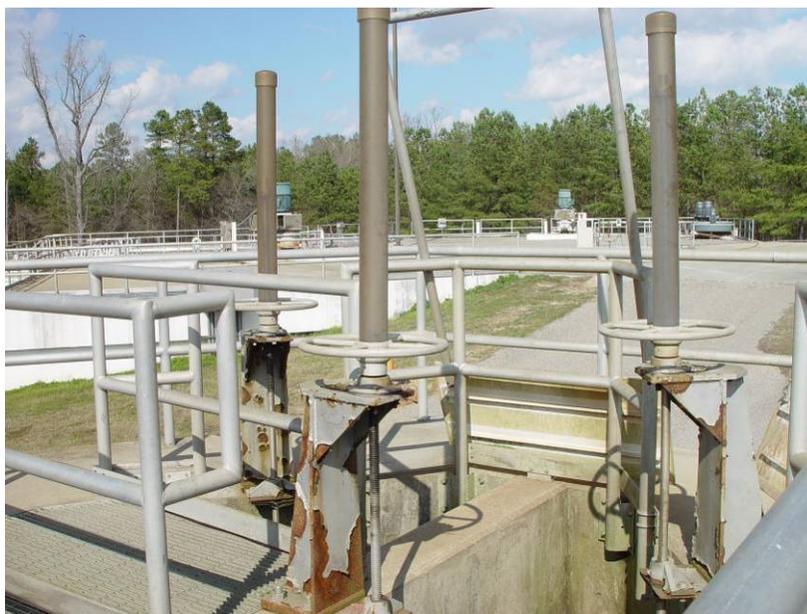
Figure 9a. Hand wheels and operator stands before refurbishment at wastewater treatment plant.

2. *Refurbish the coating on remote valve hand wheels and valve stem operator stands.* This task involved the repair of valve stands and valve wheels within the WWTP, sand blasting and coating 19 valve wheels, and sand blasting and coating 11 valve stem operator stands. The wheels and stands were sand blasted to SSPC-SP 10. Once cleaned, the wheels and stands were coated with at least 20 mils of Madewell 1103 coal tar epoxy and 2 to 3 mils of Madewell 1450 urethane. Before and after photographs are shown as Figures 9a and 9b, respectively, in the wastewater photographic journal section (Appendix 2). PDS for these materials are given in Appendix 3.

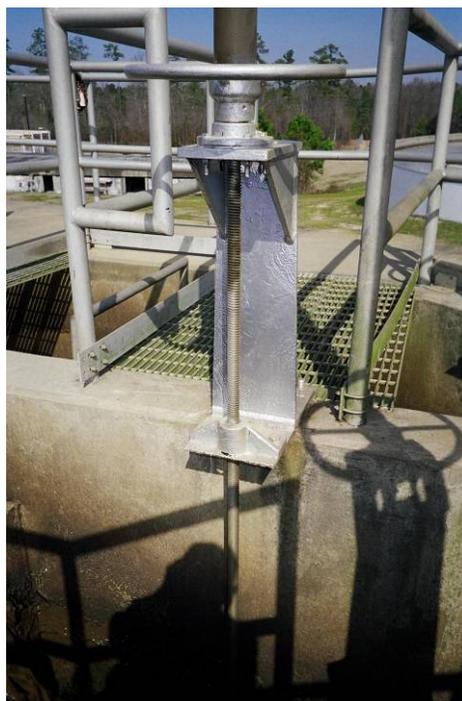
Figure 9b. Hand wheels and operator stands at wastewater treatment plant after refurbishment.

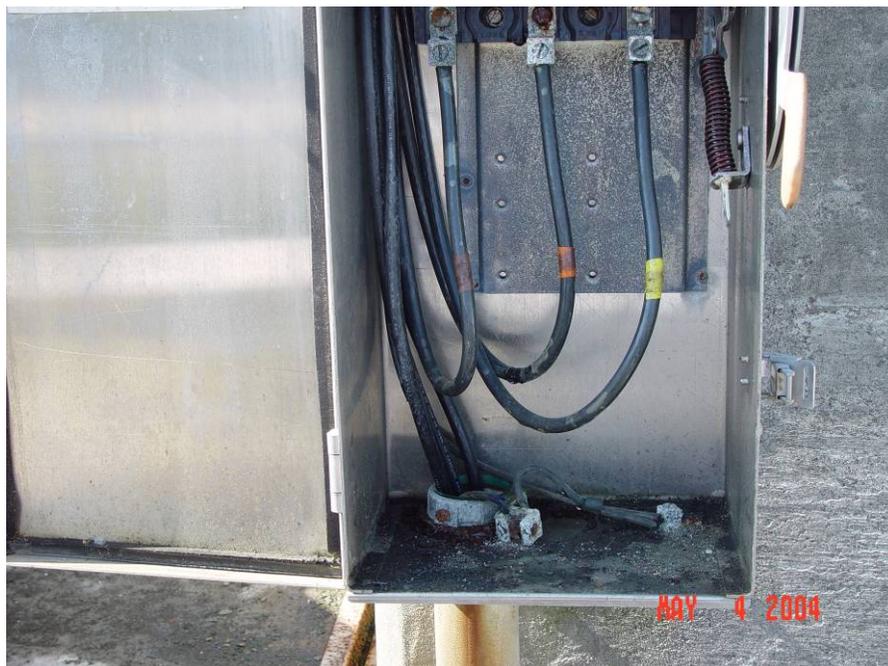
Figure 10a. A typical electrical control box before refurbishment.

3. *Refurbish and seal stainless steel electrical motor control/circuit breaker panel boxes.* This task involved repairs to ten existing electrical disconnect boxes on various pump and mixer motors in the wastewater plant. The boxes are primarily stainless steel, with a mixture of galvanized, polyvinyl chloride (PVC) and PVC-coated flexible conduits. The contractor inspected each box, replaced damaged hinges and hasps, repaired conduit connections, replaced missing or damaged gaskets with corrosion-resistant nitrile gaskets, and sealed the conduits. Before and after photographs are shown as Figure 10a and Figure 10b, respectively, in the wastewater photographic journal section (Appendix 2). Nitrile or buna-N rubber seals are used more than all the other elastomers combined, since nitrile is the most versatile material and is not as likely to fail as do most other rubber gaskets and seals due to the natural breakdown of the elastomeric molecular bond of rubber when stressed (e.g., compressed, elongated). Additional specifications may be found on the PDS for these materials, as given in Appendix 3.

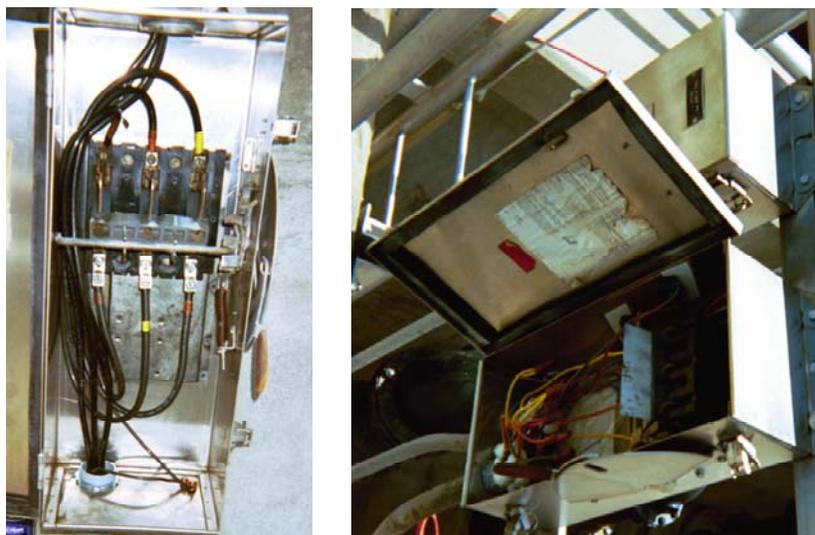
Figure 10b. Electrical control boxes at wastewater treatment plant with nitrile gaskets after refurbishment.

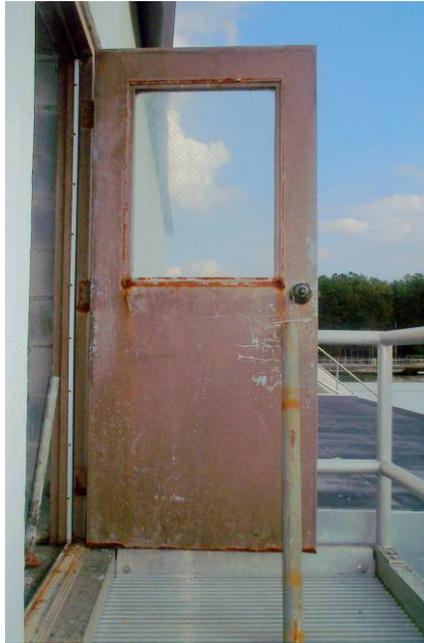
Figure 11a. Typical steel door at chlorine building at wastewater treatment plant before refurbishment.

4. *Replace one single and two double metal doors with FRP doors.* This task involved replacement of five sets of doors on the chlorine injection building (V-3408), within the potable water plant. The original steel doors and frames were removed, and the thresholds cleaned. New fiberglass frames and doors were then installed with stainless steel hardware. The new doors (manufactured by Tiger Doors) were of phenolic honeycomb core construction with exclusive press molding technology, yielding an integrally fused product. They also have a polyurethane skin coating on that provides the same excellent mechanical durability and superior resistance to sunlight, moisture, and chemicals. They carry a lifetime warranty as it specifically relates to delamination or corrosion, excluding third-party damage, vandalism, force majeure events, etc. Before and after photo-

graphs are shown as Figures 11a and 11b, respectively, in the wastewater photographic journal section in Appendix 2. Appendix 3 provides additional specification on the FRP doors. Appendix 4 presents a more detailed report on FRP doors installed at Fort Bragg under this OSD-sponsored project and at Fort Drum, NY, under a previous corrosion control technology demonstration project.

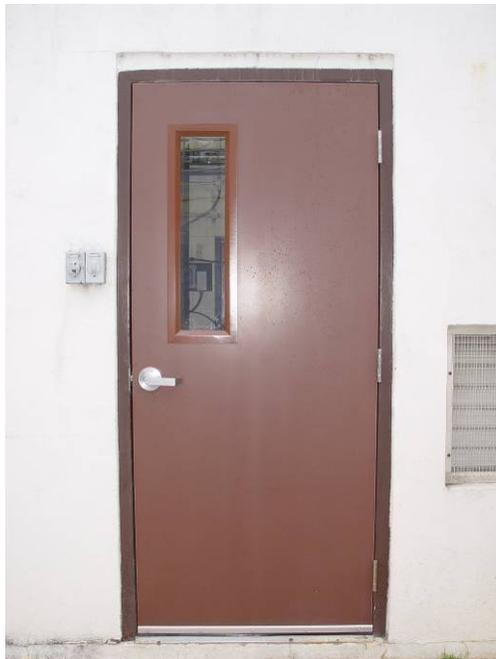
Figure 11b. Typical steel door at chlorine building at wastewater treatment plant after refurbishment.

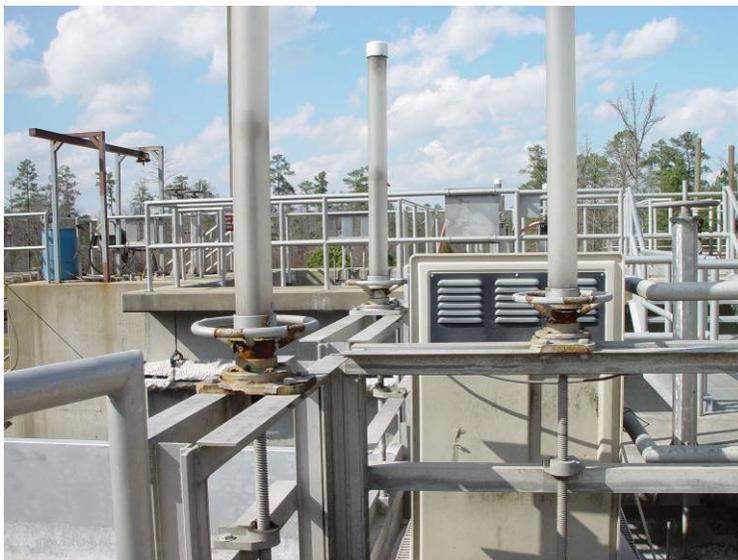
Figure 12a. Severely corroded (un-salvageable) corroded steel hand wheels at WWTP before replacement.

5. *Replace remote valve hand wheels and remote operator stands.* Three hand wheels were unsalvageable and had to be replaced. They were replaced with a corrosion-resistant aluminum alloy B26-525. Before and after photographs are shown as Figures 12a and 12b, respectively, in the wastewater photographic journal section in Appendix 2.

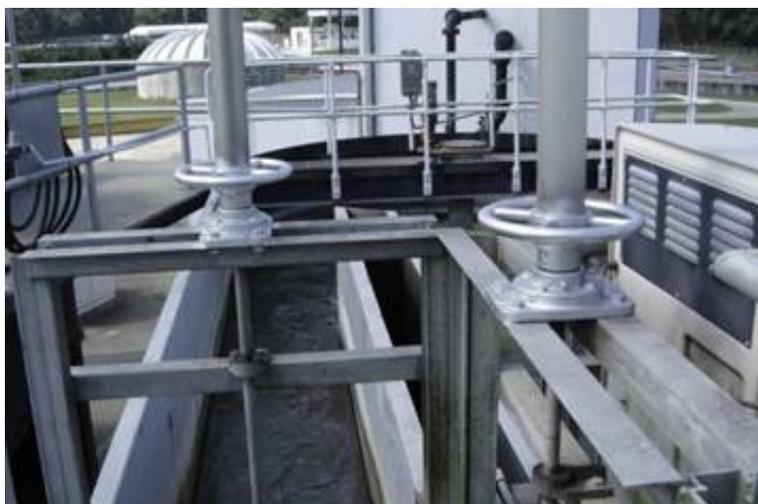
Figure 12b. New hand wheels (aluminum alloy B26-535) at WWTP replacing the corroded steel hand wheels shown in Figure 12a.

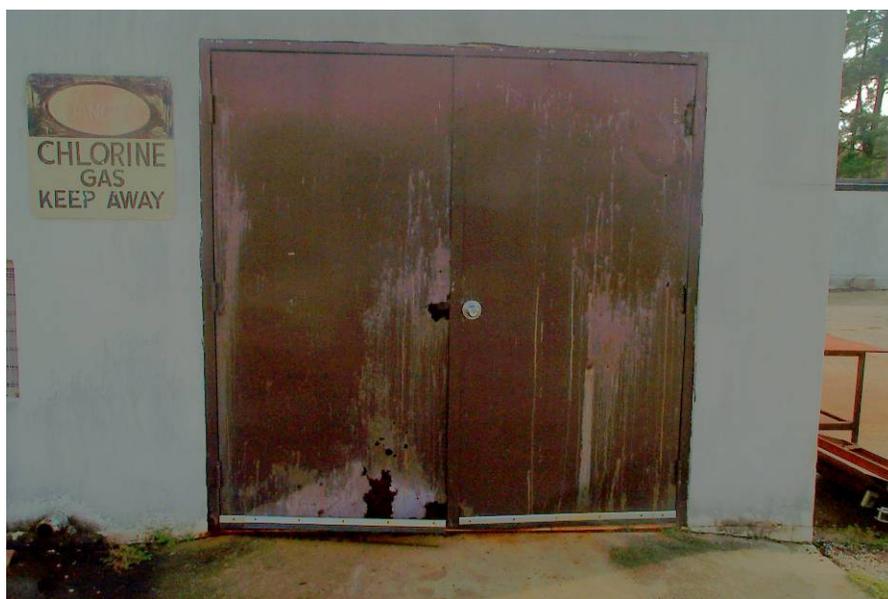
Figure 1. Corroded metallic doorway at the Fort Bragg water treatment plant.

The doors shown in Figures 1–4, and other doors on the same building, were scheduled for replacement with FRP doors, which should be more resistant to corrosion and weather. The lack of sills or other overhangs contributes to the corrosion of these doors, but they have also deteriorated due to the aggressive nature of the chemicals in use at the water treatment plant.

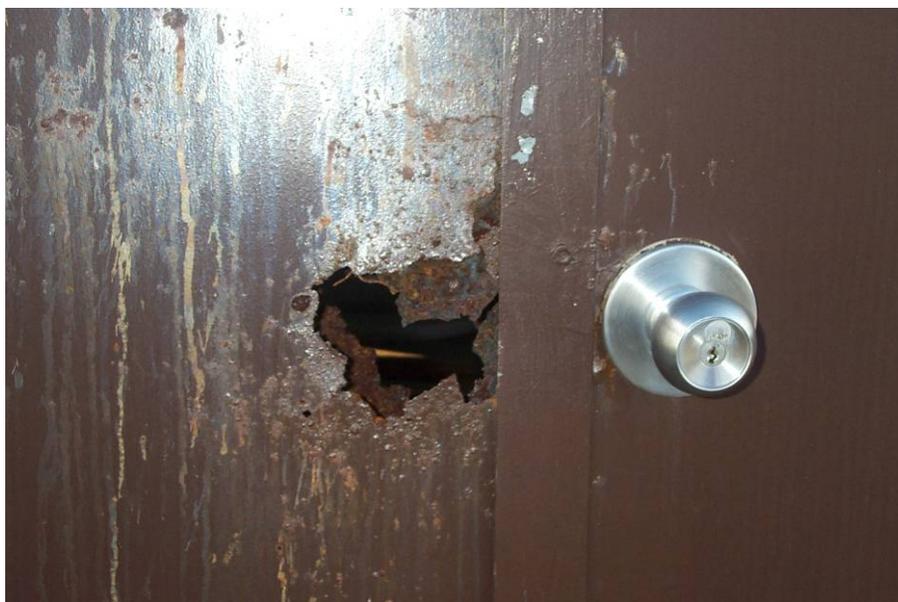
Figure 2. Closeup of corrosion on doors shown in Figure 1.

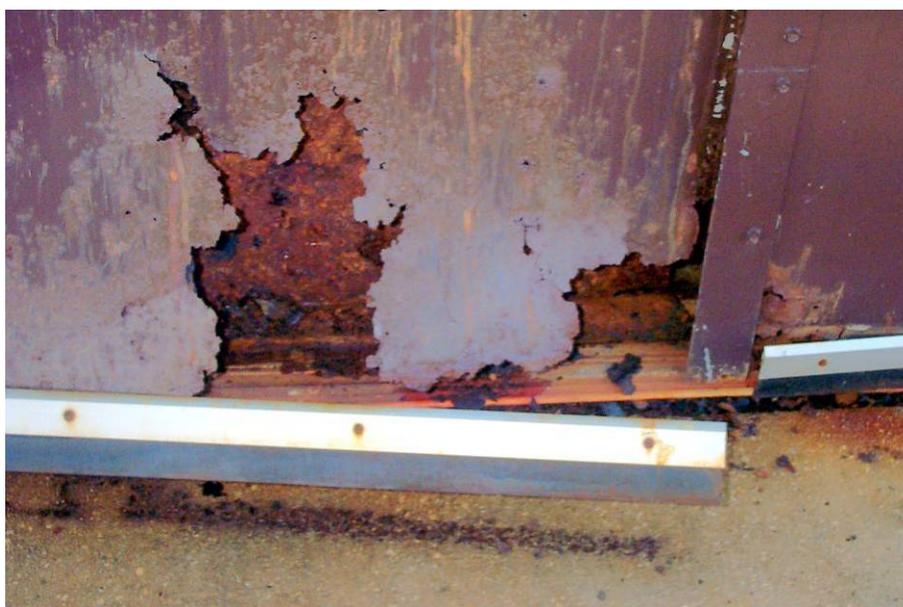
Figure 3. Corrosion of the bottom of the doors shown in Figure 2.

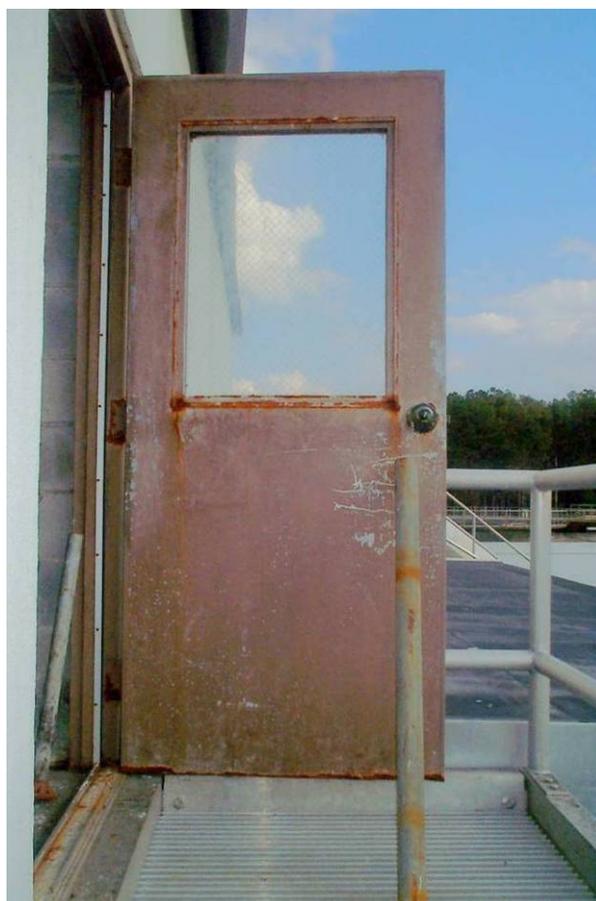
Figure 4. Corroded metallic doorway at the Fort Bragg water treatment plant.

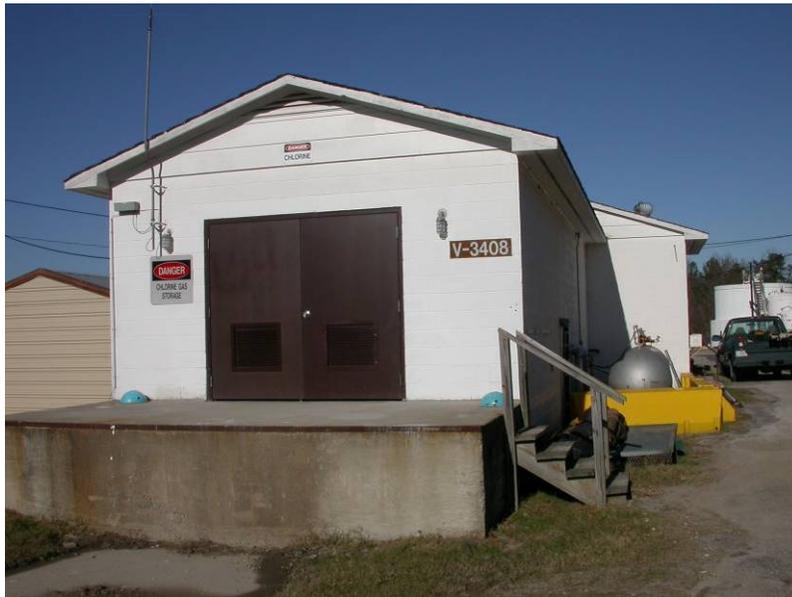
Figure 5. Replacement doors for the doors shown in Figures 1–3 above.

The concrete block surrounding the doorway had also deteriorated and needed to be replaced. The repaired wall and new door sills allowed replacement with standard-sized doors in this location.

The doors of the water treatment plant were replaced by a contractor in November 2005. Figure 5 shows the new doors that replaced the doors shown in Figures 1 through 3.

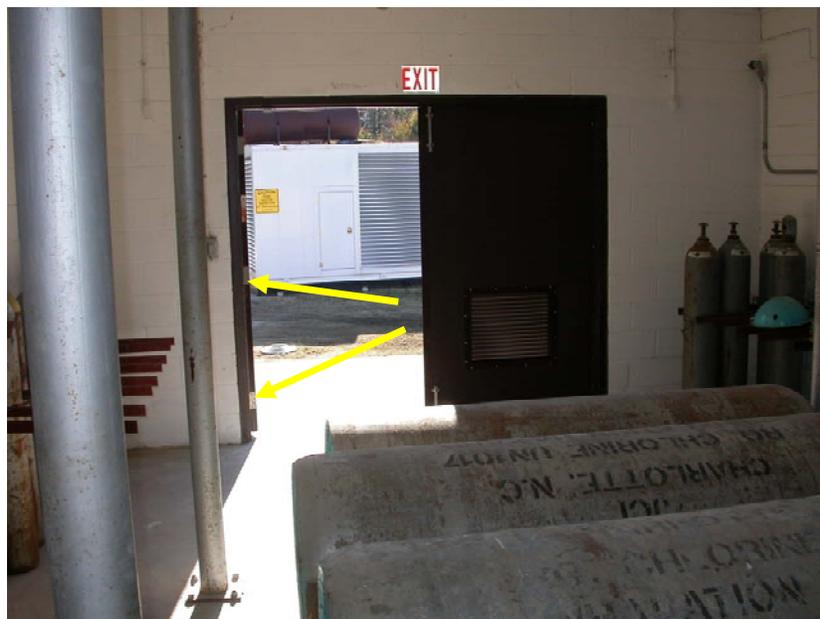
Figure 7. Interior view looking out at door shown in Figure 6. Arrows point to stainless steel hardware necessary because of corrosive conditions at this location. Note the chemical gas cylinders in the foreground.

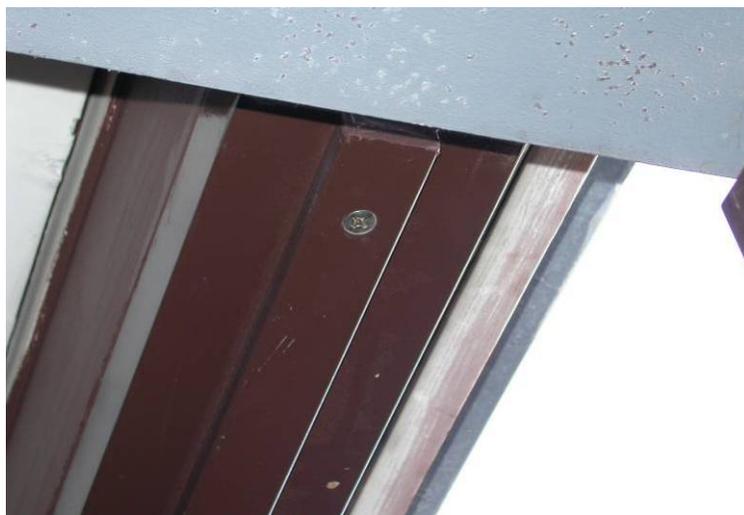
Figure 9. Overhead door sill cut to allow equipment loading track shown in Figure 8.

Figures 8 and 9 show the overhead FRP door sill that was cut to accommodate the steel rail. Stainless steel screws were used to attach the FRP sill to the masonry building.

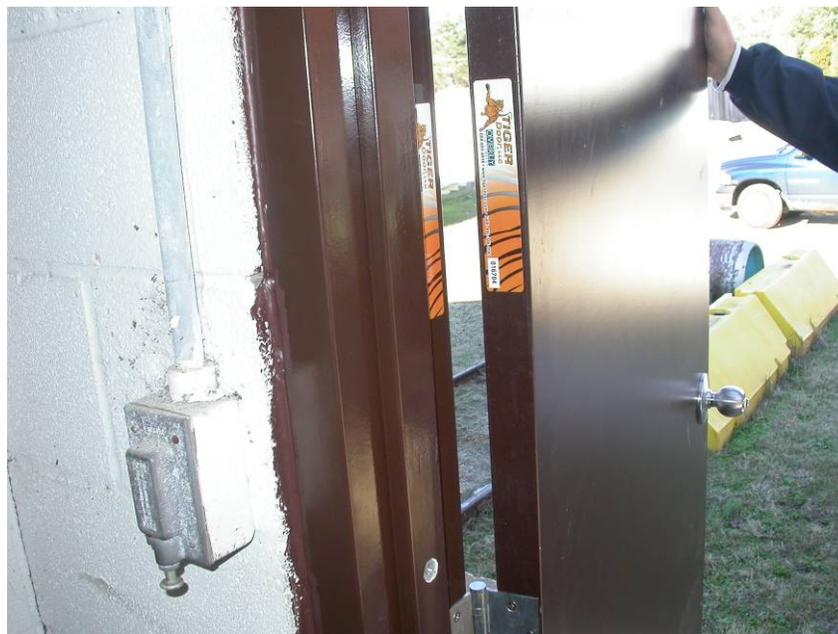
Deterioration of the door jamb necessitated new FRP door jambs that were installed around the doorway. Figures 10 and 11 show details on the left

Figure 10. Special door jamb fabricated for the FRP doors shown in Figs. 5-7.

side of the doorway shown in Figure 7. Because of the corrosive conditions in this location, it was necessary to utilize stainless steel screws, hinges, and other hardware for this entire installation.

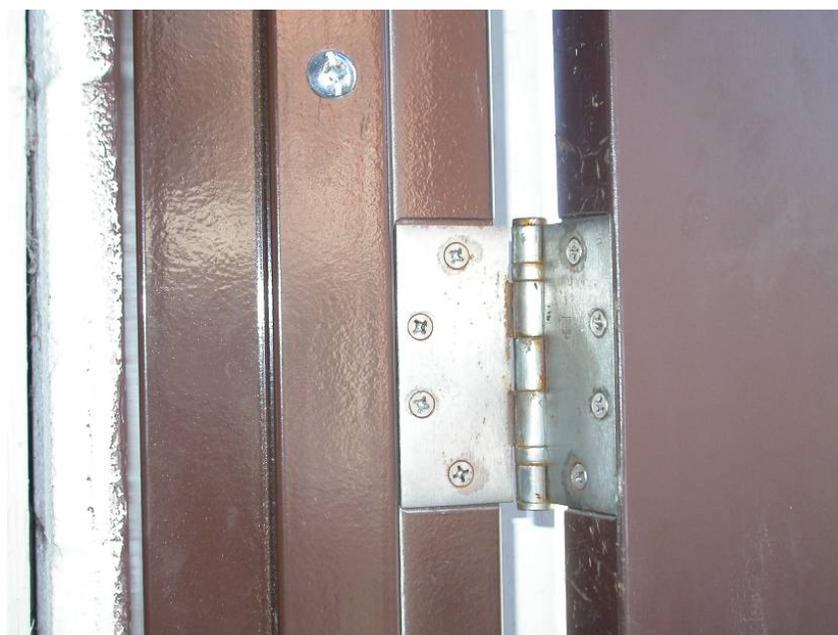
Figure 11. Stainless steel hinges for doors shown in Figs. 6-10.

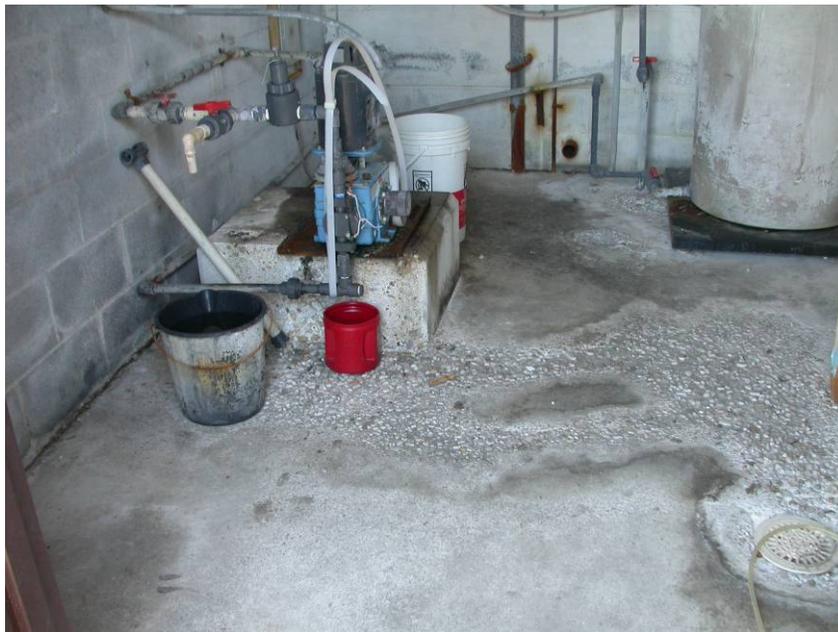
Some of the chemicals shown in the room discussed in Figures 6–11 are mixed and used in the room behind the door shown in Figure 12. The corrosive acids used in water treatment have etched the concrete floor of this room. The floor etching due to chemical spills is apparent in Figure 13.

Figure 13. Interior of room behind door shown in Figure 7. Note the etching of the concrete floor due to spills of acid onto the floor.

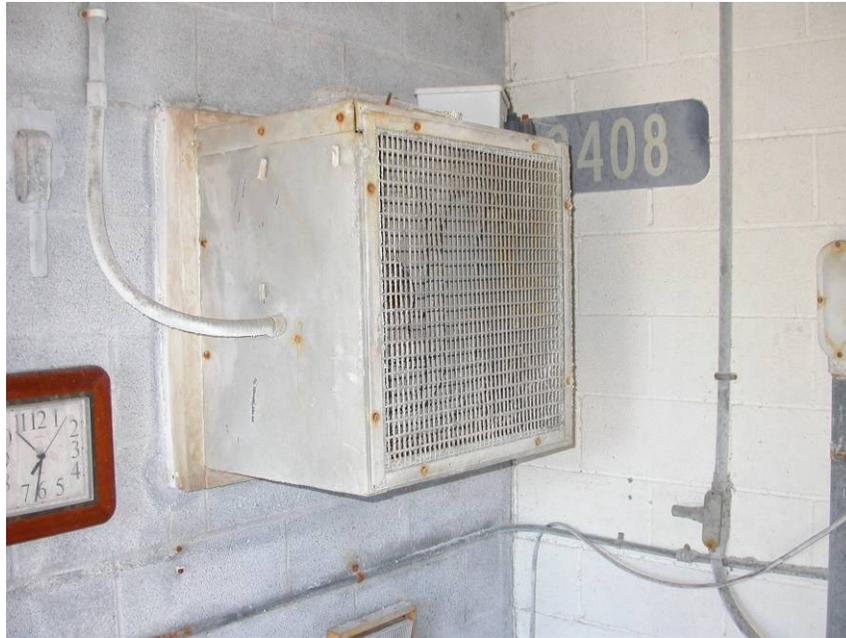
Acid fumes have also caused corrosion of the wall mounted air conditioner in this room, as shown in Figure 14.

Figure 14. Wall mounted air conditioner on the wall above the equipment shown in Figure 13.

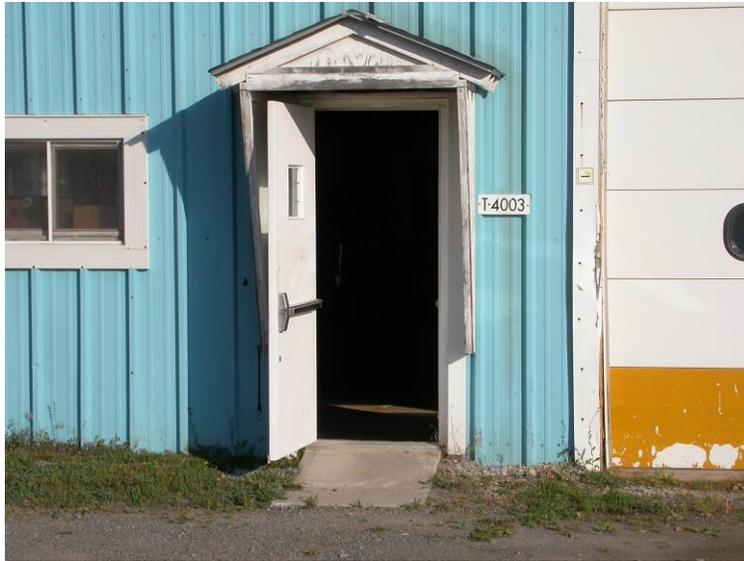
During a parallel project at Fort Drum, New York, several FRP doors that were approximately two years old were examined. Figures 16 and 17 show one of these doors. The panic bar on the door is pulling away from the door, as shown in Figure 17. The solution to this problem is to attach a stainless steel backer plate to the outside of the door and bolt the metal on both sides together.

Figure 16. A two-year old FRP pedestrian door at Fort Drum, New York

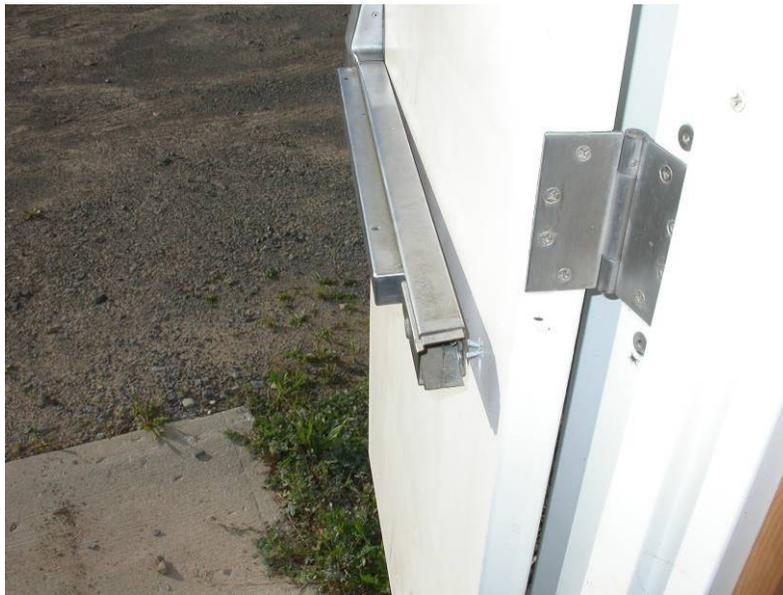
Figure 17. Screws attaching the panic bar to the door shown in Figure 16 showing that the door has bent and pulled the screws from the door.

The problem shown in Figure 17 is not a corrosion problem, but it does indicate a problem associated with the use of composite doors. They can be more flexible than the steel doors they replace, and stripping screws from the hardware is more likely on composite doors than with solid wooden doors or with most steel doors.
