# **ANALYSIS OF DEBRIS FROM HELICOPTERS FROM THE FIELD**

**INTERIM REPORT  
TFLRF No. 402**

**U.S. Army TARDEC Fuels and Lubricants Research Facility  
Southwest Research Institute® (SwRI®)  
San Antonio, TX**

**Contract No. DAAE-07-99-C-L053 (WD49)**

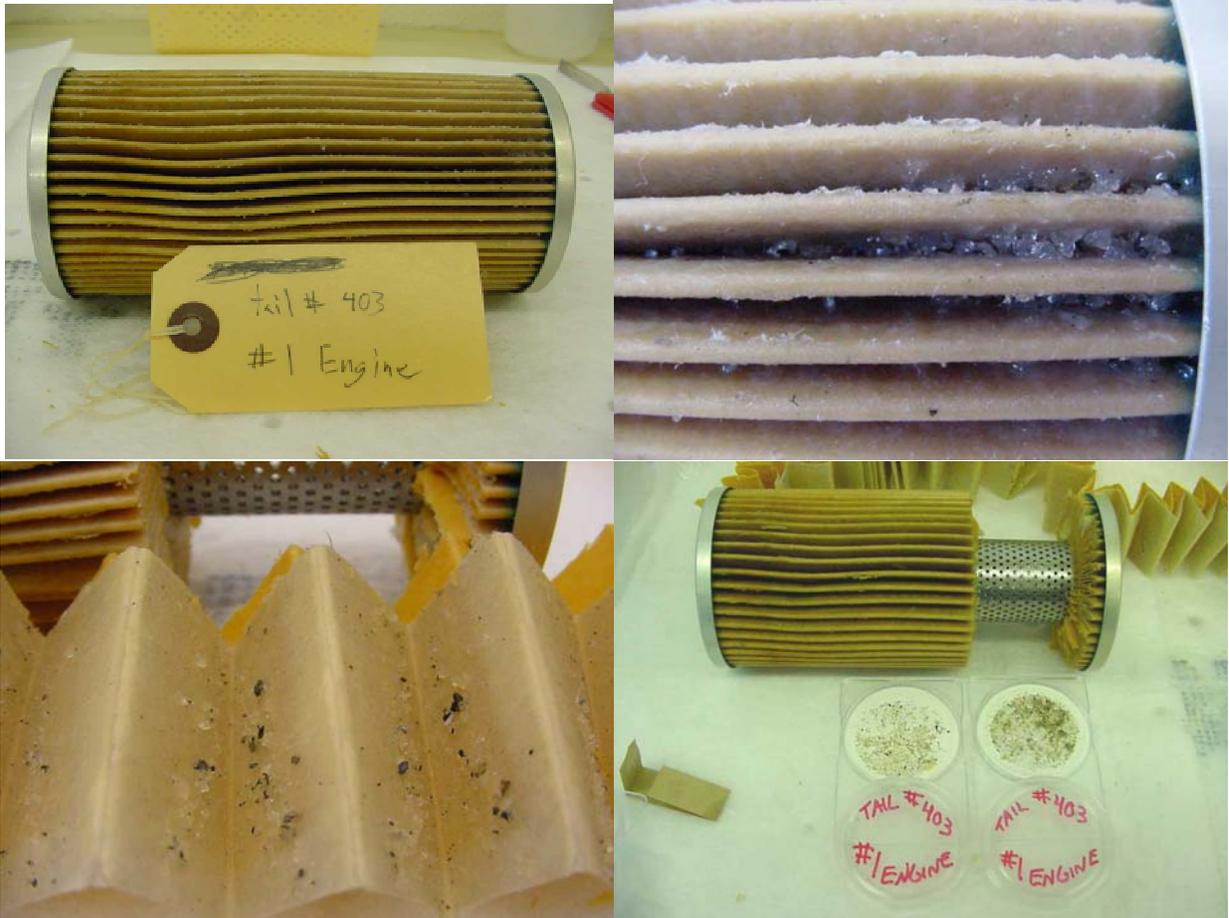
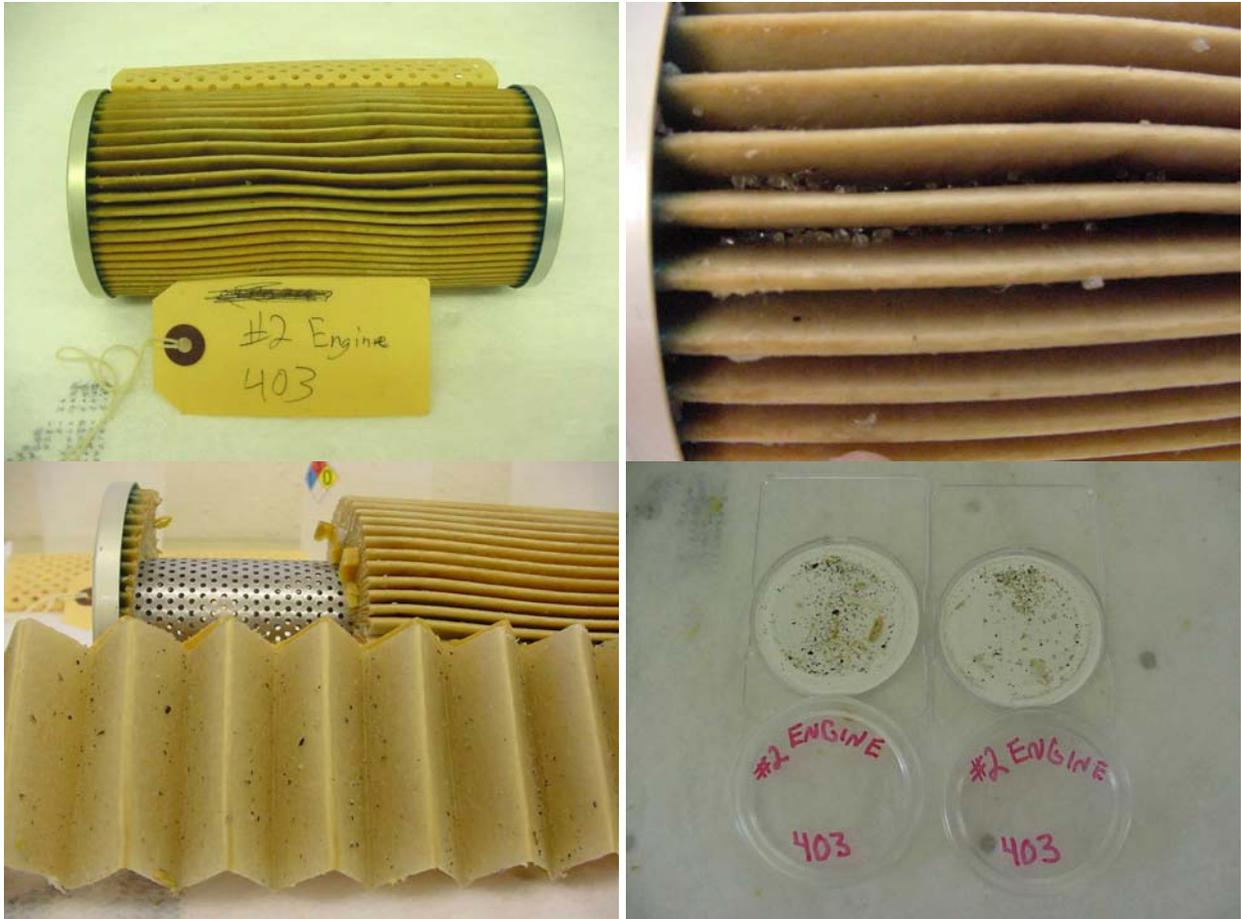
**Figure 1. #1 Engine**

**Figure 2. #2 Engine Filter, as Received**

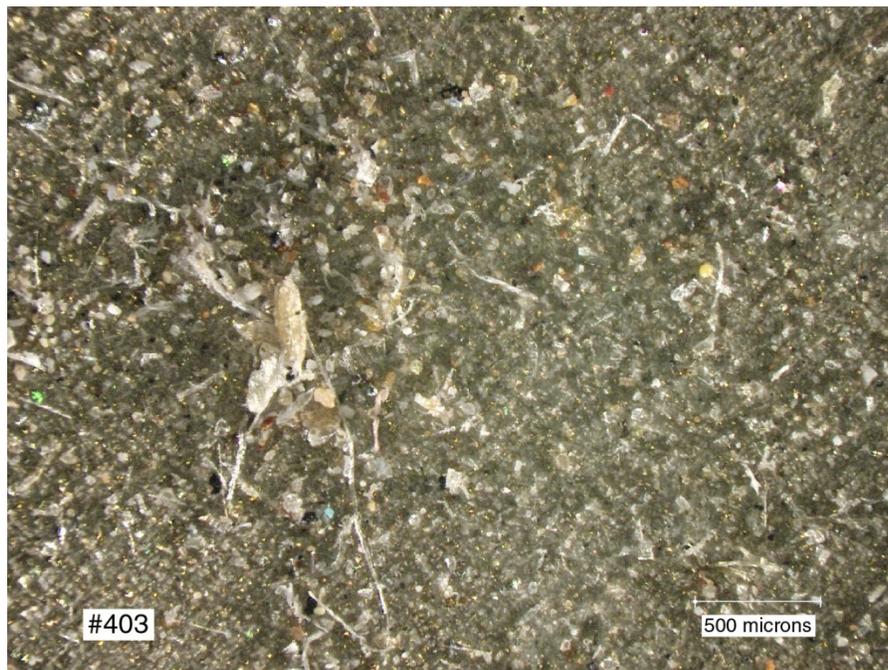
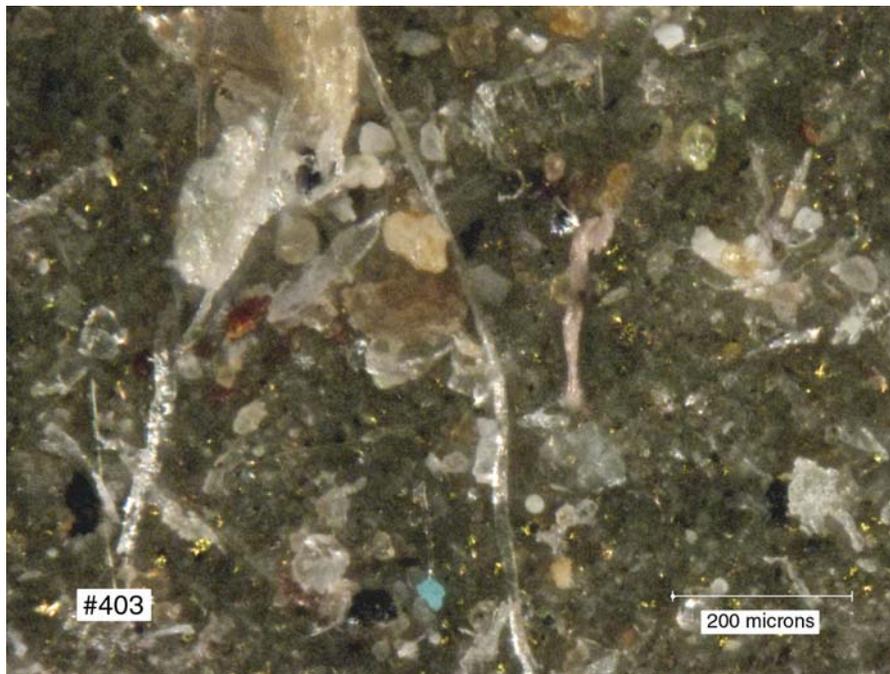
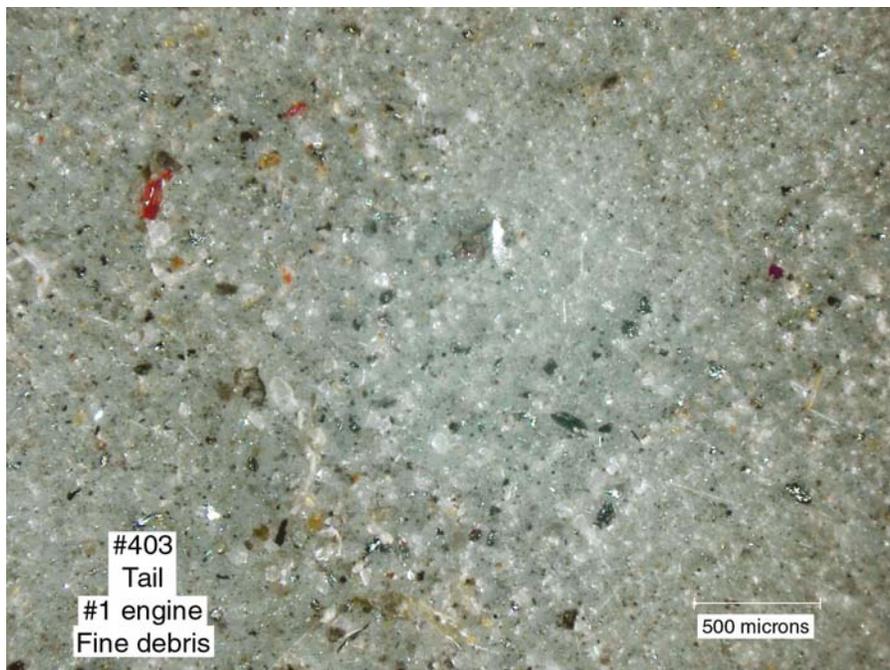
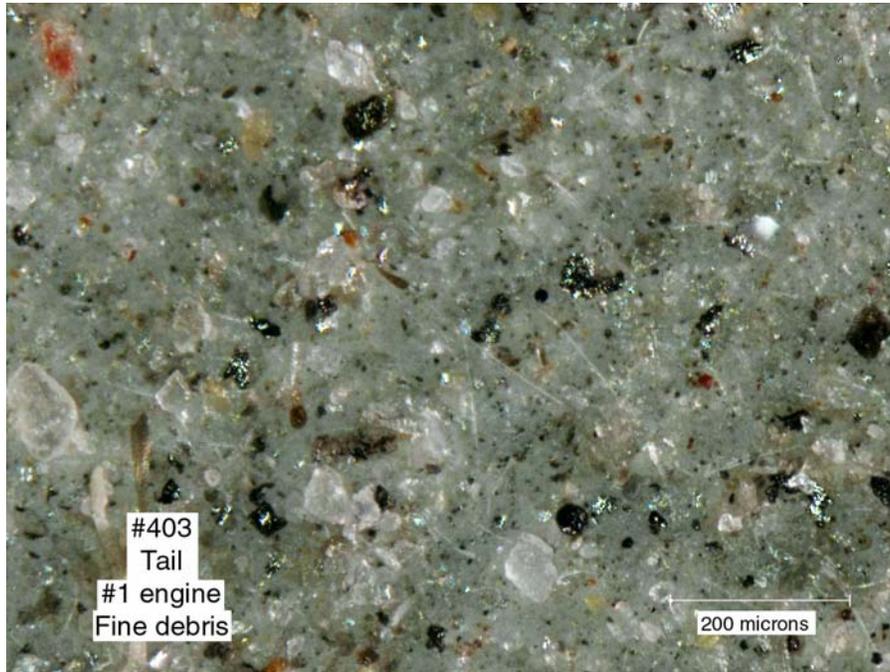
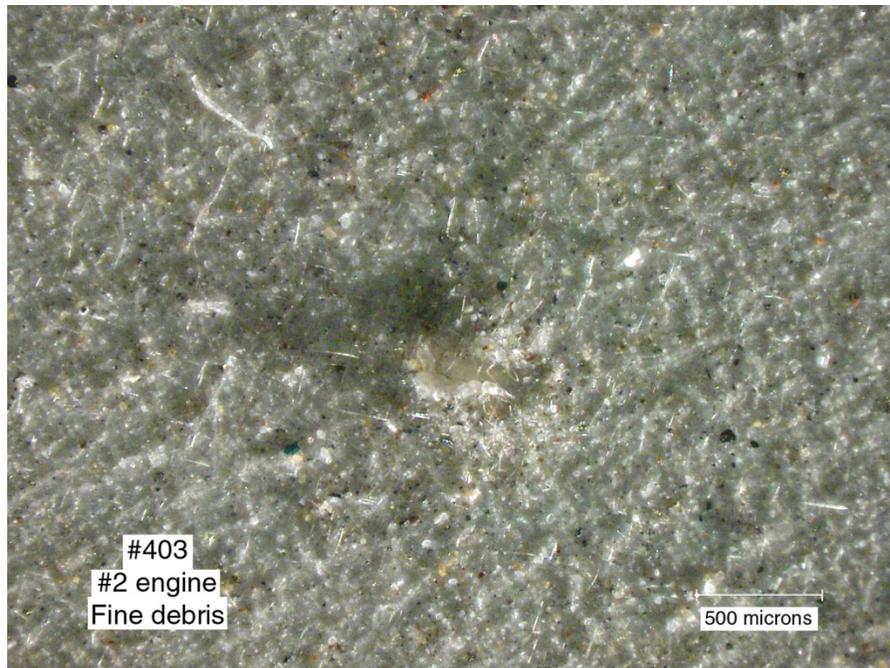
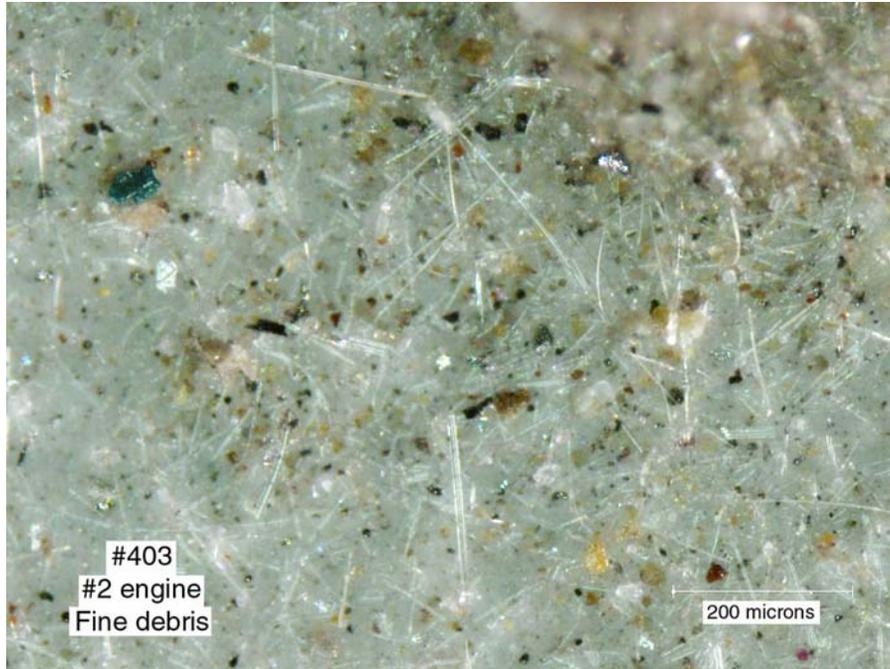
The copper sulfate analysis did not yield the expected results. However, the elemental analysis revealed copper and aluminum already in the fuel, which would complete the ion exchange process and not allow the laboratory reaction to occur. By all other accounts, the evidence collected to date suggests that a fuel monitor ruptured somewhere upstream in the system. The FTIR spectra of the fine debris shown in Figure 8 (#1 Engine) and Figure 10 (#2 Engine) show characteristics that we typically associate with the presence of SAP. This evidence can be further corroborated by the levels of sodium seen in the elemental analysis (Table 1). The optical photos shown in Figures 16–17 are also confirming evidence, as they show various layers of material that we believe belong to a specific manufacturer of fuel monitors. These layers can be compared with the cut-away of the water absorbent monitor shown in Figure 18.

**Figure 3. SEM Photos - #403 (500  $\mu\text{m}$ )**

**Figure 4. SEM Photos - #403 (200  $\mu\text{m}$ )**

**Figure 5. SEM Photos – #1 Engine Fine Debris (500  $\mu\text{m}$ )**

**Figure 6. SEM Photos – #1 Engine Fine Debris (200  $\mu\text{m}$ )**

**Figure 7. SEM Photos – #2 Engine Fine Debris (500  $\mu\text{m}$ )**

**Figure 8. SEM Photos – #2 Engine Fine Debris (200  $\mu\text{m}$ )**

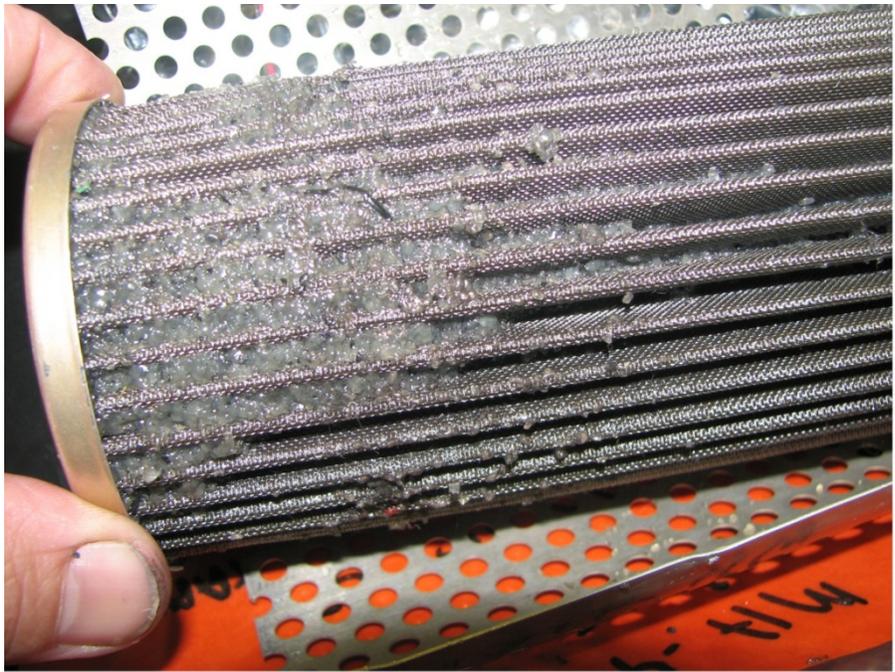
**Figure 22. #1 Main Filter (Photo Provided by Goodrich)**

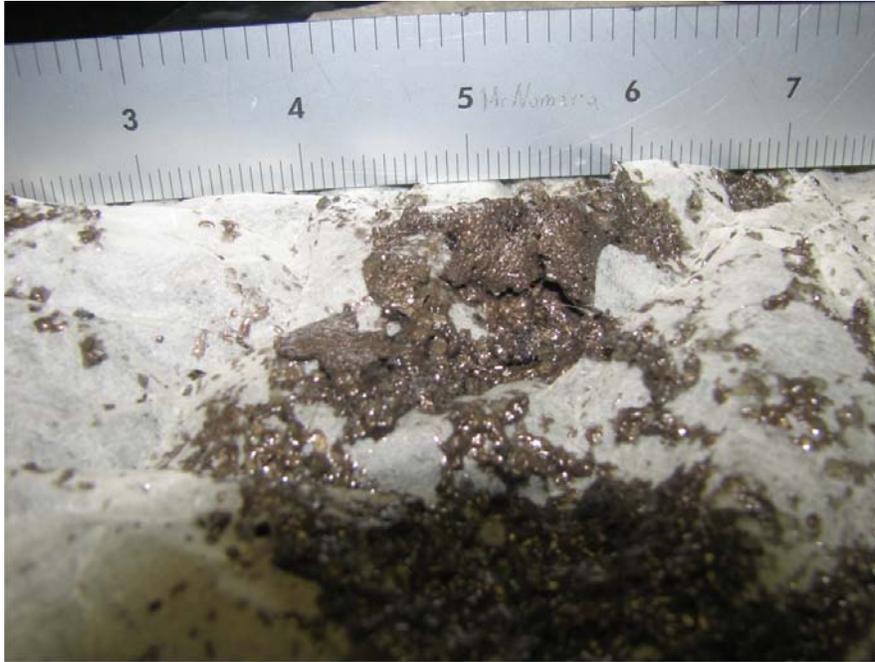
**Figure 23. Filtered “Smudge” (Photo Provided by Goodrich)**

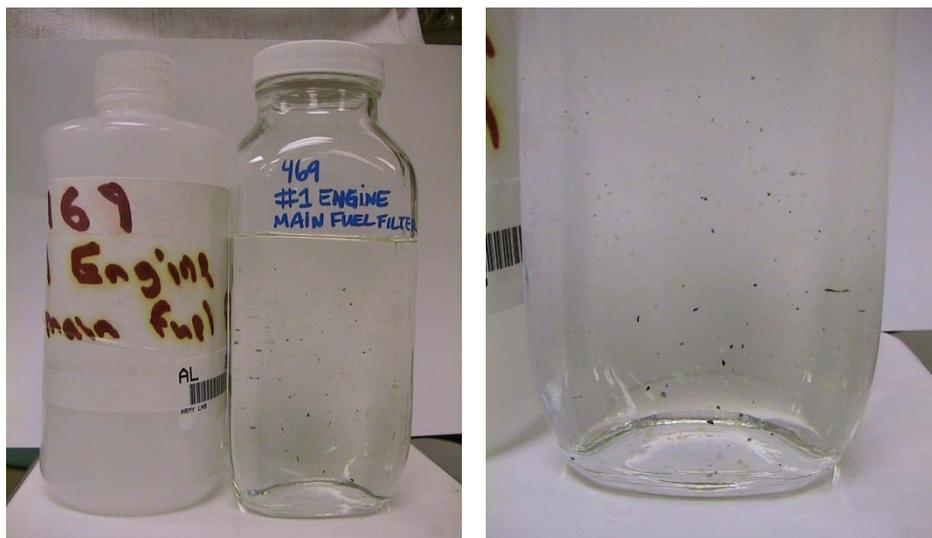
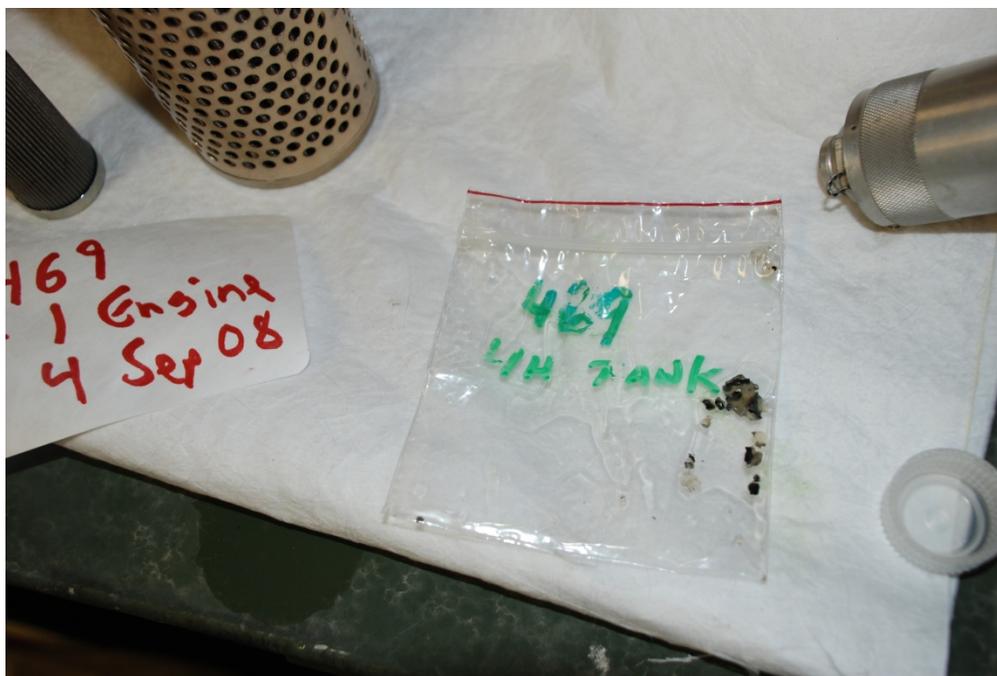
A fuel sample and debris from the left hand tank from 469 were sent to SwRI for analysis (Figures 24 and 25, respectively). The fuel arrived in a plastic bottle but was transferred to a glass container to illustrate the floating debris in the fuel. Two 100-mL samples were filtered through 0.8- $\mu\text{m}$  membranes, and the gravimetric results are shown in Table 2. The fuel sample contained a large quantity of dark particles that appeared to be elastomeric or rubber. There were also large white particles floating in the fuel. All the debris would eventually settle to the bottom of the container. Upon completion of the gravimetric and elemental analysis, the membrane was treated with copper sulfate to determine if SAP was present.

The debris from the left hand fuel tank was dried when received. When water was applied to the debris, it had the consistency of SAP.

Figure 24. Fuel Sample From 469

**Figure 25. Debris From L/H Tank – 469**

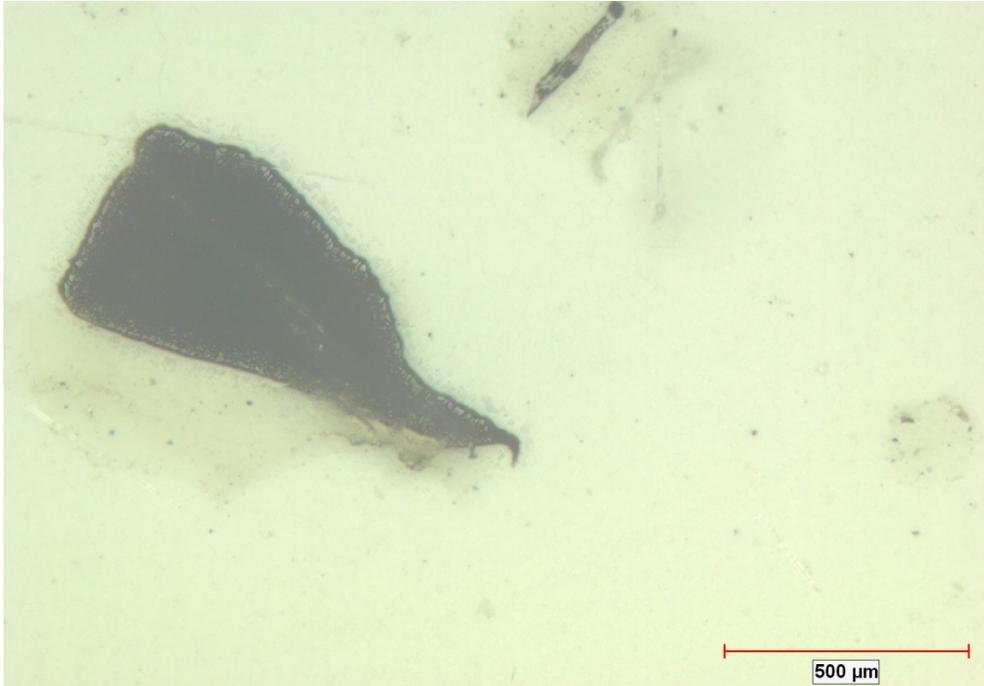
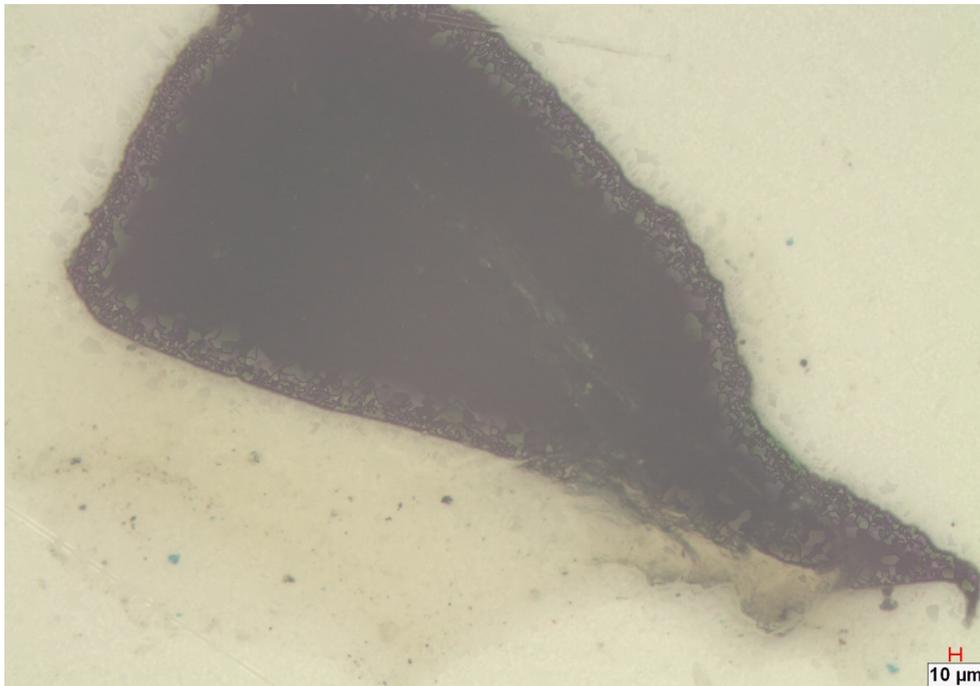
Optical analysis of the debris revealed the size of the darker debris to be 1,000- $\mu\text{m}$  or larger (Figures 26–27). Figures 28–29 illustrate the other debris from the supplied fuel sample. Small blue particles can be seen in Figures 28–29. These particles reacted with the copper sulfate solution that was applied to the membrane to determine if super absorbent polymer (SAP) was present. A few positives were found indicating some SAP migration occurred. It is difficult to determine exactly what the white debris was, but it did look gelatinous and would plug a fuel filter rapidly.

**Figure 26. Fuel Sample Debris, 50X**

**Figure 27. Fuel Sample Debris, 100X**

This fuel sample was heavily contaminated with black and white large particles. The black particles appear to be part of the fuel tank or particles from a refueling hose. The white debris shows indications there is SAP present. If the rest of the gelatinous material is not SAP, at this time it is not known what it is. The material, however, would definitely plug fuel filters. One possible explanation for the gelatinous debris not turning blue when treated with copper sulfate is that the magnesium and/or aluminum have already reacted with the metal in the SAP. Therefore, the copper would not react, and the polymer would not turn blue.

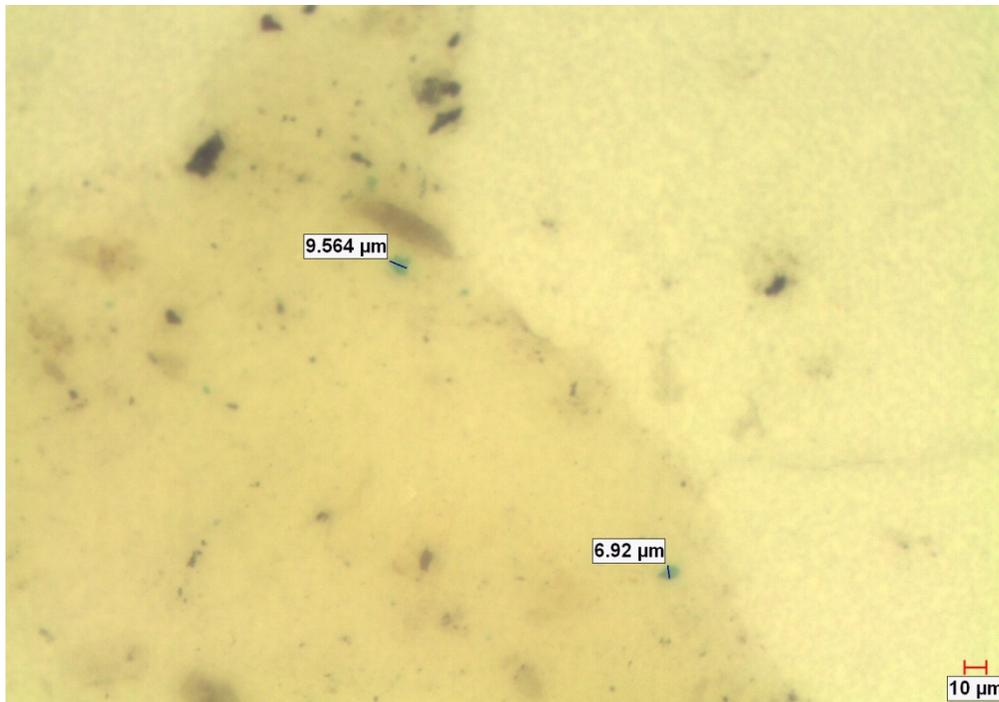
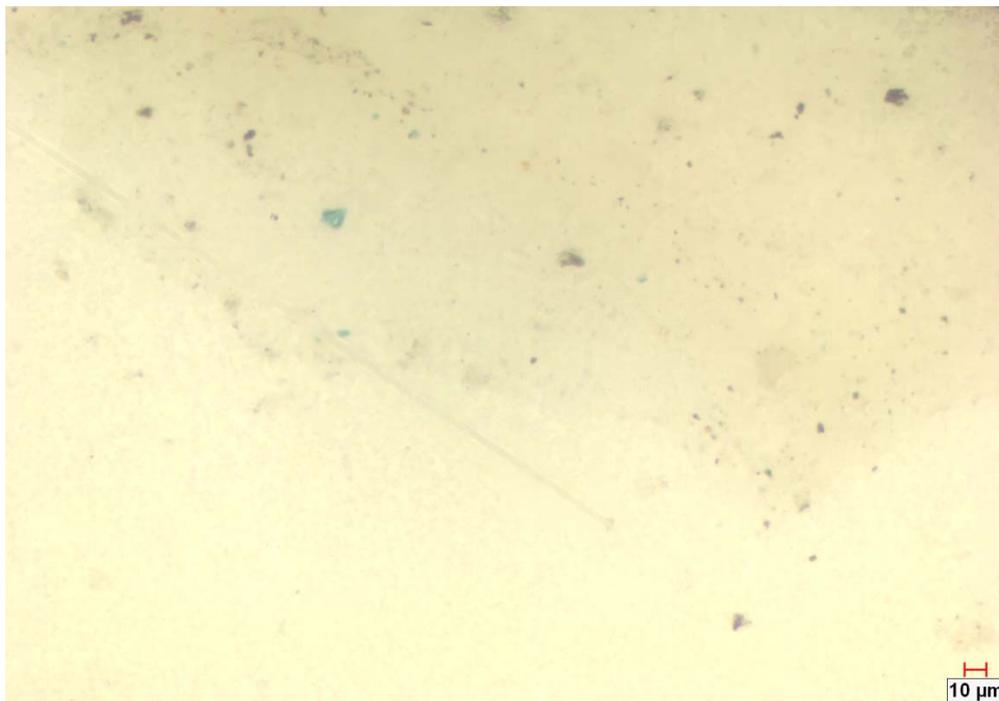
**Figure 28. White Debris From Fuel Sample, 100X**

**Figure 29. White Debris From Fuel Sample, 200X**

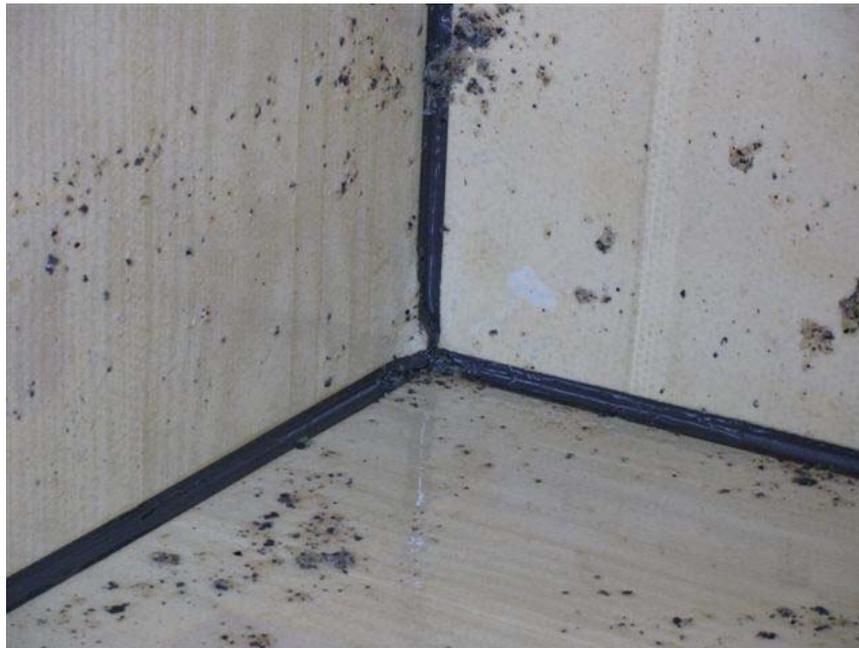
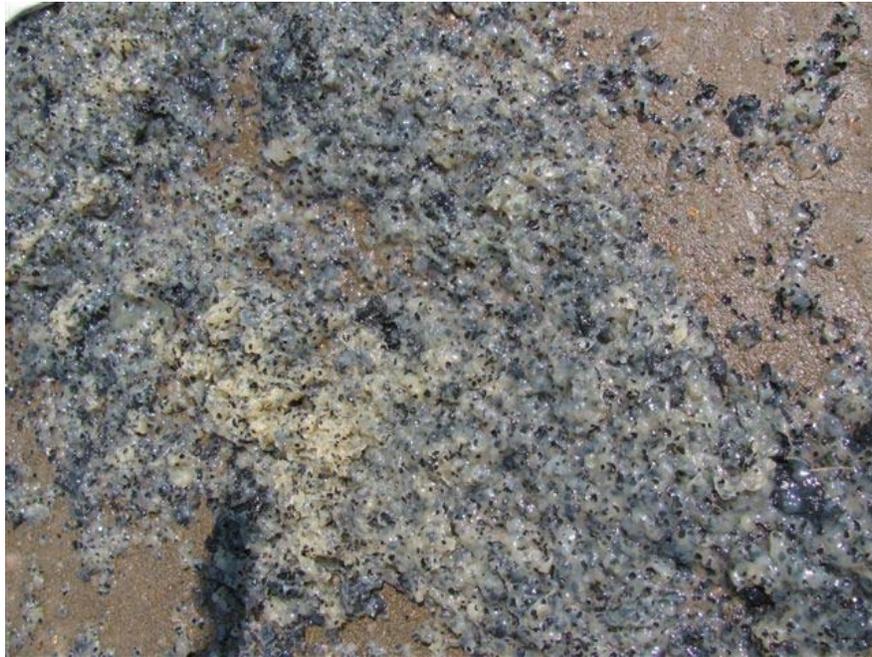
**Figure 31. Unknown Contaminant in Fuel Bladder**

**Figure 32. Close up of Fuel Contaminant in Fuel Bladder**

The debris has the appearance and consistency of apple jelly which is typically caused by the combination of water, fuel system icing inhibitor, and super absorbent polymer (SAP) from water absorbent monitors. However, none of the analysis supports this conclusion. It appears that this contaminant very well may have been dispensed into the bladder (Figures 31 and 32).

It is recommended that further analysis of the internal surface of the bladder and support structure be performed to determine failure mechanism and/or identify any corrosion activity.

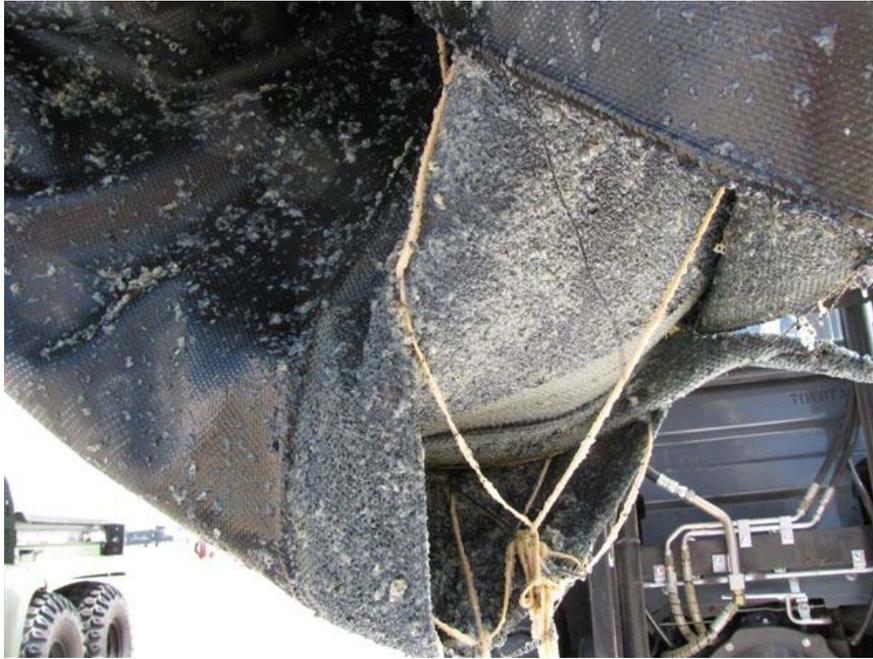
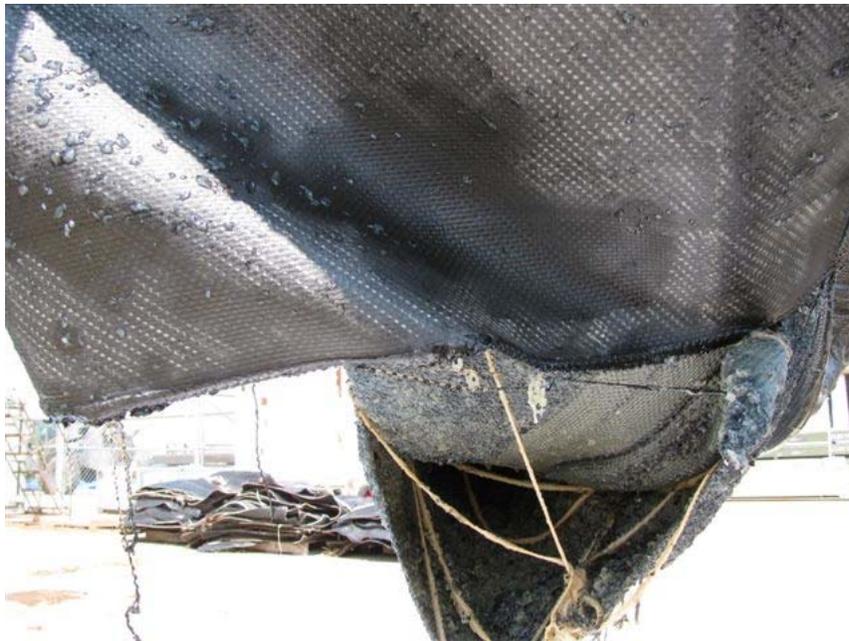
**Figure 34. External View of the Degraded Fuel Bladder – View 1**

**Figure 35. External View of the Degraded Fuel Bladder – View 2**

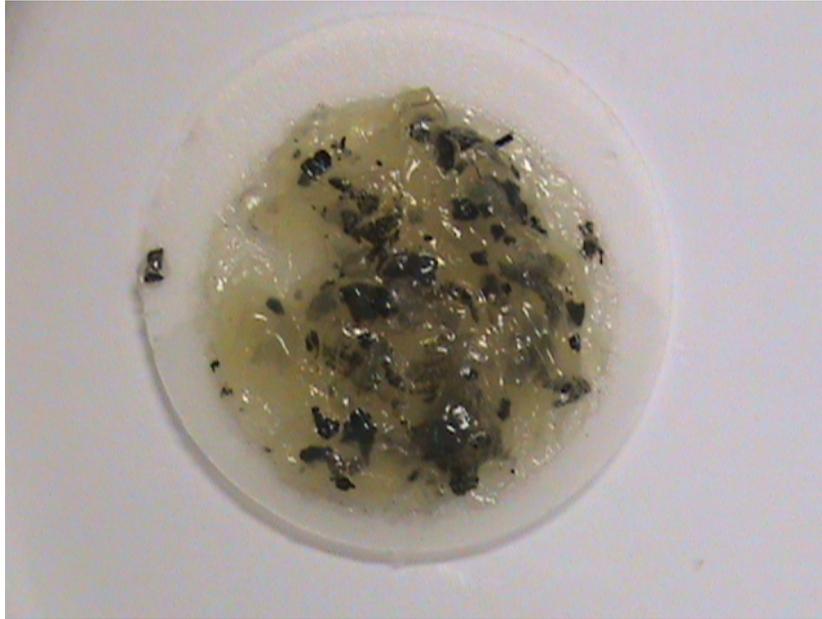
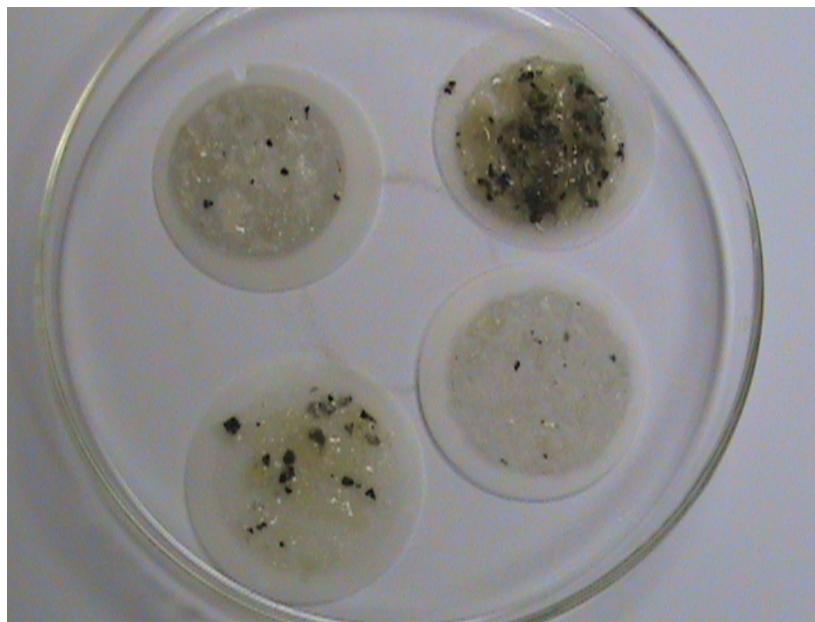
Approximately 100 mL of fuel was provided from the fuel bladder. The furnished fuel was filtered through laboratory membranes to capture the dark particles, Figure 36. The debris plugged the laboratory filters very quickly. Multiple membranes were required to filter all of the debris, Figure 37.

**Figure 36. Fuel Debris Captured on Laboratory Membrane**

**Figure 37. Multiple Laboratory Membranes Containing Fuel Debris**

Elemental analysis of the bladder and jelly-like material was performed by EDS, Table 4. The jelly-like debris did contain the dark particles shown in Figures 36 and 37. The jelly-like debris is tacky and if left in the air, it will dry out.

The dark particles do not appear to have come from the fuel bladder, but from another source such as o-rings or sealants.

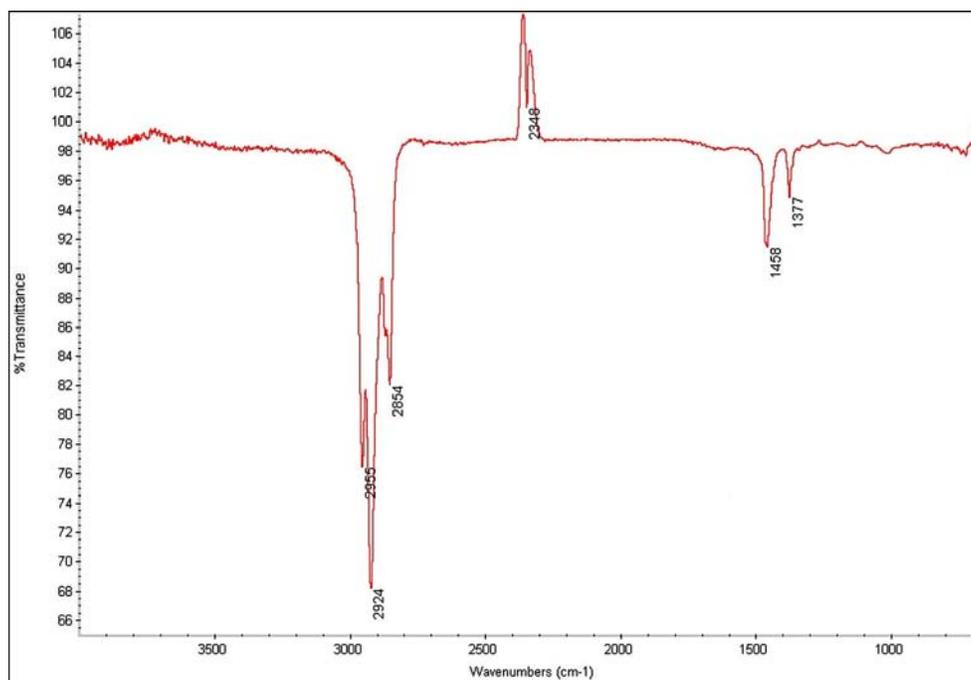
**Figure 38. FTIR of Jelly-Like Debris**

The FTIR scan only shows carbon and hydrogen peaks.
