## Reducing Fracture Tendencies in PCBN FSW Tools

ONR Contract Number N00014-09-C-0288

### Base Effort Final Report

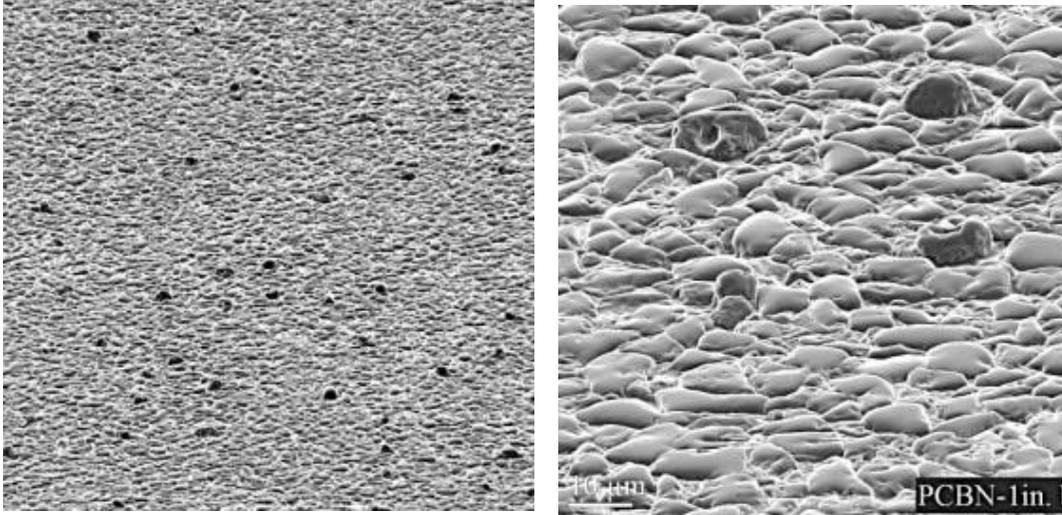
The new MS80 material was much more difficult to cut and polish than other PCBN materials. After initial attempts to polish the surface of this material using a relatively soft cloth that produced a good polish on other PCBN materials, we found that strong relief was produced, with some grains remaining raised significantly above the majority of grains. Images of these grains are shown in Fig. 3. EDS analysis indicated that these grains were carbon. Analysis by Raman microprobe spectroscopy confirmed that the grains are diamond (Fig. 4). The diamond grains were distributed very uniformly throughout the material, with a volume fraction of several percent. Their size is similar to that of the BN grains.

*Fig. 3 SEM micrographs of new MS80 material showing surface after polishing with diamond impregnated cloth which produced relief of diamond particles (same area at different magnifications). Dark grains in (a) are diamond*

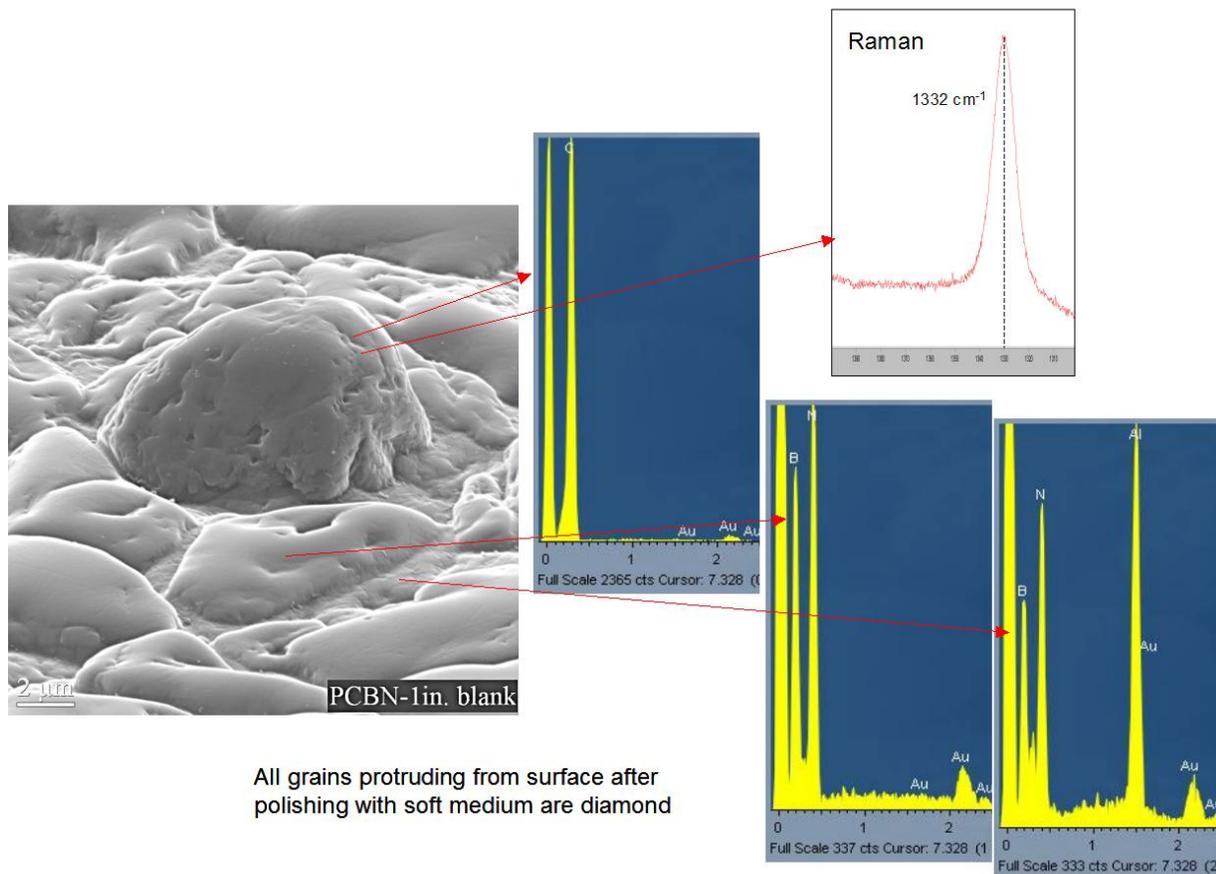
*Fig. 4. SEM, EDS and Raman spectroscopy of diamond grains in new MS80 material*

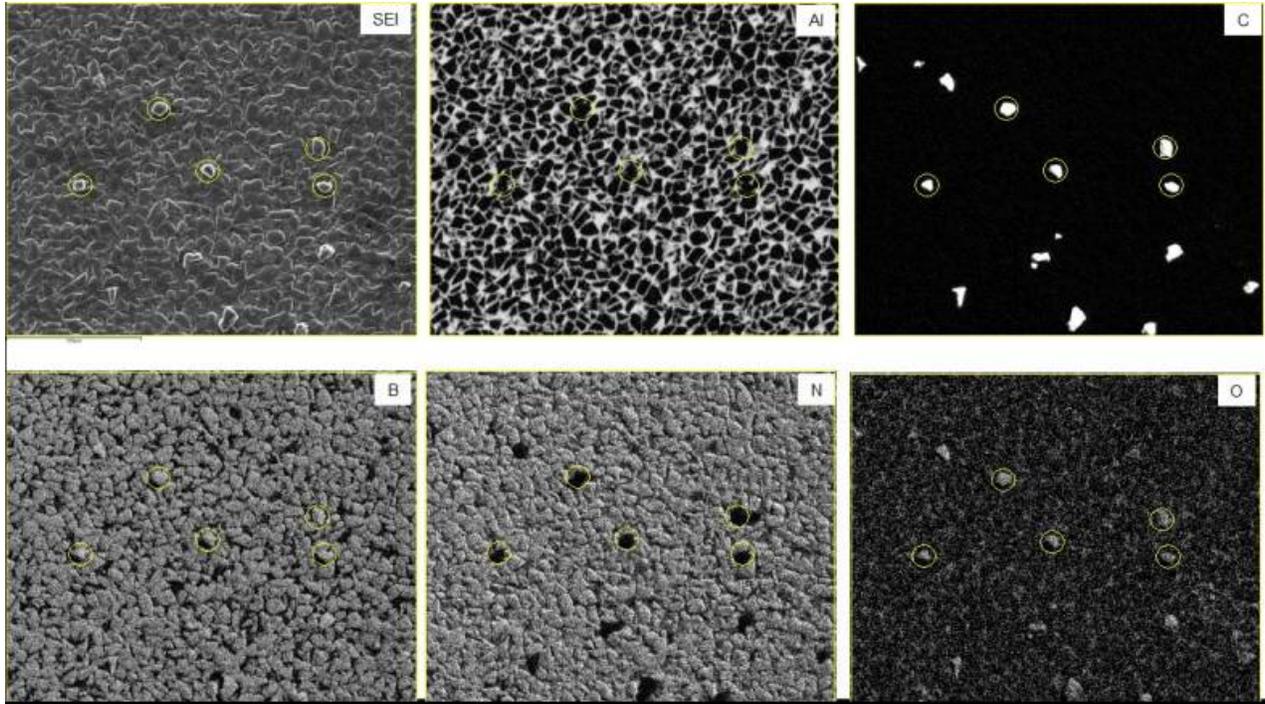
EDS mapping was carried out to assess whether other impurities were present. Typical results are shown in Fig. 5. The results showed a one-to-one correlation between grains showing large surface relief after polishing and carbon composition, indicating that the diamond grains were the only significant impurities. The remainder of the material consisted of BN grains with an AlN grain boundary phase, as expected. The oxygen map shows slightly higher oxygen concentration in the diamond particles than in the remainder of the material. However, we note that this map has been enhanced for visibility: the true intensities of the O signals are orders of magnitude lower than the B, N, and C signals.

*Fig. 5. EDS maps from polished surface of new MS80 material (yellow circles are references for fixed positions)*

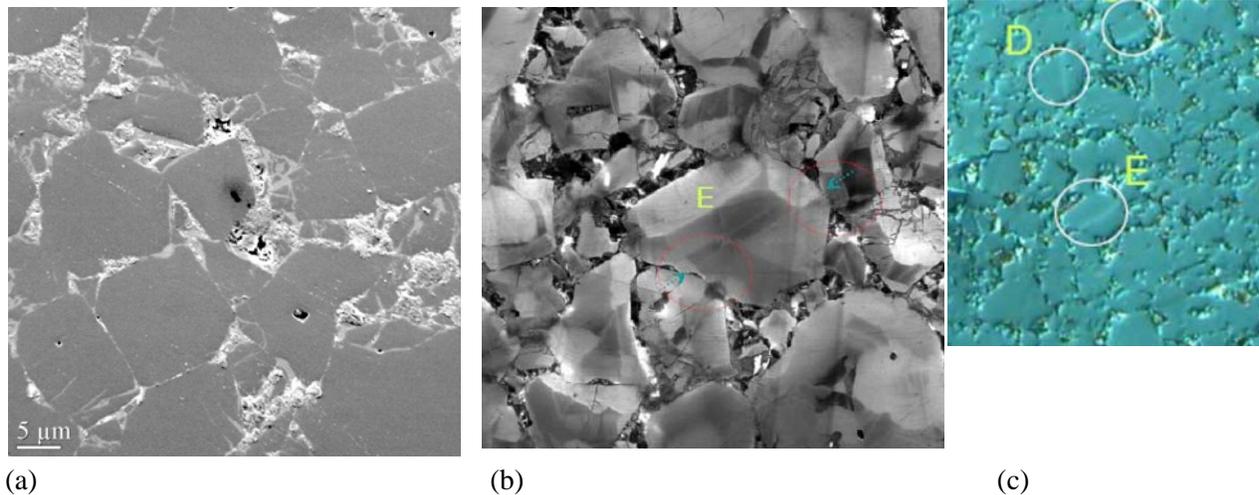
*Fig. 7. Polished surface of MN100 material: (a) SEM image from surface coated with conducting layer of gold; (b) SEM image from uncoated surface (micrograph from Qingyuan Liu, Megadiamond); (c) Nomarski interference micrograph from area in (b), showing surface relief features in some grains.*

We hypothesize that these contrast features may correspond to internal twins or other deformation structures in BN grains, possibly caused local contact forces due to grain-to-grain contact during high pressure consolidation. Similar contrast features are observed in the MS80 materials, although only a small fraction of grains show internal features (consistent with expectation that, with the higher binder content, less damage occurs in MS80 from neighboring grains being in direct contact during densification).

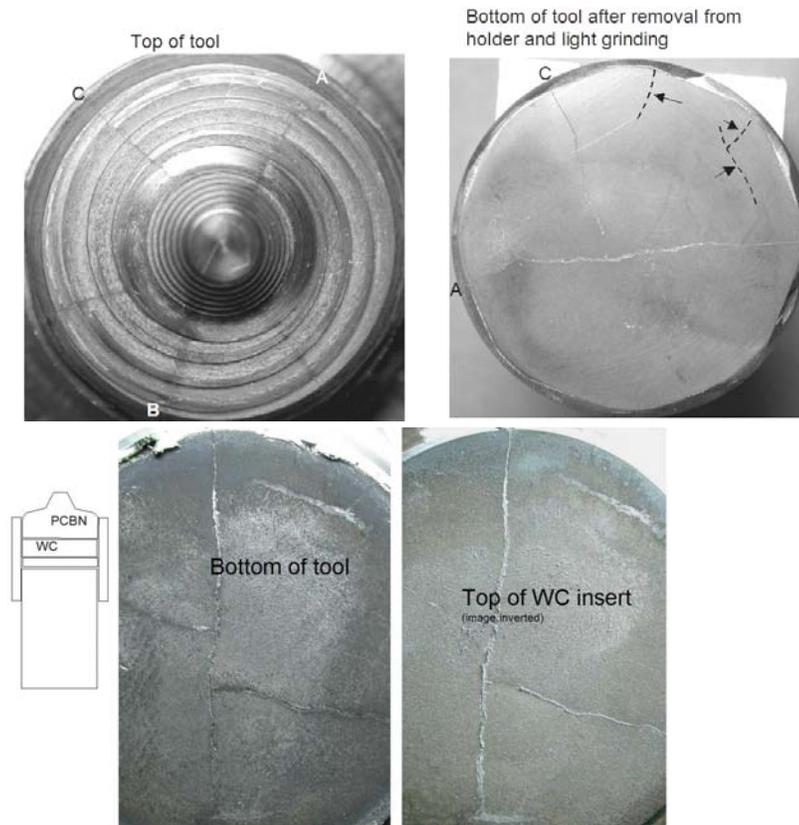
Photos of the top and bottom of the tool are shown in Fig. 10. Several cracks oriented in radial directions are visible on the top surface. One of these (A-B) was continuous around the sides and bottom of the tool insert. The others were continuous around the sides but either ended or followed more irregular paths on the bottom.

The PCBN tool rested on a WC/Co insert in the holder. The top of this insert had ridges that mirrored the pattern of cracks on the bottom of the PCBN tool (Fig. 10).

*Fig. 10. Top and bottom surfaces of PCBN tool and top surface of WC/Co insert after removal from holder.*

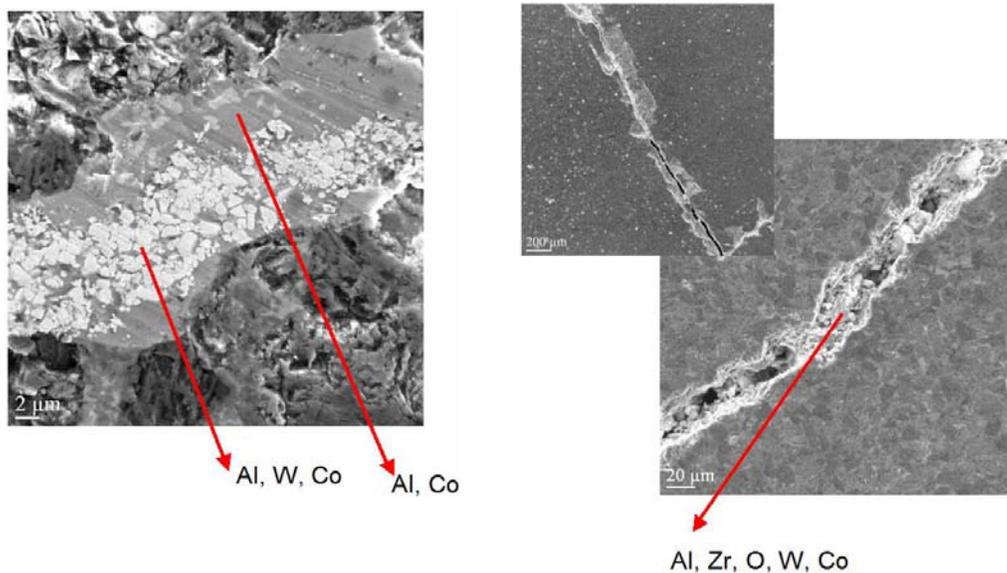
SEM analysis of the WC/Co insert after sectioning indicated that the ridges corresponds to an underlying reaction zone consisting of regions of Co-Al metal and regions with WC particles in a metal of similar composition. Examination of the bottom of the PCBN tool indicated that most cracks were filled, at least near the surface, with metal consisting of regions of C-containing Al surrounding regions of Al-W-Co (Fig. 11). In some regions it appeared that this material had chipped out when the tool was removed leaving an underlying region containing Al., Zr,O,W and Co. The presence of Zr and O is accounted for by a spray coating of ZrO<sub>2</sub> that was applied to the tool surface before assembly. The only potential source of Al metal is the decomposition of trace amounts of AlB<sub>2</sub> formed in the PCBN material during its densification:

This reaction indicates that the temperature at the base of the PCBN tool exceeded ~1000°C during use. At this temperature, an Al liquid phase can contain up to ~10% Co, consistent with the observed reaction of the Al with the Co grain boundary phase in the WC/Co insert.

Fig. 11. SEM analysis of material filling cracks in the bottom of the PCBN tool from Fig. 10

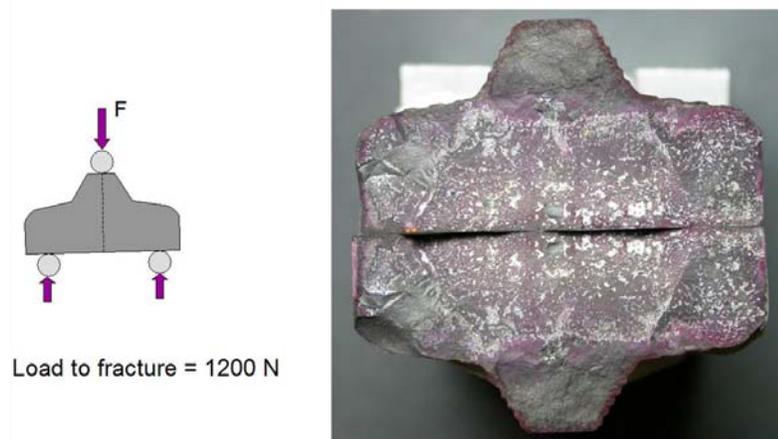
The PCBN tool in Fig 10 was broken apart along crack A-B, as indicated in Fig. 12, after infiltrating the cracks with a dye penetrant. A large force (1200 N) was required to fracture the tool. The force was large for two reasons: (i) although the crack A-B formed a closed path around the outside of the tool, there were intact regions in the interior, near the top of the tool, where the crack had not penetrated (visible in Fig. 12 as gray regions that were not decorated by the pink dye penetrant); (ii) large areas of the cracked region were strongly bonded together with Al metal, as indicated in subsequent SEM analysis, which showed the ductile rupture of Al metal on both sides of matching fracture surfaces (Fig. 13).

Fig. 12. Fracture of the PCBN tool from Fig. 10 along crack A-B

The composition of the metal that filled most of the cracked region varied with location. Near the top of the tool there was a large amount of Fe and Al, the Fe coming from the steel work piece that was used in the FSW and the Al from the decomposition reaction mentioned above. Near the bottom of the tool the metal was mostly Al, with a trace of Fe in local regions.

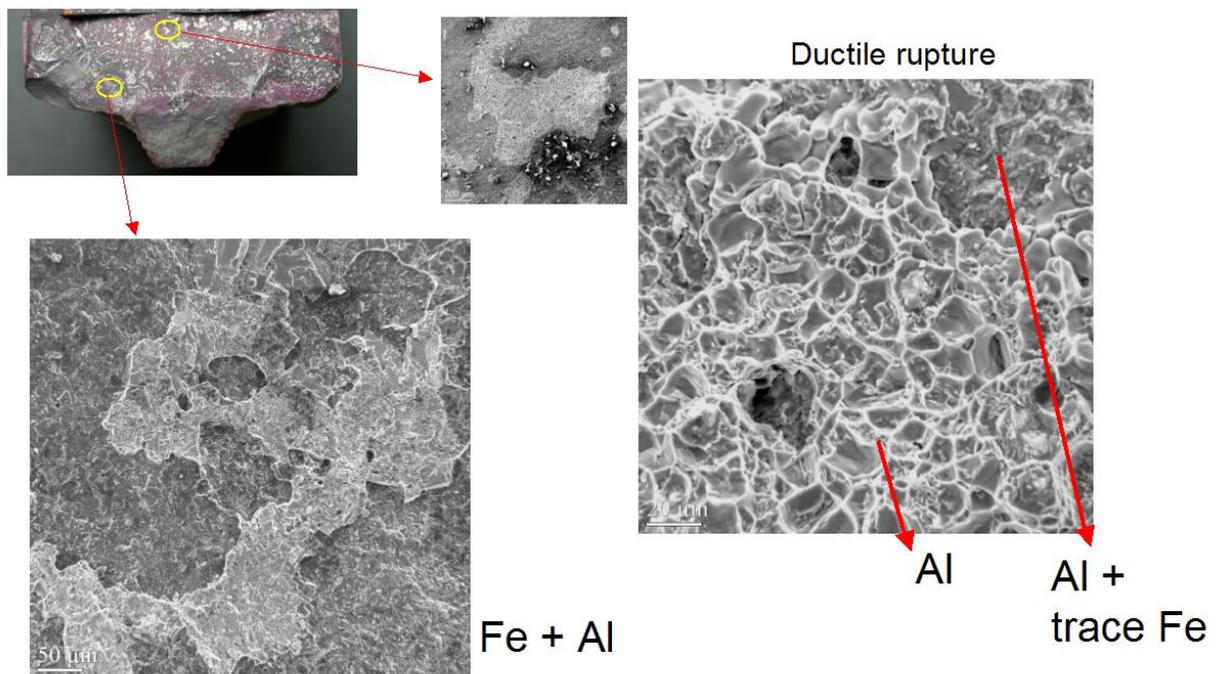
Fig. 13. SEM analysis of fracture surface of tool in Fig. 12

In summary, these observations indicate that there were at least 6 major cracks in the tool, none of which passed completely through tool. This explains the general observation that these types of tools continue to function surprisingly well in FSW long after they are severely cracked. The observations indicate that crack growth occurs incrementally, likely over many thermal and/or mechanical cycles, rather than by

unstable growth at a critical condition. The presence of Al liquid filling the cracks indicates that the temperature exceeded  $\sim 1,000^{\circ}\text{C}$  throughout the PCBN tool during FSW. Under these conditions diffusion of Fe from work piece occurred into the Al liquid in cracks through most of tool thickness.
