INVESTIGATION OF AN EXPLOSIVE

ACCIDENT USING SIMULATION AS A TOOL

J.F. DROLET, G. COUTURE AND R. FARINACCIO

DEFENCE RESEARCH ESTABLISHMENT VALCARTIER
P.O. Box 8800, COURCELETTE
QUEBEC, CANADA, GOA 1R0

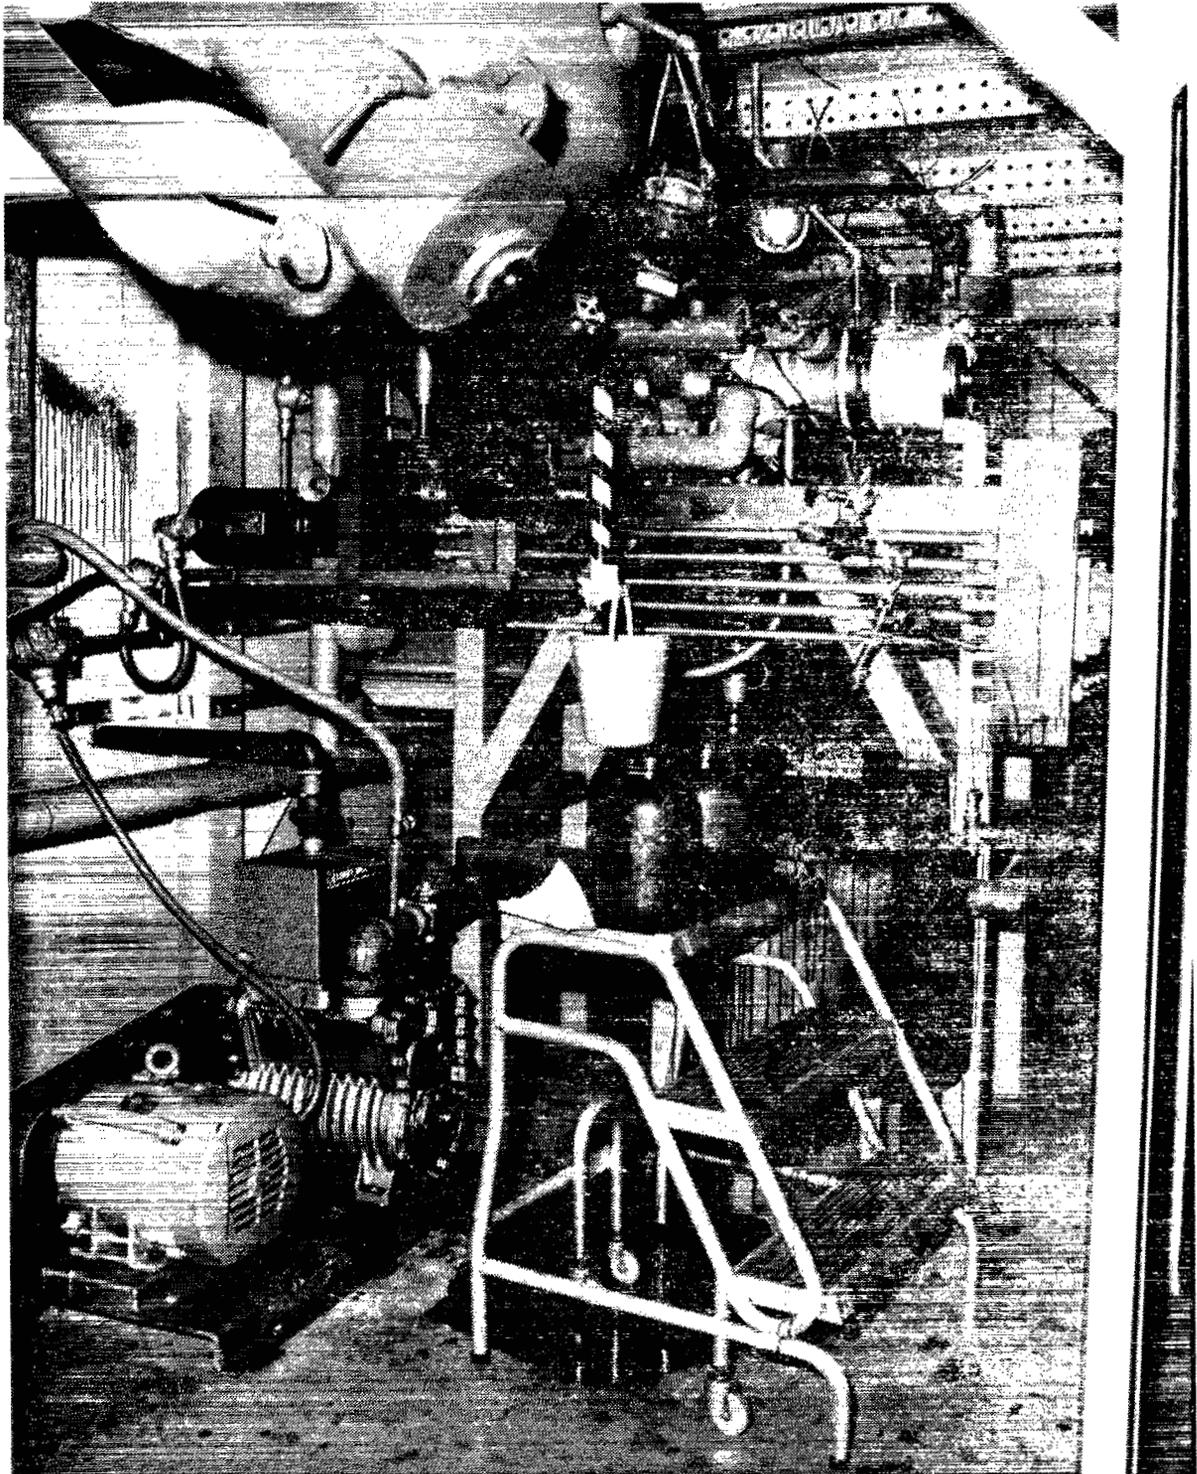
FIGURE 2: Overall view of equipment

A picture of the equipment is shown in Fig. 2 after the accident. Polymer residues was seen on the walls, the ceiling, the floor and the equipment. Figure 3 shows the polymer reservoir attached to the ceiling and the gear pump in the back with the different valves and piping. Figure 4 shows the remaining part of the pipe that was burst open and the heating tape that was wound around. Finally, Fig. 5 shows the stainless steel elbow where the explosion occurred and some plastic parts that connected the EXP reservoir to the equipment.

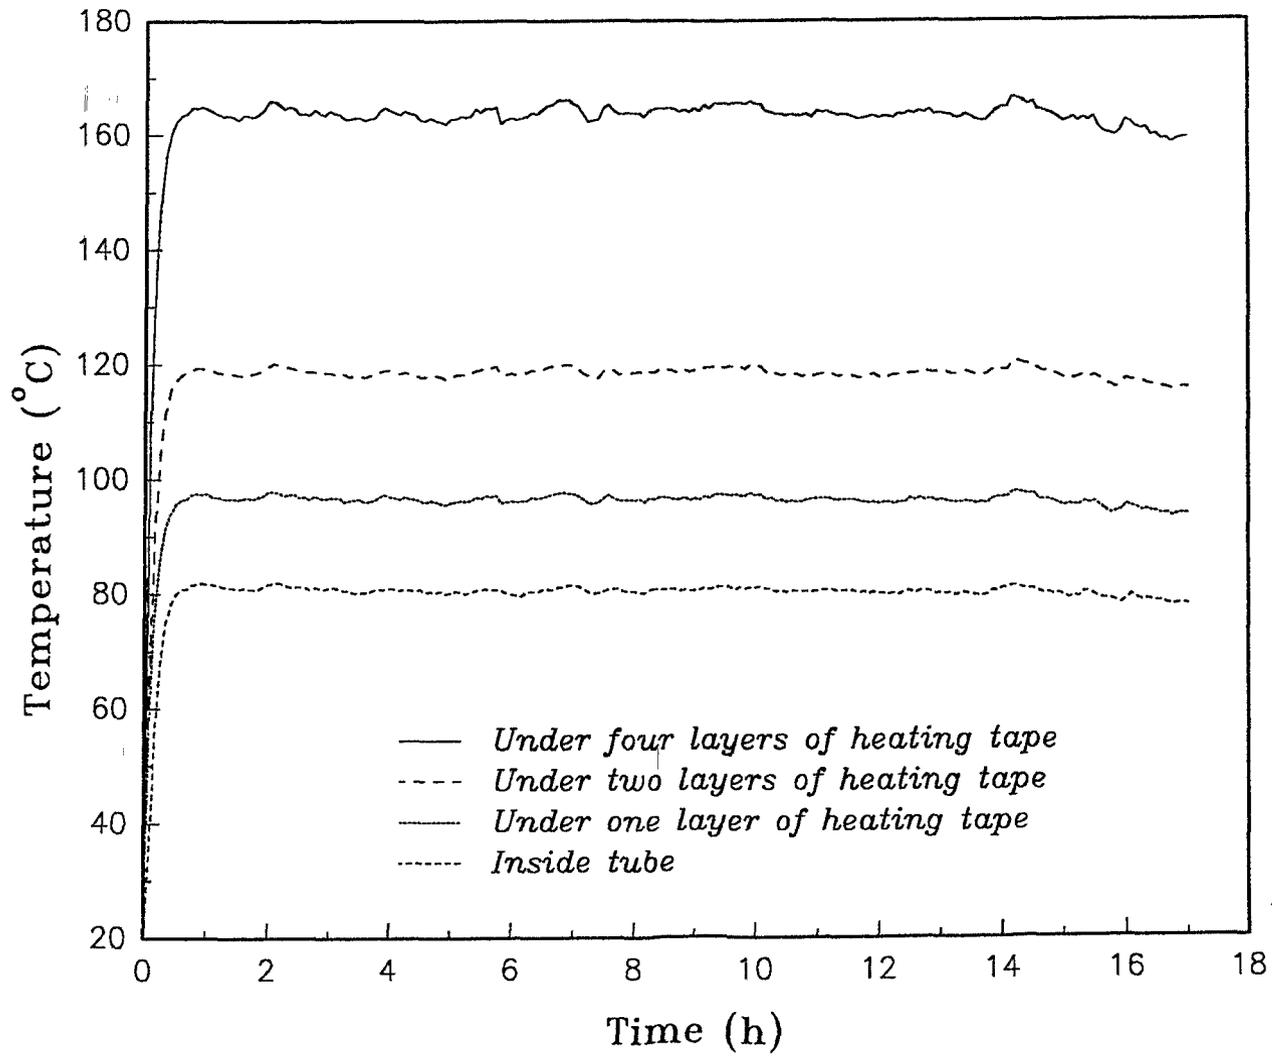
FIGURE 7: Test results from first simulation

A schematic of the simulation test is shown in Fig. 6 and the results appear in Fig. 7. It can be concluded from the results that the number of layers has a strong effect on the temperature of the pipe but in this case, it does not seem to bring it high enough (170°C) to explain the ignition of EXP.

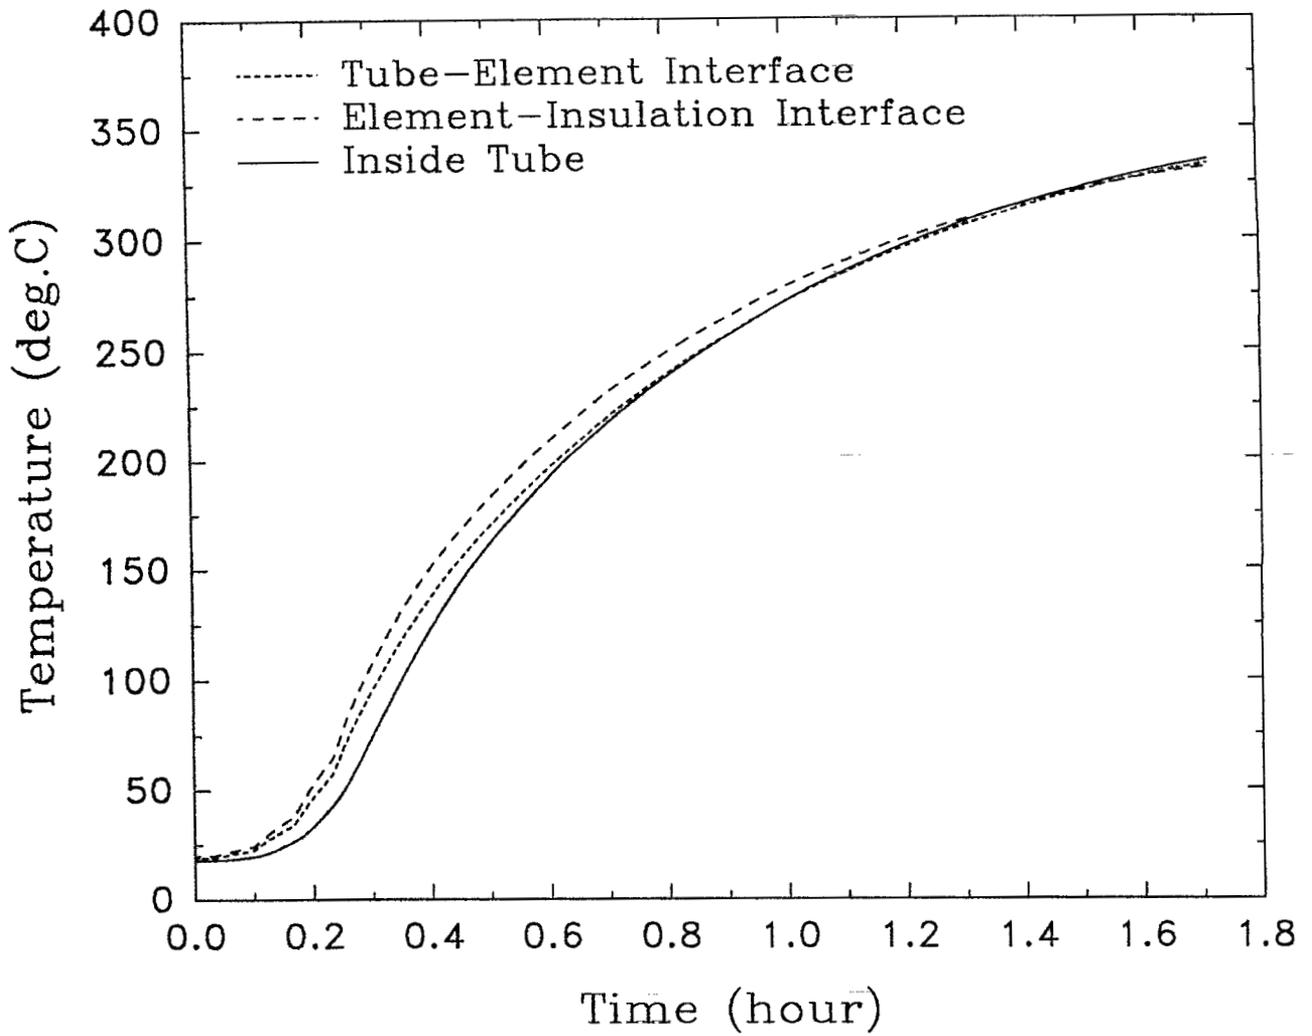
Figure 9: Experimental results of second simulation test.

A second simulation similar to the one just described above but with the addition of insulation over the heating tape (see Fig. 8) was prepared. As shown in Fig. 9, this simulation revealed that the temperature inside the piping could have reached, after equilibrium, a temperature as high as 370°C, a temperature more than sufficient to cause the auto-ignition of EXP (auto-ignition of EXP is $214 \pm 2^\circ\text{C}$).

- 1) installation of a safety valve in the equipment;
- 2) not using heating tape as a source of heat in the presence of energetic materials;
- 3) formation of a team of experts to study the risks associated with new processes or new equipment and make the proper recommendations.
- 4) writing of SOPs even for a one time operation when the level of risk is high.
- 5) operation of equipment by remote control whenever possible.
