**REPORT ON THE
PETERBOROUGH EXPLOSION**

Peterborough, UK; 22 March 1989

BLAST DAMAGE AND INJURIES

**Health and Safety Executive
H M Explosives Inspectorate**

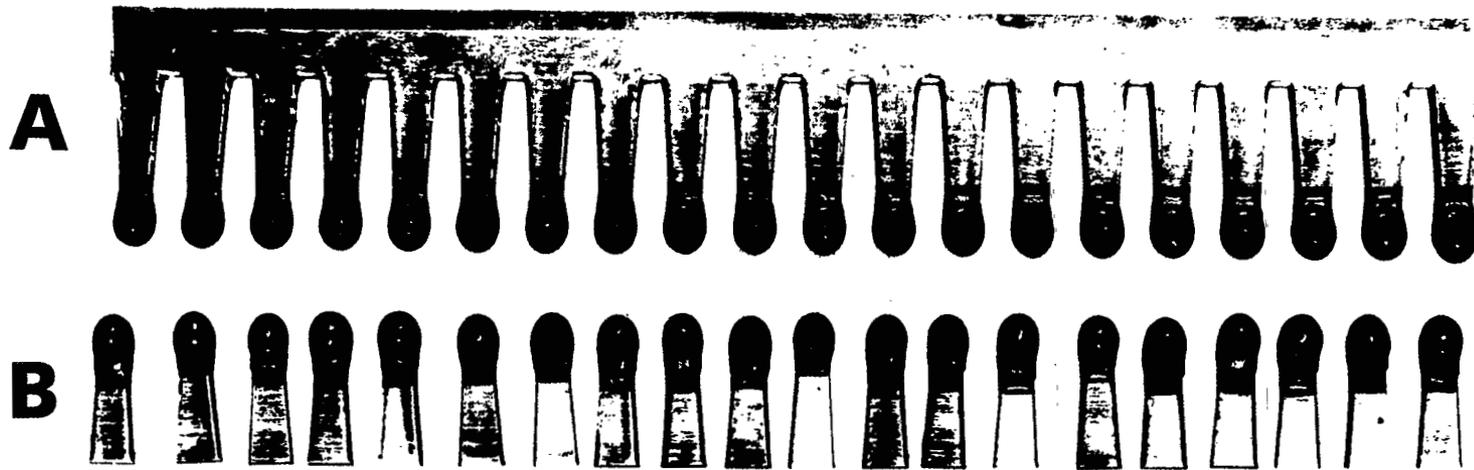
- 8 The high explosives and detonators were typical of those used in quarrying and other blasting work. Powergels are relatively insensitive and are initiated by detonator and booster such as Magna Primer or other more sensitive explosives such as Ammon Gelit. The fuseheads were to be used at a fireworks factory as electrical igniters in pyrotechnic devices. The Cerium fuseheads were supplied uncut on combs with 20 fuseheads per comb -see Figure 2. The Vulcan fuseheads were supplied already cut into single devices.

- 16 The initial minor explosion was probably caused by ignition of the Cerium fusehead combs when the vehicle jolted over the speed ramp control. The likely mechanism for ignition being impact or friction of the fusehead debris or loose composition against the metal box packaging. The fusehead composition was probably sensitised by the presence of rust. The fireball which followed threw burning debris around the load compartment, starting a number of fires.

Fig 2 A - Cerium Fusehead Comb. B - Cut Fuseheads.

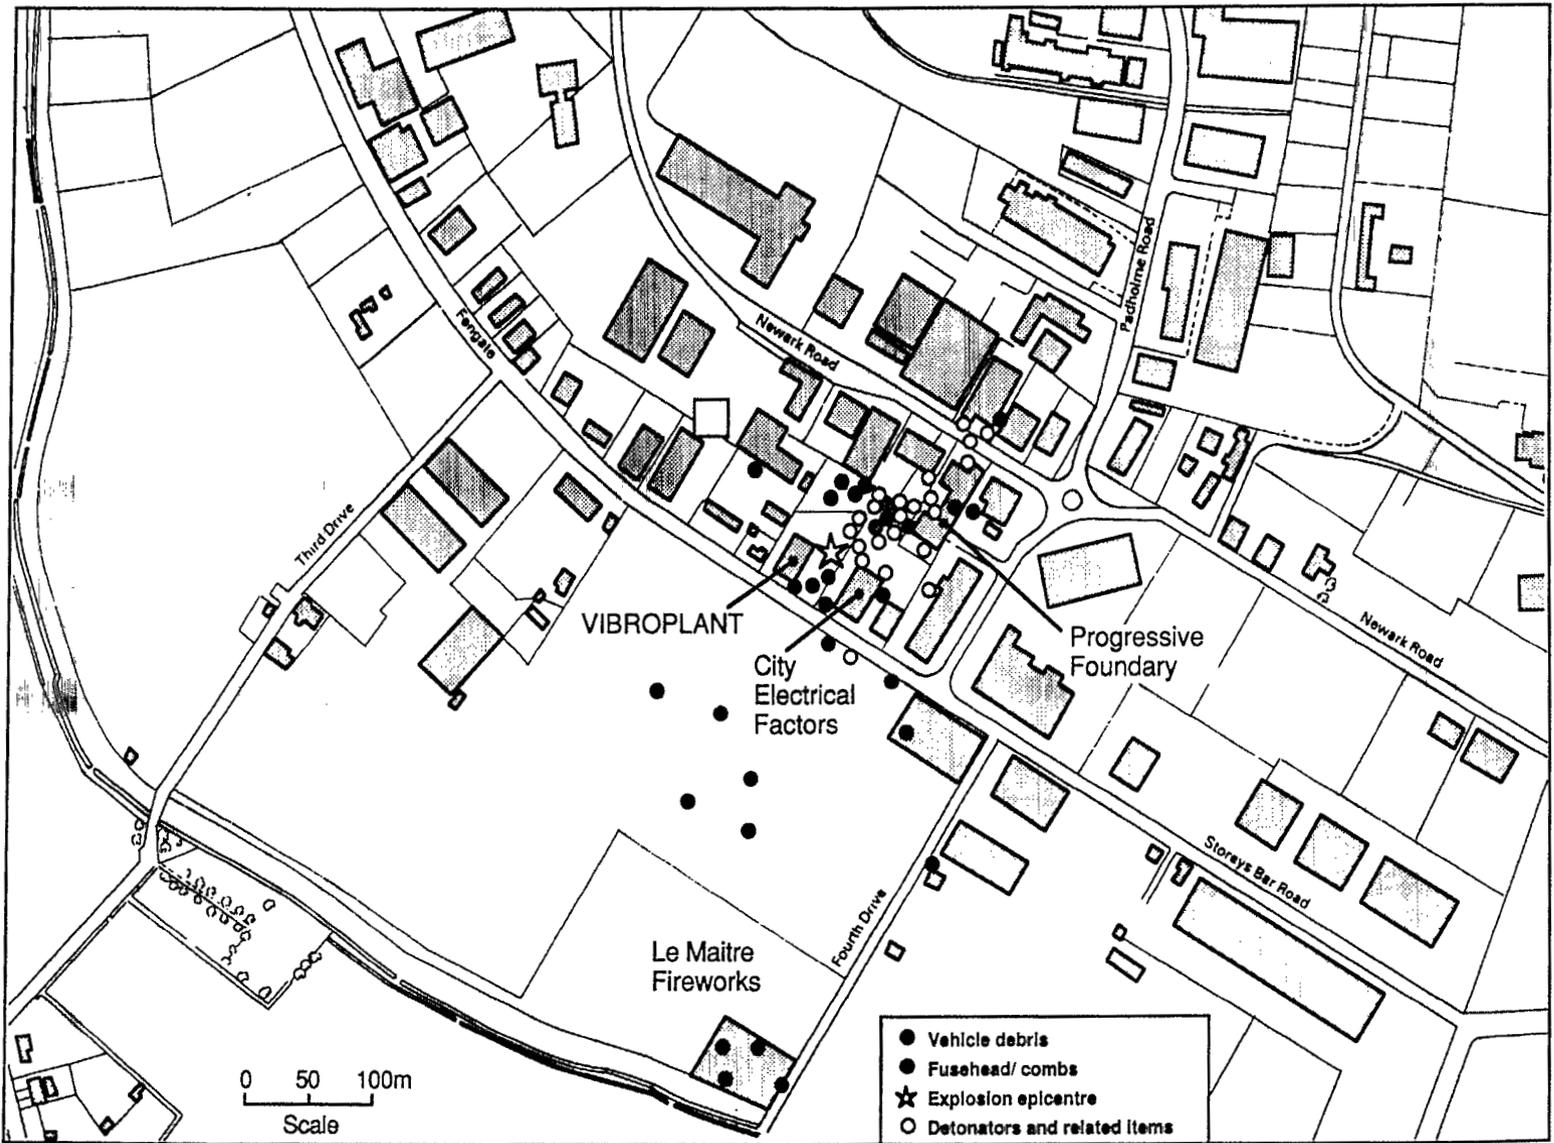
- 27** Fragments were thrown over a wide area - see Figure 7. The prime requirement in the immediate post accident situation was to collect all live pyrotechnic items from the surrounding area. Recognisable pieces of vehicle (except the many small pieces of aluminium from the body) were also collected. The extremity of fragment throw was not accurately determined, but within a licensed fireworks site some 380-400 m away, a number of small items in the weight range 100-3000 gramme were found. Also at approx 470 m a number of cars were allegedly damaged by falling gravel.

Fig 7 Explosion at premises of Vibroplant, Peterborough. Debris plan

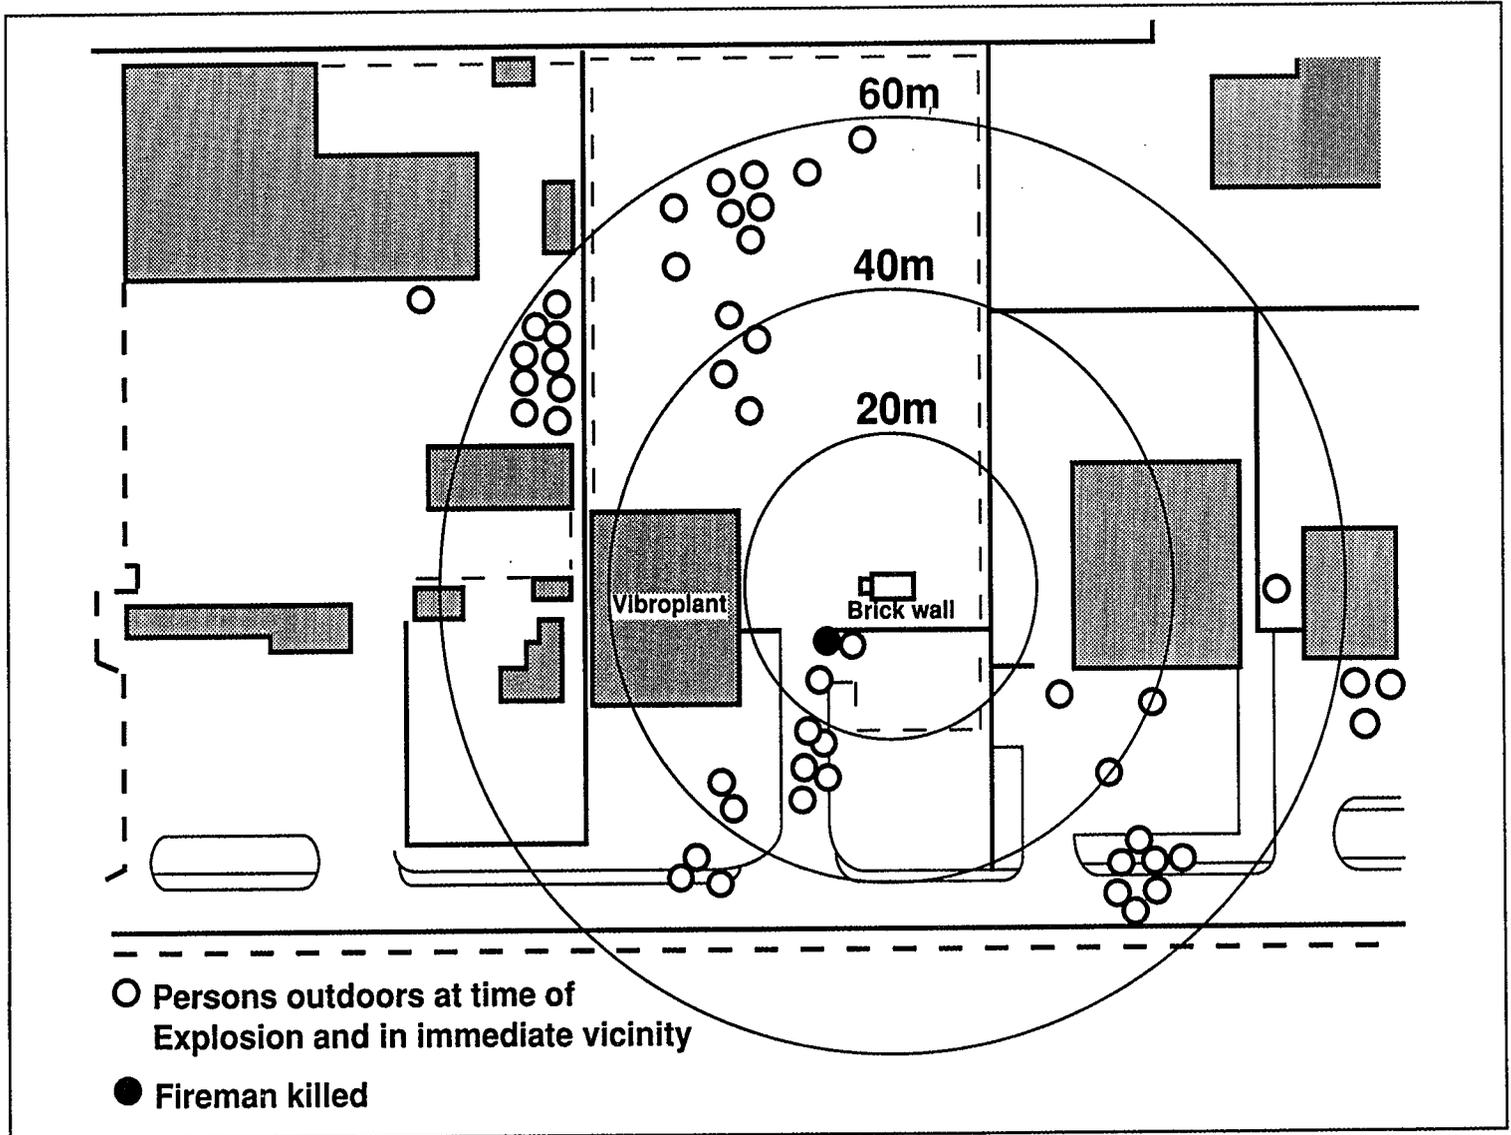
Fig 8

- 31 The fireman killed in the incident was approximately 15 or so metres away from the centre of the explosion and was killed by a fragment (see Figure 8). One of the badly injured persons (burned) was a fireman who had been standing close to the fatality. The other badly injured person was outdoors approx. 40 metres away, and was hit by a fragment. The injury 'contours' are summarised in Table 4.

- 34 In the 12 minute period between the onset of fire and the final explosion, numbers of people congregated both outdoors in close proximity to the van, and against windows which overlooked the Vibroplant yard (see Figure 8). This had the effects of causing persons outdoors to be blown off their feet, sustain hearing damage, and for some to be injured by fragments. Persons indoors sustained serious cuts from flying glass, translational injuries, and injuries from falling

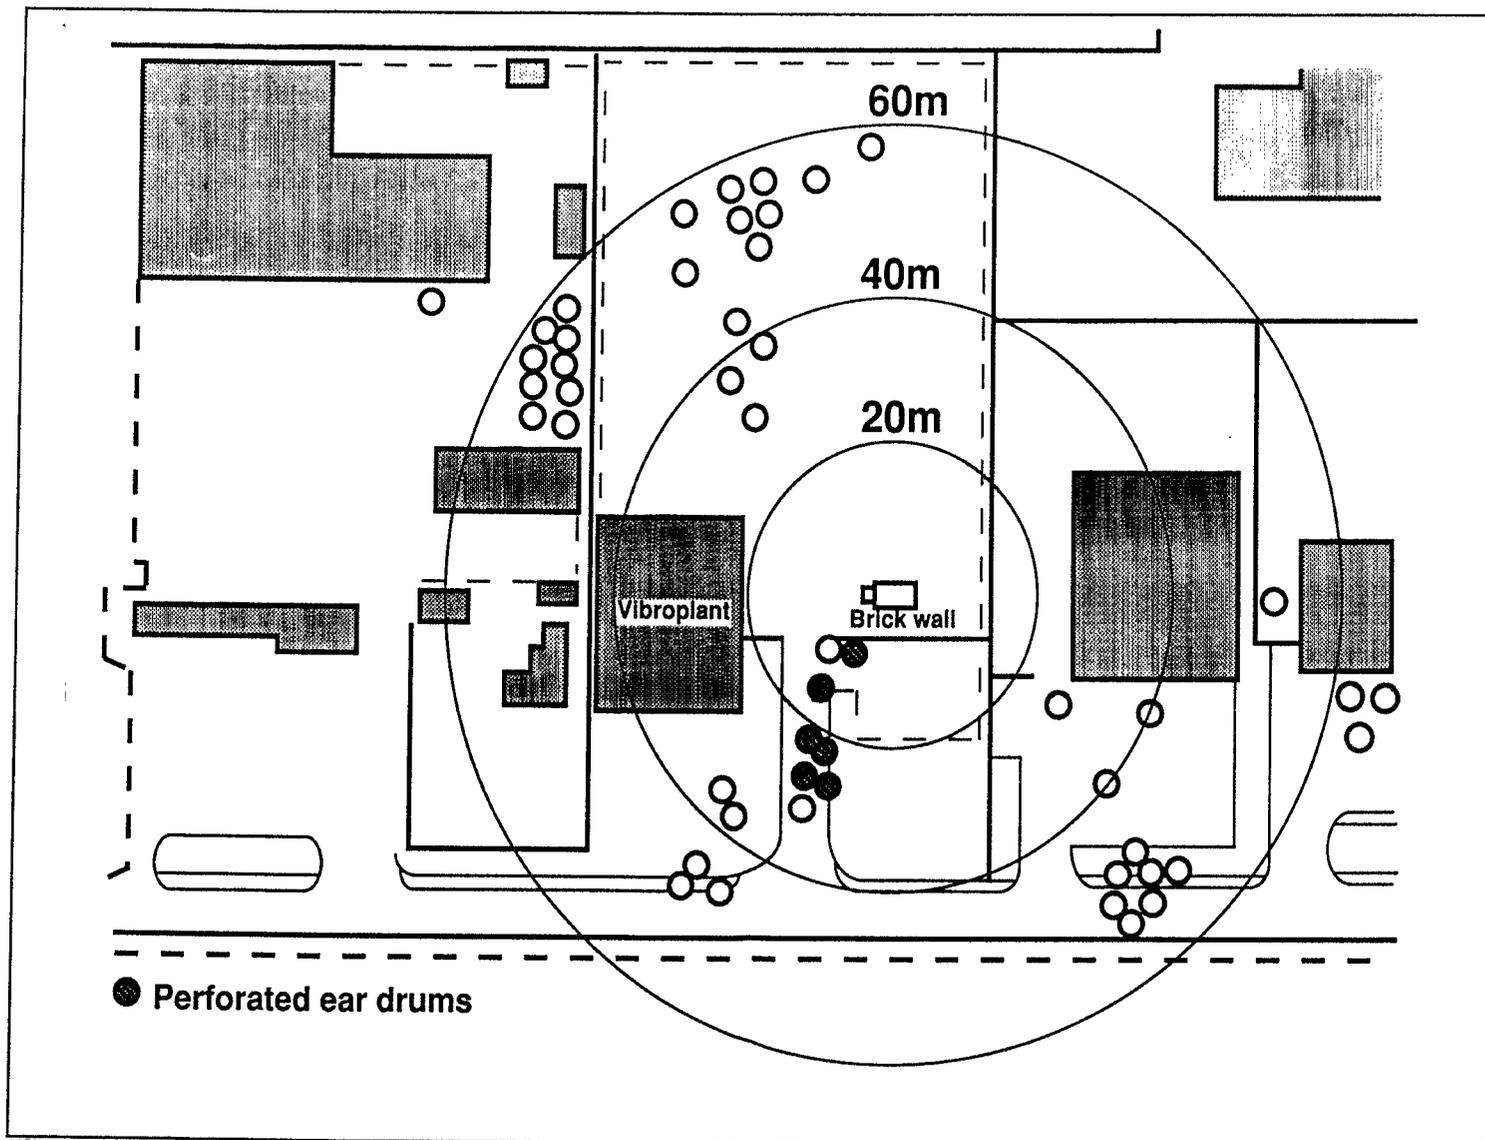
- 32 Persons outdoors and close to the explosion sustained perforated eardrums (see Figure 9), cuts and bruises from flying debris, and were thrown to the ground (see Figure 10). Persons indoors sustained the greatest numbers of injuries from flying glass. Other injuries indoors were due to collapsed ceilings.

Fig 9 Injuries sustained to persons outdoors

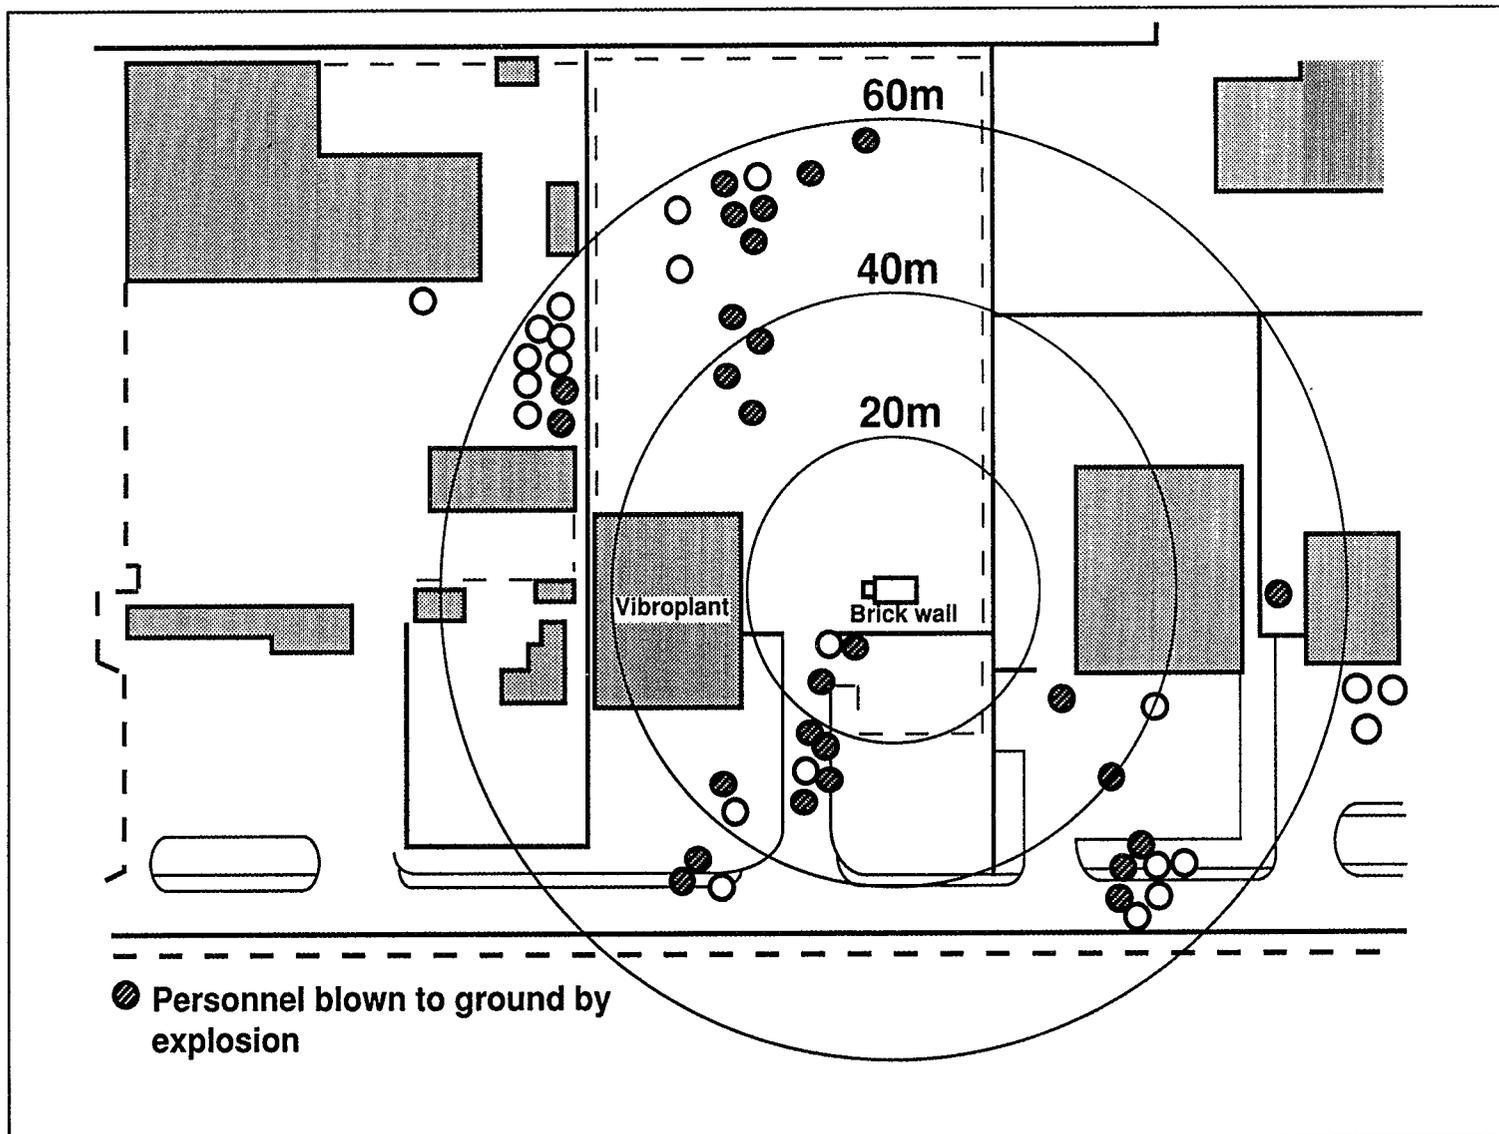
Fig 10 Blown to ground
