Nondestructive Characterization of Low Velocity Impact Damage in Transparent Laminate Systems

ARL-TR-5582

June 2011

**Raymond E. Brennan and William H. Green
Weapons and Materials Research Directorate, ARL**

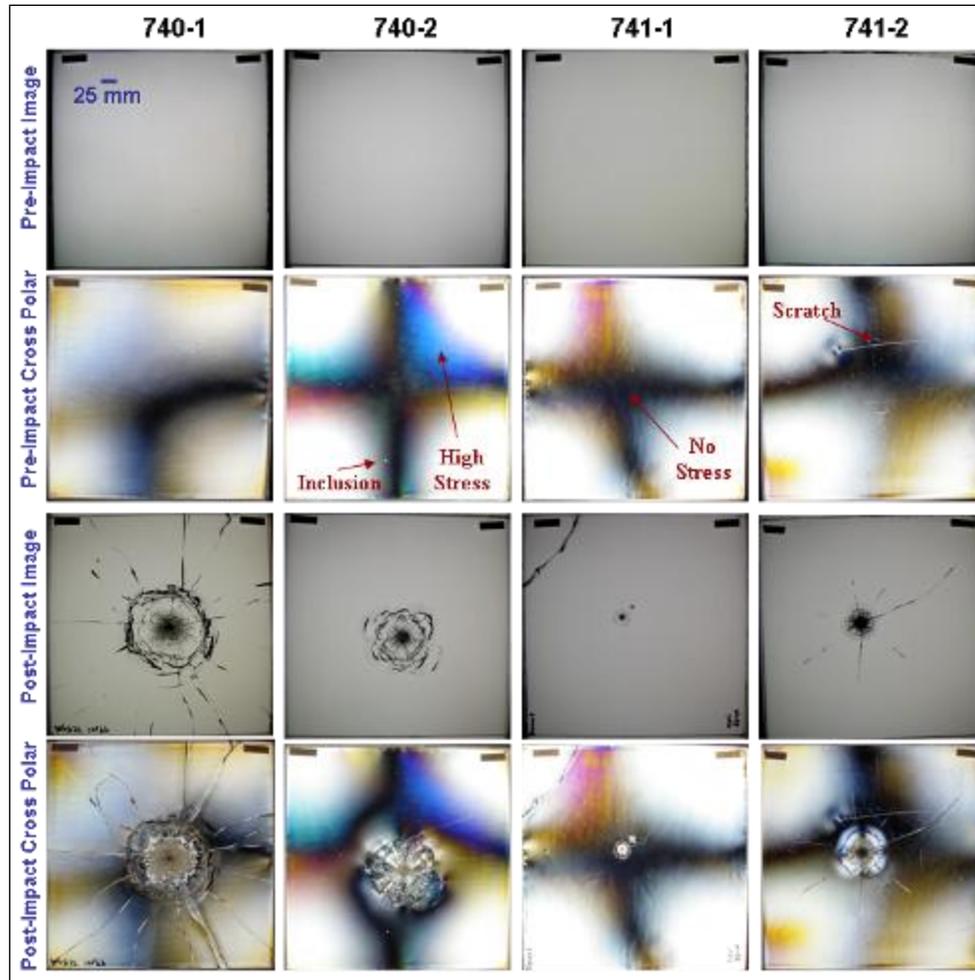
Figure 1. Visual characterization and cross-polarized digital images pre- and post-impact.

Through visual characterization, several millimeter-sized inclusions were found in the transparent laminate panels, numbering ~14 in 740-1, ~18 in 740-2, ~11 in 741-1, and ~36 in 741-2. In 741-2, two surface scratches and cracking damage at the upper edge of the panel were also visible (figure 1). Through cross-polarization imaging, variations in stress patterns were observed (figure 1). According to the Michel-Levy birefringence chart, the black regions represented areas with no stress, the white regions represented areas with minimal stress, the yellow-orange regions represented areas with a significant degree of stress, and the red-blue regions represented areas with a relatively high degree of stress (7). Despite the panels being fabricated in the same manner, the stress patterns appeared to be drastically different. While 740-1 showed minimal stress with some yellow-orange regions near the edges, 740-2 showed large regions of high stress throughout the center. Panels 741-1 and 741-2 showed some significant yellow-orange stress regions, with 741-2 exhibiting a high stress region near two of the largest inclusions.

After impacting the series 1 panels with the air gun and the series 2 panels using sphere impact testing, the laminates were observed and compared to their pre-impacted states. The first qualitative observation from the digital images was that the degree of damage appeared to be greater for the thicker 740-series laminates. This was especially evident when comparing the impact damage diameter of ~168 mm and extensive radial cracking in 740-1 to the minimal impact damage diameter of ~28 mm and absence of radial cracking in 741-1. The crack in the upper left corner of 741-1 was believed to be caused by the clamp used to hold the panel in place during air gun testing. For the sphere impact tested panels, the ~132-mm-diameter damage at the impact region of 740-2 was approximately twice the size of the ~63-mm-diameter damage of 741-2. However, for the higher velocity sphere impact testing, the crack formation trend was reversed, with radial cracking present in the thinner laminate panel but not in the thicker laminate. When observing the impacted panels through cross-polarizers, some local stress variations were found, but the overall patterns did not appear to be drastically altered. There was an observable change in 740-2 that appeared to indicate stress relief after impact, in which a blue high stress region changed to a black region where no stress was apparent. In contrast, the impact region of 741-2 appeared to show concentric high stress regions in the same orientation of what was perceived to be a cone crack at the point of impact. Overall, the 740-series panels exhibited a higher degree of damage after impact when compared to the 741-series panels. As the velocity was increased and mass decreased from air gun to sphere impact testing, the magnitude of damage was reduced from 20 times larger (740-1 vs. 741-1) to twice as large (740-2 vs. 741-2). In terms of visibility through the transparent panels, the 741-series panels performed better, as the degree of damage was less pervasive.

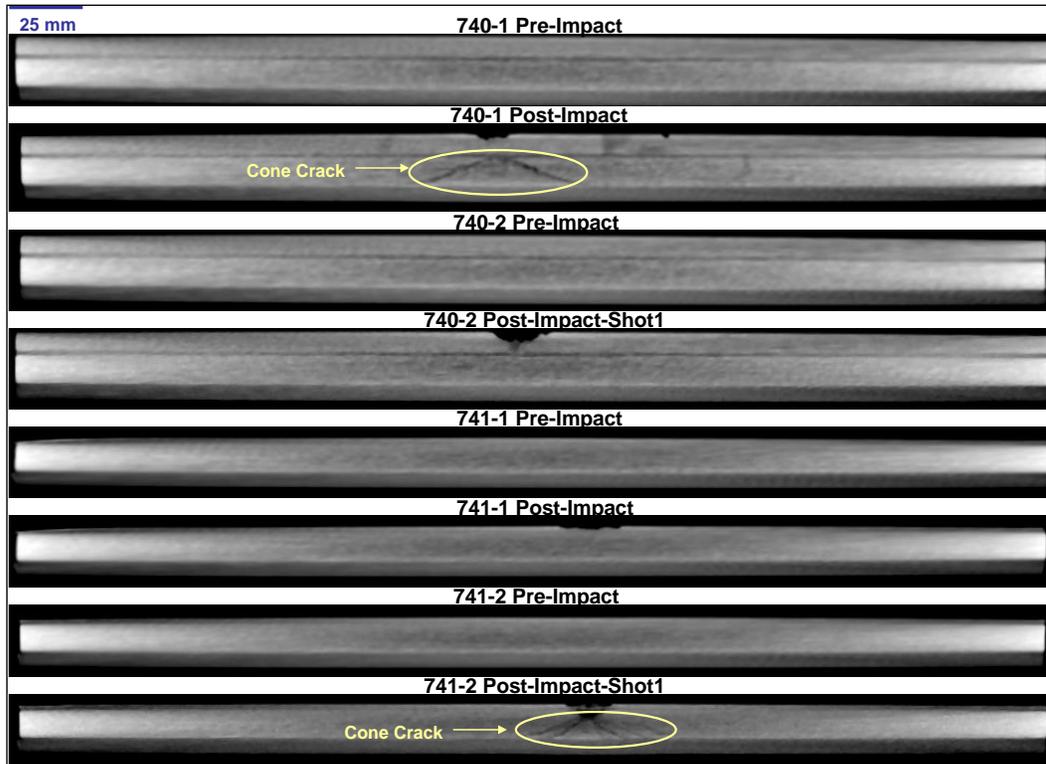
Figure 2. XCT cross-sectional images pre- and post-impact.

The DRs of the pre-impacted panels were unable to detect any distinguishable features. All of the images appeared to be homogeneous, as the inclusions and surface scratches could not be resolved. On the other hand, the XCT images detected and contrasted the laminate layers effectively (figure 2). For the 740-series panels, the Borofloat strike face layer, Starphire interlayer, and polycarbonate backing layer were readily apparent in the cross-sectional image slices. Although the Eagle glass strike face layers in the 741-series panels were 12 times thinner than the Borofloat strike face layers, they could still be resolved in the XCT images, though this was more difficult near the edges.

After impact, the DRs showed damage at the immediate impact point where the sphere struck the panel, but the extent of damage in the surrounding area was unable to be resolved. For 740-1, the radial cracks were apparent upon careful observation, and appeared as hairline cracks extending from the central impact location to the edge of the panel. However, the radial cracks observed in the visual and cross-polarized images for 741-2 could not be resolved in these DRs. The XCT cross-sectional slices captured from the center of each impact were much more revealing (figure 2). For 740-1, inspection of the strike face showed the amount of material ejected after impact and indicated how deep the damage extended below the surface. The most interesting feature was the cone crack that formed at the top of the Starphire layer and extended all the way through this second layer. While it was difficult to distinguish damage at different layers through visual observation, the XCT images provided a definitive distinction of damage as a function of depth. In contrast to 740-1, the XCT image of 740-2 indicated that the damage at the impact site did not extend all the way through the strike face layer and that the second layer remained undamaged. For 741-1, the damage appeared to occur only in the Eagle glass strike face layer, while the damage in 741-2 extended into the Starphire layer and formed another cone crack similar to the one observed in 740-1. These results were consistent with the optical images, as panels that restricted the damage to the strike face layer did not result in radial cracking, while panels that allowed penetration into the second layer resulted in radial cracking and more extensive damage. While the DRs provided little information beyond impact location, XCT images provided a wealth of information for effective characterization through the depth of each panel.

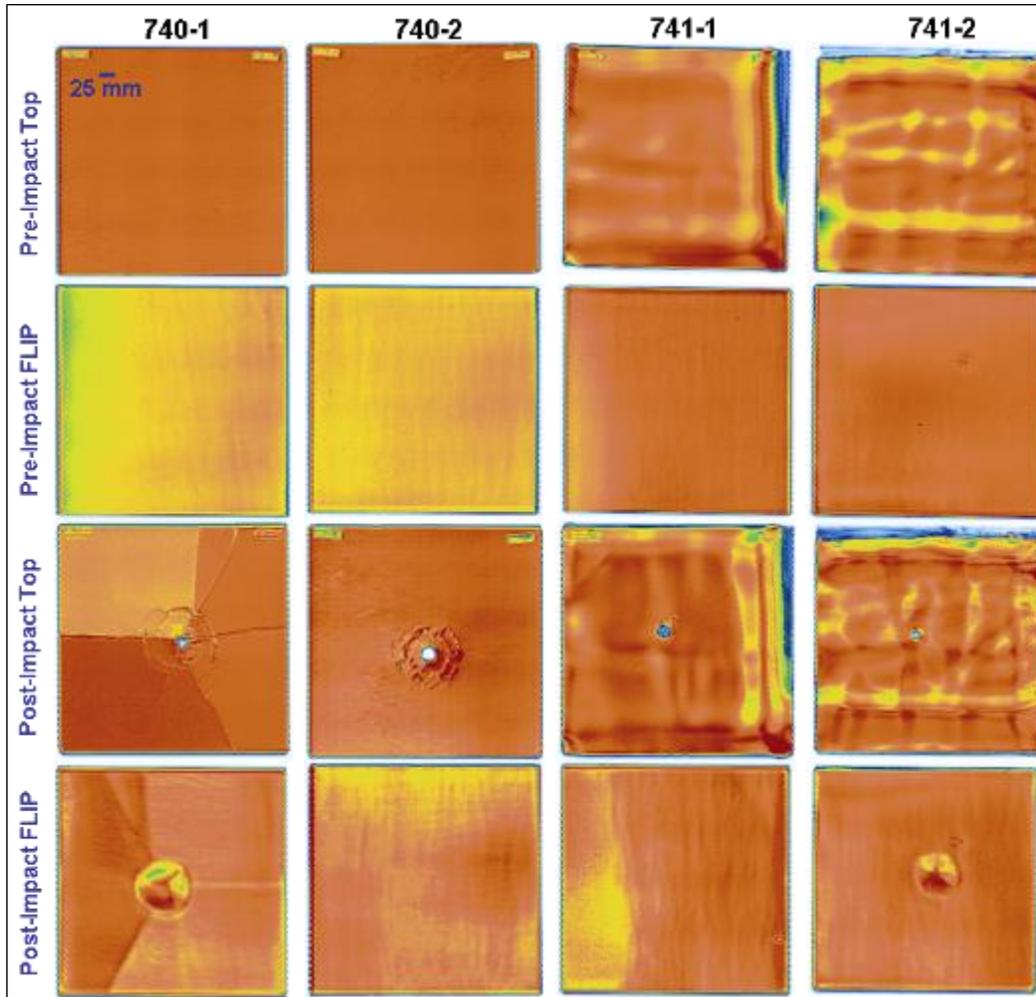
Figure 3. Surface/near-surface UT C-scan images pre- and post-impact.

through the strike face as well as the back face to observe acoustic variations from either side (figure 3). While the 740-series samples appeared to be relatively homogeneous, surface/near-surface inclusions were detected that were consistent with visual observations.

An interesting phenomenon occurred upon observation of the 741-series. Due to the reduced thickness of the Eagle glass strike face layer, significant amplitude variations caused by surface variations and uneven deposition of adhesive layers in the near-surface were detected. Since the C-scan images collected through the strike face side of these panels were sensitive to adhesive variations, a much greater contrast was apparent. When these same panels were ultrasonically imaged through the back face, these features were not detected, and the results were comparable to those of the 740-series panels scanned in the same orientation. The damage to the upper edge of 741-2 was also distinguished in the C-scan images, as a lower amplitude signal was evident where pre-impact cracking was present.

After impact, the ultrasound C-scan images were adept at showing the damage in great detail. For 740-1, the surface/near-surface scans showed the point of impact as a complete loss of amplitude (figure 3). The cone cracks as well as the radial cracks were also observed in these

images, in contrast to the DRs, which were only able to resolve the radial cracks. The C-scan images through the back face of 740-1 showed a circular region representative of the bulge that occurred in the polycarbonate backing layer post-impact. The dimensional change was an observation unique to the C-scan images and was found in both 740-1 and 741-2, the two samples in which damage to the Starphire layer was identified in the XCT images. For the other two samples, C-scan images through the back face revealed no isolated regions of damage. For the 741-series samples, the adhesive pattern variations appeared to change upon impact to the panels. This could have been an indication of physical change to the adhesive layers, which were designed to mitigate stress and prevent crack propagation into successive layers (1).

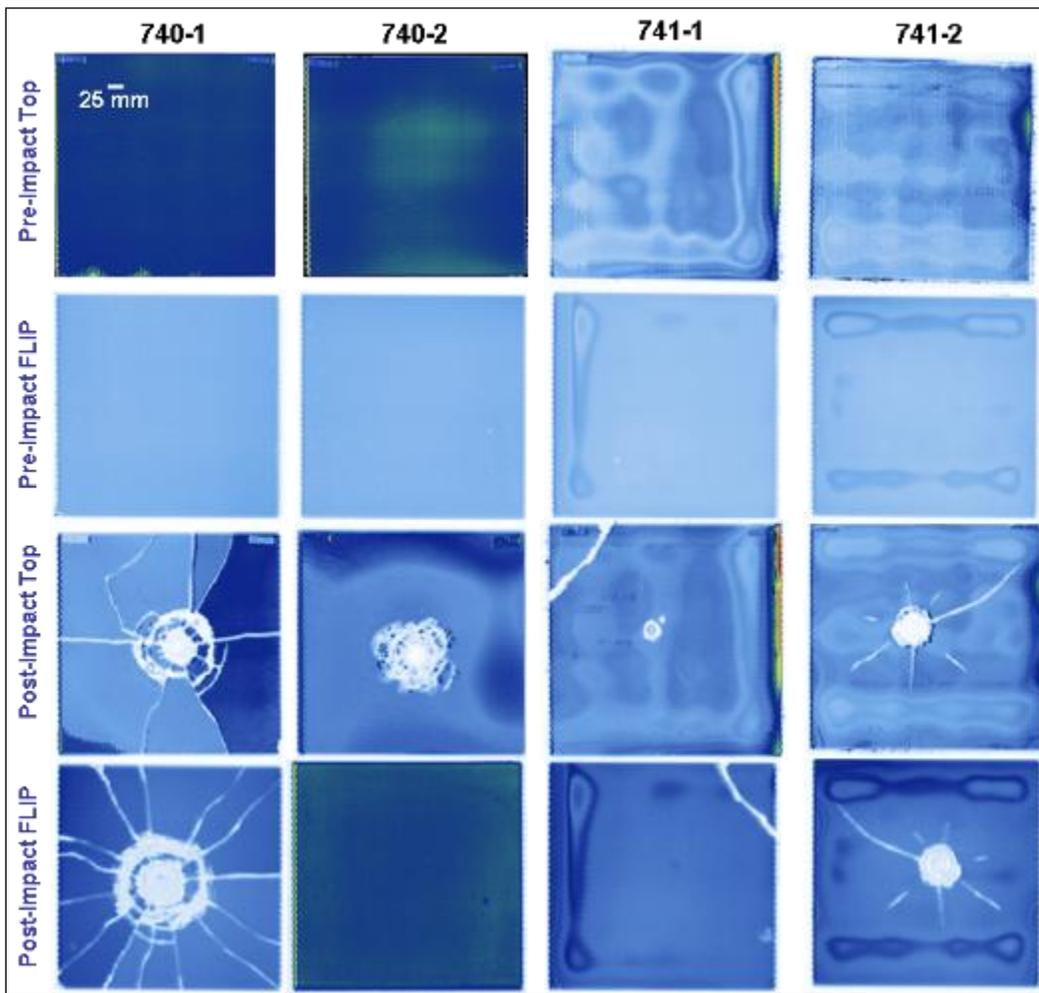
Figure 4. Bottom surface reflected signal UT C-scan images pre- and post-impact.

For the second set of images, the bottom surface reflected signal was gated and the amplitude changes through the entire bulk of each panel were evaluated (figure 4). The 740-series panel scans were once again homogeneous. The only distinguishable features were inclusions with lower amplitude values than the rest of the panel. The 741-series panel scans showed more intricate adhesive patterns through the thinner strike face glass layers. In this case, the scans through the back face also showed adhesive patterns in which there were acoustic variations. A vertical band on the left side of 741-1 and parallel horizontal bands in the upper and lower regions of 741-2 were indicative of these patterns. As opposed to the previous scans that only showed surface/near-surface amplitude variations, the bottom surface scans represented a greater volume of the sample and enabled similar adhesive features to be observed through both sides of each panel.

The bottom surface reflected signal C-scan images though the bulk of each sample were very effective at contrasting damage, with cracked or damaged regions resulting in a complete loss of signal (figure 4). For 740-1, scanning through the strike face showed crack patterns within the Borofloat layer, while scanning through the back face showed crack patterns in the Starphire layer. While several cracks were able to penetrate both layers, the majority of the 18 radial cracks were unique to either the Borofloat or Starphire layer. By scanning through both sides of the panel, the depth locations of these cracks were resolved. For 740-2, the intricate damage pattern was well represented in the C-scan image and the scan through the back face indicated no penetration into the Starphire layer. For 741-1, the bulk adhesive patterns did not appear to change as much as in the surface/near-surface images. The damage at the point of impact and crack in the corner were clearly visible, and small indications of damage were detected in the back face scan. With the XCT images for 741-2 indicating damage to the Starphire layer, the impact region and resulting radial cracks were as apparent through the strike face images as they were through the back face images. Overall, the C-scan images were very effective at representing the damage to each panel after air gun and sphere impact testing.

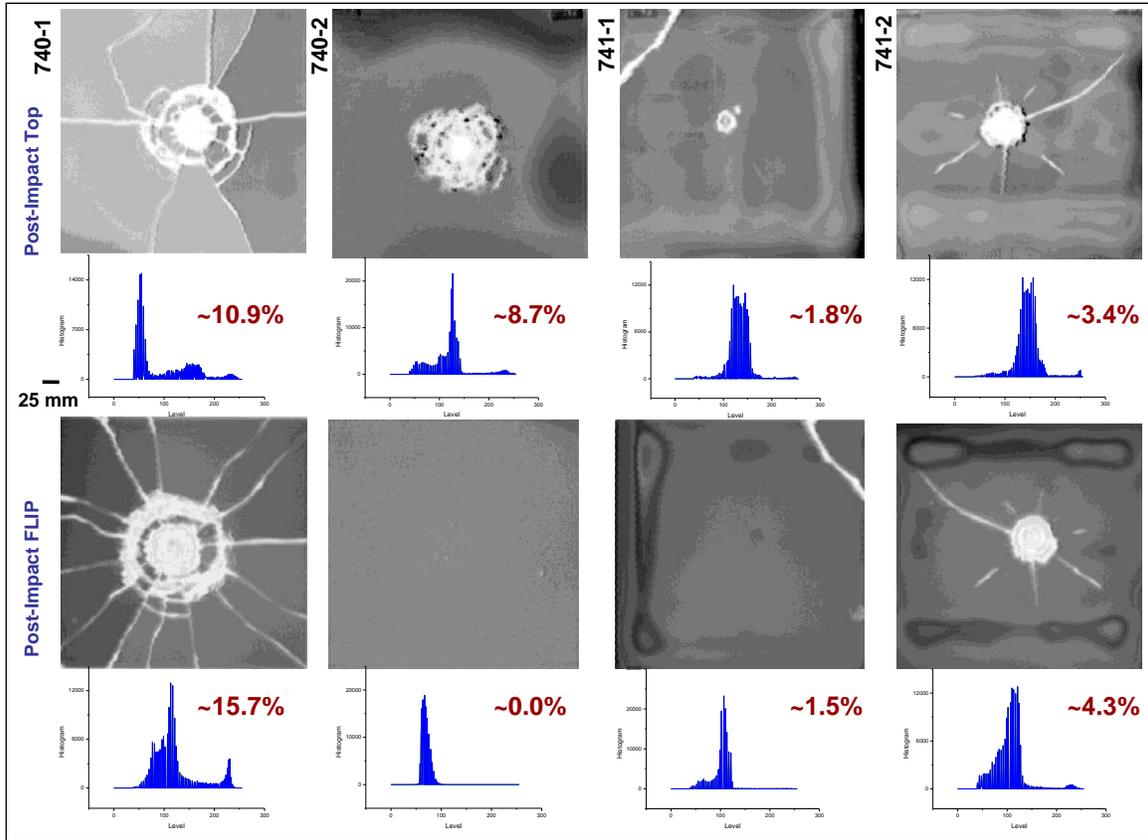
Figure 5. Quantitative histogram images and percent damage from the strike face and back face.

Estimated percent damage values were calculated for C-scan images representing the strike face and back face of each of the four transparent panels. The inverted grayscale images and corresponding histograms are shown in figure 5. For panels 740-1 and 741-2, which showed cone cracking in the Starphire layer and significant damage through the back face, the estimated percent damage increased. The damage increased from 10.9% to 15.7% for panel 740-1 due to the higher number of radial cracks present in the Starphire layer. For panel 740-2, in which there was no damage to the Starphire layer, the percent decreased from 8.7% to 0.0% since no damage could be detected in the C-scan image through the back face. For panel 741-1, the percent damage decreased from 1.8% to 1.5%. Despite the absence of a cone crack in the Starphire layer, the crack in the corner of the sample propagated through both the Eagle glass and Starphire layers, which accounted for the majority of damage through both the strike face and back face images. The quantitative damage threshold technique proved to be a useful means for estimating and comparing volumetric percent damage values for the transparent panels.

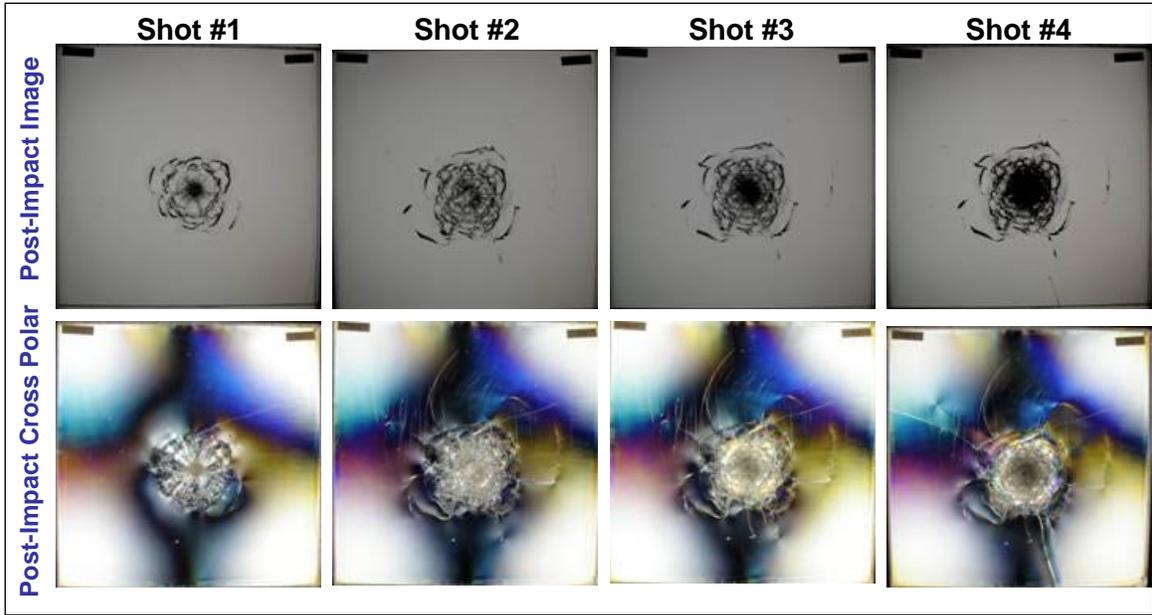
Figure 6. Visual and cross-polarized digital images of 740-2 after each of the four sphere impacts.

Figure 6 shows the progression of damage through digital and cross-polarization images. After the second impact, multiple cracks formed within the original damage zone from the first impact. Several larger cracks also started to propagate, expanding the diameter of the damage zone. The damage to panel 740-2, as observed in the visual and cross-polarized images, did not appear to change significantly after the third impact. After the fourth and final impact, three of the cracks that had started to propagate after the second impact had fully propagated to the edge of the panel.

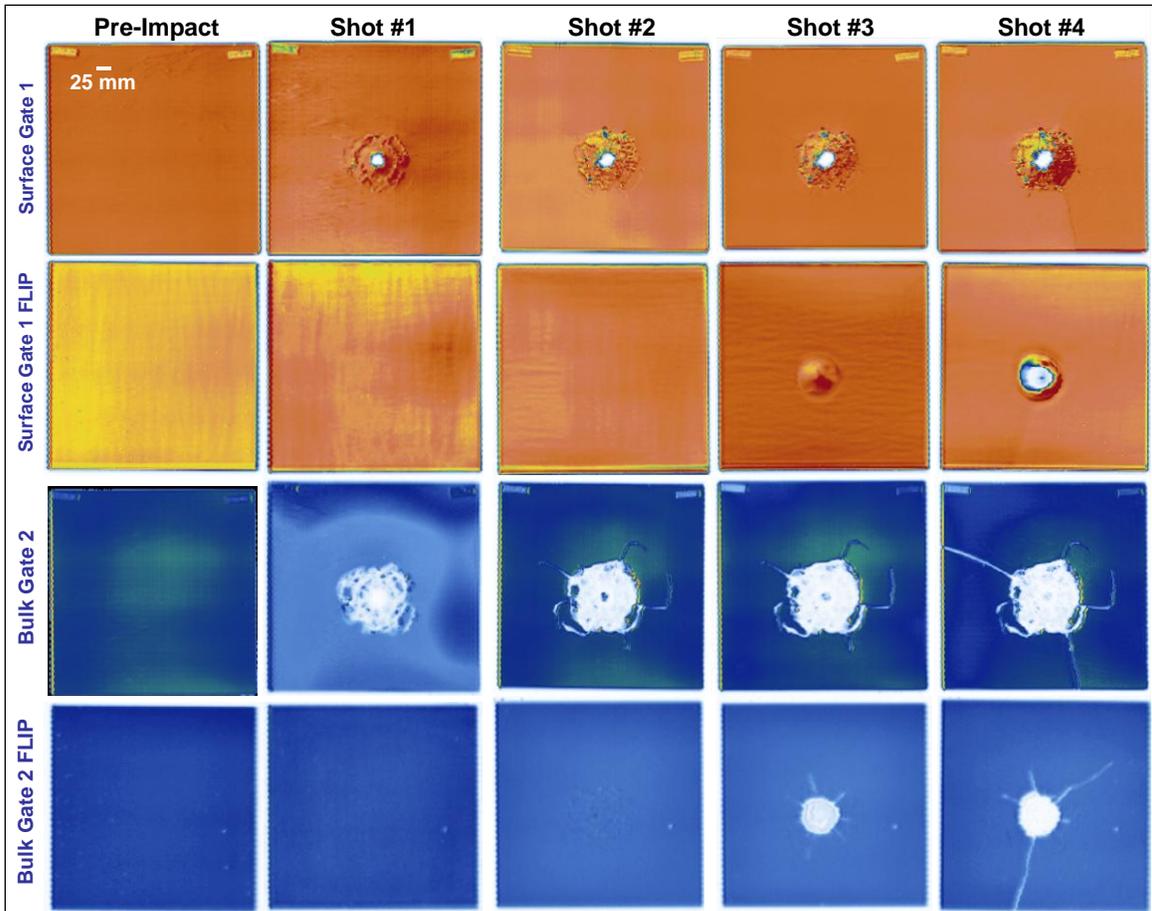
Figure 7. Surface and bulk C-scan images of 740-2 cumulative damage from the strike and back face.

In figure 7, C-scan images of the surface/near surface of panel 740-2 after each impact are shown in succession, with the first row representing the strike face images and the second row representing the back face images. The strike face images showed the degree of damage at the point of impact and its slight degree of expansion after each impact. Damage due to cracking was not present until after the final impact, where a radial crack propagated to the lower edge of the panel. The back face images showed no indication of damage to the Starphire layer until after the third impact, at which point there appeared to be a slight physical deformation to the back face opposite the point of impact. After the fourth impact, a severe degree of damage resulting in complete signal loss was evident in the surface/near surface C-scan image. The third and fourth rows represented bulk C-scan images through the entire volume of panel 740-2. For the third row containing the strike face images, the damage zone expanded after the second impact, was very similar after the second and third impacts, and resulted in propagation of two radial cracks to the edge of the panel after the fourth impact. For the fourth row containing the back face images, some micro-cracking was evident after the second impact. The third impact revealed the presence of damage and the early formation of radial cracks within the Starphire layer. After the fourth impact, several of these radial cracks began to propagate, with one extending out to the edge of the panel. This demonstrated that out of the three edge cracks that were detected, one of them was present in the Starphire layer. These results showed a large contrast between panel 740-1, which had a large number of radial edge cracks after a single impact, and panel 740-2, in which four impacts to the same location were required to produce a radial edge crack.

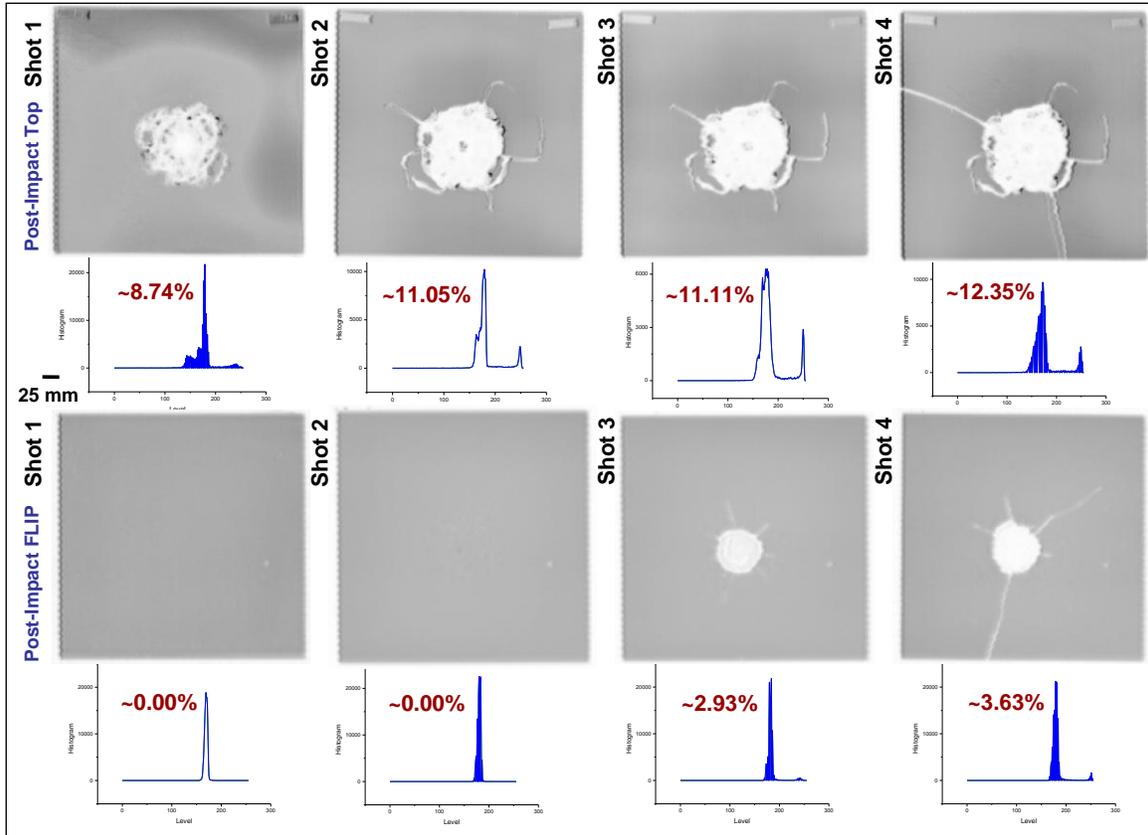
Figure 8. Histogram images and percent damage from the strike and back face of 740-2 after each impact.

For the strike face images, the quantitative results were consistent with the qualitative observations from visual inspection. The percent damage increased from 8.74% to 11.05% after the second impact with additional cracking to the damage zone and initial crack propagation, from 11.05% to 11.11% after the third impact with a minimal increase in damage, and from 11.11% to 12.35% after the fourth impact with radial crack propagation to the edges. For the back face images, there was no detectable damage after the first or second impacts, as the initial micro-cracking was not distinguished. After the third impact, the damage increased to 2.93% and again to 3.63% as one of the radial cracks propagated to the edge of the panel. All of the quantitative results consistently showed an increase in cumulative damage after each impact test.

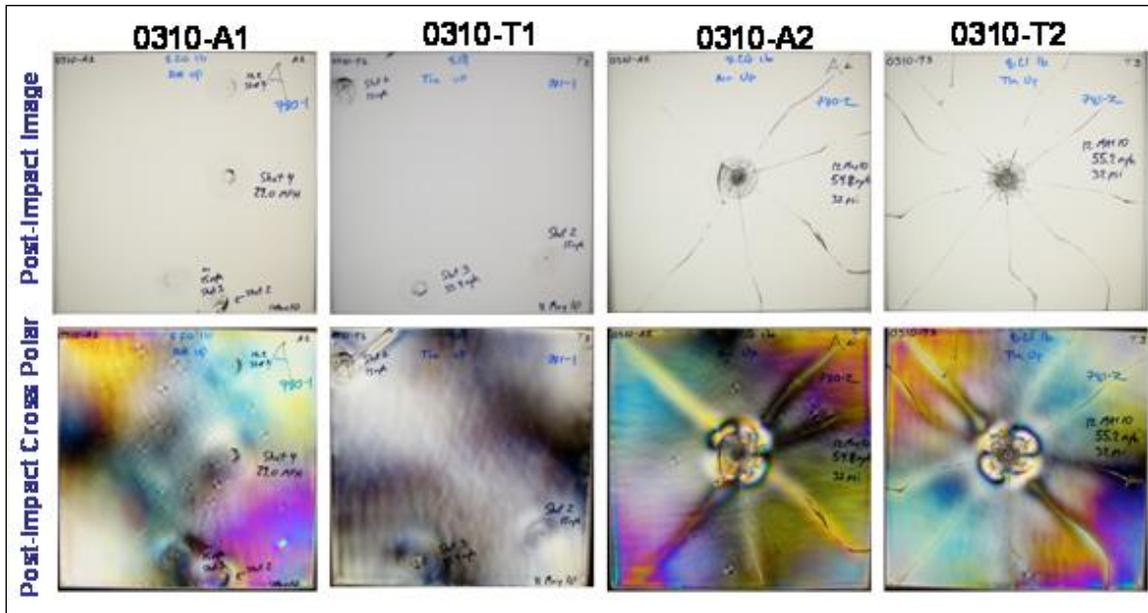
Figure 9. Visual characterization and cross-polarized images of the 0310-series post-impact.

The same characterization methods used to evaluate the 740- and 741-series panels were applied to these panels. Visual characterization was conducted on the four panels in a pre-impact and post-impact state. Cross-polarization techniques were used to observe residual stress states before and after low velocity impact. The post-impact images are shown in figure 9. The four impacts to 0310-A1 and three impacts to 0310-T1 occurred at a high enough velocity to produce damage to the surface as well as delaminations in the two laminates. Despite multiple impacts to each panel, there did not appear to be any overlap between damage regions.

In the cross-polarization images, panel 0310-T1 showed minor residual stress patterns while the other three panels displayed regions of higher residual stress, especially in the corner locations. The impacts to 0310-A2 and 0310-T2 both showed radial cracks originating from the point of impact and extending to the edge of each panel. In terms of the number of radial cracks, 0310-A2 exhibited 6 cracks as compared to 10 for 0310-T2, resulting in an improvement from the standpoint of visibility.

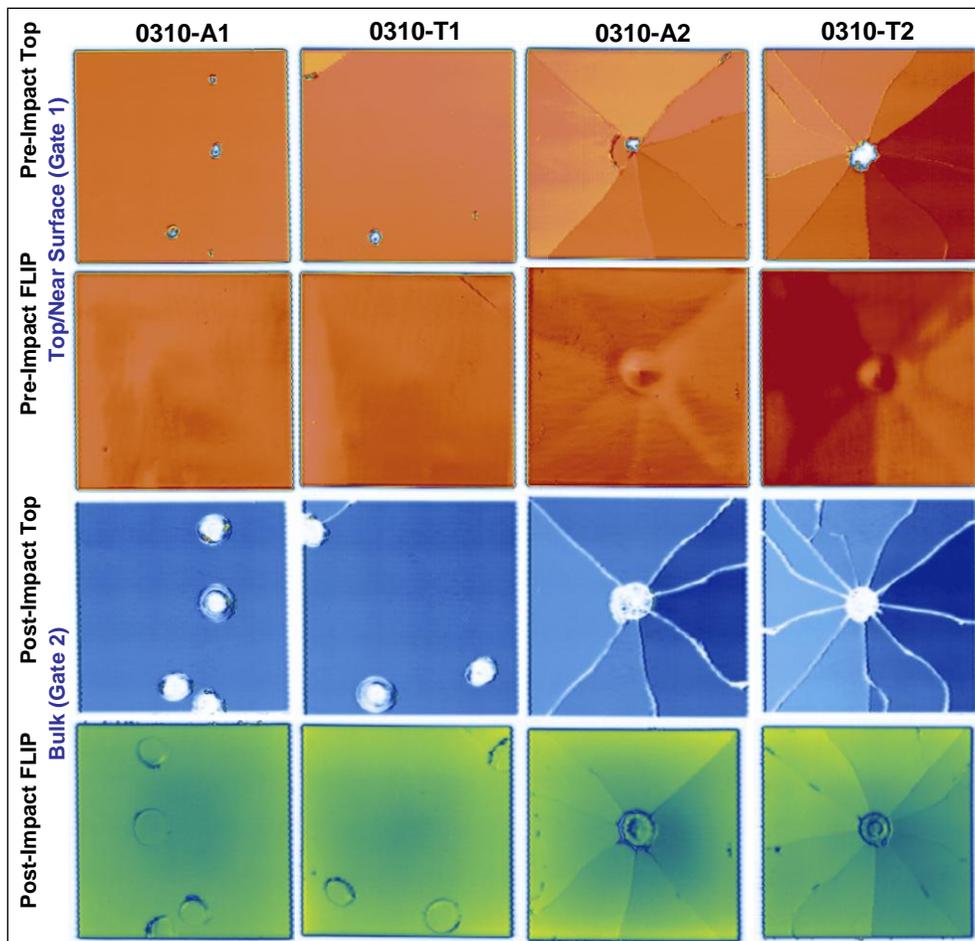
Figure 10. Surface/near-surface and bulk UT C-scan images of the 0310-series post-impact.

Ultrasound C-scan images were collected for all of the panels in both the pre- and post-impact states. Surface/near-surface images were mapped to show changes in signal amplitude at and near the point of impact of the Borofloat strike face. Bottom surface images were mapped to show changes in signal amplitude through the bulk of each panel. The post-impact surface/near surface images through the strike face and back face (rows 1 and 2, respectively) and post-impact bulk images through the strike face and back face (rows 3 and 4, respectively) are shown in figure 10. The surface/near-surface images for 0310-A1 and 0310-T1 were similar, with point of impact damage represented by complete loss of signal at each impact. The two highest velocity impact strikes resulted in the largest indications of residual surface damage. The surface/near-surface image for 0310-A2 exhibited a smaller degree of damage at the point of impact when compared to 0310-T2, but also showed a near-surface indication of a cone crack that connected two of the radial cracks. The images through the back face showed no detectable damage for 0310-A1 and 0310-T1, but both 0310-A2 and 0310-T2 showed surface indications of deformations resulting from a cone crack, as were previously detected in 740-1 and 741-2. The circular region representative of the bulge in the polycarbonate backing layer appeared to be larger in diameter for 0310-A2 as compared to 0310-T2.

The bulk images for 0310-A1 and 0310-A2 revealed damage that was much larger in diameter than the surface/near-surface images. This indicated that the damage through the bulk of these panels was the result of delaminations at the Borofloat/Starphire interface. While the surface indications were much smaller, the diameter of damage due to delamination of the glass layers appeared to be similar regardless of the impact velocity. The C-scan images through the back face mirrored these results, highlighting the damage perimeter for each impact. The bulk images for 0310-A2 and 0310-T2 identified all of the cracks that were detected visually, clearly showing a partial crack and a crack that split off of one of the main radial cracks, each which was difficult to see in the digital and cross-polarization images. The bulk images through the back face also revealed small features near the edges of the panels that could not be resolved through visual means. The combination of surface/near-surface C-scan images through the strike and back faces provided a wealth of damage information that could not be otherwise detected.

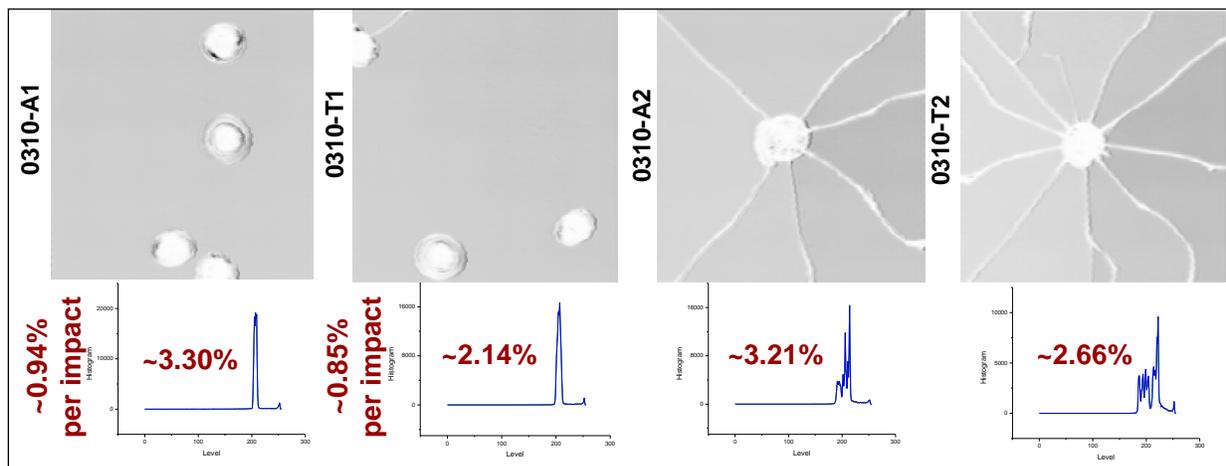
Figure 11. Histograms and percent damage from the strike faces of the 0310-series after impact.

The quantitative damage threshold technique was applied to determine the degree of damage through both the strike face and back face of all the 0310-series panels (figure 11). A direct comparison of panel 0310-A1, which had a total damage percent of 3.30%, and 0310-T1, which had a total damage percent of 2.14%, did not tell the whole story. Since 0310-A1 was subject to an additional impact and both panels were subject to impacts that demonstrated only half the damage since they occurred at the edges, the average damage per impact was a more useful value. While 0310-A1 had an average of 0.94% per impact, 0310-T1 was slightly lower at 0.85% per impact. For panel 0310-A2, which had a total damage percent of 3.21%, and 0310-T2, which had a total damage percent of 2.66%, the results appeared to be counterintuitive at first due to the difference in the number of cracks. However, while panel 0310-T2 exhibited 10 radial cracks, the percent damage appeared to be influenced more by the larger cone crack in 0310-A2, as evidenced in both the surface/near-surface and bulk images captured through the back face. The tin-side-up panel, 0310-T2, showed a higher number of radial cracks and the air-side-up panel, 0310-A2, indicated a larger cone crack, but the small variations in percent damage were not enough to definitively claim that one was superior to the other.
