**Extensive Characterization of Cracking in As-fabricated
Composite Ceramic Panels Via Ultrasonic and X-ray
Computed Tomography Testing**

ARL-TR-5638

August 2011

**William H. Green and Raymond E. Brennan
Weapons and Materials Research Directorate, ARL**

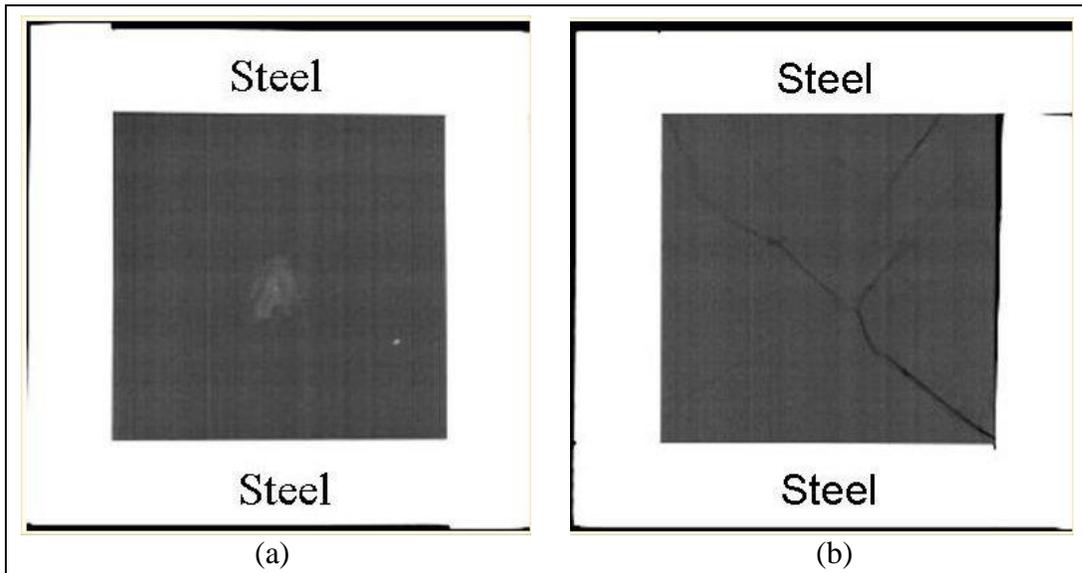
Each of the two specimens consists of a 4 in x 4 in x 0.50 in boron carbide (B_4C) tile surrounded by four 5 in x 1 in x 0.50 in pieces of steel all bonded onto a 6 in x 6 in x 0.87 in aluminum backing plate. The four pieces of steel were placed such that each one extended 1 in past the side of the tile in a wraparound surround. Digital radiographs (DRs) of each specimen were taken through their thickness using the 420 keV x-ray tube and linear detector array (LDA) setup in centered rotate-only (RO) mode. The x-ray technique parameters of the DRs were 400 keV and 2.0 mA and the geometry of the source-to-object-distance (SOD) was 750.00 mm and the source-to-image-distance (SID) was 940.00 mm. Figure 1 shows DRs of each specimen, in which the gray-shaded tiles are in the center and the steel surround pieces around the tile are white. This is because the steel attenuates the x-rays significantly more than the tile and aluminum. The DR of the first specimen (figure 1a) shows no cracks in the tile and no gaps between the sides of the tile and the steel surround. The lighter blotchy area in the center of the tile is due to material that was on the rear of the aluminum backing. The slight vertical banding is an image artifact (i.e., not physically in the specimen) due to offset and gain (window) adjustment to optimize image detail. The DR of the second specimen (figure 1b) shows cracks in the tile and a significant gap, which gets larger towards the top of the image, between the side of the tile and the vertical right surround piece. The cracks extend to the vicinity of the upper two and lower right corners of the

tile, with a fainter indication extending to the lower left corner. The DR clearly shows the tilt of the vertical right surround piece.

Figure 1. Through-thickness DRs: (a) specimen number 1 and (b) specimen number 2.

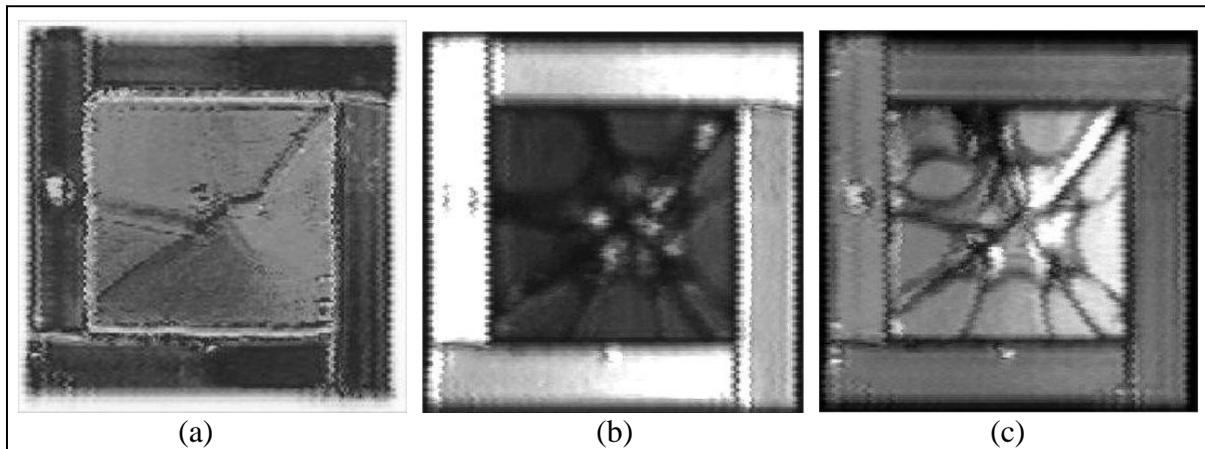
Figure 2 shows three ultrasonic variable amplitude C-scans in which the up direction from the bottom of the images corresponds to increasing z in the DR scan of the specimen. The scan in figure 2a was gated to show the front surface and near surface characteristics of the specimen and indicates two major cracks in the tile. The scan in figure 2b was gated to show only the signal amplitude at the rear surface of the tile. The scan in figure 2c was gated to show the overall bulk characteristics of the tile. Both of the images in 2b and 2c show widespread attenuation, indicated by the darker areas, most likely due to cracks within the tile. Figure 3 shows a through-thickness B-scan presentation of the specimen going from left to right approximately halfway between the bottom and top of the tile. The B-scan view shows the ultrasonic amplitude against time (i.e., depth), which is on the y -axis, over the length of the line (horizontal) defining the cross-sectional location. The physical side locations of the steel surround pieces are marked and the vertically larger white areas (e.g., left side) indicate more immediate loss of signal. The B-scan clearly shows where cracking damage is resulting in relatively fast signal attenuation, including much of the left side, the center area, and part of the right side.

Figure 2. Ultrasonic C-scans of specimen 1: (a) surface/near-surface of specimen, (b) rear surface of tile signal amplitude only, and (c) bulk characteristics of tile.

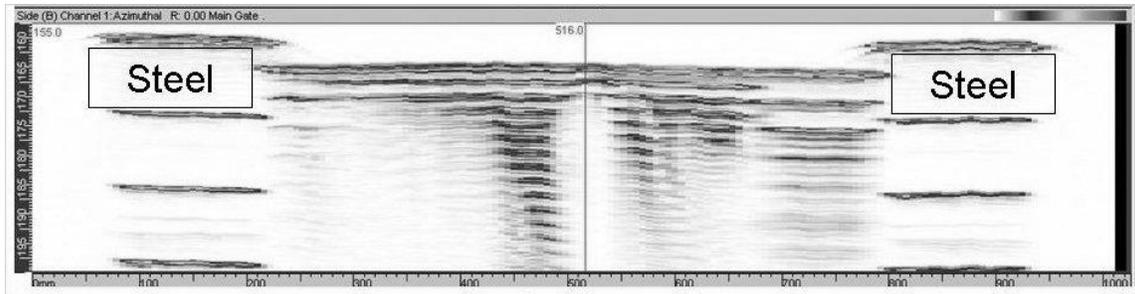
Figure 3. Through-thickness, or depth, B-scan presentation of specimen 1 going from left to right approximately halfway between the bottom and top of the tile. The physical side locations of the steel surround pieces are marked.

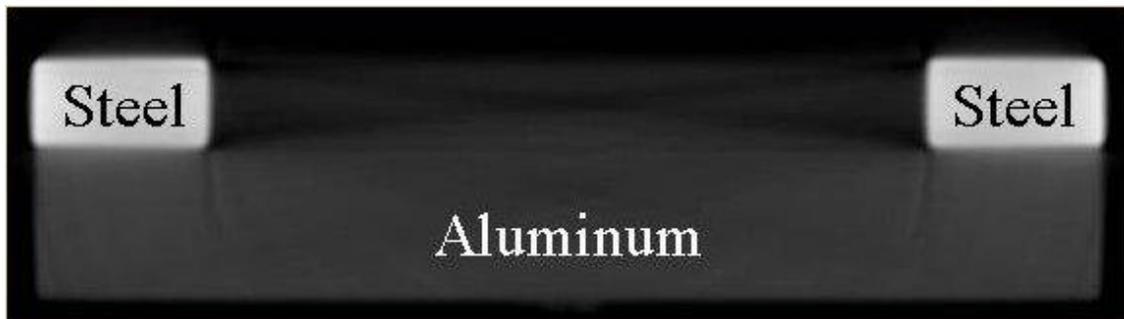
Figure 4 shows a representative XCT scan (image) of the specimen in which the aluminum backing plate and steel surround pieces are labeled. The front surface of the tile is located at the top of the image. The darkened cross pattern in the tile is due to a combination of the location of the steel in relation to the tile and significantly greater x-ray attenuation by the steel as compared to the tile. The image does not show indications of cracks. This is most likely due to some combination of the difficulty in image interpretation caused by the cross pattern artifact and very tight cracks with small or no gaps (i.e., “kissing” cracks).

Figure 4. Representative XCT scan (image) of specimen 1 with locations of steel surround pieces and aluminum backing plate labeled. Note the darkened cross pattern artifact between the pieces of steel.

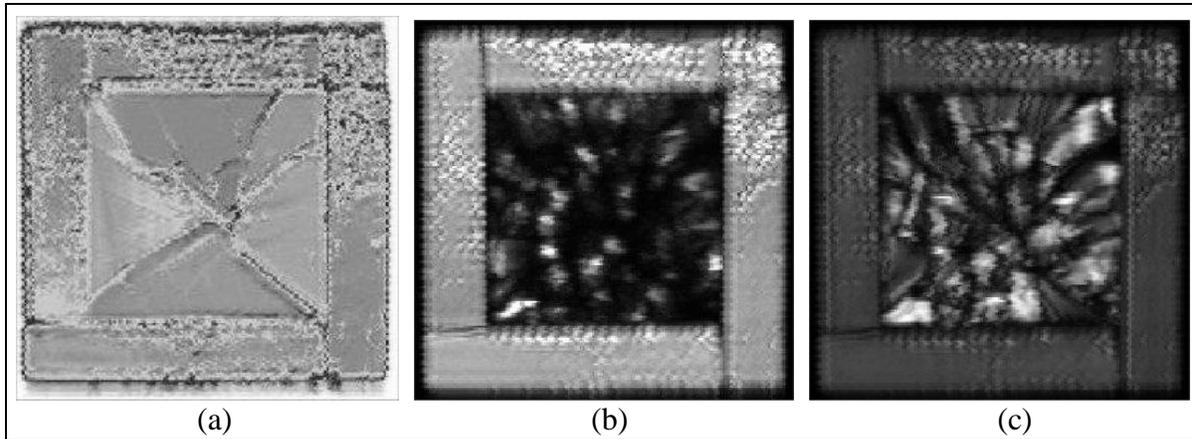
Figure 5 shows three ultrasonic variable amplitude C-scans in which the up direction from the bottom of the images corresponds to increasing z in the DR scan of the specimen. The scan in figure 5a was gated to show the front surface and near surface characteristics of the specimen and indicates at least five major cracks in the tile. The scan in figure 5b was gated to show only the signal amplitude at the rear surface of the tile. The scan in figure 5c was gated to show the overall bulk characteristics of the tile. Both of the images in 5b and 5c show widespread

Figure 5. Ultrasonic C-scans of specimen 2: (a) surface/near-surface of specimen, (b) rear surface of tile signal amplitude only, and (c) bulk characteristics of tile.

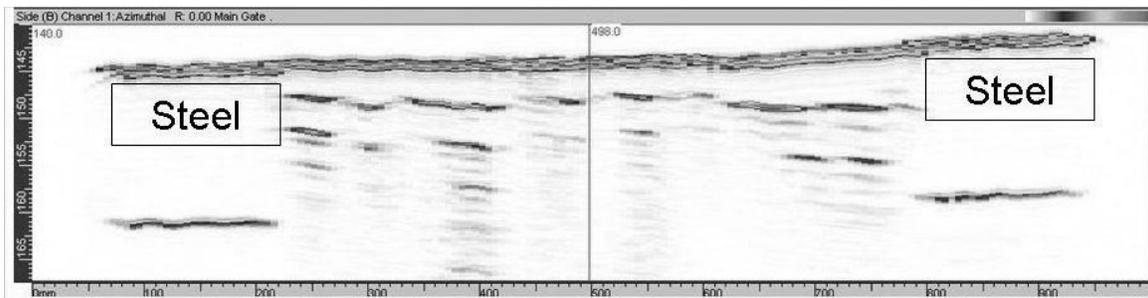
attenuation, indicated by the darker areas, most likely due to cracks within the tile. Figure 6 shows a through-thickness B-scan presentation of the specimen going from left to right approximately halfway between the bottom and top of the tile. The B-scan view shows the ultrasonic amplitude against time (i.e., depth), which is on the y-axis, over the length of the line (horizontal) defining the cross-sectional location. The physical side locations of the steel surround pieces are marked and the vertically larger white areas indicate more immediate loss of signal. The B-scan clearly shows where cracking damage is resulting in relatively fast signal attenuation, which occurs over the majority of the cross section.

Figure 6. Through-thickness, or depth, B-scan presentation of Specimen 2 going from left to right approximately halfway between the bottom and top of the tile. The physical side locations of the steel surround pieces are marked.

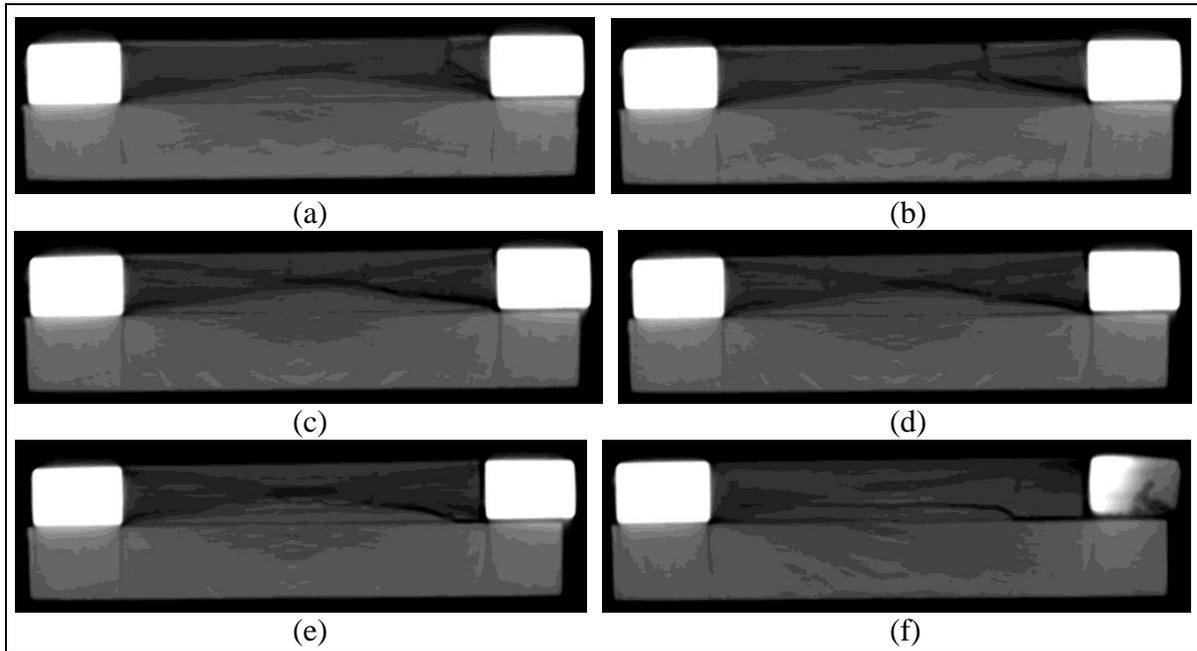
The vertical positions (z-direction) of the bottom and top of the tile were 330.5 and 432.0 mm, respectively, in the XCT scans. Figure 7 shows a series of XCT scans (images) of the specimen at vertical positions of 339.70, 353.20, 382.90, 395.50, 413.50, and 431.50 mm (a–f). The front surface of the tile is at the top of the images. The presence of cracking in the tile is evident near its bottom on the right side as shown in figure 7a. The cracking continues to extend into the interior and towards the front of the tile as the positions of the scans increase, finally reaching

from one rear side corner to the other. Other cracks approximately perpendicular to the faces of the tile also extend from this main feature to the front of the tile. The image at a height of 431.50 mm (f) also shows that part of the rear face of the tile on the right has come away from the backing plate and is no longer in intimate contact with the plate. This is the same side of the tile adjacent to which the tilted steel surround piece is located. It is evident that the crack enters the interior of the tile at the juncture between contact and stand off of the rear face of the tile with the backing plate.

Figure 7. A series of cross-sectional XCT scans (images) of specimen 2: scans (a–f) were taken at vertical positions of 339.70, 353.20, 382.90, 395.50, 413.50, and 431.50 mm, respectively.

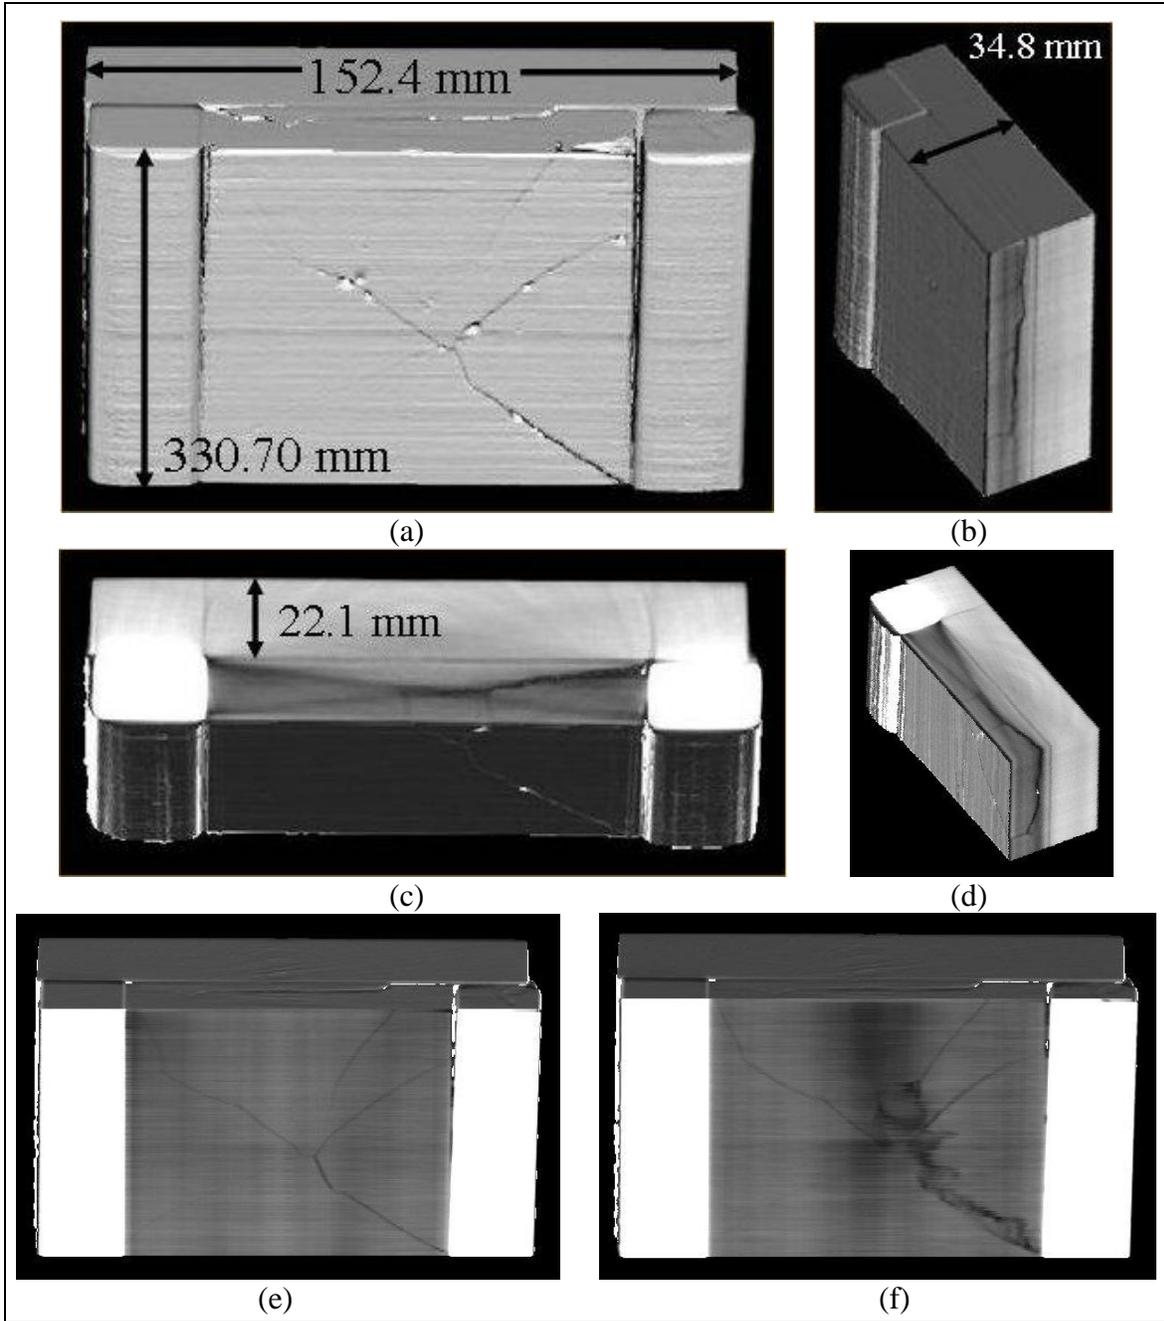
The excellent dimensional accuracy and the digital nature of XCT images allow the accurate volume reconstruction of multiple adjacent or overlapping slices. A virtual three-dimensional (3-D) solid image is created by electronically stacking the XCT images, which have thickness over their cross sections (i.e., voxels), one on top of the previous from the bottom to the top of the specimen or scanned height to generate its virtual volume. Figure 8 shows a series of 3-D solid images of the scanned volume with sections virtually removed in figure 8b–f. The method of virtual sectioning, which is essentially only showing a portion of each scan, allows viewing of generated surfaces anywhere in the scanned volume in 3-D space. The view in figures 8a, 8b, 8e, and 8f is looking at the front of the specimen with it tilted forward. In figures 8c and 8d, the specimen has been tilted forward as well as rotated in order to better view the side sections. Figure 8a shows the entire scanned volume with surfaces and no sections virtually removed. In figure 8b, approximately the right-hand side of the specimen has been virtually removed. The main lateral crack near the rear of the tile is visible, as are some perpendicular cracks that go to

the front surface of the tile. In figure 8c, approximately the top half of the specimen has been virtually removed. It shows cracking at about the middle of and to the right in the sectioned surface, as well as the connections between the crack indications on the front surface and the interior cracks perpendicular to the surfaces. In figure 8d, approximately the top half as well as a smaller section on the right-hand side of the specimen has been removed. The connection of the cracks from one sectioned surface into the adjacent sectioned surface at the intersection (edge) of the two surfaces is evident. In figure 8e, a few millimeters of material in the thickness direction parallel to the faces of the tile has been removed from the front of the specimen. The crack pattern looks similar to the crack pattern on the surface of the tile (figure 8a). In figure 8f, about half of the thickness of the tile has been removed. More severe damage in the center region where the cracks come together, as well as in the lower right area, is evident. The vertical darker broad band in the center of the tile is the manifestation of the relative attenuation effect of the steel as compared to the tile (and aluminum).

Figure 8. A series of 3-D solid visualization images of specimen 2: (a) entire specimen with the front tilted forward, (b) section removed perpendicular to thickness, (c) section removed perpendicular to height, (d) sections removed perpendicular to both thickness and height, (e) section removed parallel to the faces showing the majority of thickness of the tile, and (f) section removed parallel to the faces showing about half the thickness of the tile.

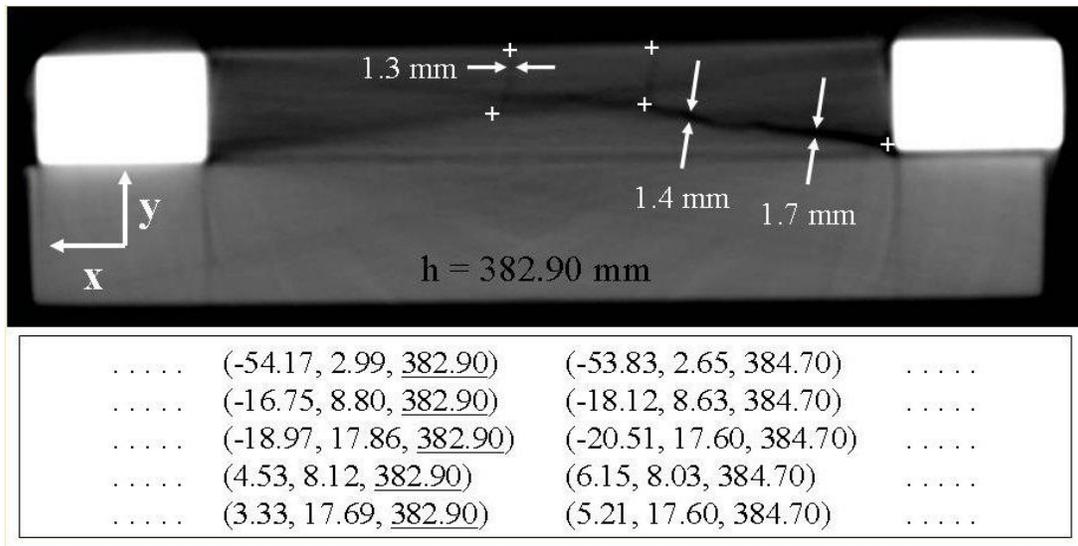
Figure 9. XCT scan (image) at vertical height of 382.90 mm and defining spatial locations of crack planes.

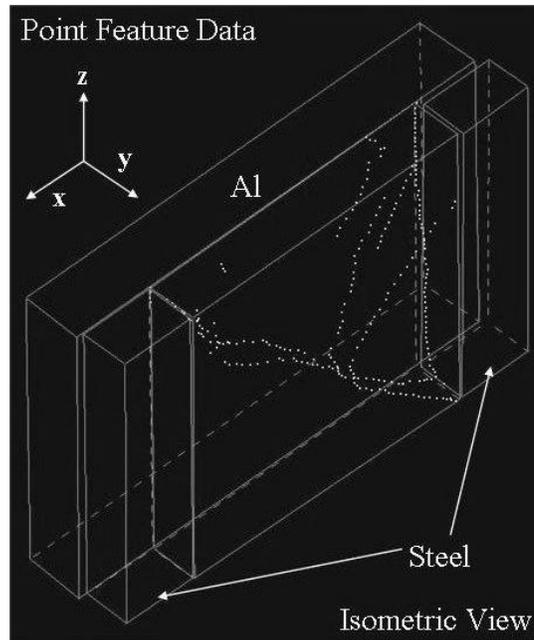
Figure 10 is an isometric view of the scanned volume of the specimen, in which the edges of each component are shown in wire frame mode and dashed lines indicate rear or blocked view edges. The points defining the crack locations and orientations are shown within the body of the tile. The tilted steel surround piece is on the right side of the image. Figure 11 is an isometric view of the scanned volume showing the points and the boundary curves that were fit to the points. Figure 12 is an isometric view of the scanned volume showing only the boundary curves within the body of the tile. Figure 13 is an isometric view of the scanned volume showing gridded surfaces fit to the boundary curves defining major crack regions and their interconnection. Figure 14 is an isometric view of the scanned volume showing shaded surfaces

Figure 10. 3-D point cloud of the defining locations of the crack planes.

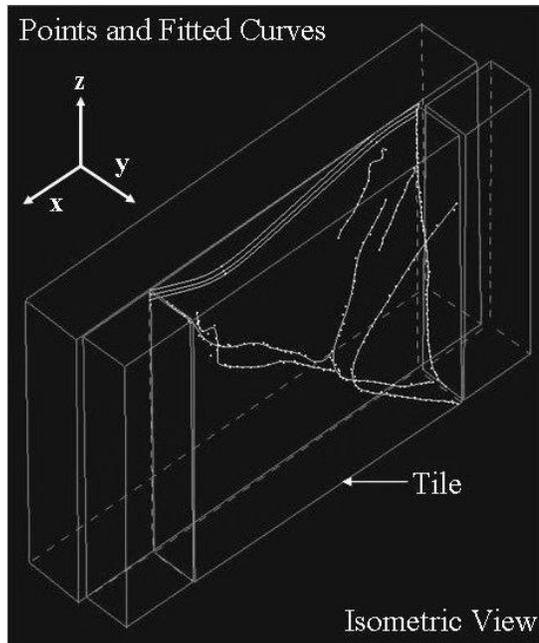
Figure 11. 3-D point cloud and boundary curves of the crack planes.

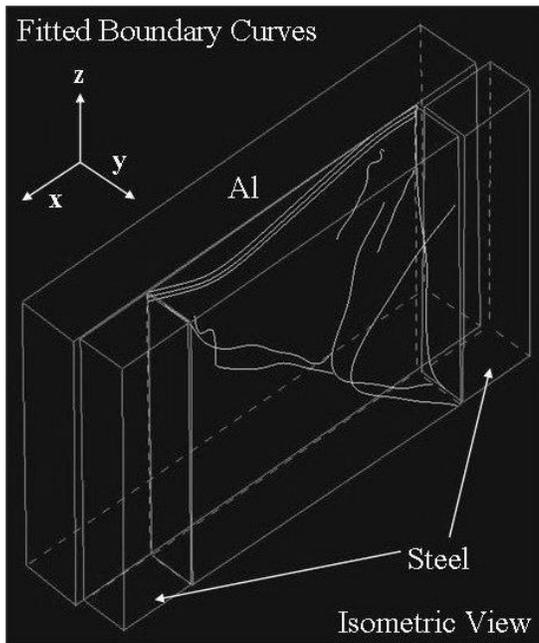
Figure 12. Boundary curves of the crack planes.

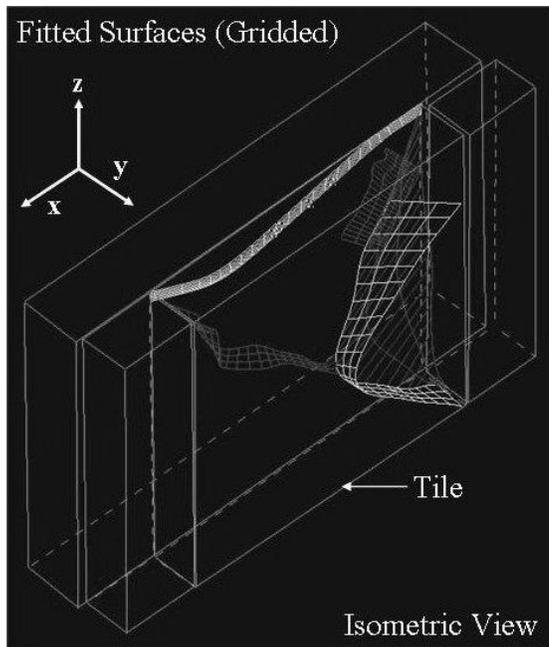
Figure 13. Fitted crack plane surfaces (gridded).

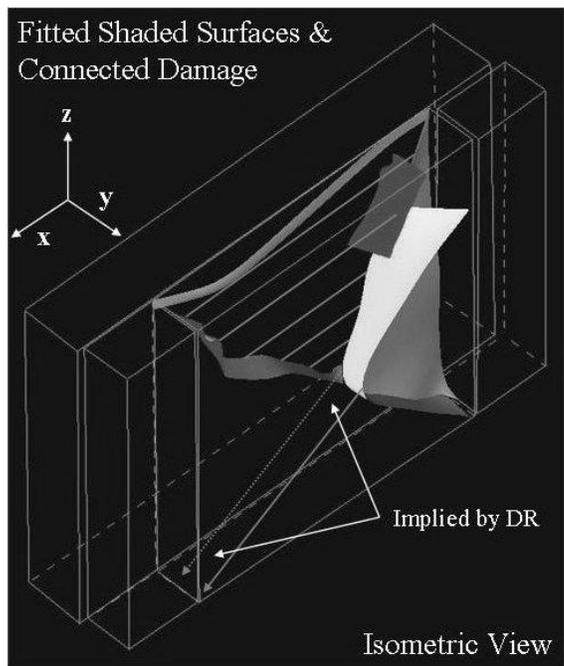
fit to the boundary curves defining major crack regions and their interconnection, as well as other crack plane features. The parallel gray lines drawn in the top of the tile indicate that there is also a crack plane in the region spanned by them. Secondly, the relatively faint crack indication in the lower left area of the DR of the specimen is marked by the two parallel arrows in the lower left part of the body of the tile. Figure 15 is an isometric view of the tile only showing the various crack regions, indicating that a significant volume of the tile is severely cracked. This volumetric representation of the damage also clearly shows that the crack regions go from both side-to-side and bottom-to-top in the body of the tile.

Figure 14. Crack plane surfaces showing the entire specimen.
The tilted steel piece is on the right.

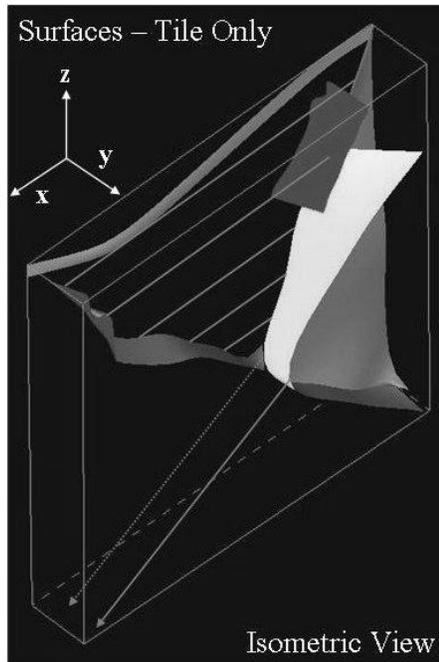
Figure 15. Crack plane surfaces showing the tile only.
