F-111 Adhesive Bonded Repair Assessment Program (FABRAP) - Phase I Testing, Preliminary Results

DSTO-TN-1024

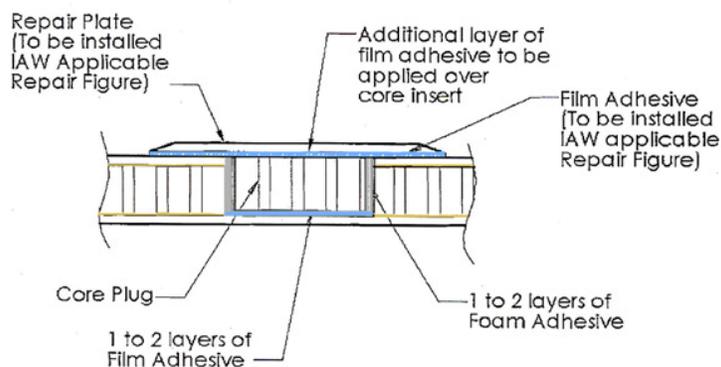
The installation of the repair would have involved cutting through the original panel, disturbing the asbestos-containing adhesive, and potentially exposing operators to loose asbestos fibres. However once the repair was in place, the original panel and any adhesive containing asbestos would have been re-encapsulated by the adhesives used in the repair. Since at least the early-1990s, adhesives used in Australian bonded repairs have not contained asbestos.

Figure B.1. Full core repair to bonded sandwich panel

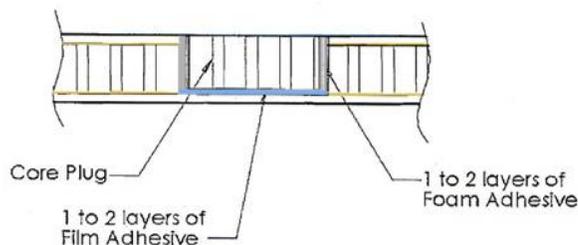
Figure B.3 shows the panel at the end of testing. Although the repaired core has been exposed, the original panel has not been breached in any way. The repaired section of core is isolated from the original panel by one or two layers of adhesive, therefore there is no exposure to the original adhesive used in construction. However, visible sections of open core may cause concern to casual onlookers, and DSTO is able to seal up any opened core sections using an aluminium doubler and sealant. This would also provide additional protection against impact damage during disposal activities.

Figure B.3. At the end of testing, the doubler is peeled off for visual assessment of the adhesive bond

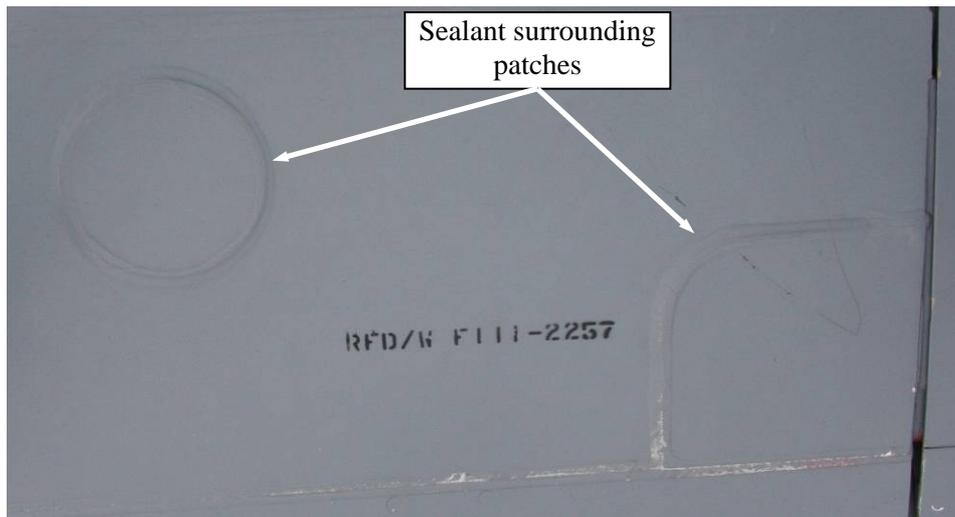
Figure C.1: Photograph of the sealant around two bonded repairs and their RFD/W identification number

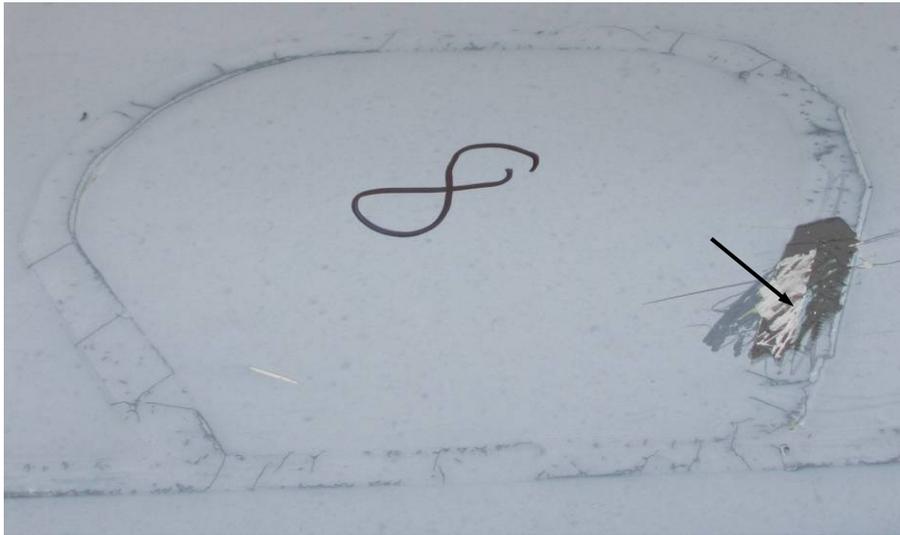
Figure C.2: Photograph of a patch with sufficient sealant removed to identify the blue FM300 adhesive (arrowed)

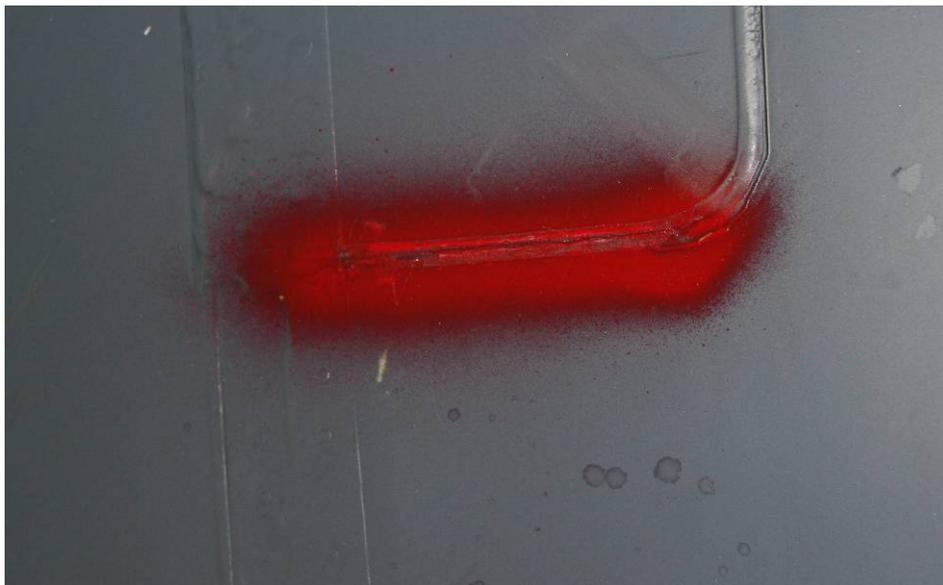
AF130 and AF131 adhesives are brown and contain asbestos. If the adhesive colour is in the yellow to brown range, consult bonding technicians with experience in identification of adhesives containing asbestos. Patches bonded with these adhesives are to be marked with Rust Away red enamel paint as shown in Fig. C.3 and not handled under FABRAP. Any exposed AF130 or AF131 adhesive is to be sealed with a continuous film of Rust Away red enamel spray paint. Where there was any doubt, adhesives were treated as potentially containing asbestos.

Figure C.3: Photograph of a patch containing AF131 adhesive marked with red enamel paint

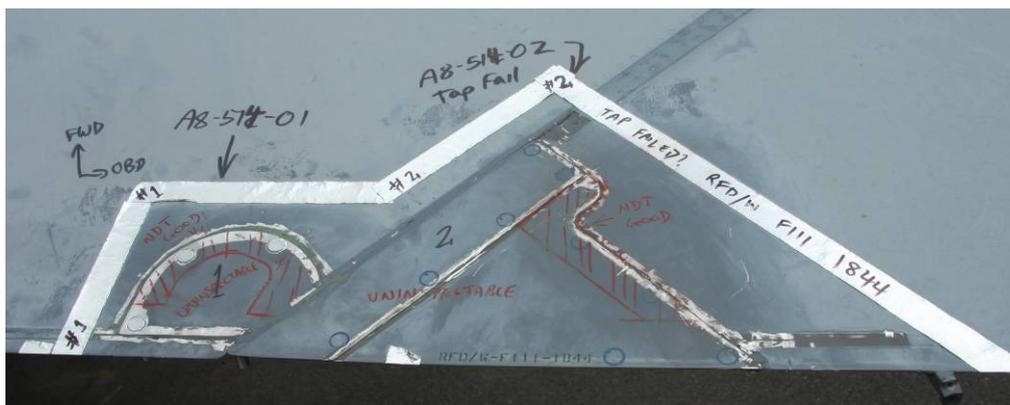
Figure C.4: Photograph of two patches that had been inspected and marked up by 6 Squadron

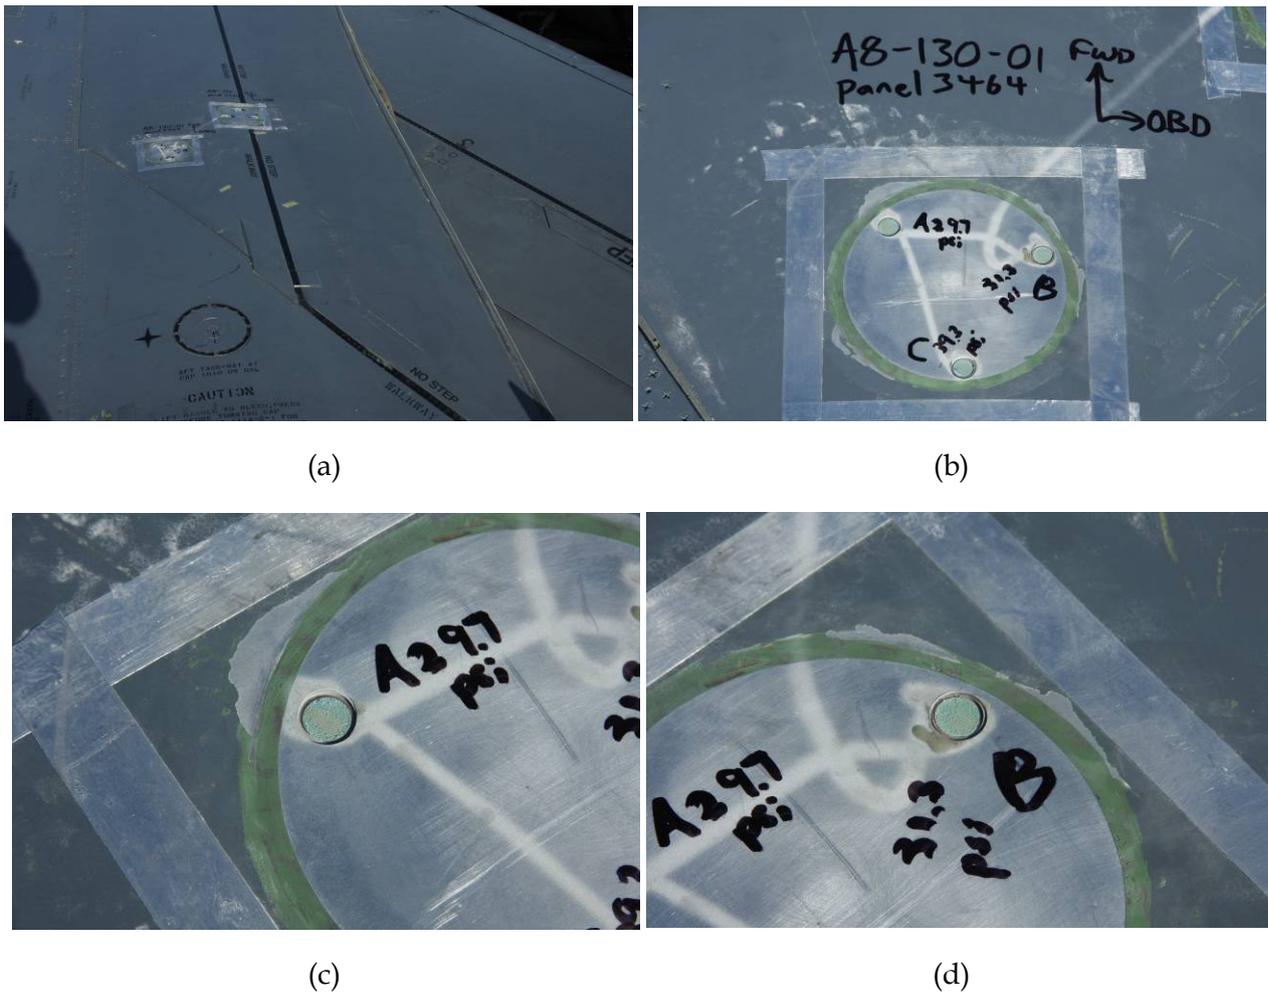
Figure C.11 A typical set of post-test photographs showing the (a) panel, (b) patch, and (c) and (d) two of the stubs
