**Investigation of Failed Components from a 7-in
High Altitude Research Program (HARP) Cannon**

ARL-TR-5814

November 2011

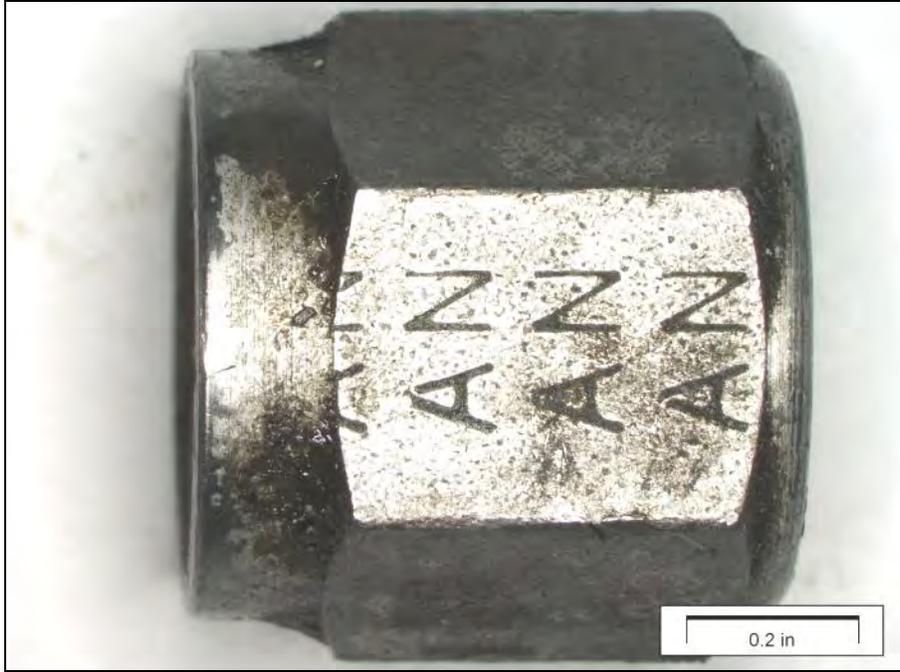
Figure 3. Nut from the failed end of the tube.

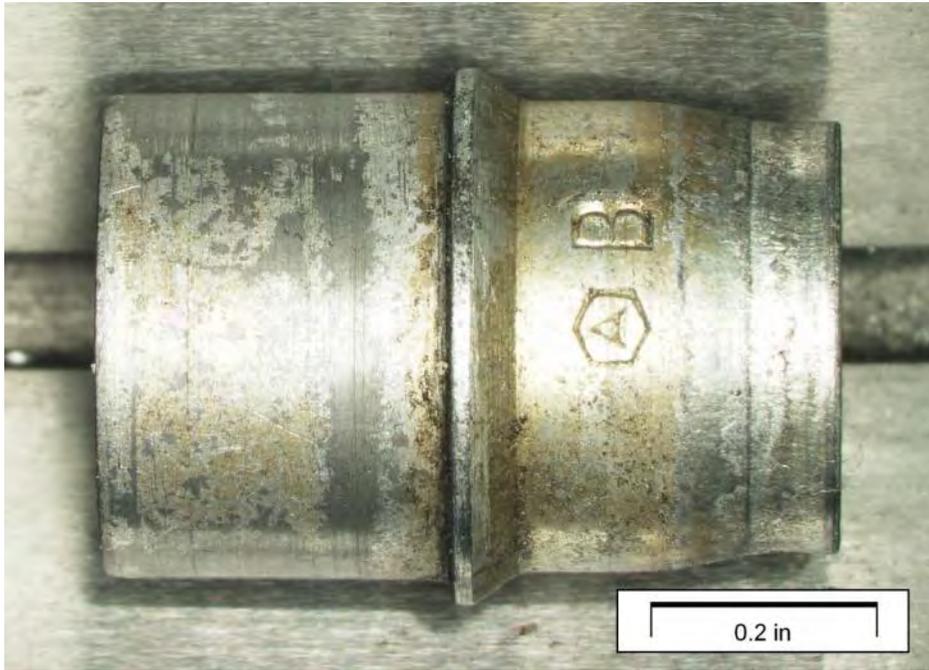
Figure 4. Ferrule from the failed end of the tube.

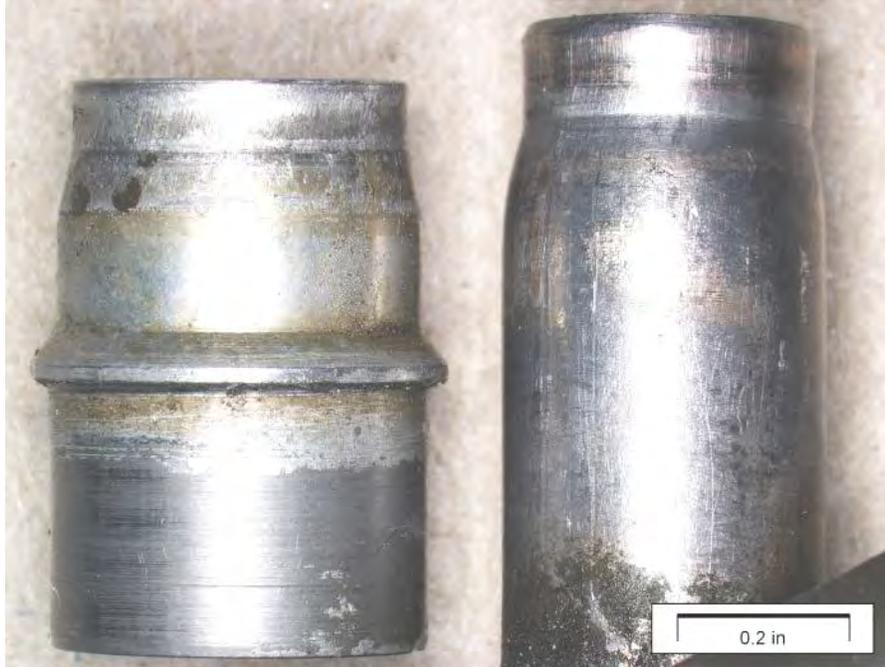
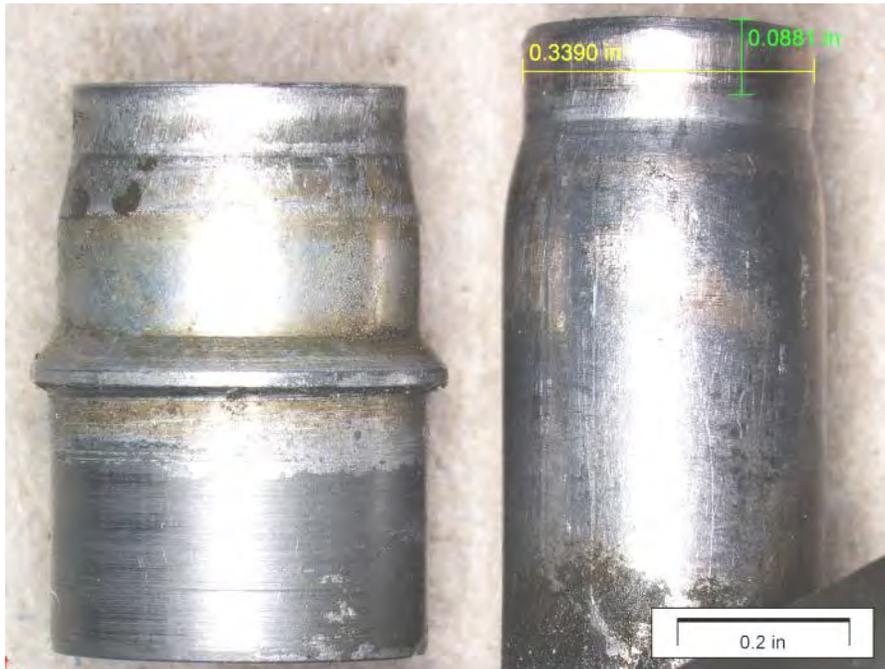
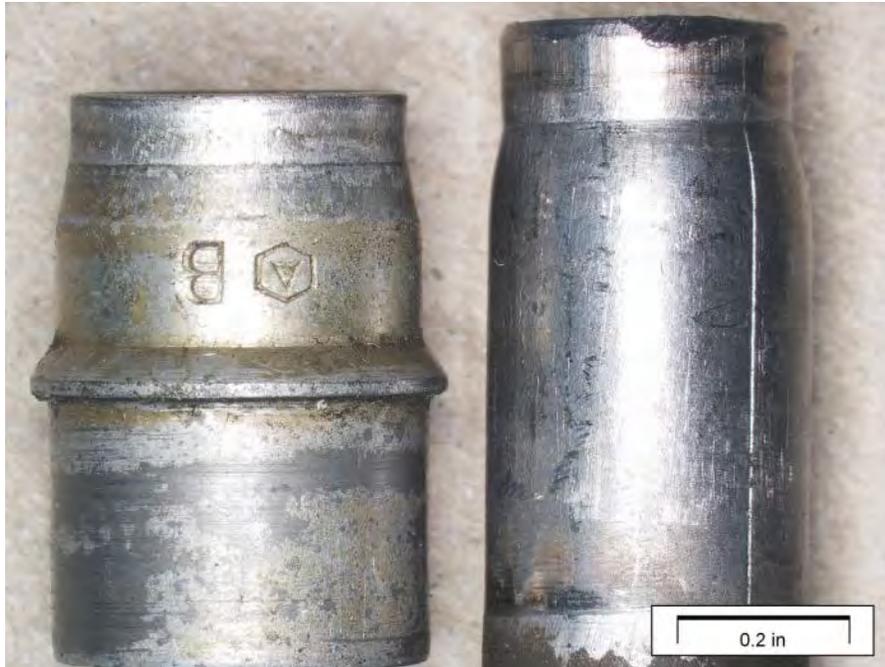
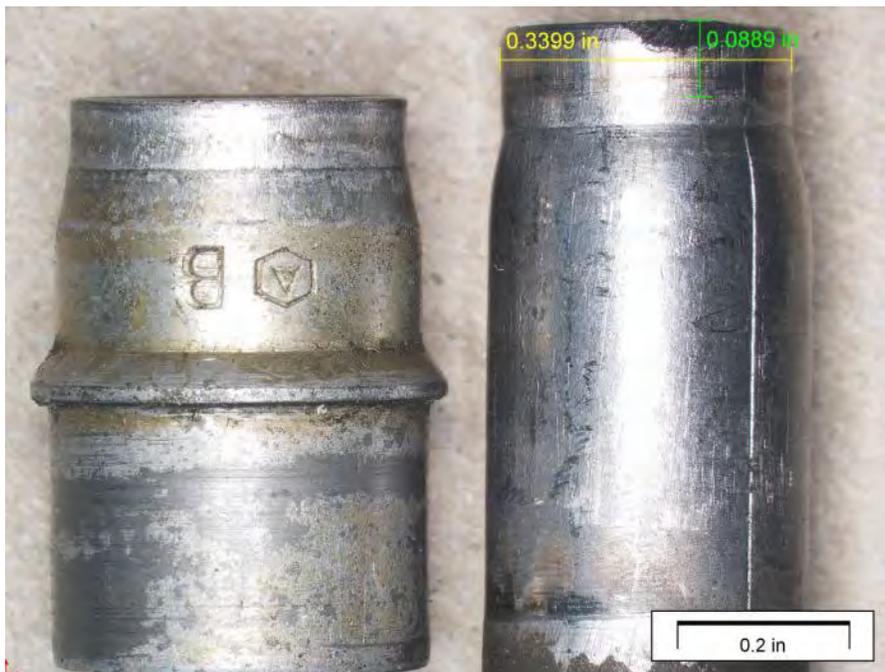
Considerable care was taken to match up the ferrule with its original location on the tube. Witness marks were identified and mated with corresponding marks on the interior of the ferrule. This was done in an attempt to ensure that the joint was properly installed as designed. Figures 5 and 6 present “side A” of the ferrule and the failed end of the tube in their approximate original position as determined from the witness marks observed. Measurements of these locations can be observed in figure 6. Figures 7 and 8 present “side B” of the ferrule and the failed end of the tube in their approximate original position as determined from the witness marks observed. The corresponding measurements are available in figure 8.

Figure 5. Ferrule position matched with the failed end of the tube, side A.

Figure 6. Measurements of ferrule position matched with the failed end of the tube, side A.

Figure 7. Ferrule position matched with the failed end of the tube, side B.

Figure 8. Measurements of ferrule position matched with the failed end of the tube, side B.

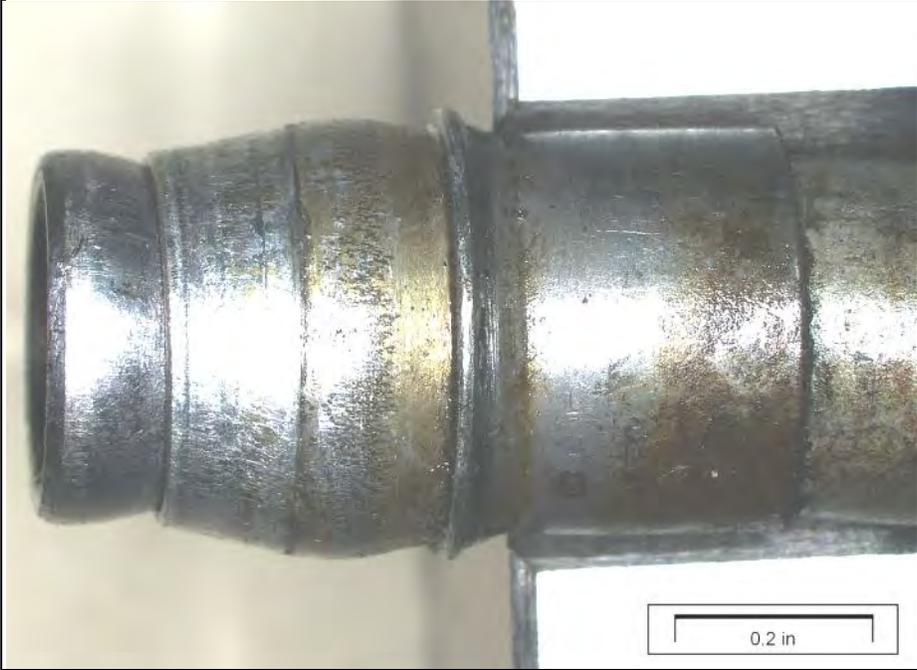
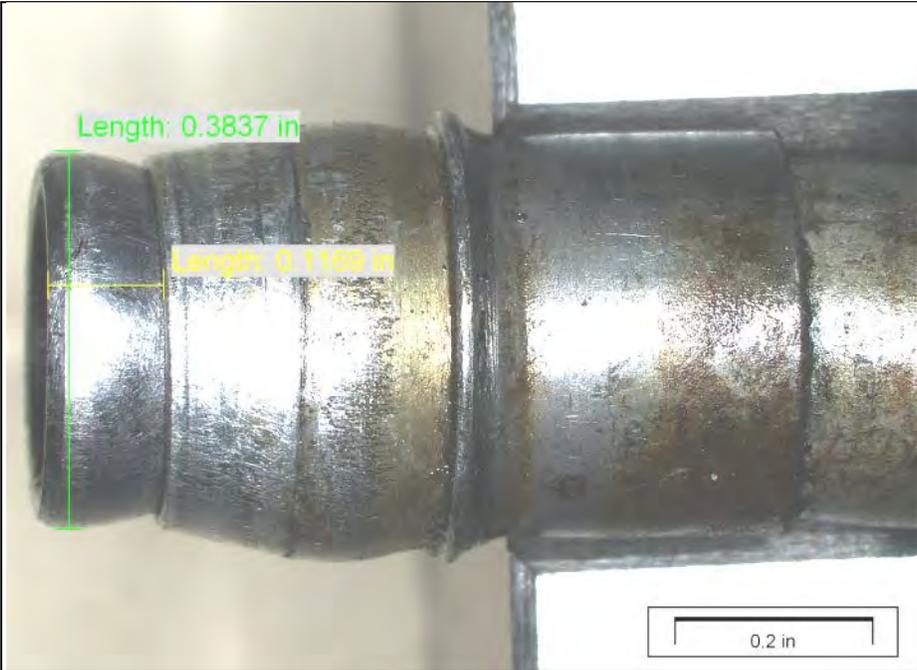
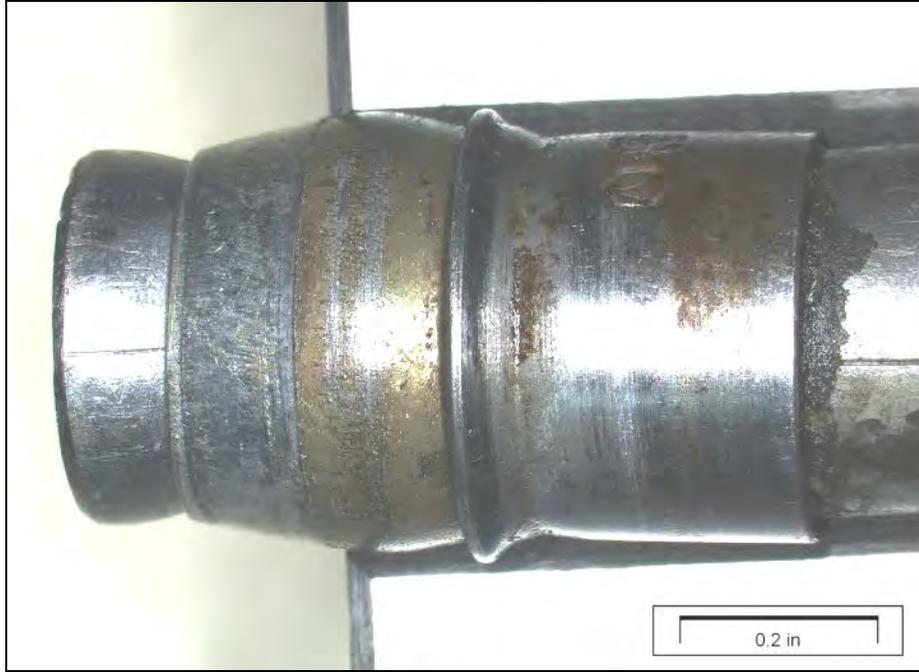
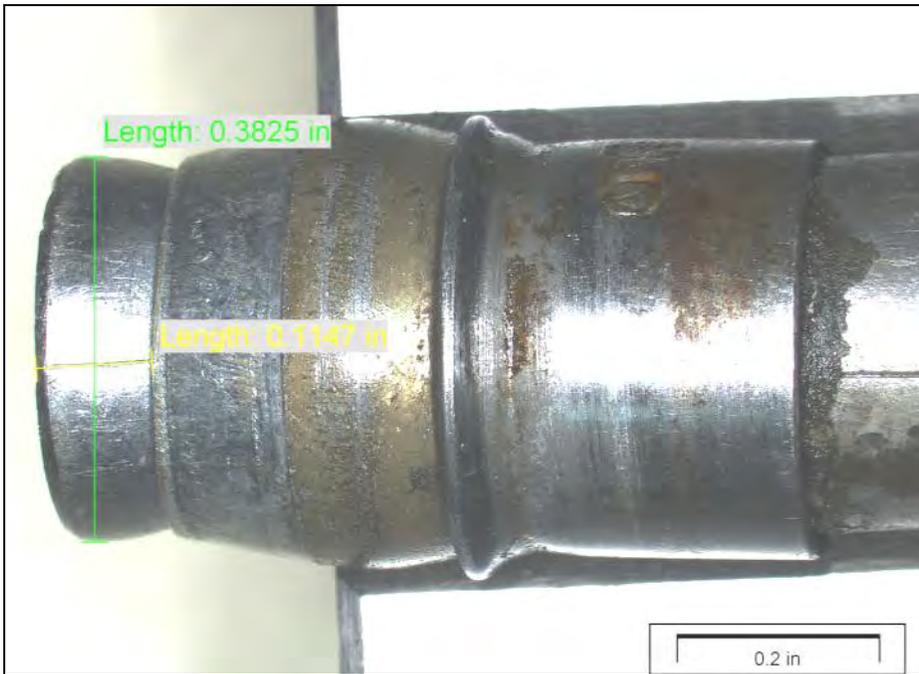
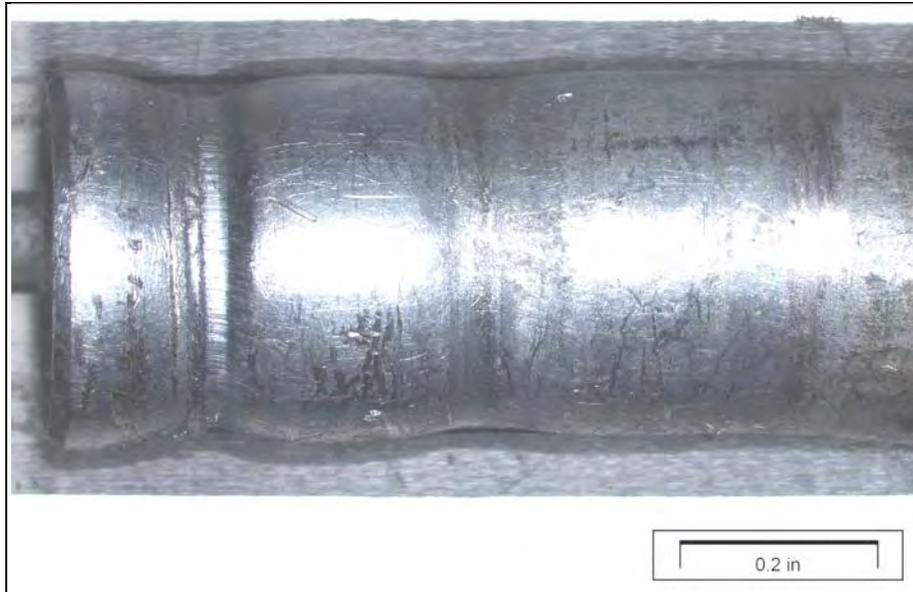
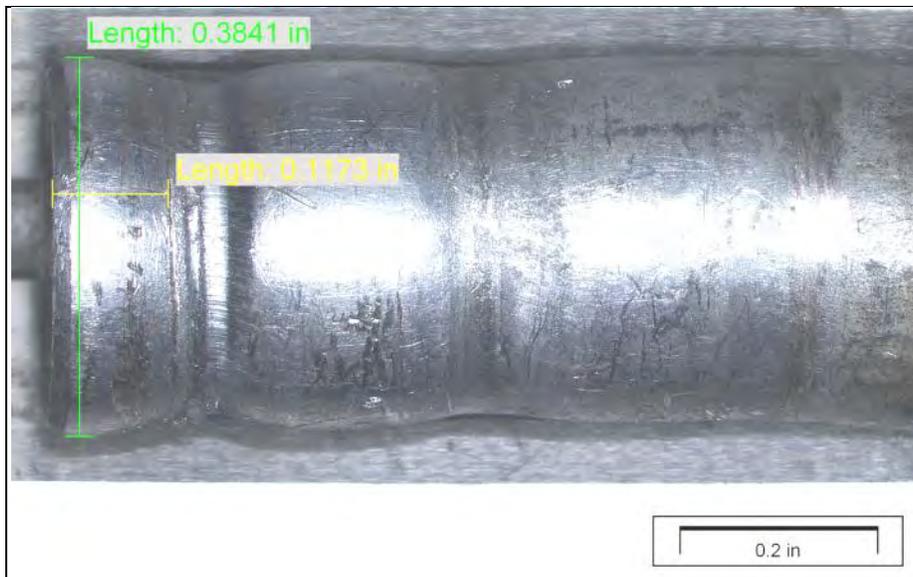
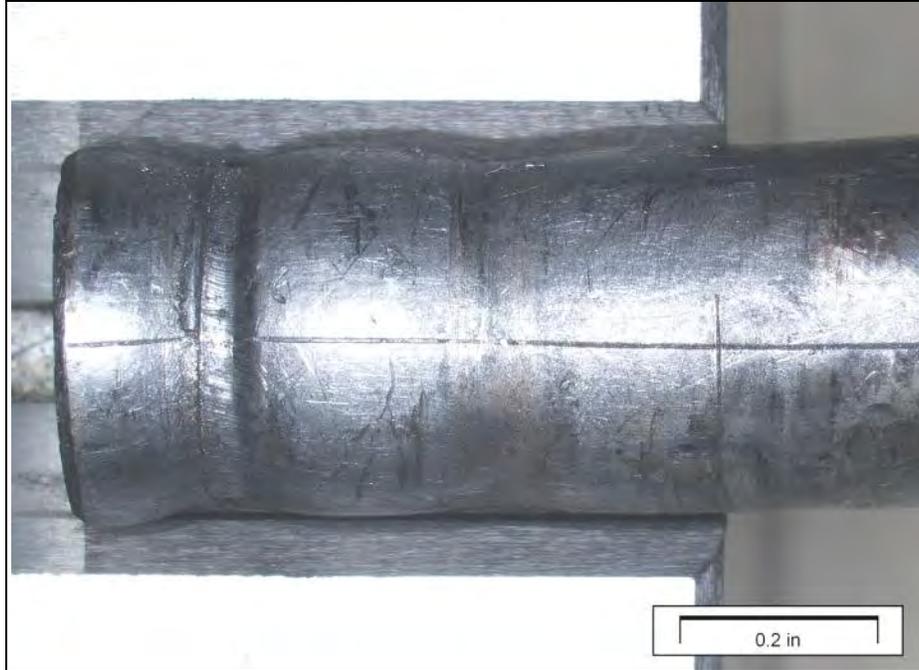
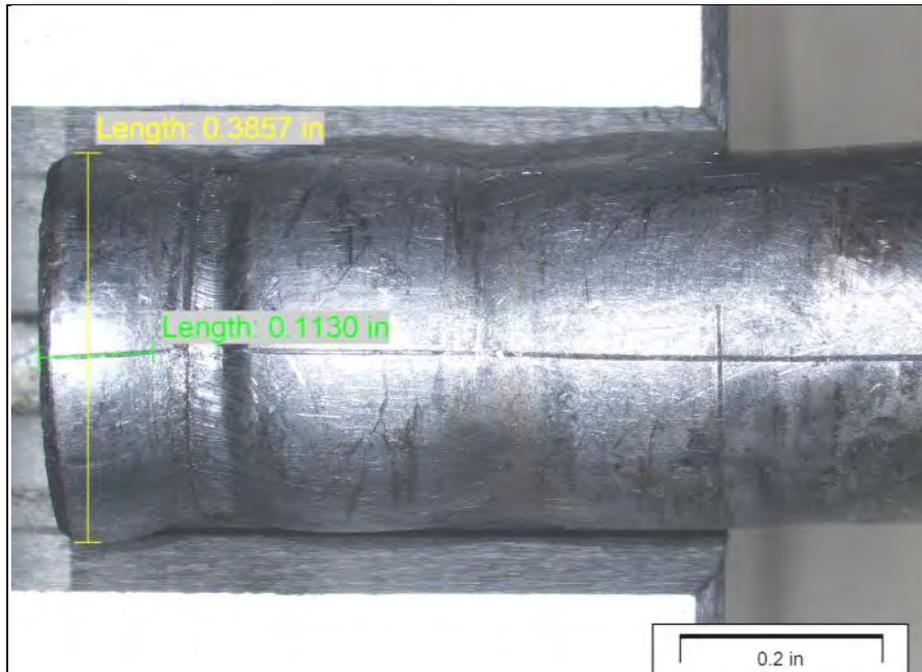
This analysis demonstrated several things. The resting place of the ferrule on the failed end of the tube was considerably closer to the end of the tube when compared with the intact end. The tubing was also visibly flared on each end. The flare on the failed end was less than on the intact end; however, this would have likely been affected by the forcing of the tube out of the ferrule. The ferrule from the intact end was carefully sectioned from the tube without damaging the underlying surfaces. Both sides of the intact end of the tube can be observed after the removal of the ferrule in figures 13–16, with and without dimensional measurements.

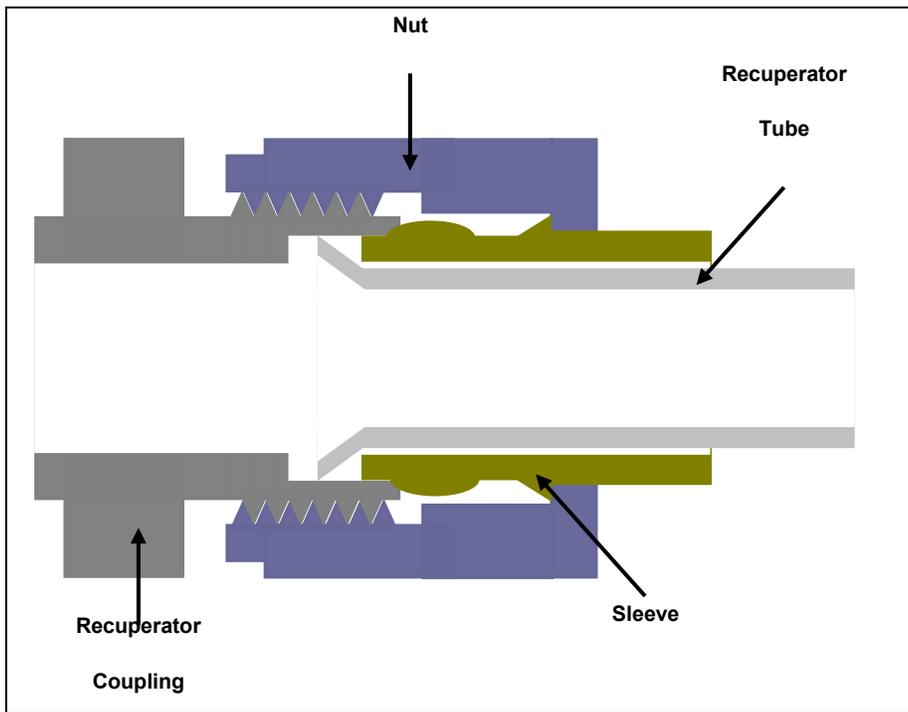
The M174 hydraulic line joints examined have an interesting design. Hydraulic joints are usually either a compression or flare type. In compression joints, the ferrule is compressed between the nut and the end fitting causing it to clamp down on the tubing by a reduction in the inner diameter (ID) of the ferrule. The ends of the tubing are not usually flared. In flare joints, the tubing ends are flared and the tubing is sandwiched between the end fitting and the ferrule, or between the end fitting and the nut itself, if the design doesn't include a ferrule. In either case, the tubing is physically sandwiched and held in place by the torque of the nut. Both joint designs are shown by example in figures 17 and 18. The flare design is a much more secure fitting and will hold a much greater line pressure than a simple compression fitting. The actual design in this case appeared to have traits of both types. The tubing was flared before installation; however, the tubing was not sandwiched between clamped metal surfaces. It was most similar to a normal compression design type. A schematic of the actual design used on the M174 recoil unit can be observed in figure 19 and compared with both figures 17 and 18.

Figure 19. Schematic of the hydraulic line joints on the M174 recoil unit.

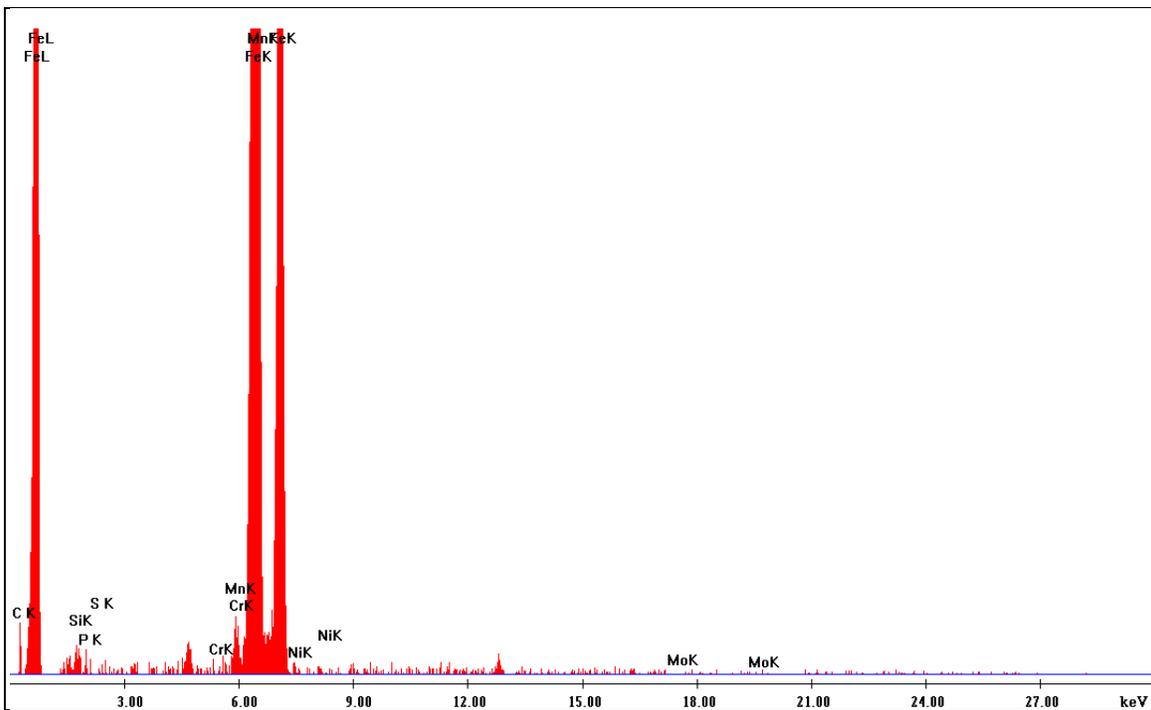
The chemistry of the failed tube was determined with EDS and compared with that of known materials frequently used in the tubing industry. The elemental composition conformed to that of ASTM-A-254 (1) spiral-wound copper-brazed steel. Figure 20 presents the EDS spectrum obtained from the M174 recoil unit failed tube. Table 1 shows the elemental composition in comparison to known accepted values for ASTM-A 254 (1) steel. It should be noted that performing EDS analysis to determine carbon and sulfur levels is extremely inaccurate. EDS is a very useful tool for analyzing metallic and semi-metallic elements of higher atomic number. Experience using this tool and analyzing the resultant data confirms that the material in this case was ASTM-A-254 (1) steel. A cross section of the material can be observed in section 2.4.

Figure 20. EDS spectrum from the failed M174 recoil unit tube.

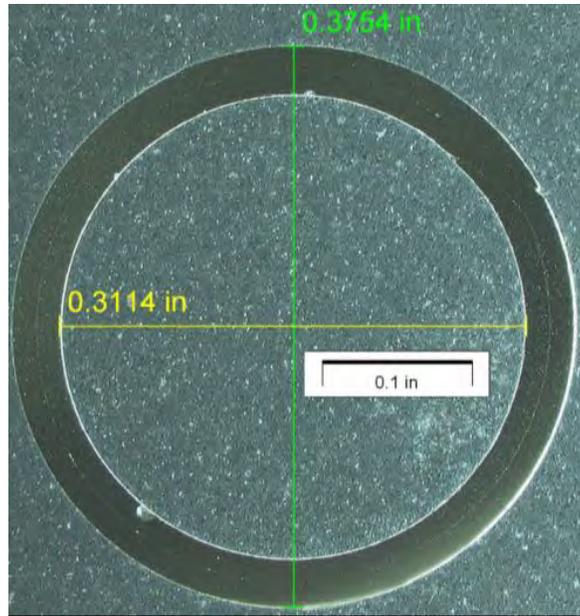
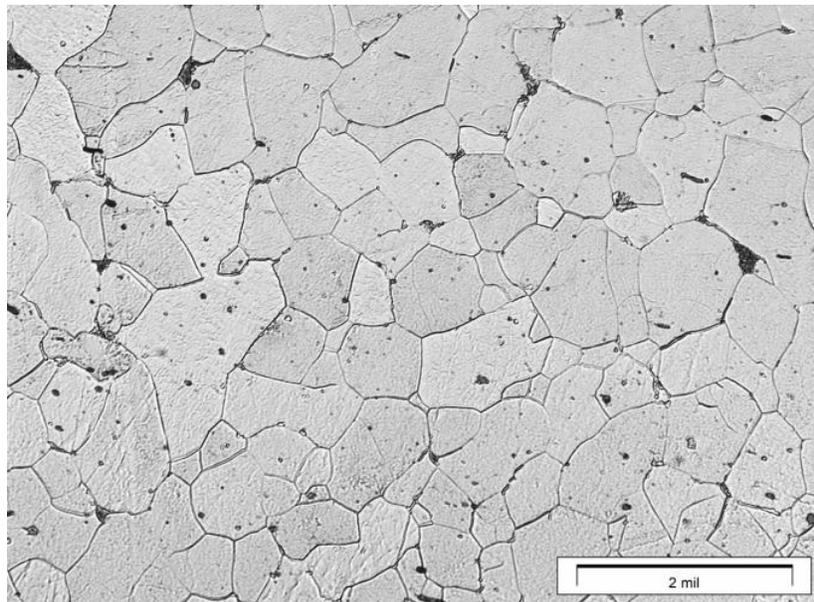
The microstructure of the M174 recoil unit tube was analyzed by polishing and nital etching a cross-sectional mount obtained from a radial cut of the tube. Figure 21 shows the cross section. The single-strip type of spiral-wound and copper-brazed steel tube can be observed on this figure as well as the overall cross-sectional dimensions. The polished and etched microstructure can be observed in figure 22. The structure consists of primarily ferrite and is consistent with that expected for this alloy.

Figure 21. Cross section of the failed M174 recoil unit tube material.

Figure 22. Ferritic microstructure of the failed M174 recoil unit tube material.

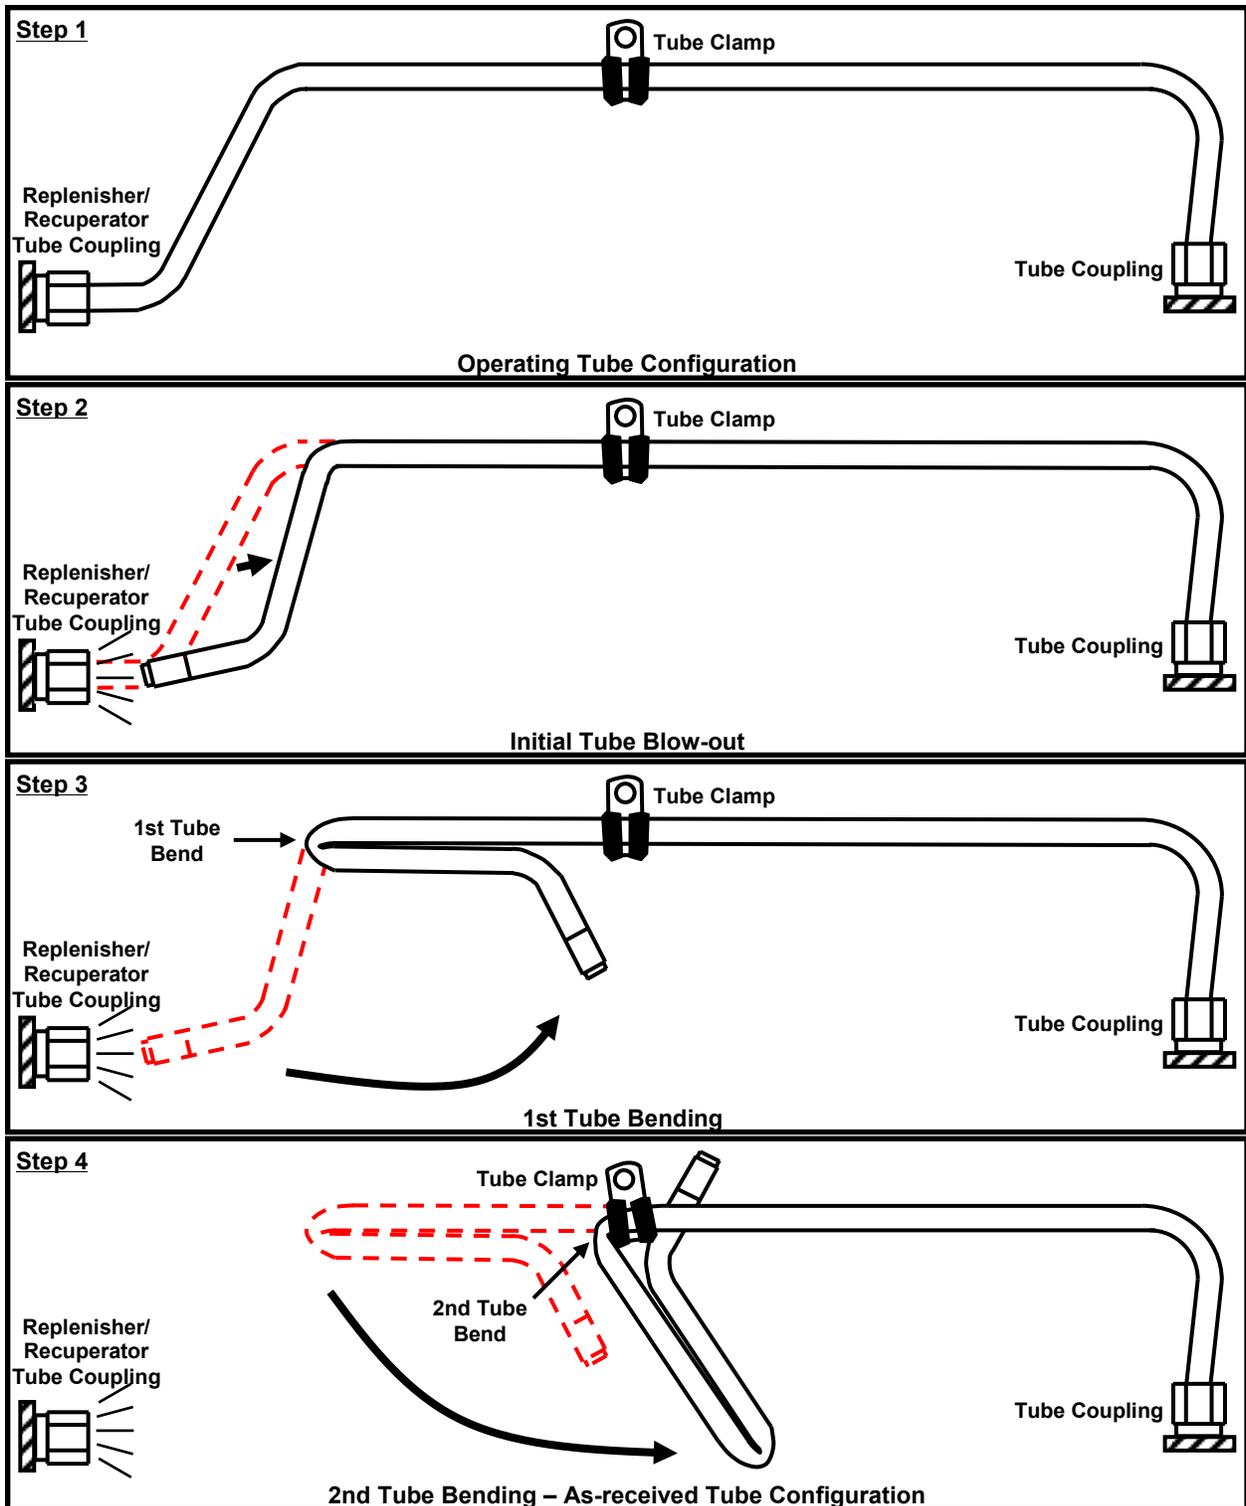
The failure of hydraulic lines is usually either from a pullout of the tubing or a tubing burst, if the burst pressure is exceeded. In accordance with ASTM-A-254 (1), tubing of the size used on the M174 recoil unit should have a proof pressure of ~5.5 ksi. Commercial calculations for the burst pressure of this tubing yield ~10 ksi. A diagram of the likely failure steps for the replenisher/recuperator line can be observed in figure 23.

Figure 23. Likely failure steps for the replenisher/recuperator line.

The failure of the replenisher/recuperator line on the M174 recoil unit was due to a line pressure event greater than its design pressure. There was no indication that the joint was installed improperly or that there was anything wrong with the materials involved. The ferrule on the failed end was likely flared before installation and was in place only slightly closer to its respective tubing end when compared to the joint on the non-failed end of the tube (via measurements in figures 7–16). Although nonstandard, the joint design was similar to a simple compression joint. This type of joint allows the tubing to slip out of the ferrule and away from its fitting when a given pressure is exceeded. If the joint had been of the flare type, it is likely that the joint would have held, but it might have induced a burst of the line itself, if the maximum burst pressure was exceeded. The cause of the high pressure event remains unknown.

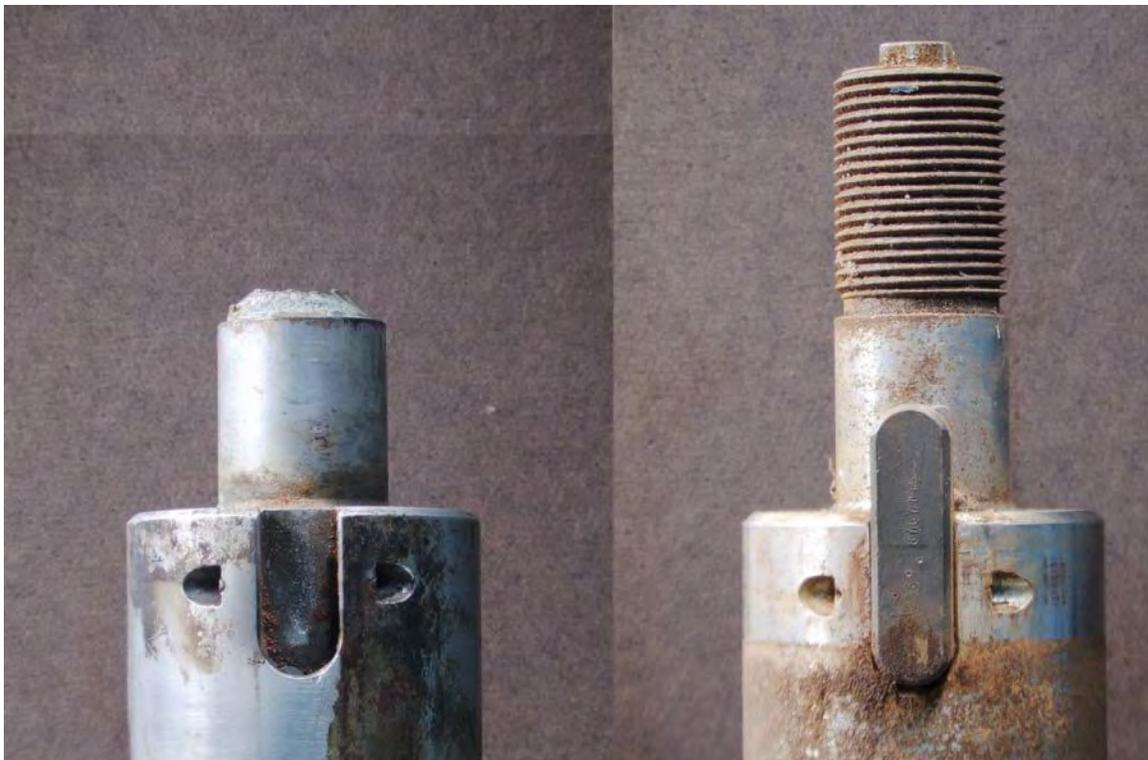
Coincidentally, this area is near the exit of the Mk-15 primer cartridge when fitted and locked into the interior bore of the spindle. This relationship can be observed via the simplified schematic in figure 25. From a design perspective, it is likely less than optimum that the exit from the primer charge is located upstream and adjacent to the machined step for the threads. A side-by-side comparison between the failed spindle and an intact example can be viewed in figure 26.

Figure 26. Side-by-side comparison between the failed and an intact spindle.

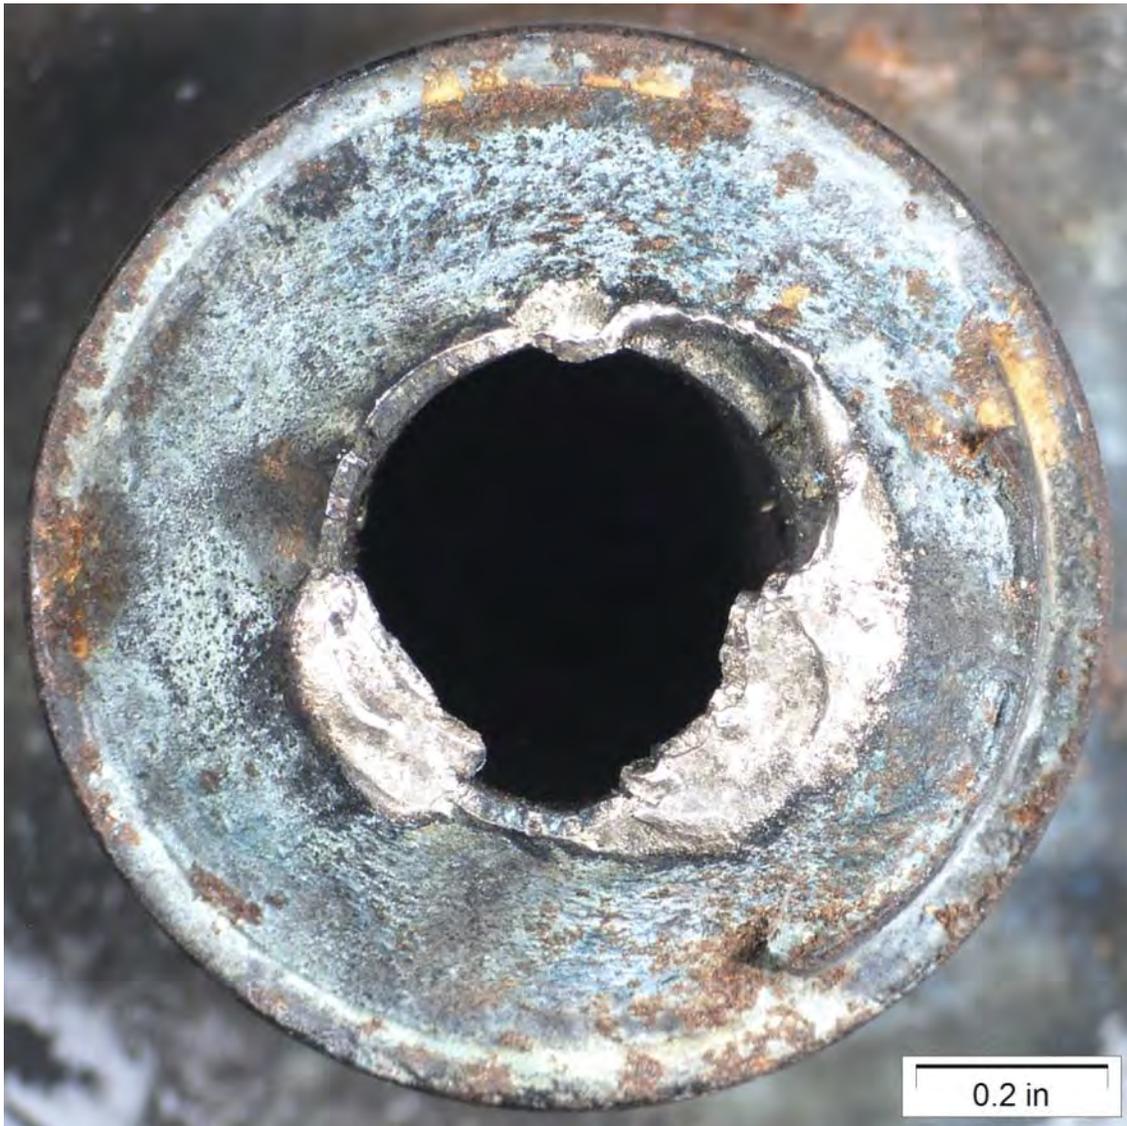
The as-received fracture surface can be observed in figure 27. This figure shows some flash rust (orange/brown), residue from primer and/or main propellant wash (blue/green), and three marred metal areas (shiny metallic color) where the fracture was smashed against another hard metal surface. This likely occurred on the second shot during the event against the missing mating fracture half, as this marred surface was well protected inside the recesses of the breech carrier after the catastrophic failure. Greater detail of these marred surfaces and the surface of a circumferential radial crack are presented in figure 28. The figures show considerable hot gas wash over the surface from the primer and main propellant charge. These residues were confirmed through laser induced breakdown spectrometry (LIBS).

Figure 27. As-received spindle fracture surface.

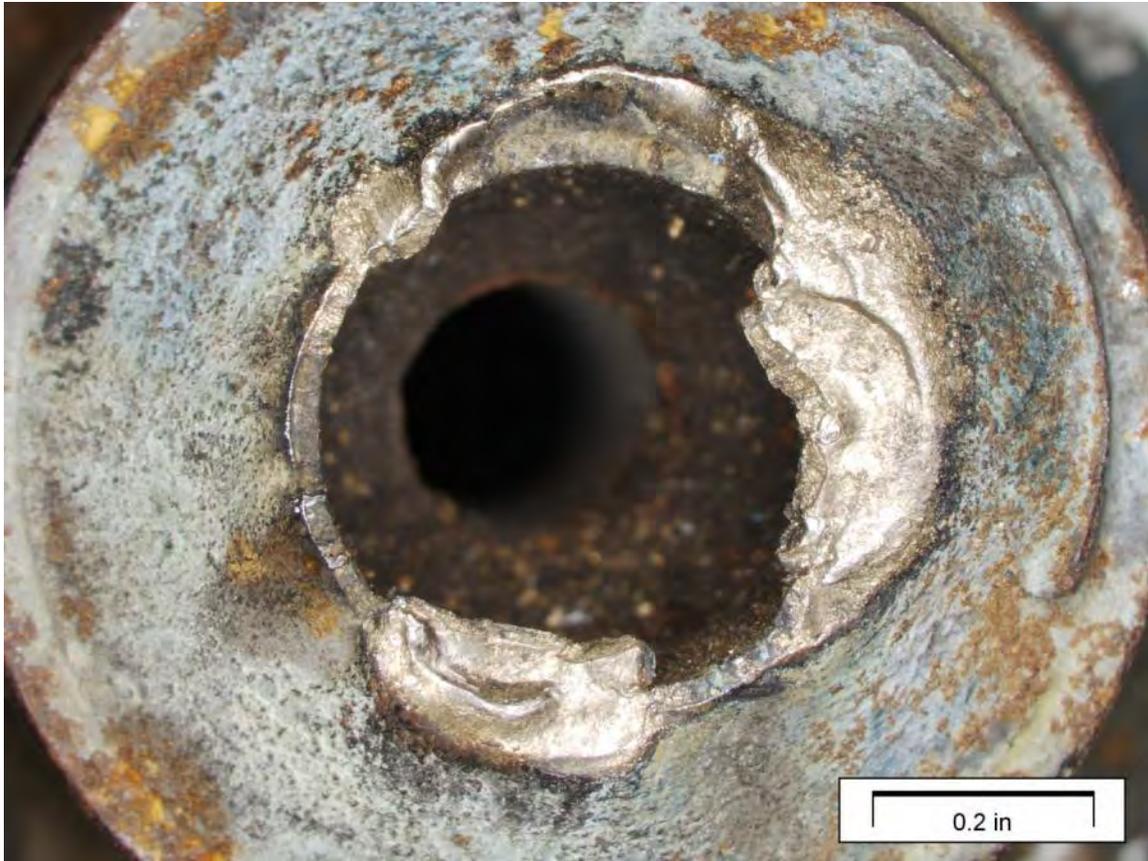
Figure 28. Greater detail of the marred areas and radial crack from the interior.

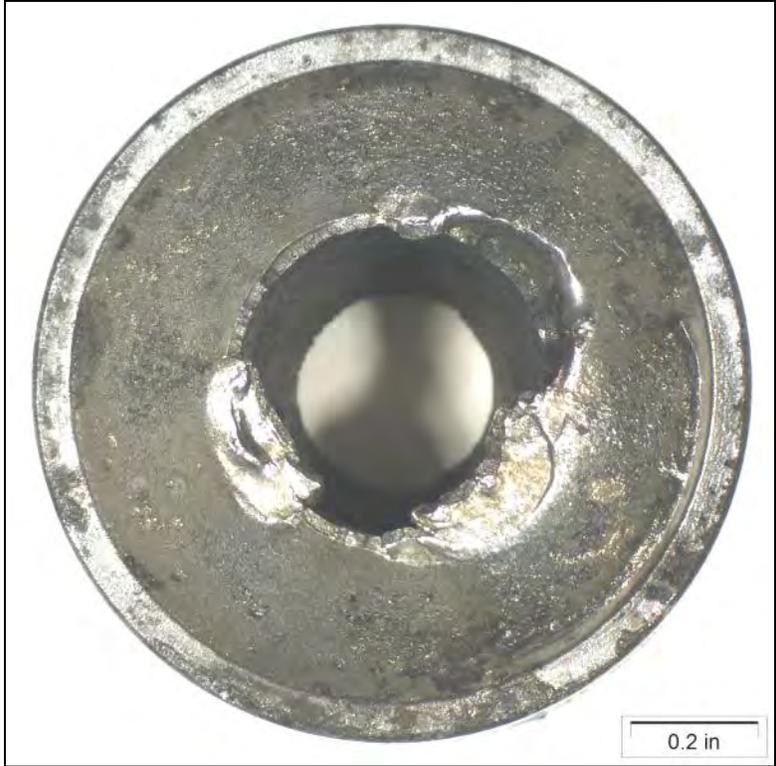
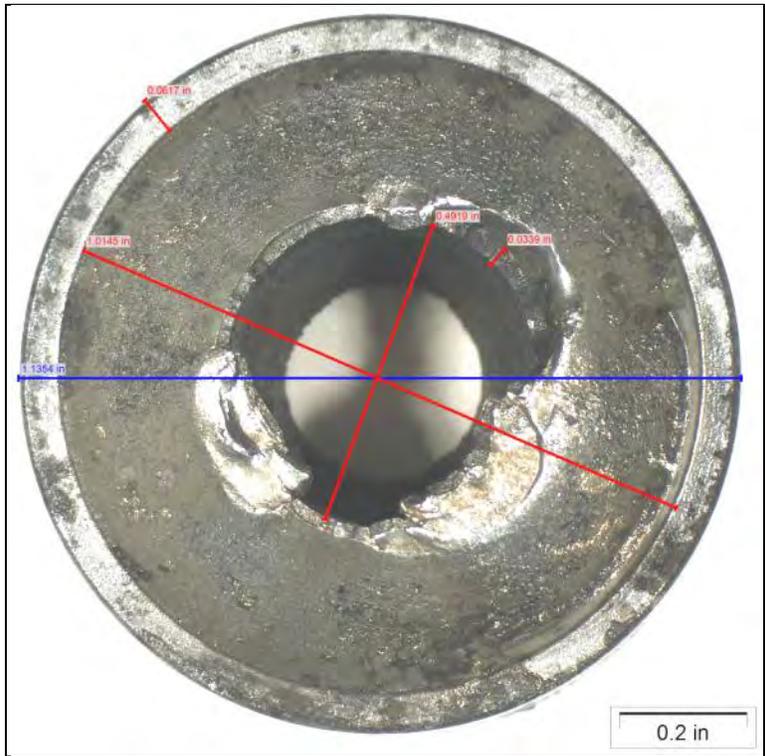
After the LIBS analysis, the surfaces were delicately cleaned to provide a clearer picture of the fracture morphology. The cleaned surface is represented in figure 29 and with dimensions applied in figure 30. After this cleaning, it became obvious that the circumferential radial crack originated on the interior bore of the spindle. Oblique lighting techniques were applied to facilitate showing the radial cracks with more detail. Four views of the interior surface taken at 90° rotations are presented in figures 31–34. Enhanced contrast images of these areas are presented in figures 35–38 to demonstrate the extent of the cracking. This area is normally covered with chromium plating to prevent this kind of erosion and cracking, as shown in the schematic of figure 25. However, the enhanced corrosion protection of chromium over steel does not last forever, and once it is depleted, erosion and cracking of the steel ensues by a hydrogen-assisted stress corrosion cracking mechanism. The “hydrogen assisted” part of the mechanism is related to the hot gas propellant wash products forming gaseous hydrogen that is then absorbed by the steel, embrittling it. There was a great deal of corrosive action evident from the hot gas propellant wash products on the fracture surface.

Figure 29. Cleaned spindle fracture surface.

Figure 30. Cleaned fracture surface with dimensions.

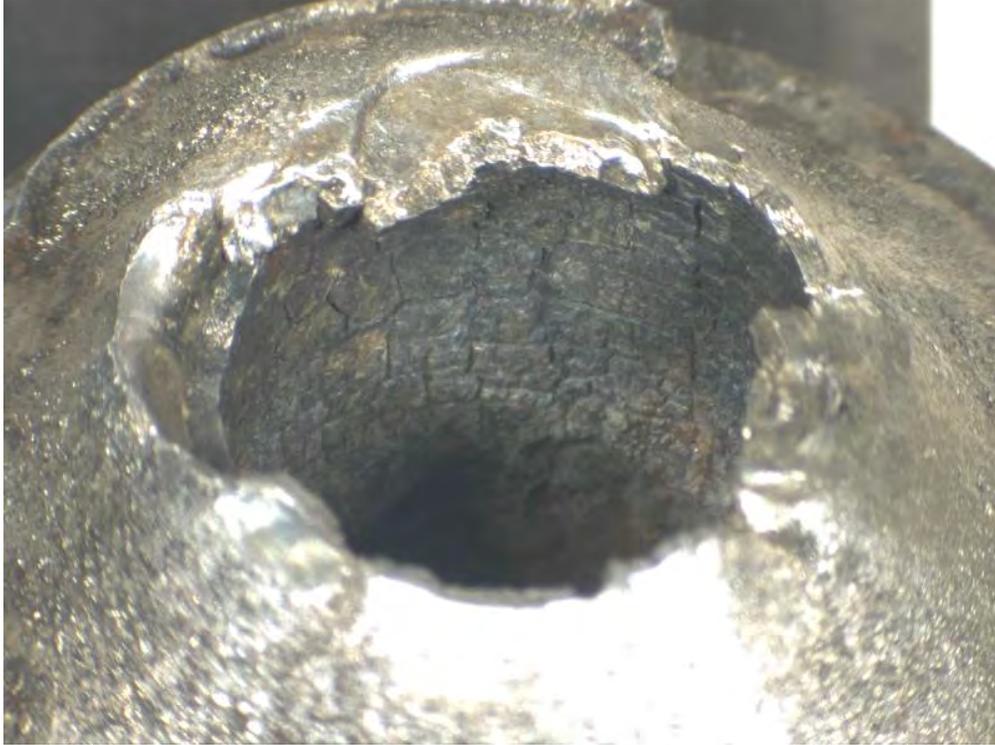
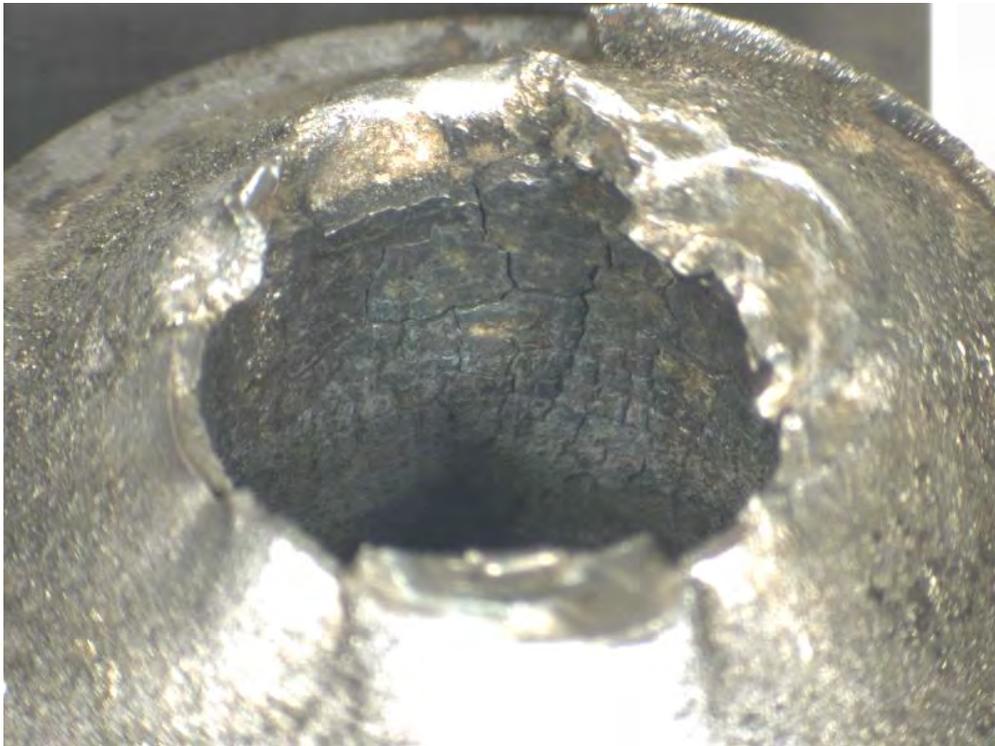
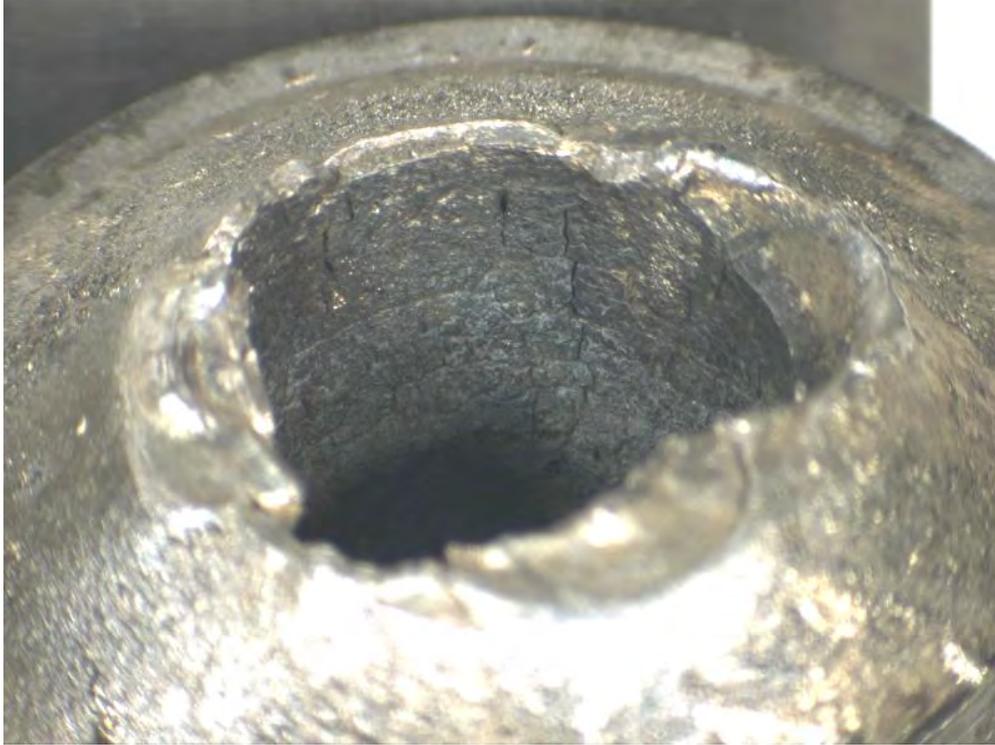
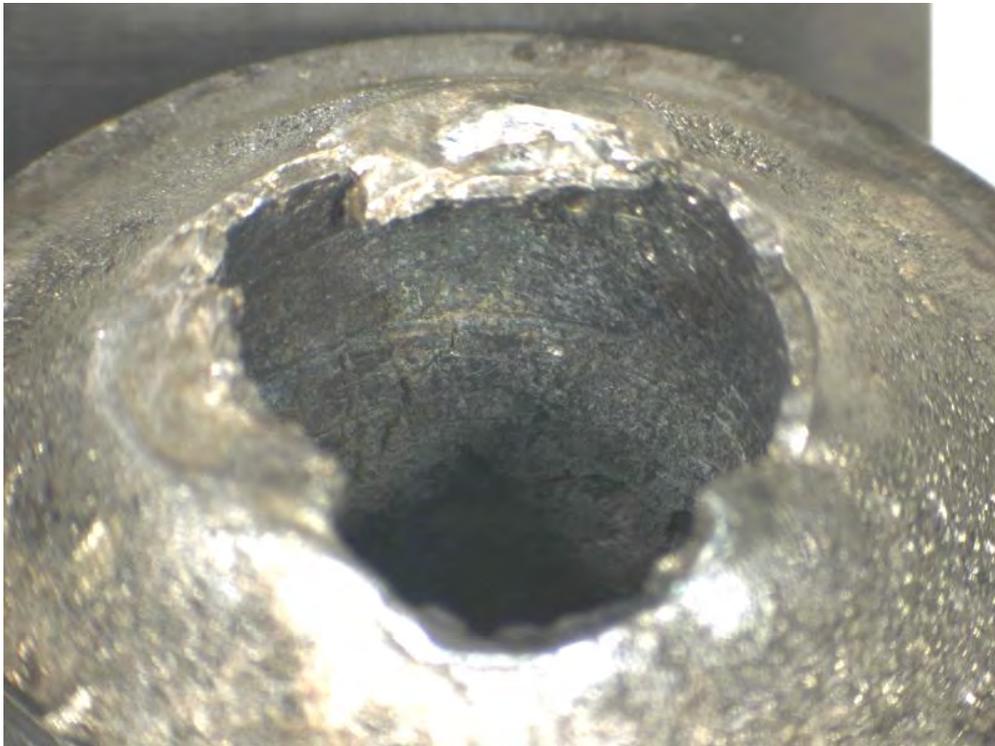
Figure 31. Interior bore of the spindle showing cracks.

Figure 32. Interior cracked bore in figure 31 plus a 90° rotation.

Figure 33. Interior cracked bore in figure 32 plus a 90° rotation.

Figure 34. Interior cracked bore in figure 33 plus a 90° rotation.
