**Investigation of Failed Components from a 7-in
High Altitude Research Program (HARP) Cannon**

ARL-TR-5814

November 2011

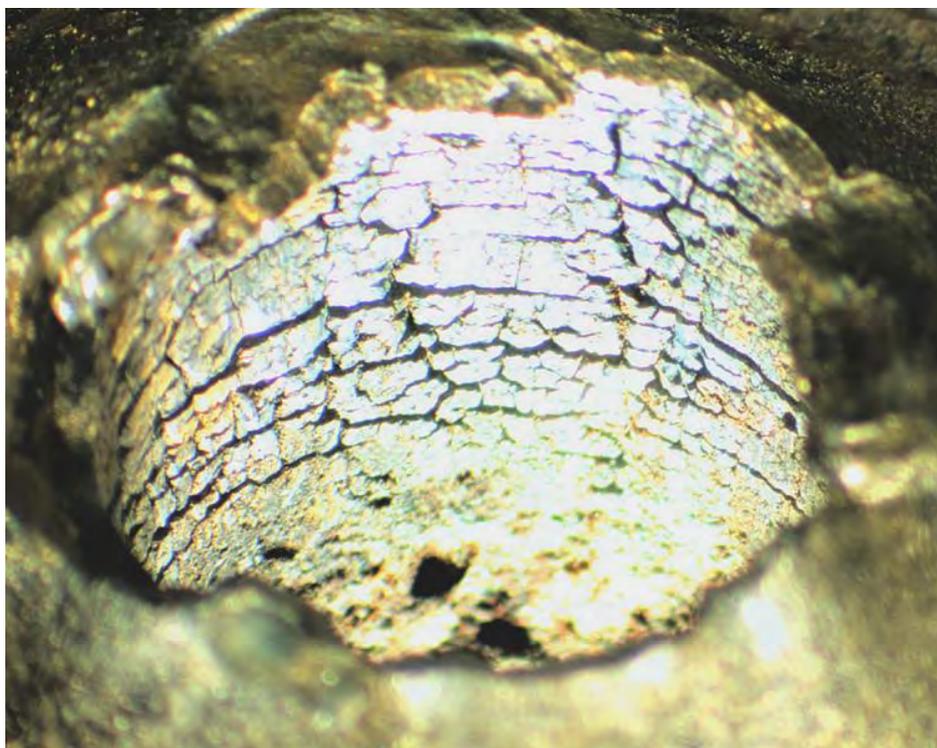
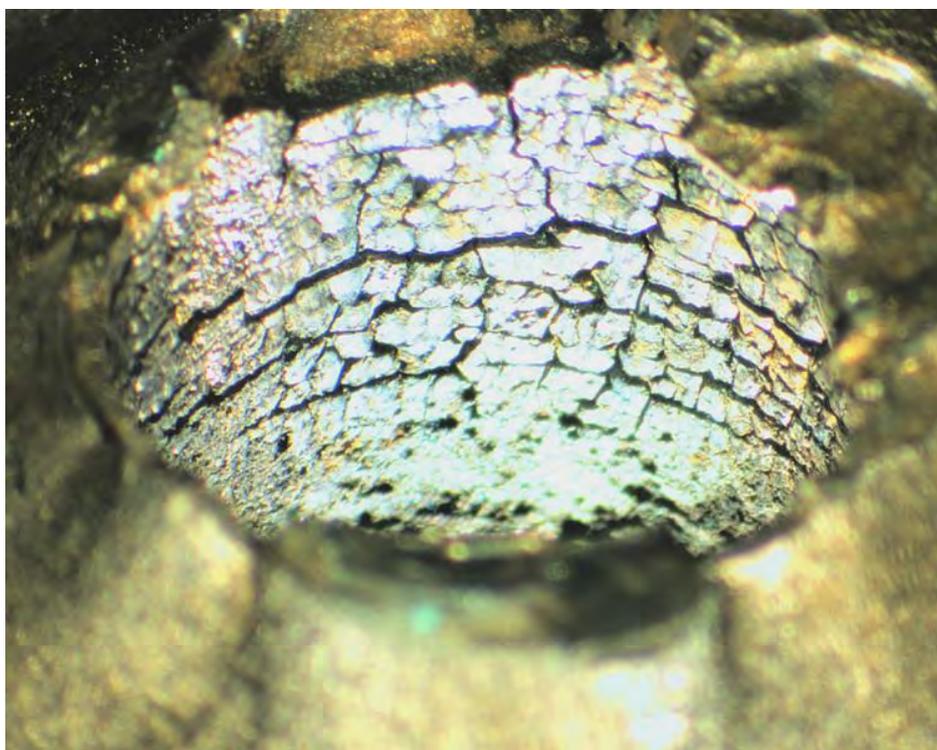
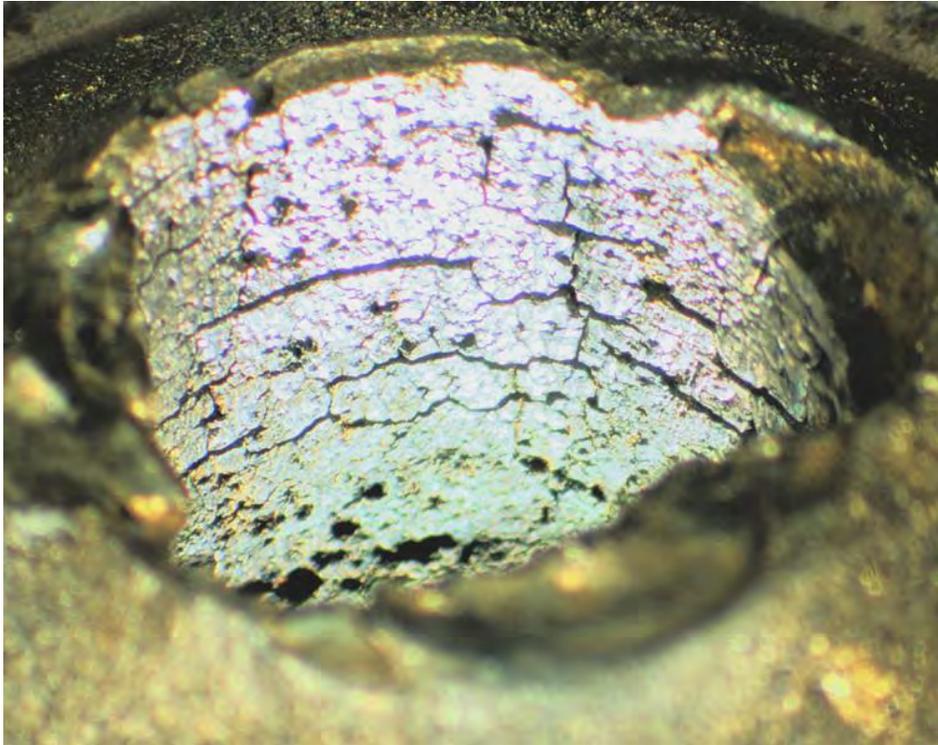
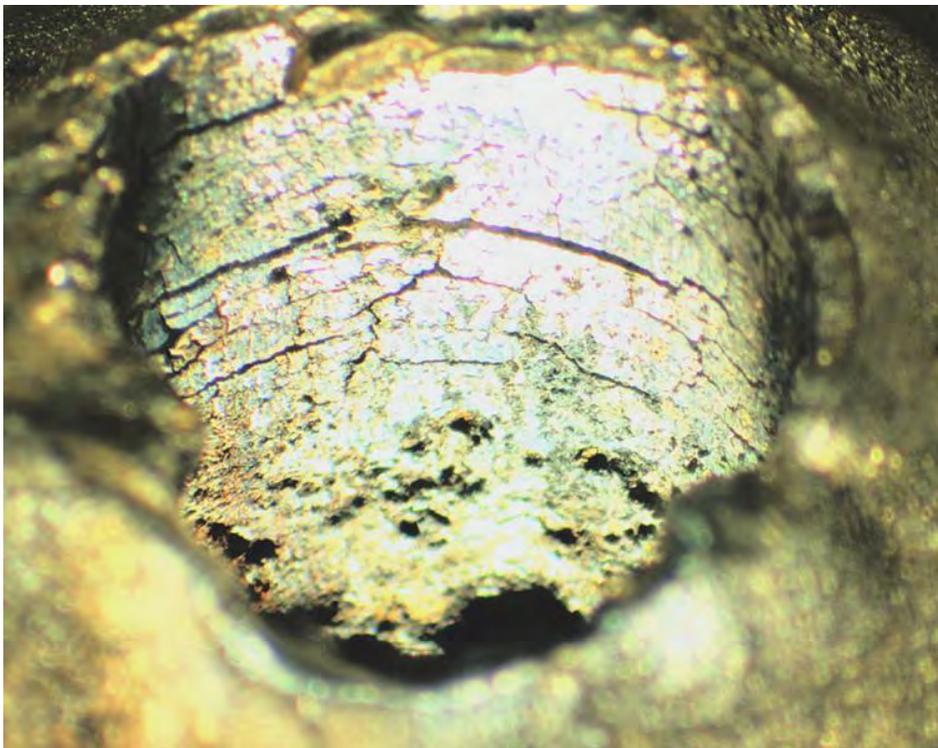
Figure 35. Enhanced contrast image of the area in figure 31.

Figure 36. Enhanced contrast image of the area in figure 32.

Figure 37. Enhanced contrast image of the area in figure 33.

Figure 38. Enhanced contrast image of the area in figure 34.

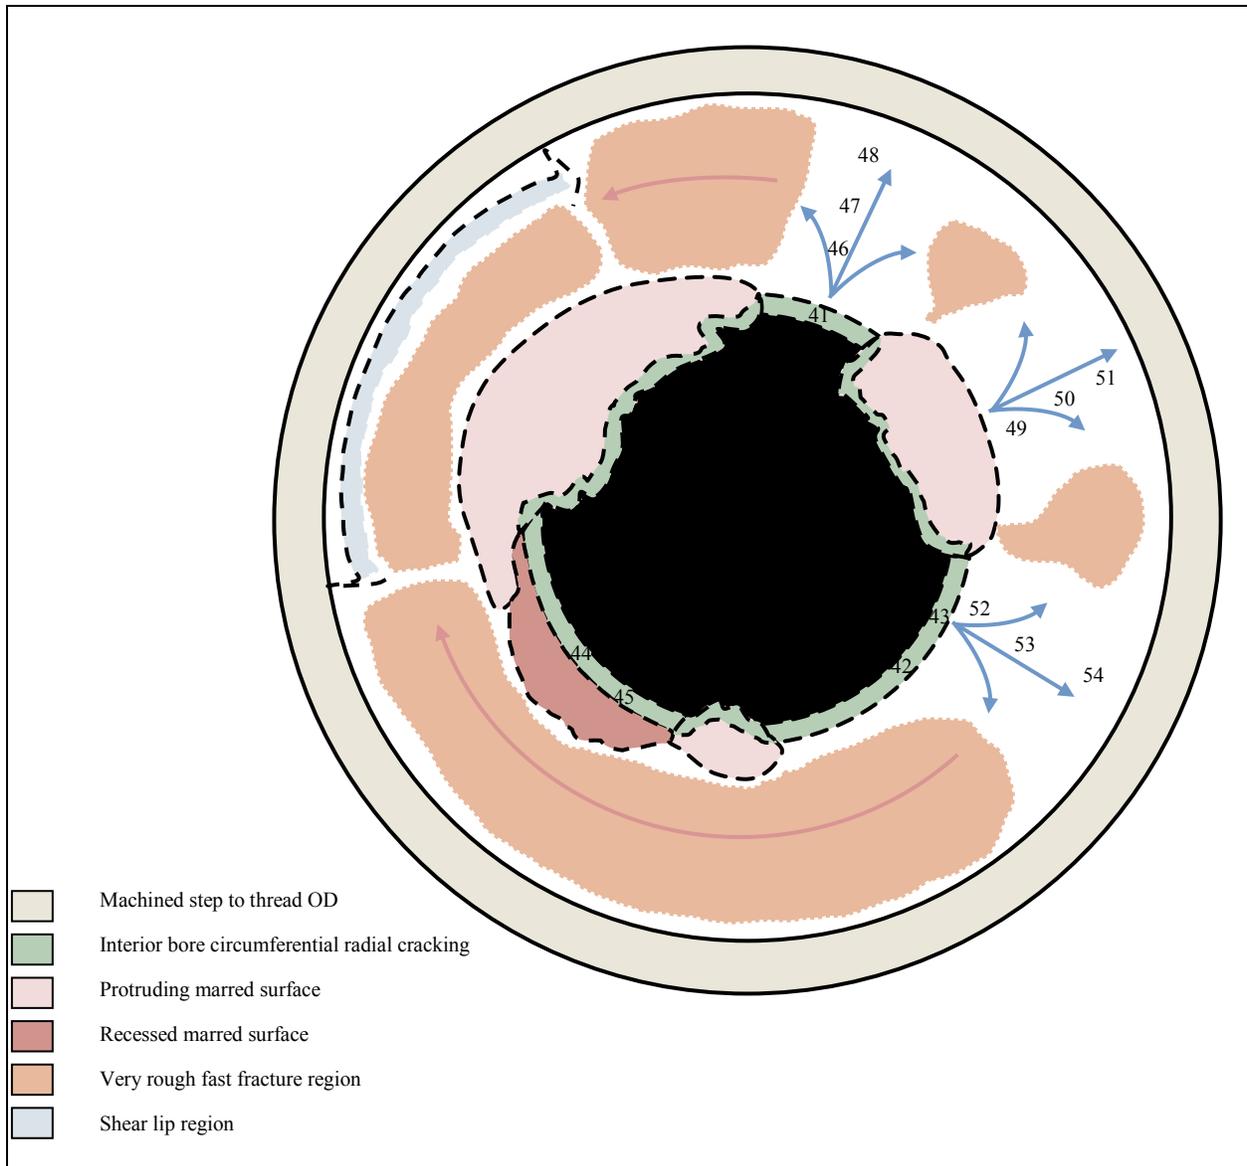
A fracture schematic labeling the details discussed previously is presented in figure 40 for clarity and can be compared with figures 27–39. Figure 40 also shows the areas where the scanning electron microscopy (SEM) images were obtained in the next section.

Figure 40. Failed spindle fracture schematic.

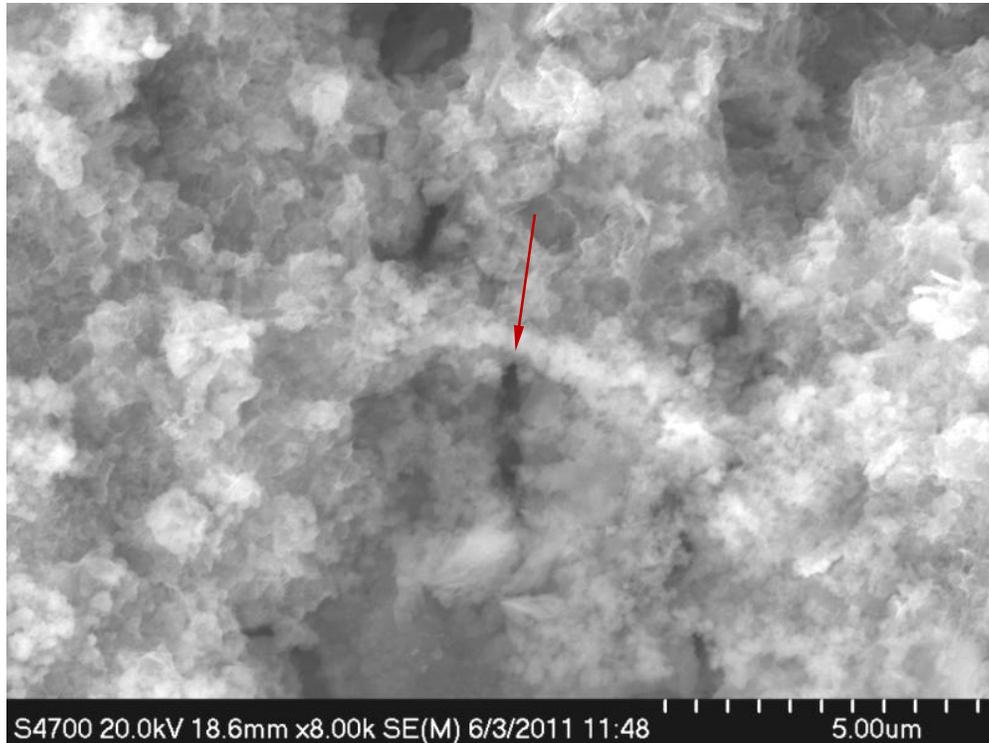
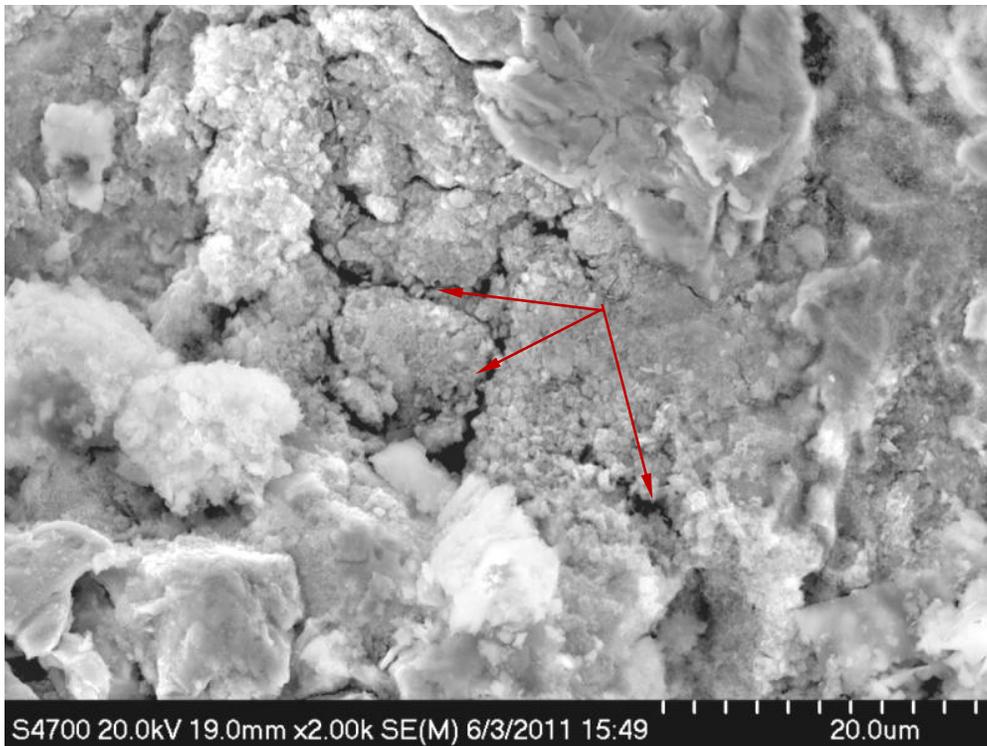
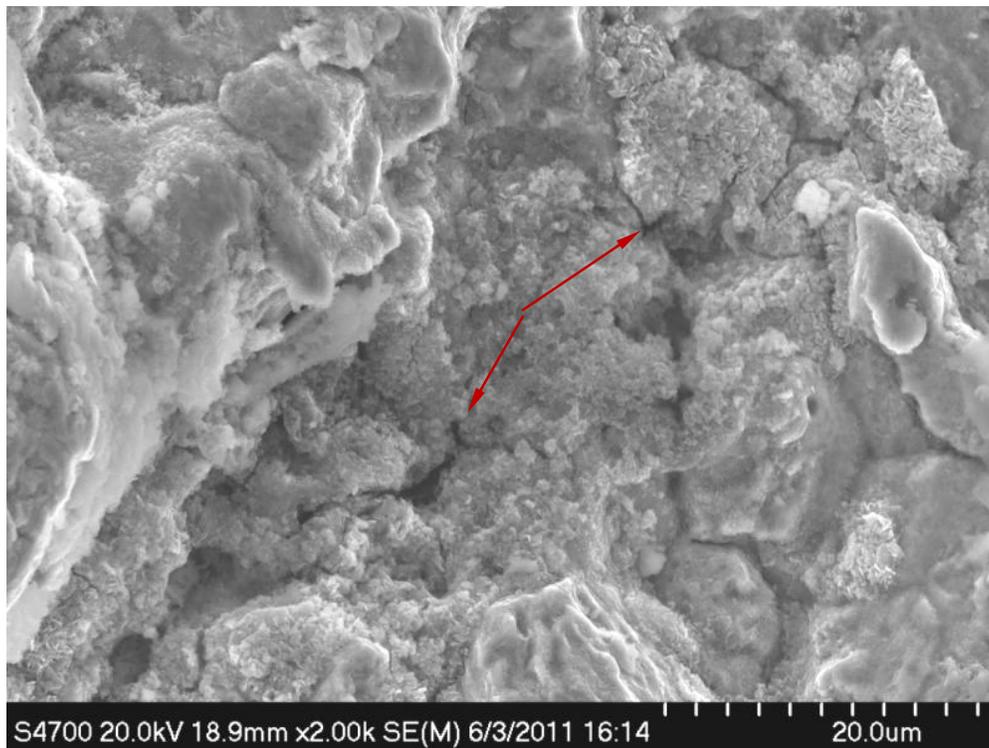
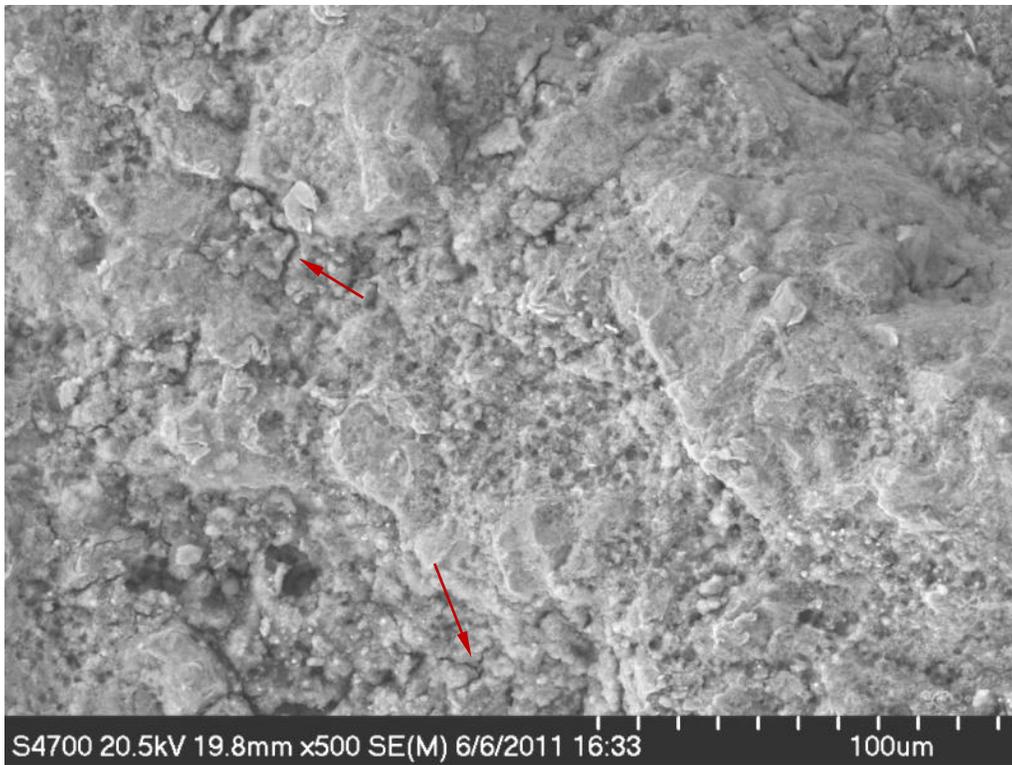
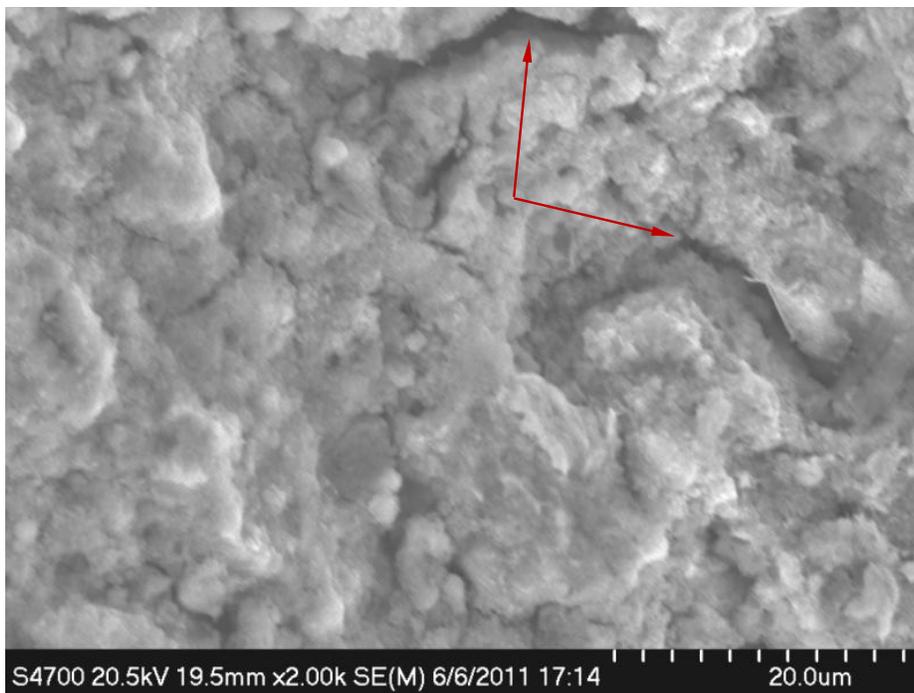
SEM was then conducted on the fracture surface to verify the fracture morphology and confirm the failure mechanism. The surface of the interior bore circumferential radial crack was examined. Figures 41–45 show this surface at various magnifications and demonstrate both the corrosive nature of the mechanism and the intergranular characteristics of the hydrogen effects. The intergranular cracks are denoted with red arrows in the photos.

Figure 41. Crack from bore showing stress corrosion cracking (SCC) and intergranular cracks, area 41.

Figure 42. Crack from bore showing SCC and intergranular cracks, area 42.

Figure 43. Crack from bore showing SCC and intergranular cracks, area 43.

Figure 44. Crack from bore showing SCC and intergranular cracks, area 44.

Figure 45. Crack from bore showing SCC and intergranular cracks, area 45.

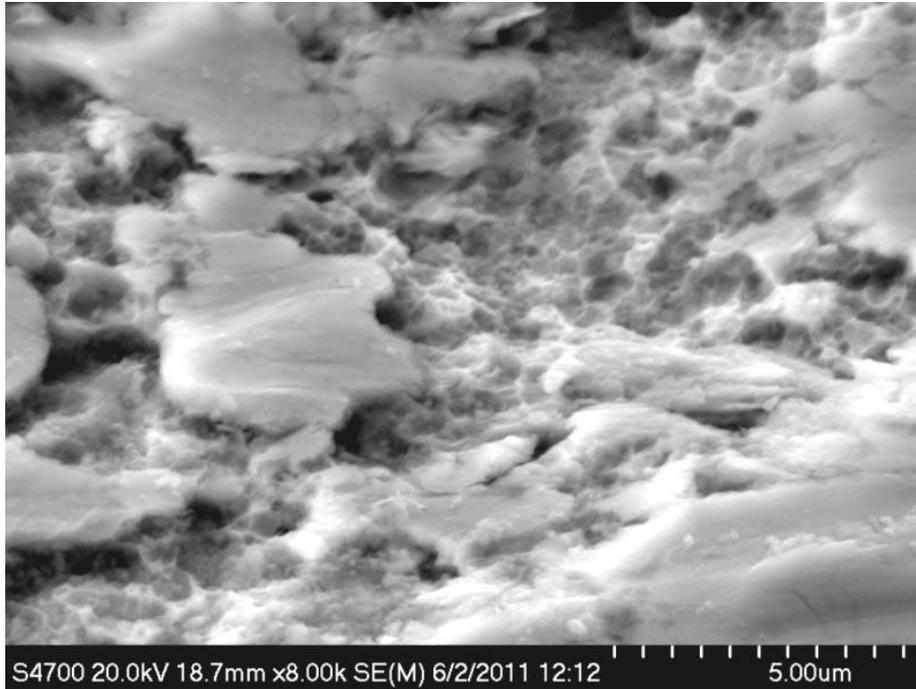
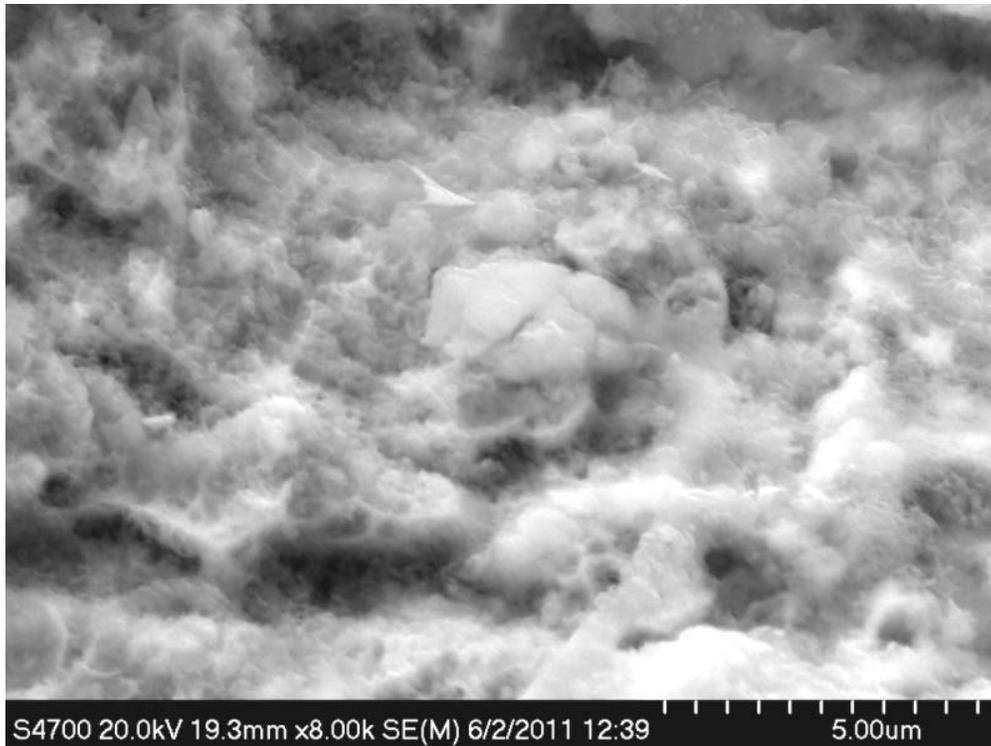
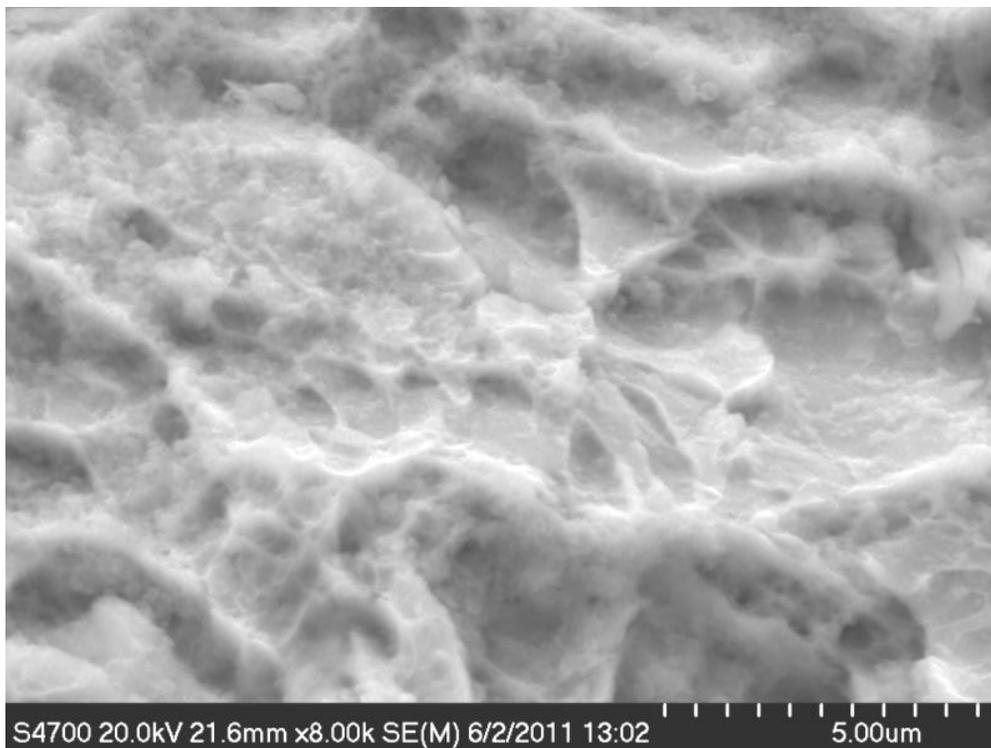
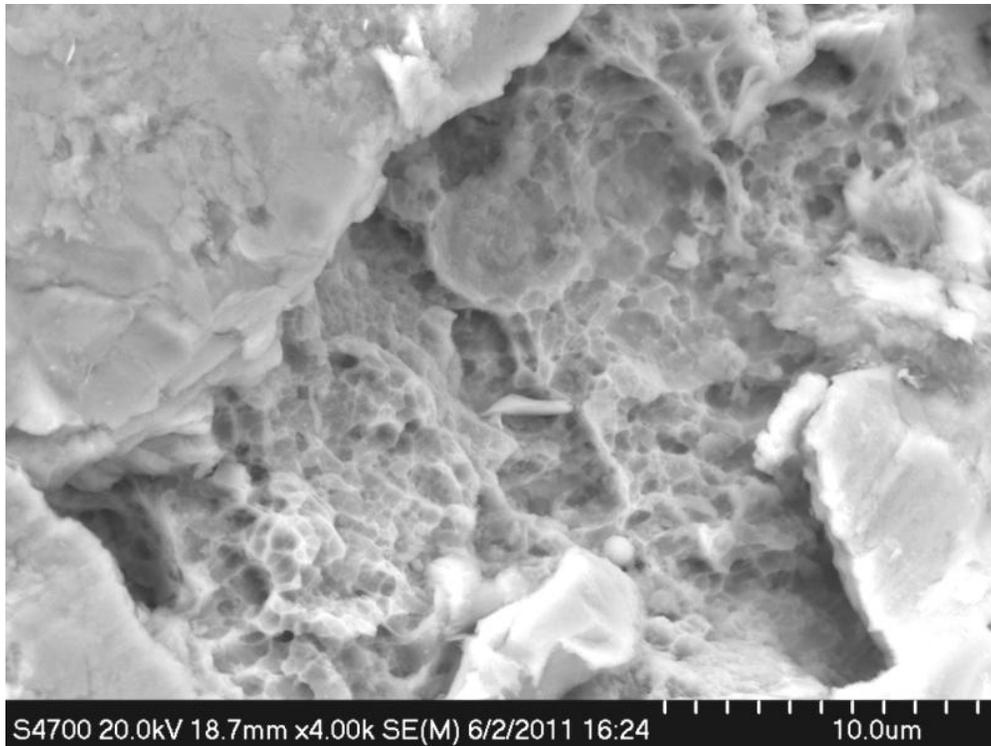
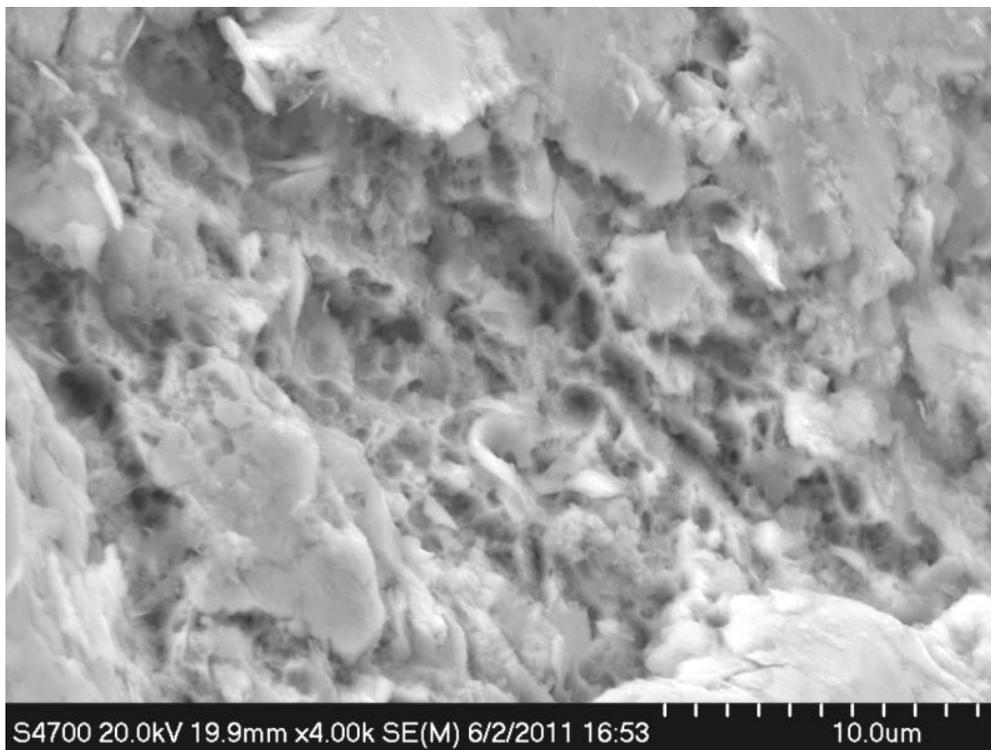
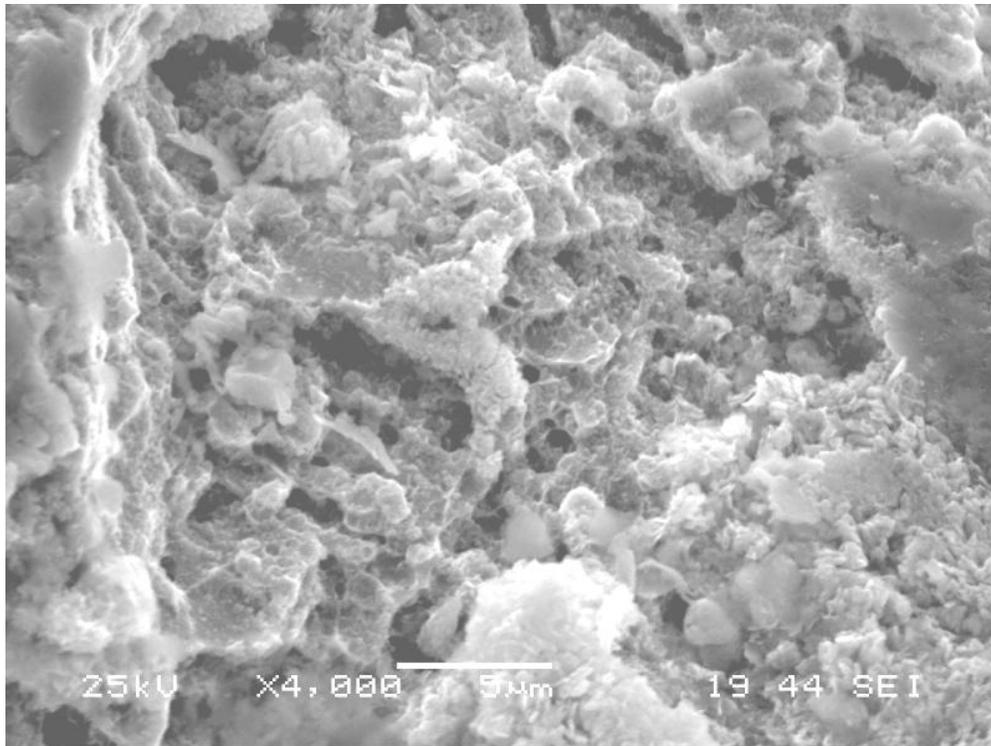
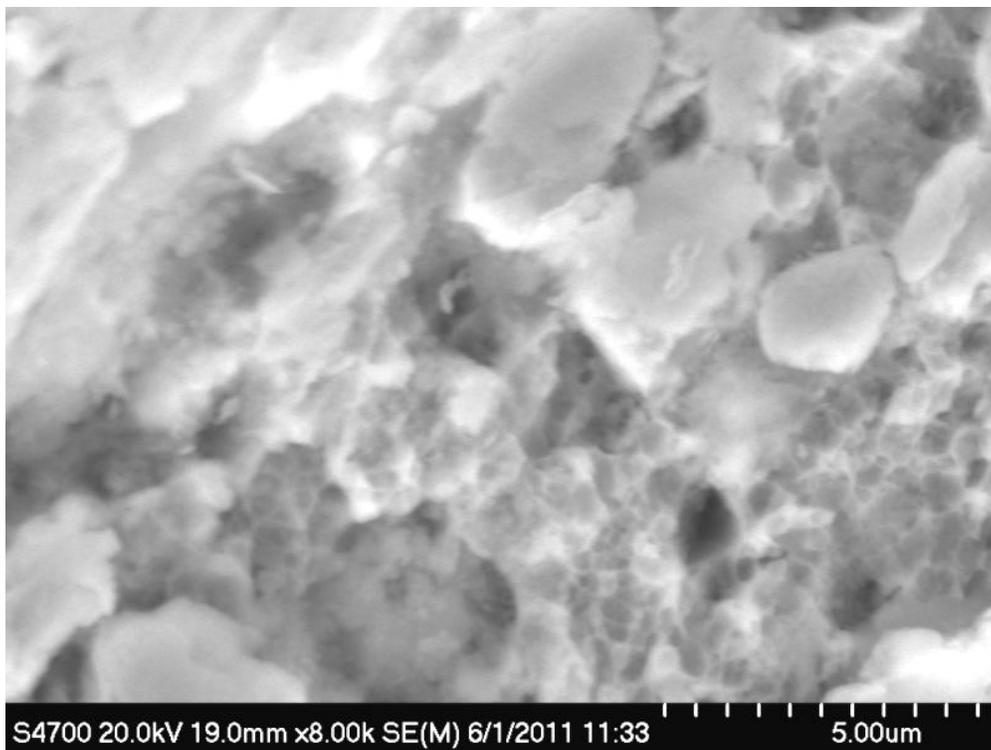
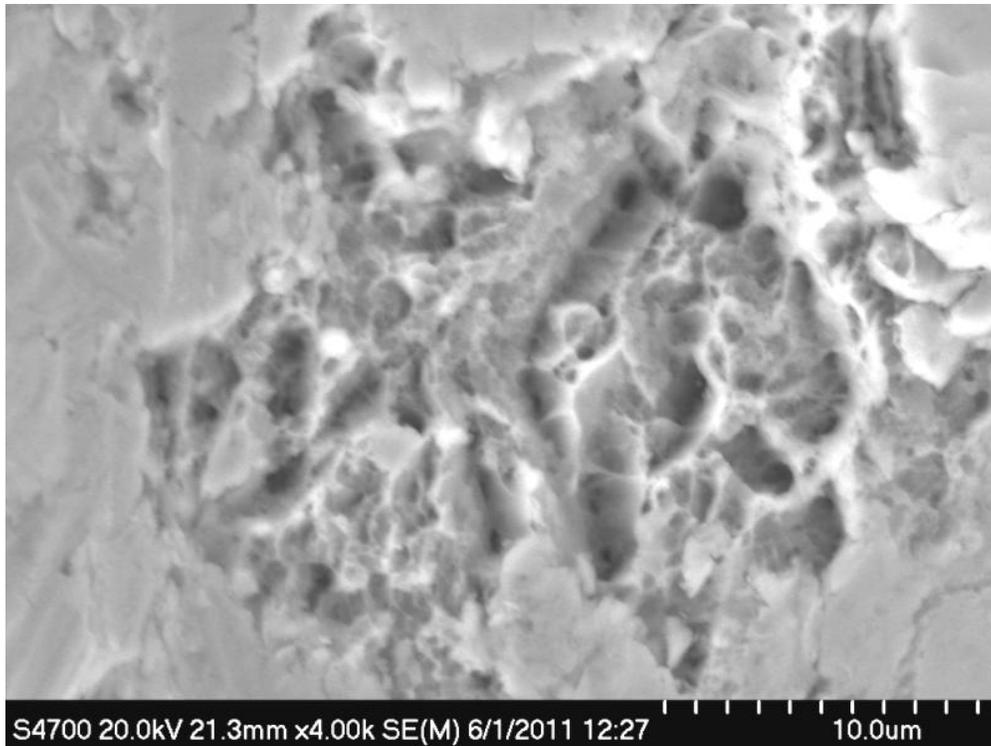
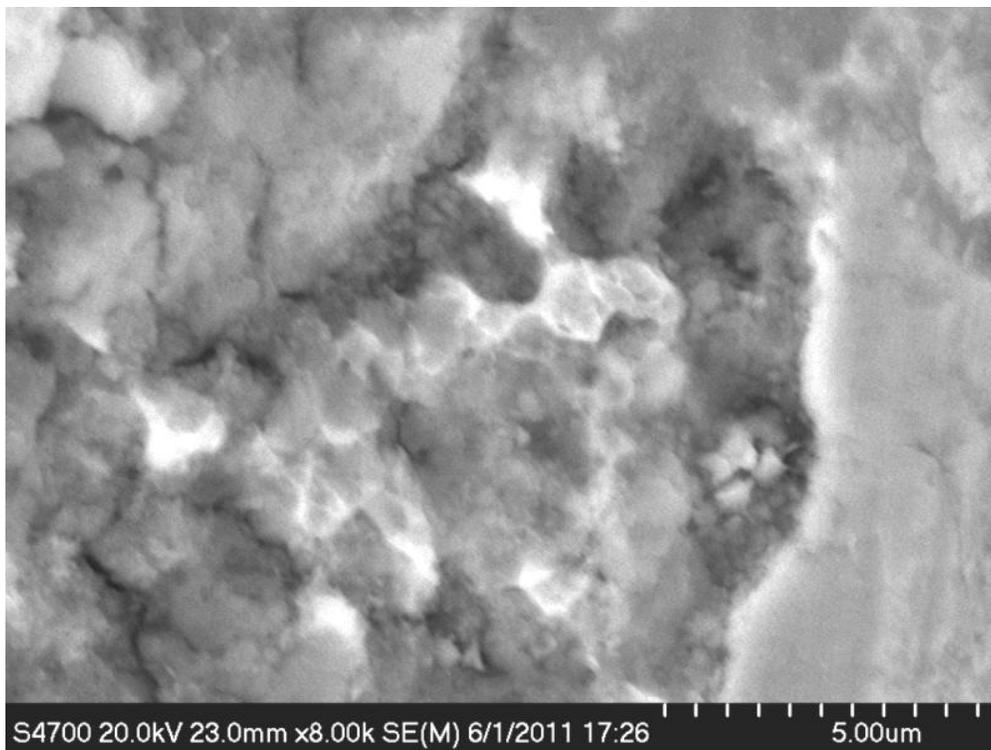
A linear series of images was then obtained from each of the three fracture origin regions. The minuscule changes in fracture morphology can be observed as the crack progresses in each of the three areas. Figures 46–54 show these three areas, respectively.

Figure 46. Fracture morphology in area 46, as depicted in figure 40.

Figure 47. Fracture morphology in area 47, as depicted in figure 40.

Figure 48. Fracture morphology in area 48, as depicted in figure 40.

Figure 49. Fracture morphology in area 49, as depicted in figure 40.

Figure 50. Fracture morphology in area 50, as depicted in figure 40.

Figure 51. Fracture morphology in area 51, as depicted in figure 40.

Figure 52. Fracture morphology in area 52, as depicted in figure 40.

Figure 53. Fracture morphology in area 53, as depicted in figure 40.

Figure 54. Fracture morphology in area 54, as depicted in figure 40.

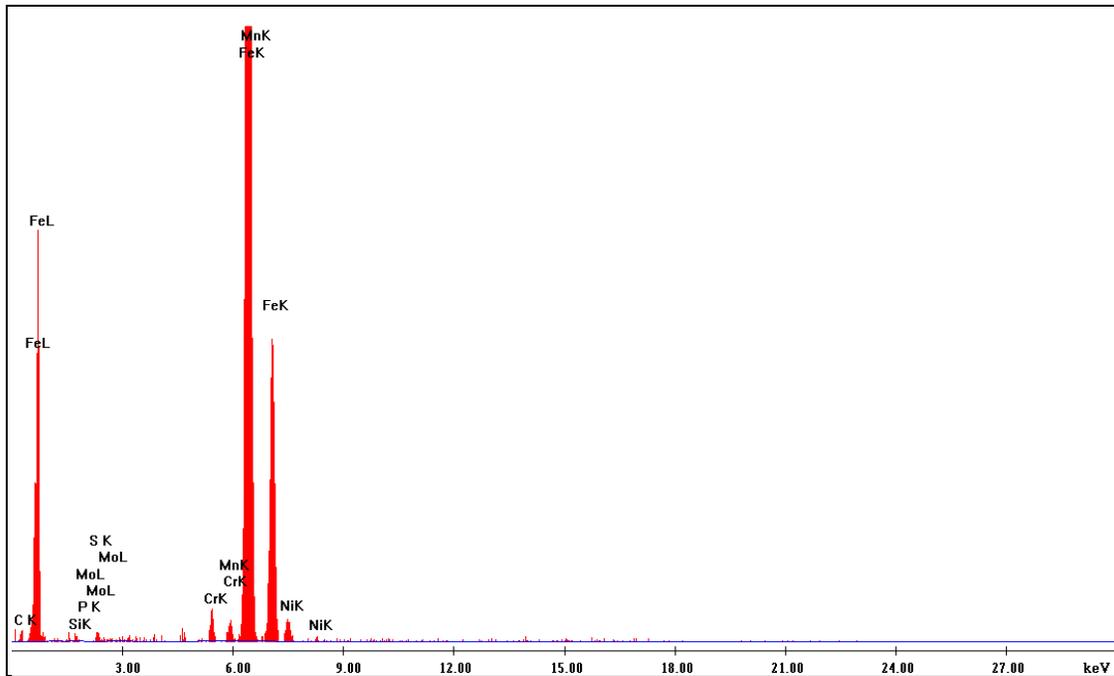
EDS was performed to verify the chemical constituency of the 4340 steel alloy. This material was originally procured under MIL-S-5000 (3), which has since been cancelled and superseded by SAE-AMS-S-5000 (4). The chemical composition conformed to the requirements within the specification. The results of the EDS analysis are presented in figure 55 and in tabular form in table 3. EDS also confirmed that the chromium layer on the interior bore had been eroded away. There were no traces left on the interior surface. The chromium plating was confirmed to exist on the exterior surface in the failed area.

Figure 55. EDS spectrum obtained from the failed spindle material.

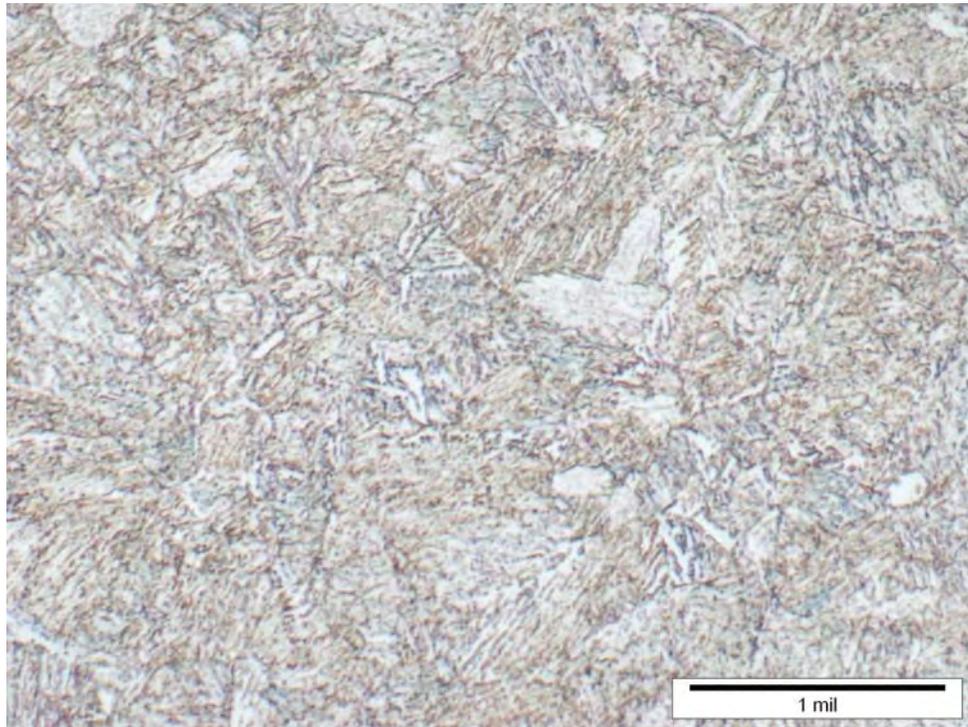
The microstructure of the spindle was analyzed by polishing and nital etching a cross-sectional mount obtained from a radial cut near the fractured end. Figure 56 shows the cross section revealing the etched microstructure. The structure consists of primarily tempered martensitic lathes and is consistent with that expected for this alloy.

Figure 56. Microstructure of the failed spindle etched with nital.

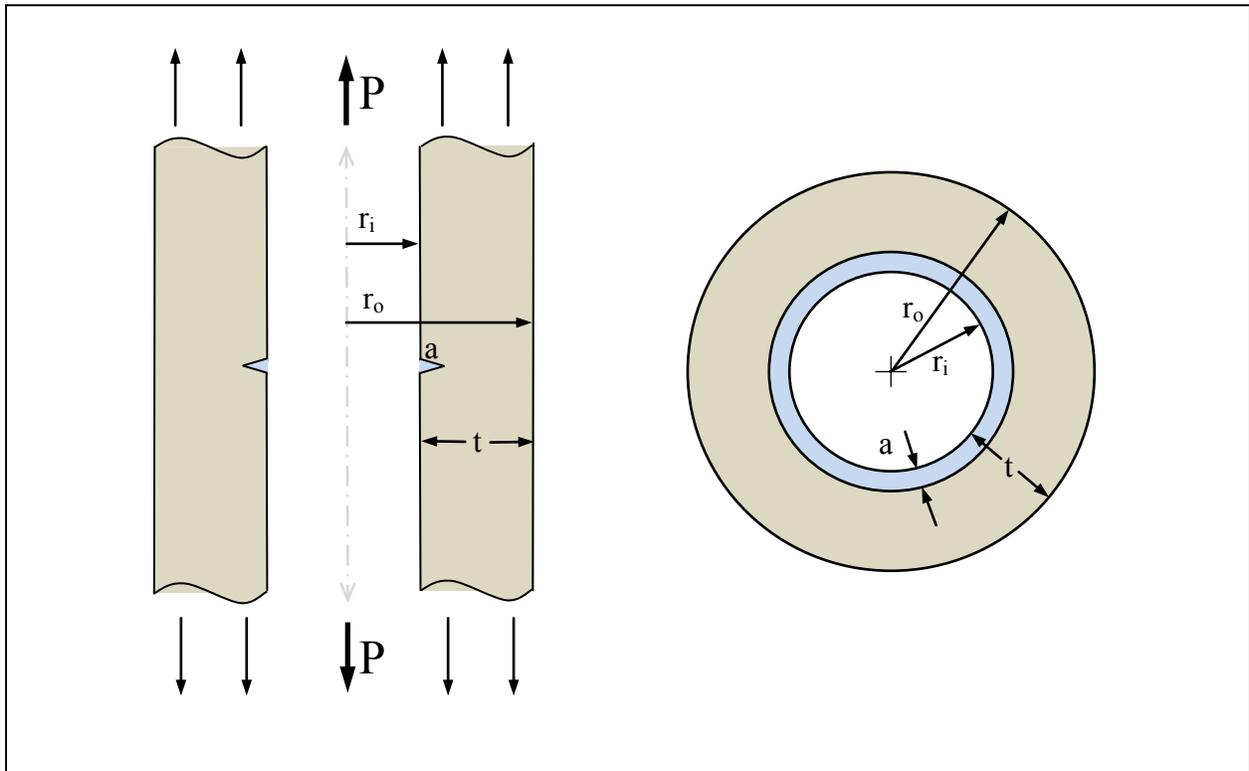
The evidence in the failure of the HARP breech spindle suggests the component failed most likely under a single load cycle. There was a crack-like defect along the circumference of the interior bore in the radial direction. When a component fractures in this manner, the failure is determined by the material property called fracture toughness, or K_{Ic} . The geometry in the failed region is similar to a tube with the radial circumferential crack on the interior wall, as represented by the schematic in figure 57.

Figure 57. Schematic of the loading on the failed breech spindle.
