*Monitoring Completed Navigation Projects Program*

## **Kaumalapau Harbor, Hawaii, Breakwater Repair**

Final report

Under MCNP Work Unit Kaumalapau Harbor, Hawaii, Breakwater Repair

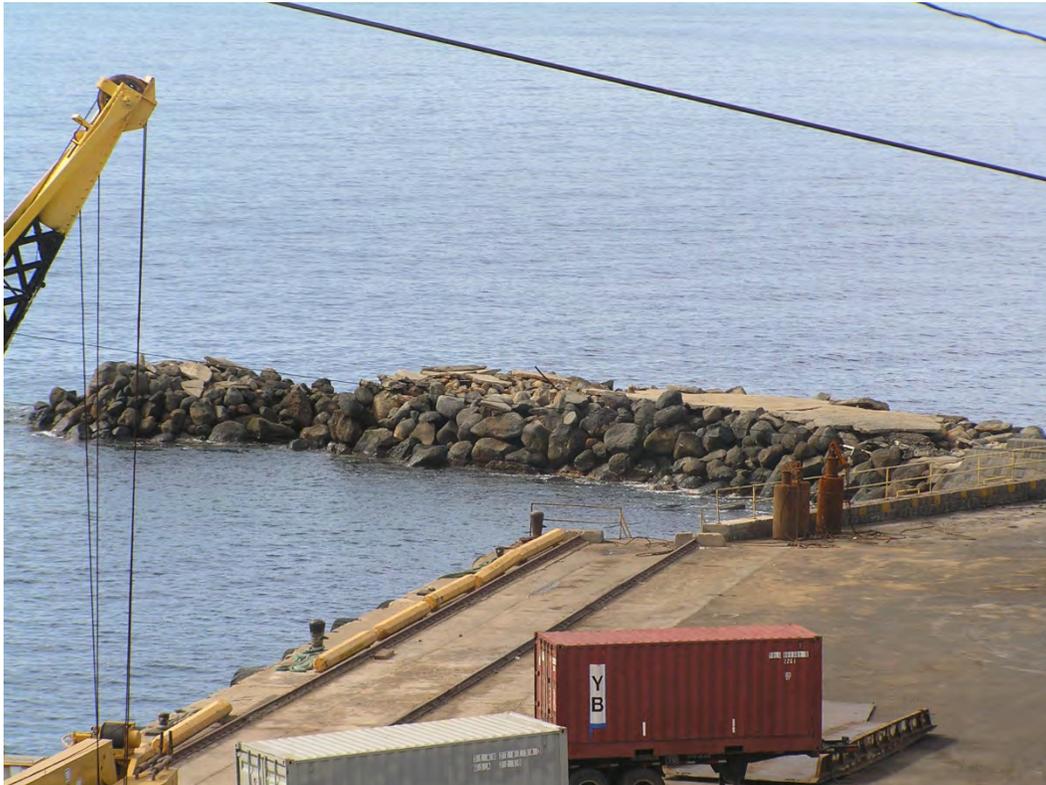
events, and repairs, resulted in a large, broad rubble mound, with a side slope of about 1 vertical on 1.5 horizontal. By the 1990s, the deteriorated condition of the breakwater permitted significant wave energy to reach the pier, resulting in berthed vessel motion that rendered cargo handling and fuel offloading difficult, and at times hazardous or impossible (Figure 1.3).

Figure 1.3. Deterioration of Kaumalapau Harbor breakwater prior to 2007 repair.

With exposure to storms arriving from the south through northwest, Kaumalapau Harbor was closing several times during each winter storm season. These storms had steadily damaged the breakwater structure with a loss of about half of its original 400-ft length. Waves had removed armor stone over the outer 200 ft of the structure to the point where the structure crest elevation was below the MLLW elevation.

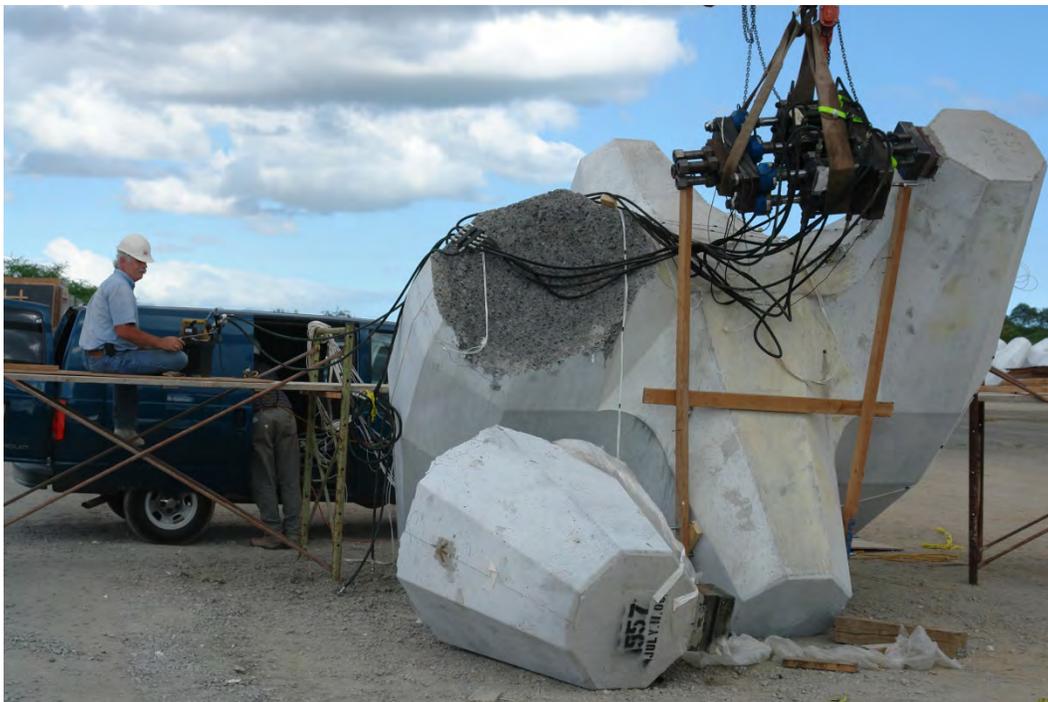
The Core-Loc failed just above the saddle in the upper half of the leg (Figure 5.8). The extreme outer fiber tensile strain on the failure plane occurred at the location of strain rosette 3. The failure plane started at the mid-height of the rosette and traveled in a plane that was at an angle of approximately 35 deg downward from the horizontal until it emerged from the Core-Loc leg on the compression face approximately 14 in. below strain rosette 1.

Figure 5.8. Core-Loc armor unit after testing to failure (O'Neil and Haskins 2008).

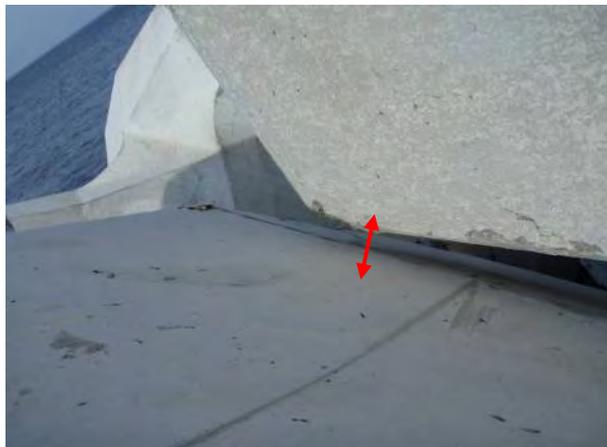
Figure 10.4. Approximately 2-in. gap between armor unit #605 and adjacent unit at Station 0+50 on ocean side trunk (2007 photo). Unit #605 has moved 1.6 in. (4 cm) from 2007-2010 (T-LiDAR).

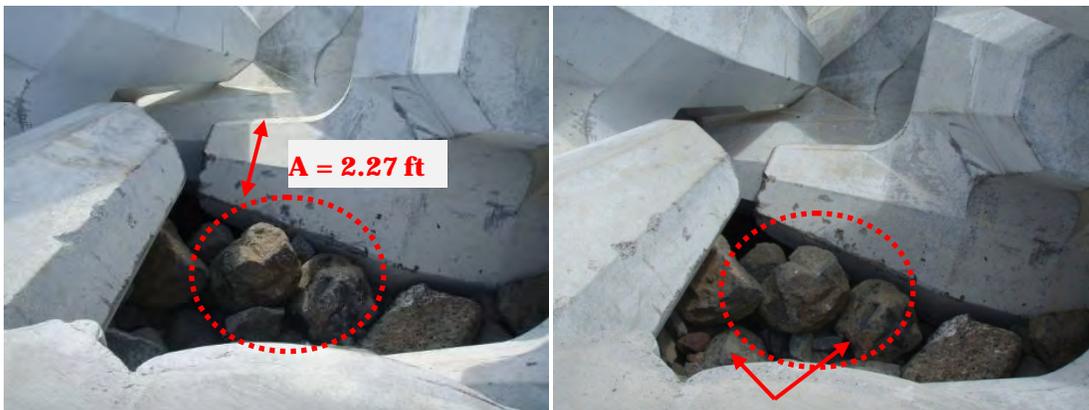
Figure 10.8. 2007 photo of undersized stone between ~0.8- and 2.5-ft diam, near crest on harbor side of breakwater head (left). 2009 photo of same location with noticeable changes including broken stones and additional small stones indicated by arrows (right).

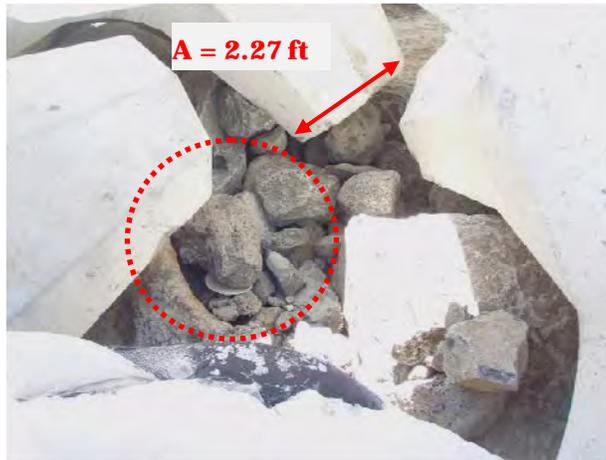
Figure 10.9. Undersize stone between ~0.5- to 2-ft diam, in void between armor layers and concrete cap on harbor side of breakwater head (2010 photo).

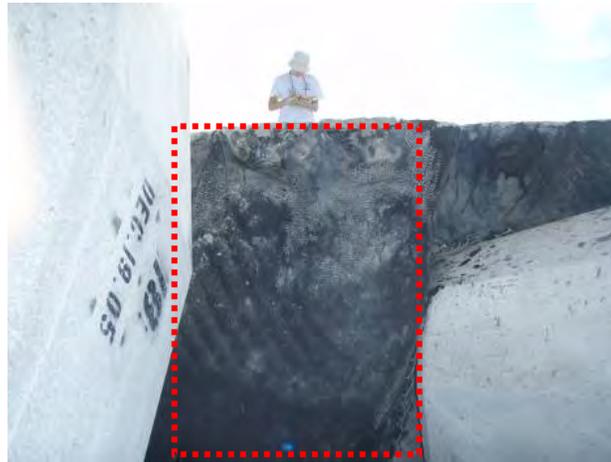
Figure 10.11. Exposed underside of concrete cap at Station -0+28 along ocean side trunk.

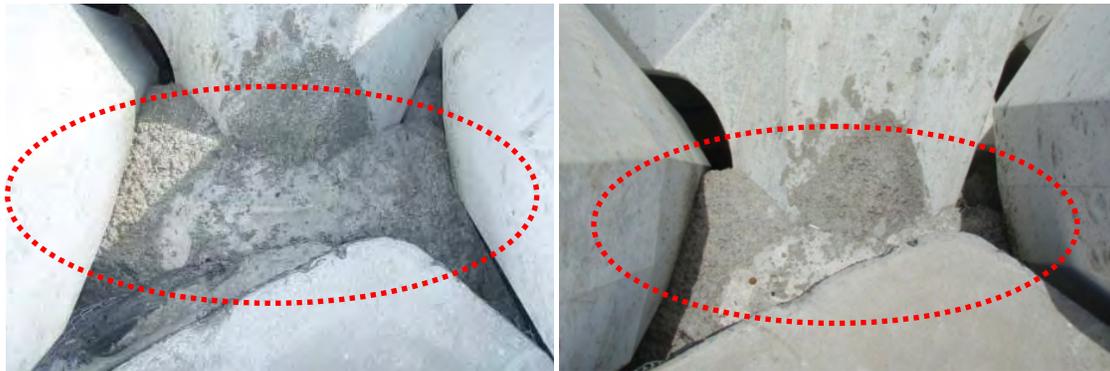
Figure 10.13. Grouted area along harbor side trunk at Station 1+80 (2007, left). Same area appears to have had some weathering and loss of grout (2009, right).

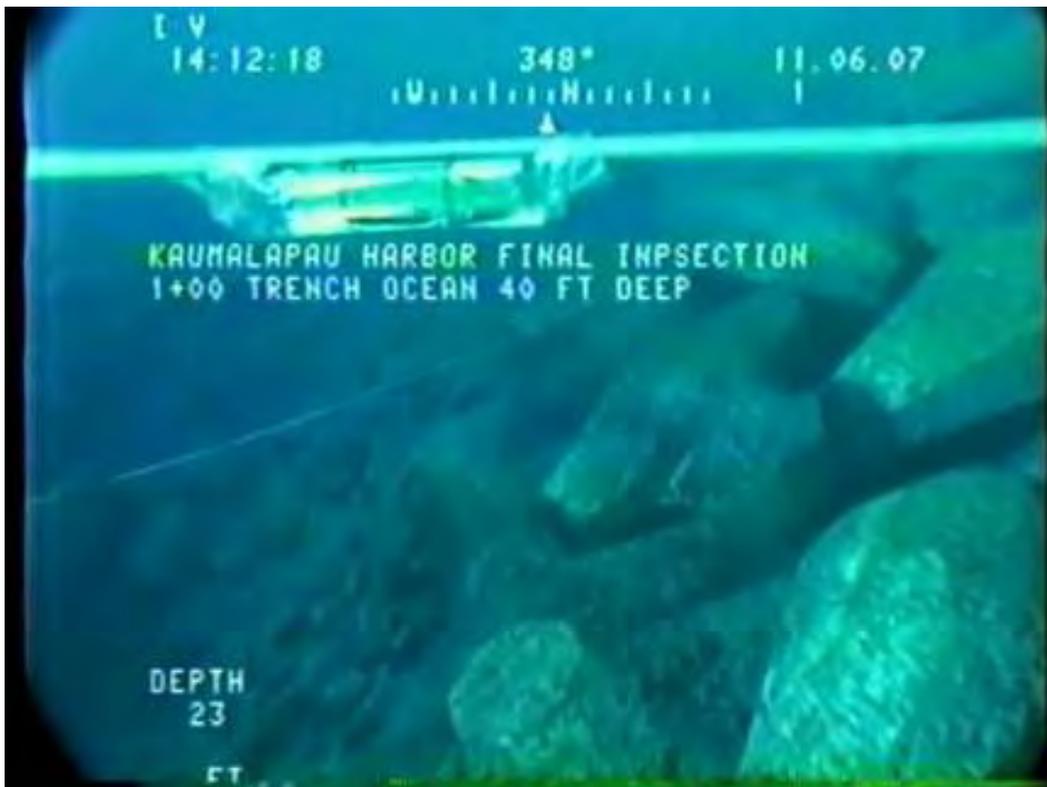
Figure 10.32. Ocean side trunk at approximately Station 1+00. Interlocking of armor units appears somewhat loose and toe trench appears to have widely varying stone sizes.

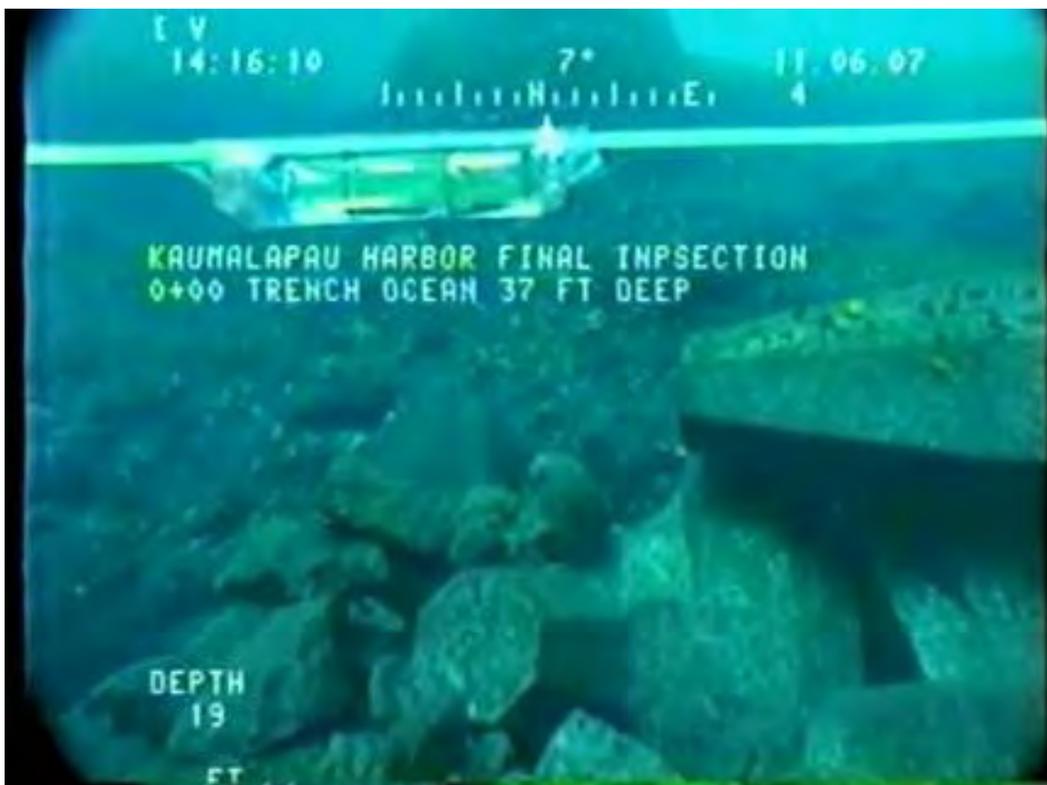
Figure 10.35. Ocean side root. Tieback of armor layer into reef platform appears flush. Scattered armor stones from toe trench or stone buttress visible near tieback.

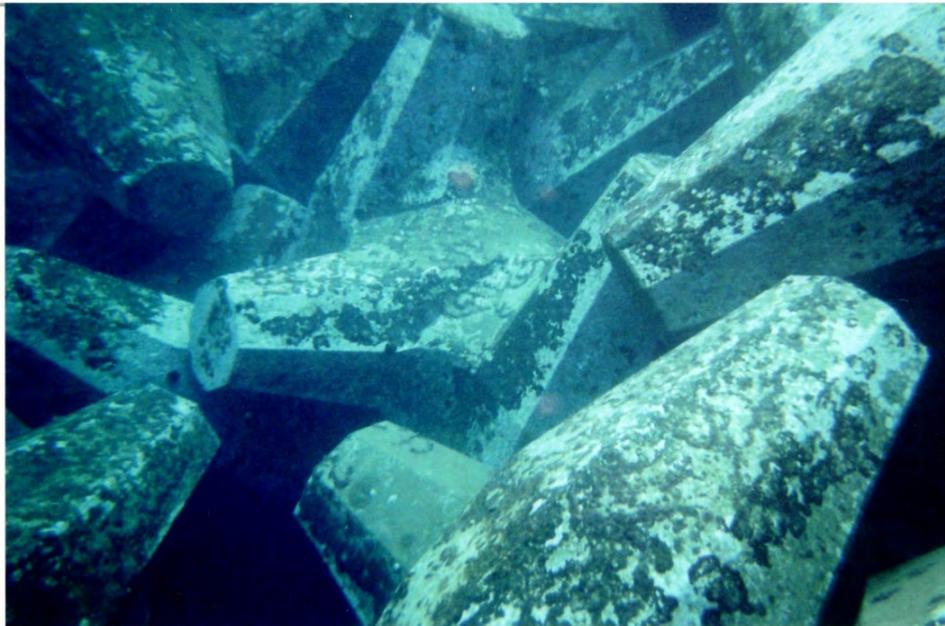
Figure 10.37. Photo of side slope armor units. No damage visible and well interlocked. (Photo by Orville T. Magoon, August 2009).

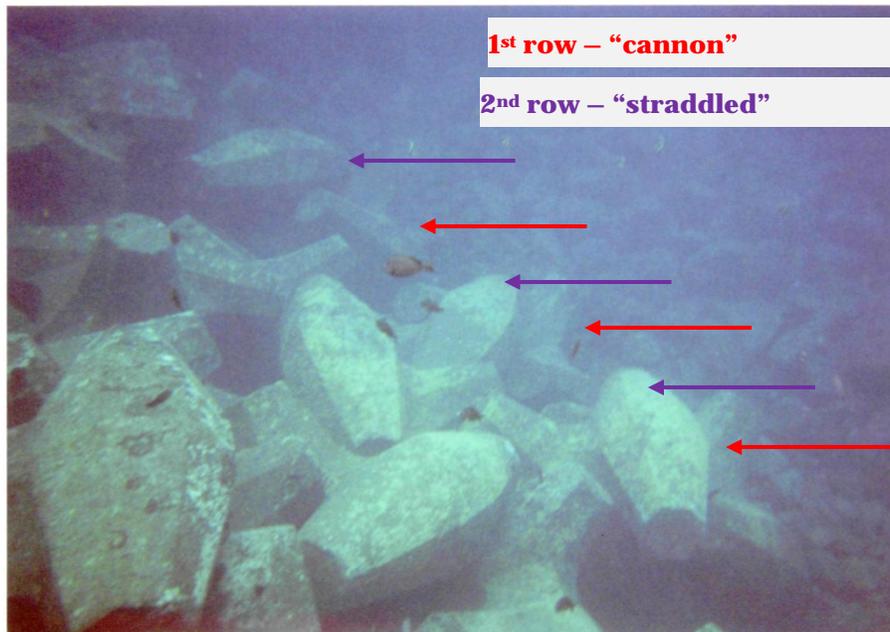
Figure 10.38. Photo of breakwater toe and toe trench. First row of “cannon” oriented units appears uniform and second row of “straddled” units well seated on first row. (Photo by Orville T. Magoon, August 2009).

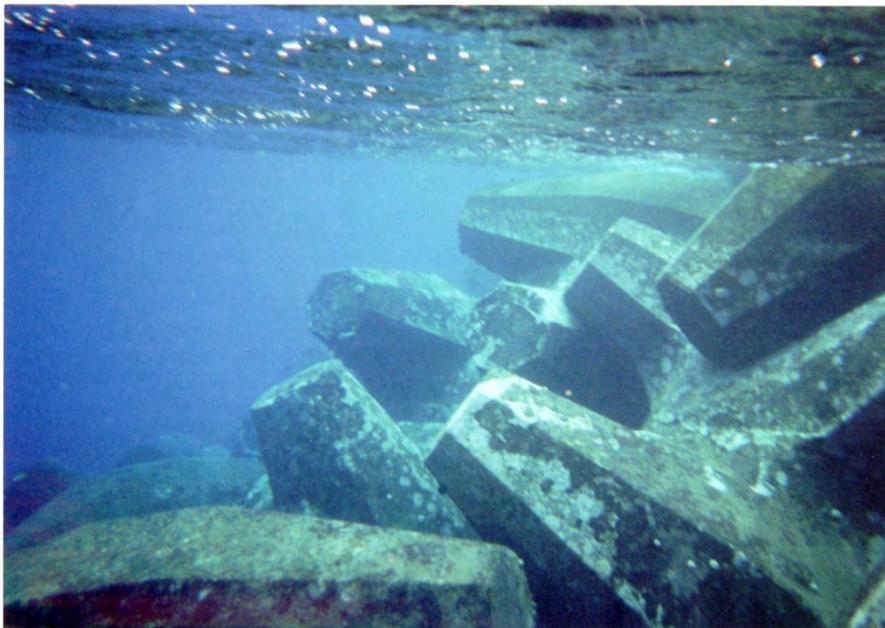
Figure 10.39. Photo of armor units near water surface showing no visible damage and consistent interlocking. (Photo by Orville T. Magoon, August 2009).
