ESTCP Cost and Performance Report

(WP-200620)

Cold Spray for Repair of Magnesium Components

November 2011

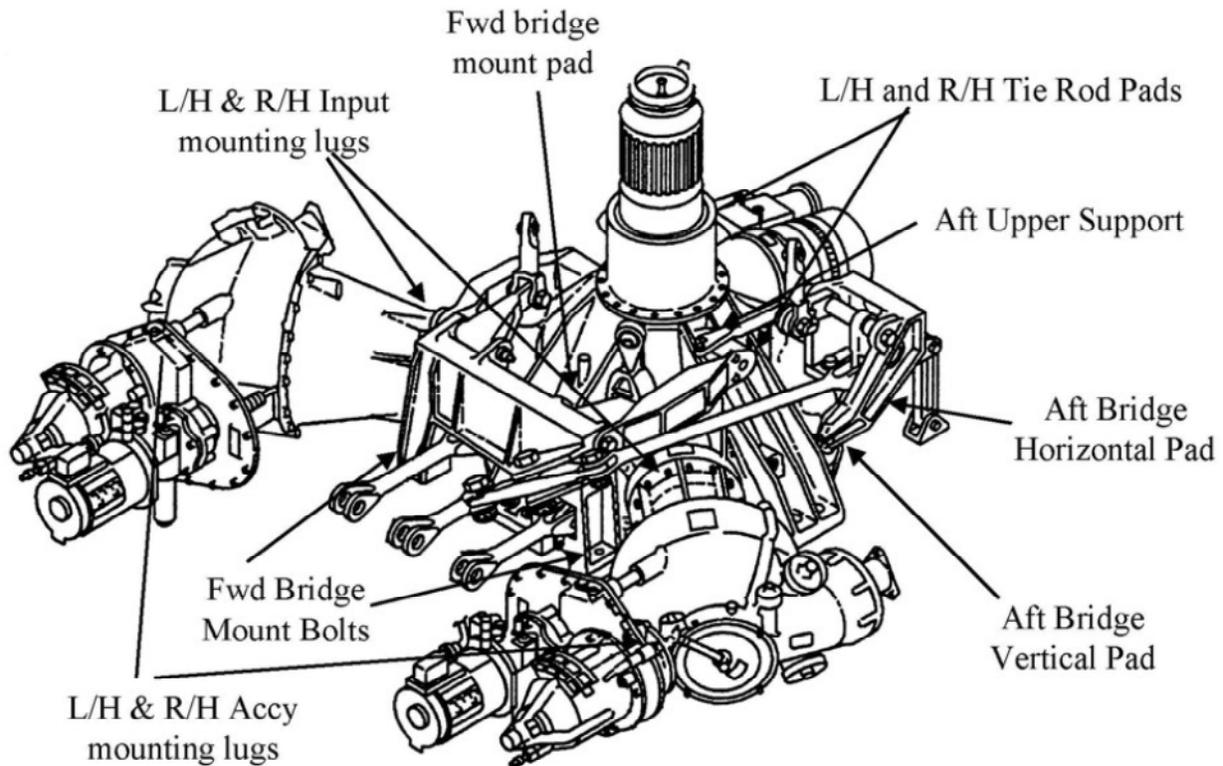
Figure 1 is a schematic of the main transmission housing for the H-60 helicopter showing the areas most susceptible to corrosion. Because of the localized nature of the corrosion, surface treatments intended to mitigate the problem would have to be applied only in these specific areas. A combination of galvanic and crevice corrosion is the primary corrosion mechanism for Mg alloy gearboxes. Water and salt spray tend to accumulate in the recessed holes around the bolts, and galvanic corrosion occurs between the cadmium (Cd)-plated bolt head and the surrounding Mg alloy, as well as between the shank of the bolt and the inner diameter (ID) of the hole. In addition, gearboxes usually have Cd-plated steel studs and bushings press fitted into them, and galvanic corrosion occurs around these areas (see Figures 2 and 3). In particular, Rosan inserts are frequently used to hold bushings, fittings, and threaded fasteners into housings (see Figure 4). These fittings are designed to be press fitted into the housing, where their teeth bite into the Mg alloy and create a high degree of plastic deformation. Any coating or surface treatment that is applied to the Mg at repair facilities must be able to withstand the insertion. When corrosion becomes excessive, material is removed and an Al shim is glued in place of the missing Mg alloy. This can be done up to a thickness of 0.100 inches. Obviously, these shims cannot carry load and thus lead to weakening of the structure.

Figure 1. Schematic of an H-60 Main Transmission Housing showing areas most susceptible to corrosion.

Most of the corrosion occurs at attachment points where a dissimilar metal is in contact with the coated Mg component. This includes flanges, mounting pads, tie rods, lugs and mounting bolts.

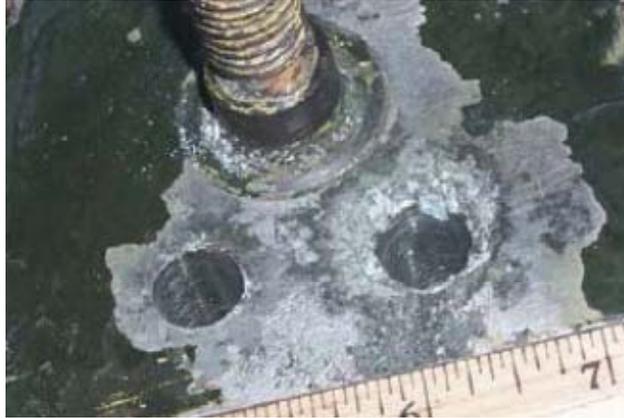
Figure 2. Corrosion around a stud and hole on a helicopter Mg gearbox housing.
(Courtesy Robert Kestler, FRC-E)

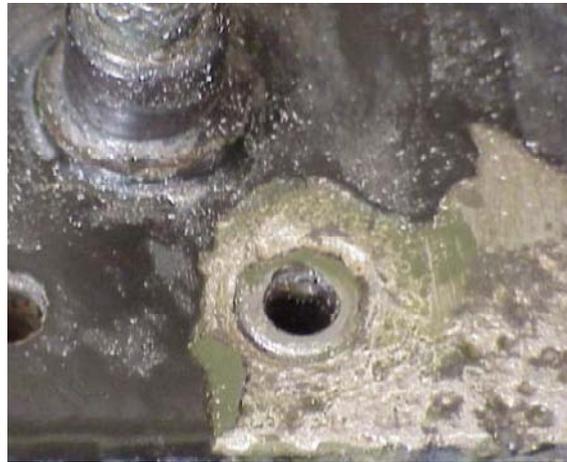
Figure 3. Corrosion around an insert on a helicopter Mg gearbox housing.
(Courtesy Robert Kestler, FRC-E)

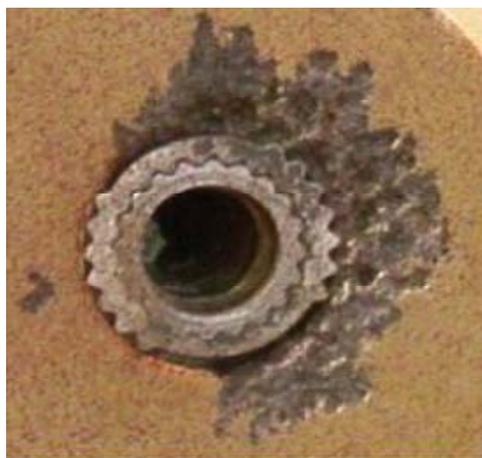
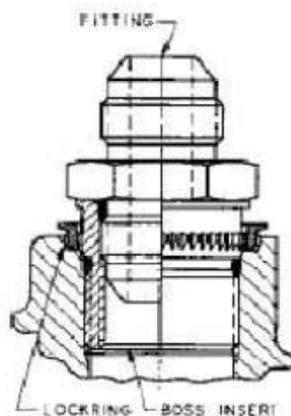
Figure 4. Rosan insert: corrosion around insert on a helicopter Mg gearbox housing (left) and cross section of insert with fitting (right).
(Courtesy Robert Kestler, FRC-E)

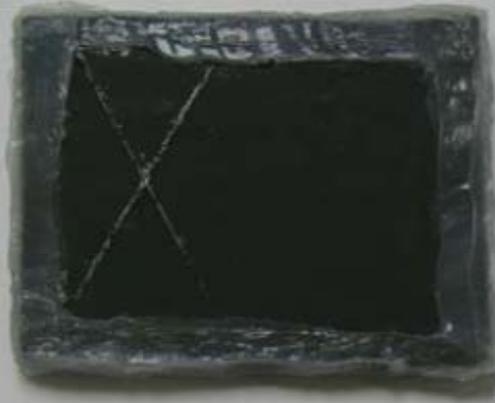
a

EV31-CP-Al-N2-8
with Rockhard
B117 Scribed to Coating
1000 hrs

Figure 13. An EV31-T6 panel coated with CP-Al N₂ after (a) testing the top coat-Cold Spray compatibility and (b) after testing with the scribing through to the substrate.

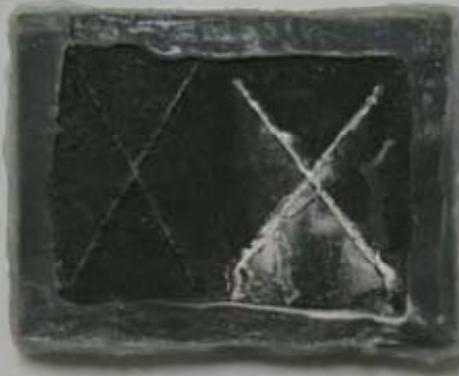
b

EV31-CP-Al-N2-8
with Rockhard
B117 Scribed to substrate
Failed- 15 hrs

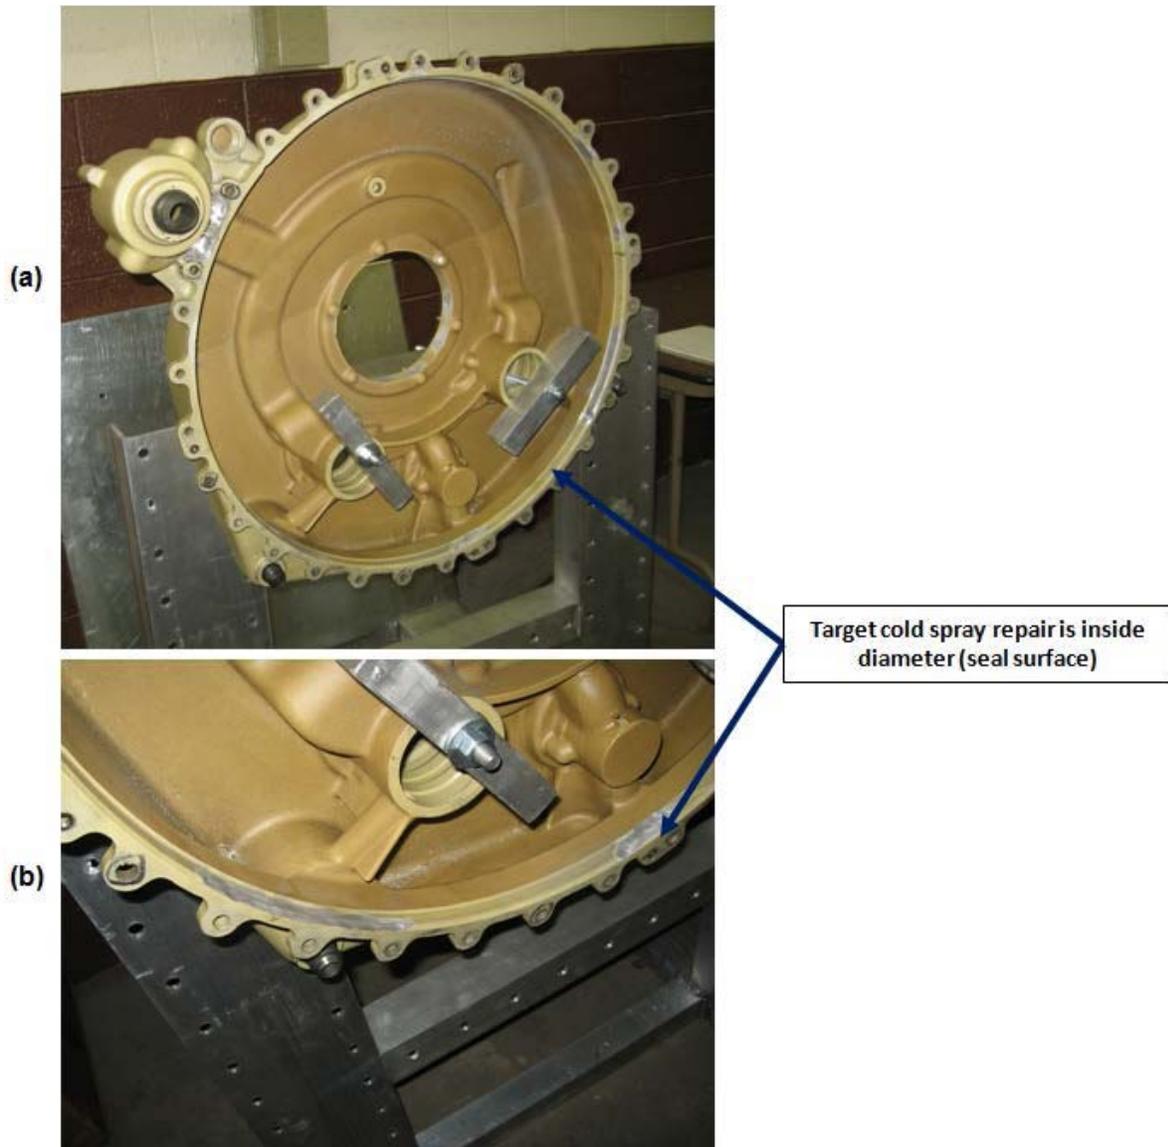
The first Cold Spray application that SAC is considering implementing is the repair of corroded areas on the H-60 sump. Currently, SAC uses an HVOF Al-12Si repair technique, but this coating is limited in use due to both thickness and performance limitations. Figure 14 shows an H-60 sump and the corresponding repair area of interest. At SAC's request, ARL then transferred the coating process parameters to a potential Cold Spray subcontractor, ASB Industries in Akron OH, in order to start the full-scale repair qualification process required to implement this repair.

Figure 14. SAC H-60 Sump (a) and detail of inside diameter showing simulated corrosion damage (b).

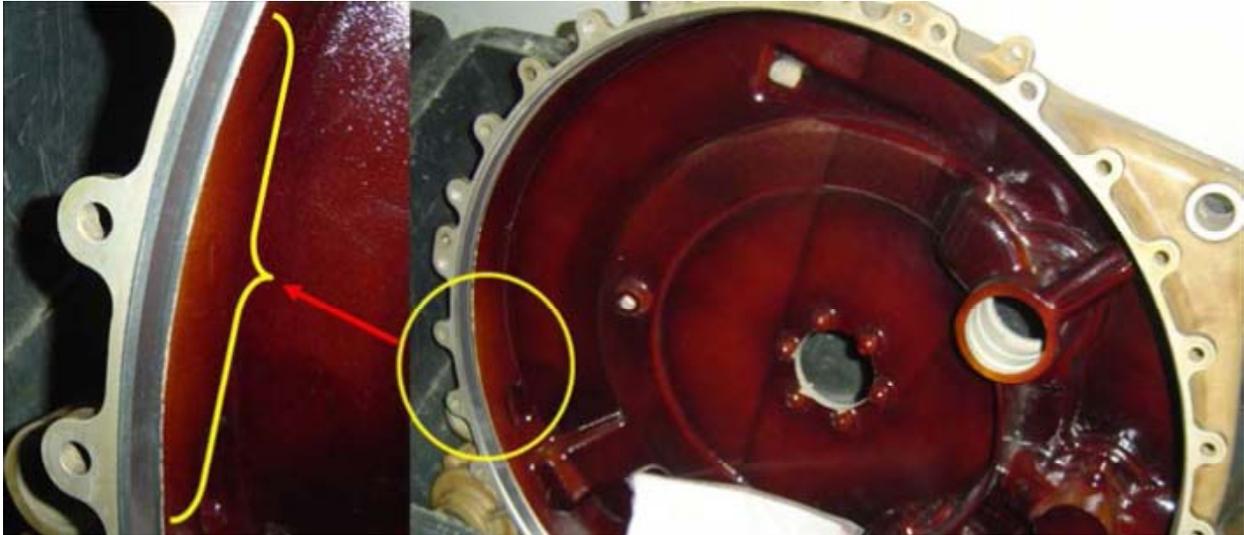
The H-60 Main Sump Gearbox (Figure 15) is currently repaired by SAC using an HVOF Al-12Si coating together with a bond coat. This method is not satisfactory as the HVOF coating tends to crack on insertion of Rosan fitting and does not reclaim the mechanical properties of the Mg alloy. It is expected that the use of Cold Spray coating will allow these gearboxes to be reclaimed, largely eliminating condemnations.

Figure 15. Flange repair area of H-60 Main Sump Gearbox.
