*Infrared Reflectance Imaging for Environmentally
Friendly Corrosion Inspection Through Organic Coatings
Project Number WP-0407*

Mr. John Weir, P.E., Northrop Grumman Corporation
Mr. Jack Benfer, NAVAIR Jacksonville FL

ESTCP Conference
Tempe, AZ

25-29 February 2008

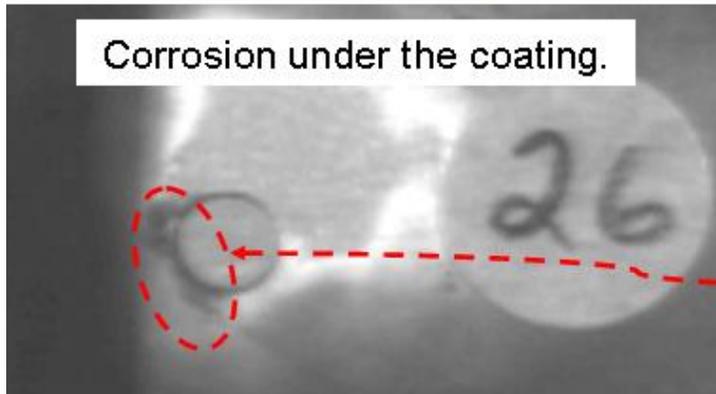
IR Painted Image

Corrosion under the coating.

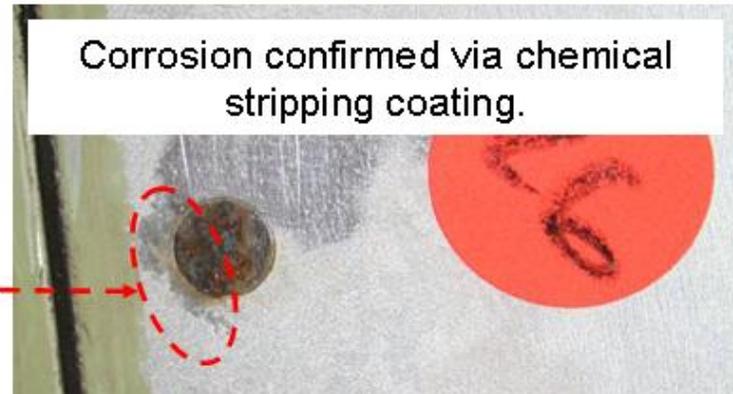
Visual Stripped Image

Corrosion confirmed via chemical stripping coating.

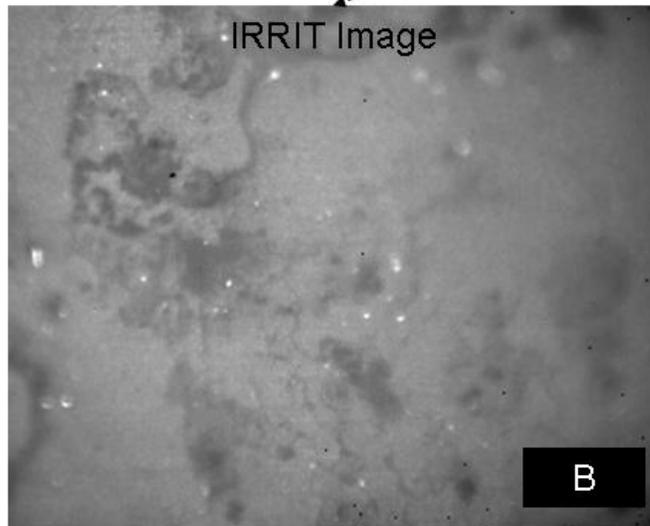
Corrosion Indicated by the Dark Areas in the IR Reflectance Mode

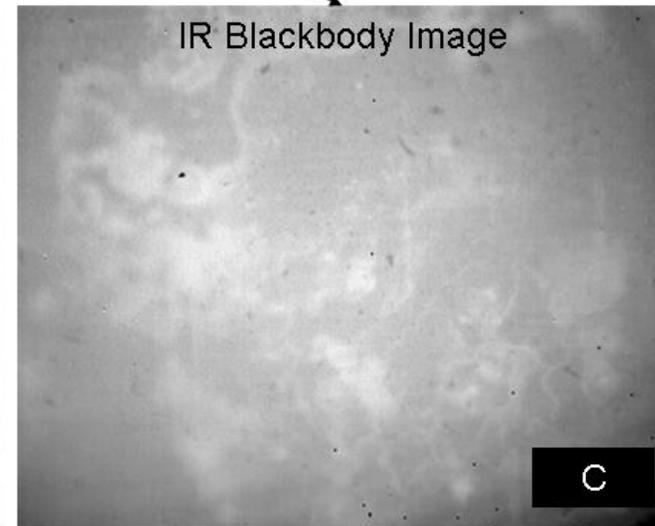
Corrosion Indicated by the Light Areas in the IR Blackbody Mode
