M1A1 Cannon Cradle Repair at Anniston Army Depot

Tony Pollard
Anniston Army Depot (ANAD)

Phillip F. Leyman
Army Research Laboratory (ARL)

13. SUPPLEMENTARY NOTES 24th Replacement of Hard Chrome Plating Program Review Meeting, July 20-21, 2004, Park City, UT. Sponsored by SERDP/ESTCP.

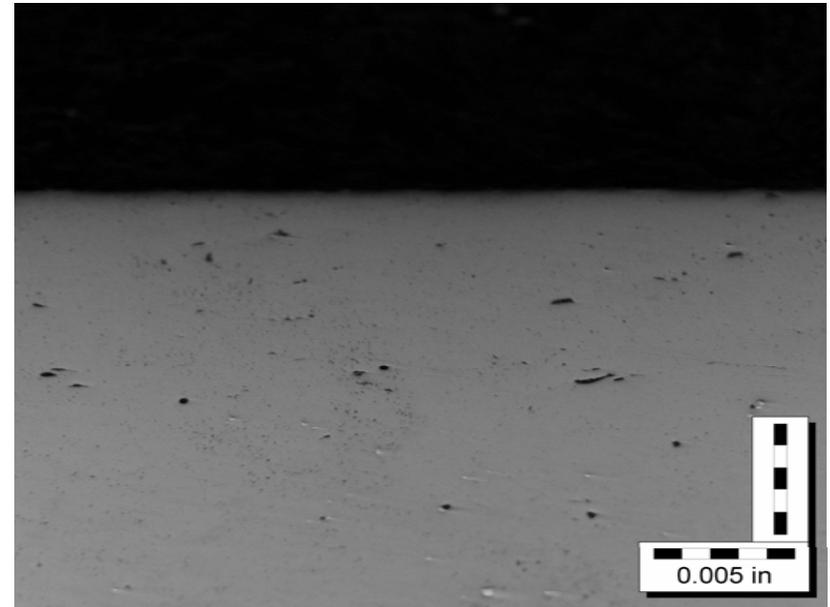
Micrograph of ESD applied Iconel 718
(.010" dimple)

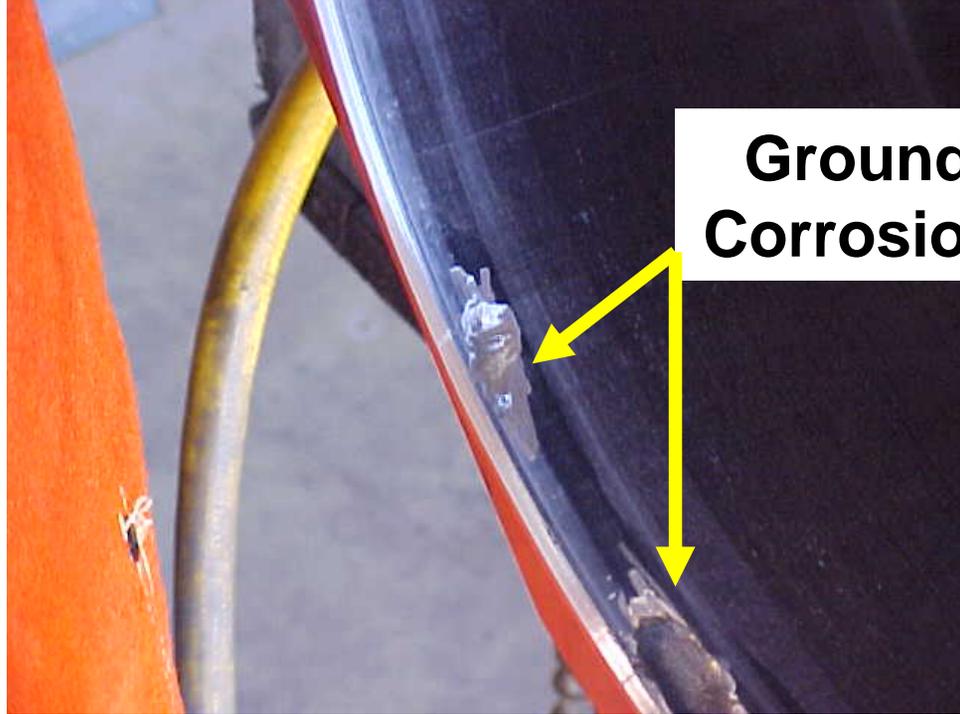
**Ground Out
Corrosion Pits**

- Clean cradle using vapor degreaser.
- Using hand-held grinder w/wire brush, remove corrosion from pit.
- Using hand-held grinder w/grinding tool, break the sharp edges of the pit.
- Using the ESD Equipment fill the pit to .005" - .010" above the parent material surface.
- Using ID grinder, grind ID to prepare for chroming.
- Chrome plate and finish grind.

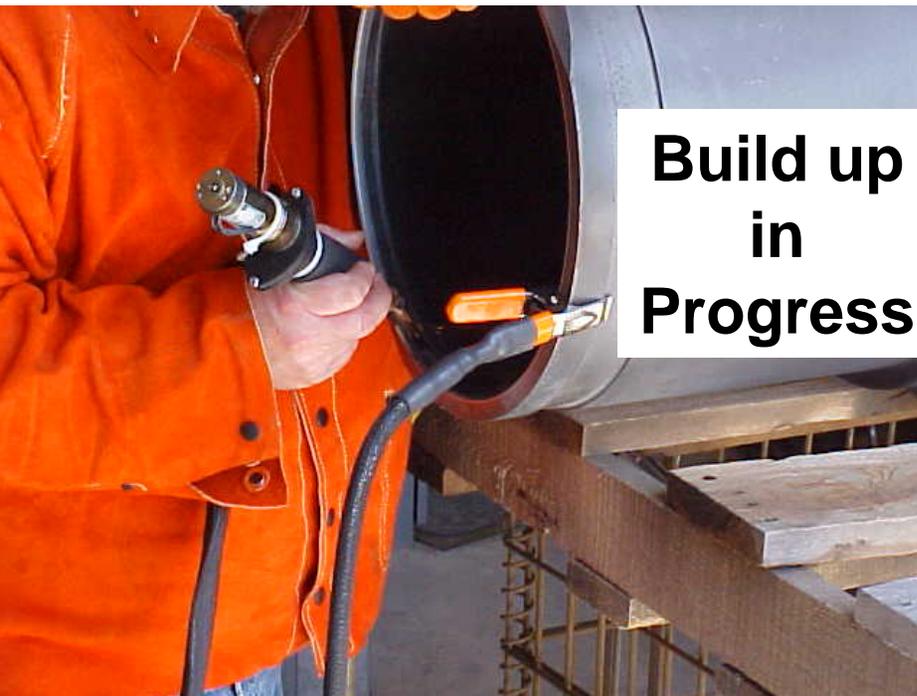
**Build up
in
Progress**

- Pulse Rate – 400 Hz
- Capacitance – 30 mfd
- Voltage – 150 volts
- Step Rate – 340 Hz
- Swing – 3
- Rotate Increment – 3
- Direction – CW
- Interval – 6
- Argon Gas Atmosphere

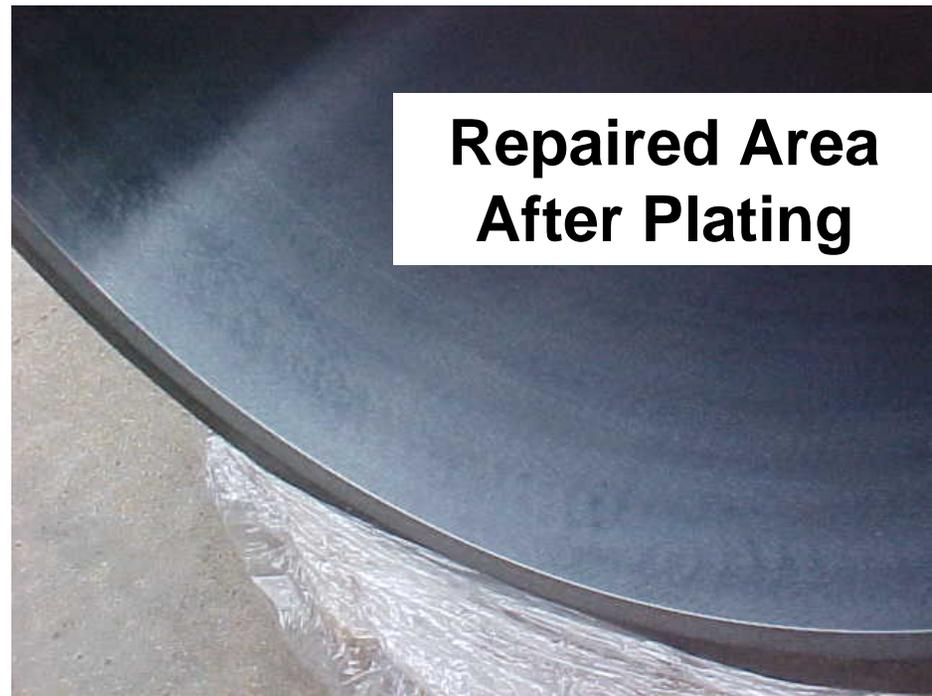
**Repaired Area
After Plating**
