TECHNICAL REPORT REMR-CS-16

REPAIR OF DAM INTAKE STRUCTURES AND  
CONDUITS. CASE HISTORIES

Roy L. Campbell, Sr., Dennis L. Bean

January 1988

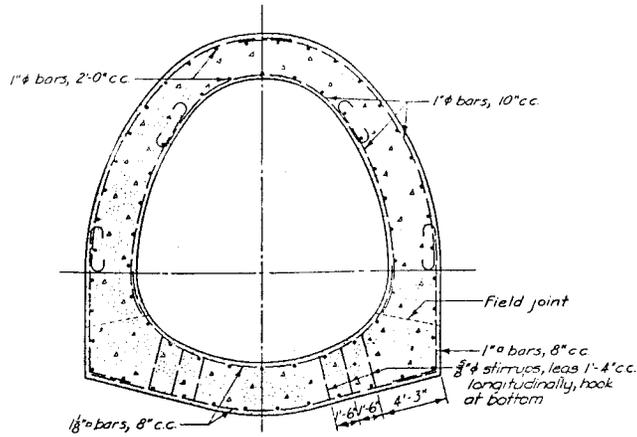
Figure 1. Typical conduit section, Arkabutla Dam

10. It appears that the omission of water stops in the invert is the major contributing factor in the leakage and associated deficiencies observed at the monolith joints of the conduit. During the early operations of the outlet works, leakage was observed at the upstream joints between monoliths 1 and 7. Leakage continued after remedial grouting in 1950 and was accompanied by loss of foundation material and differential movement. Movements of 0.04 ft or greater were reported in 1969 for monolith joints 3/4, 6/7, 9/10, and 10/11. Also reported were spalling and missing filler at various joint locations. Remedial grouting of all conduit joints was performed in 1970. In 1974, a sinkhole developed in the embankment above the downstream end of the conduit near the west edge of the toe road. This sinkhole was cleaned out and backfilled with sandy clay after an investigation concluded that the sinkhole had developed from earlier foundation material losses through openings which were grouted in 1970. Leakage continued and remedial grouting was performed in 1977. In total, leakage has occurred to varying degrees at all monoliths

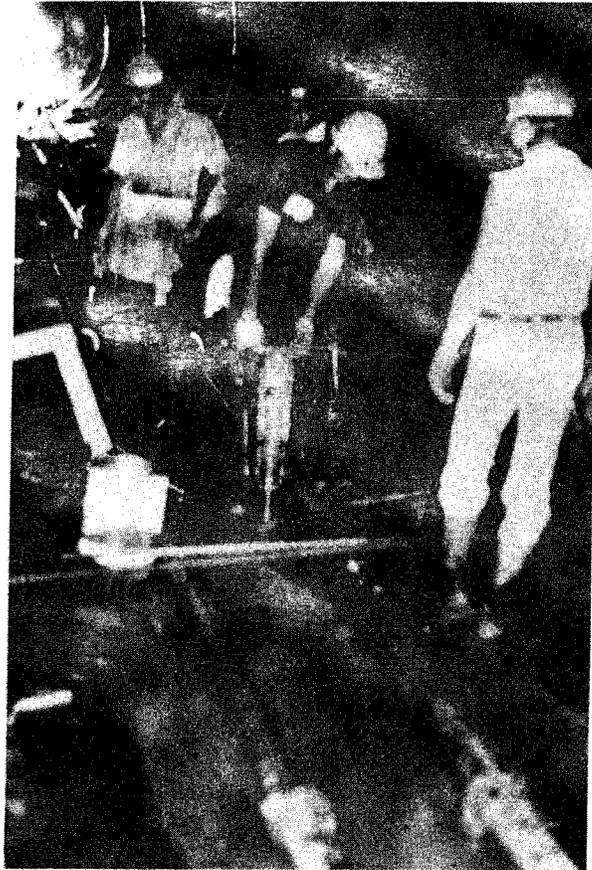
Figure 4. Drilling of grout hole in conduit invert, Arkabutla Dam, 1977

in the invert to a depth of 22 in. (Figure 4). A 1-1/2-in. inside diameter pipe coupling with nipple (flared at the bottom) was grouted in each hole. After the grout had set, a 1-3/8-in.-diameter hole was drilled to refusal (steel rebar) or through the conduit concrete to foundation sand and a 1-in. inside diameter cutoff valve installed.

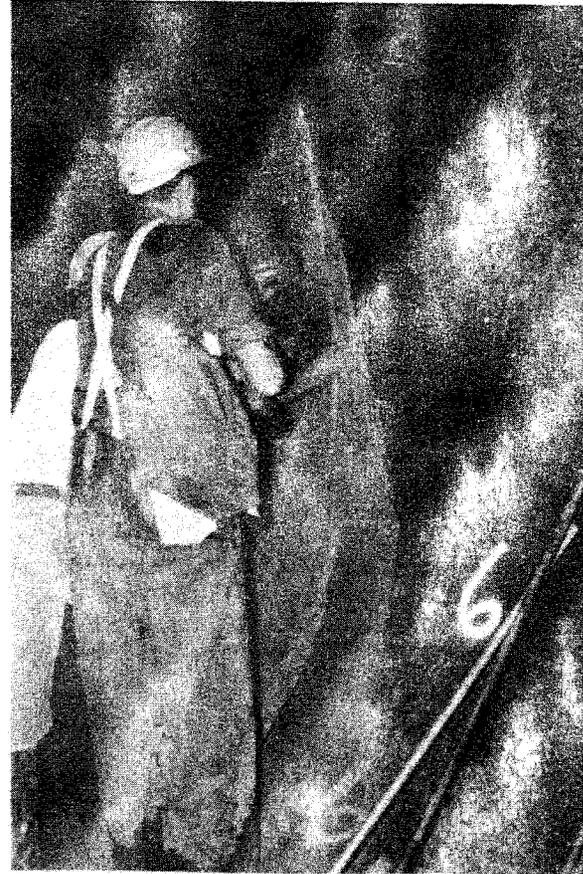
Figure 8. Chinking joint with lead wool, Arkabutla Dam, 1977

22. A hydraulically operated dual mixing bin grout machine with a 20-cu-ft sump tank capacity was located on the embankment surface about 20 ft from the right stilling basin wall. Approximately 300 ft of 1-1/2-in. inside diameter hose extended from the grout machine to a set of control valves (Figure 6). An additional 300 ft of the hose was used to complete the loop back to the machine for recirculation of the grout during periods when the grouting operation had to be interrupted. At the control valves, a 50-ft-long, 1-1/2-in. inside diameter line was used to connect to injection ports. Grout pressure was indicated by a gauge at the set of control valves (Figure 6) and a second gauge at the injection port (Figure 7). Lead wool was used to chink grout leaks in the conduit (Figure 8).

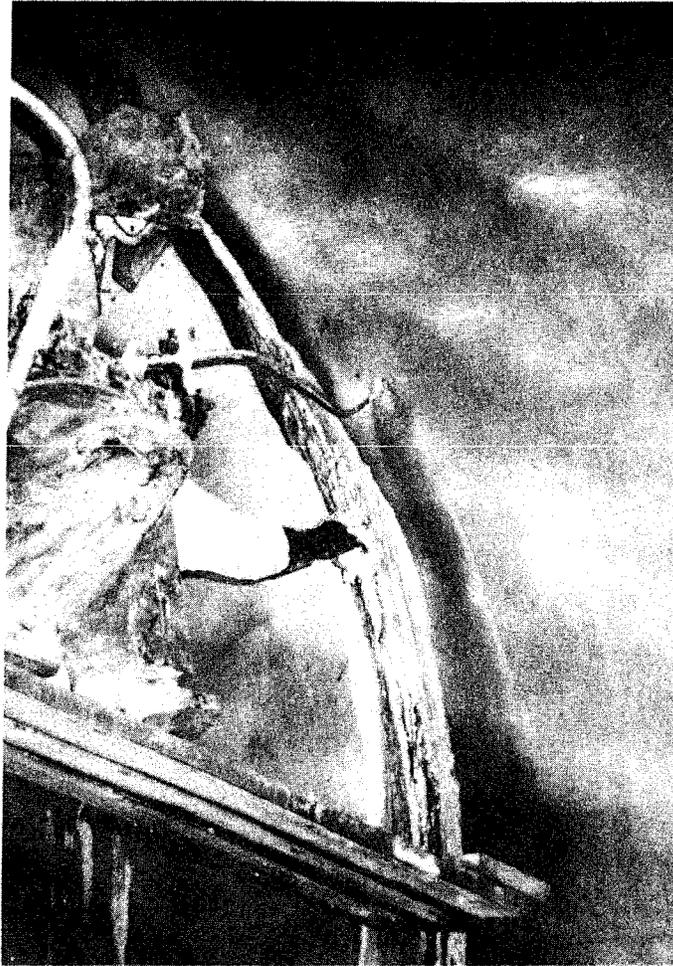
Figure 18. Injection of monolith joint 4/5 with chemical grout leaking out of joint, Blakely Mountain Dam, 1986

86. A switch was made to TACSS 020 NF to obtain a more rapid gel time with the maximum dosage of 10 percent accelerator. Injection of grout was moved to 8 ft left where 8.0 gal of grout were injected with 2.0 gal coming through joint (Figure 18). The left side of the tunnel started to seal and the injection of grout was moved to 5 ft left where 2.0 gal of grout were

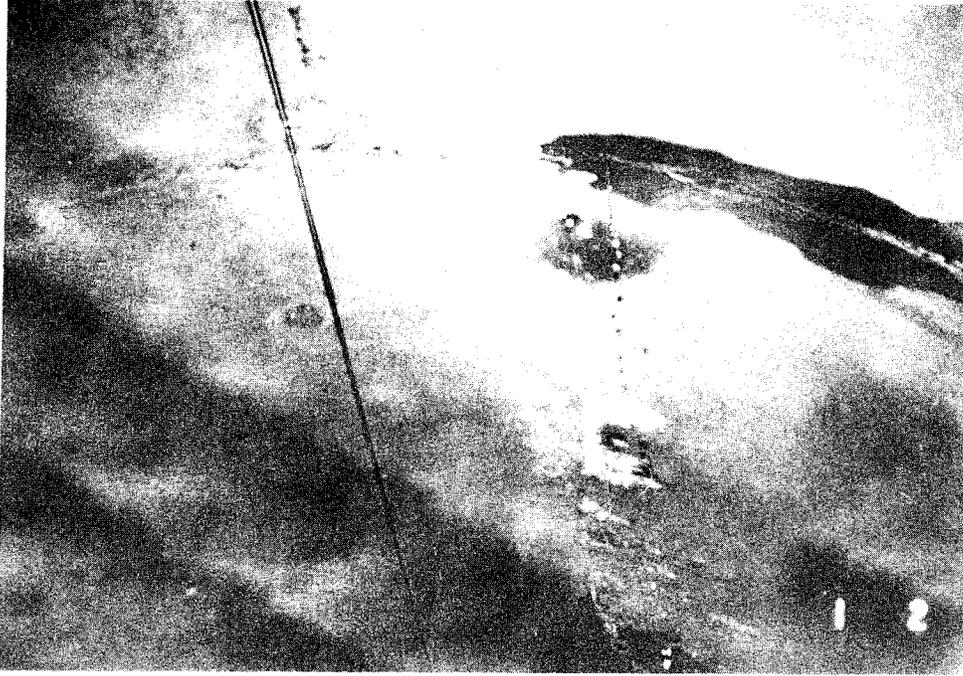
Figure 19. Monolith joint 4/5 before grouting, Blakely Mountain Dam, 1986

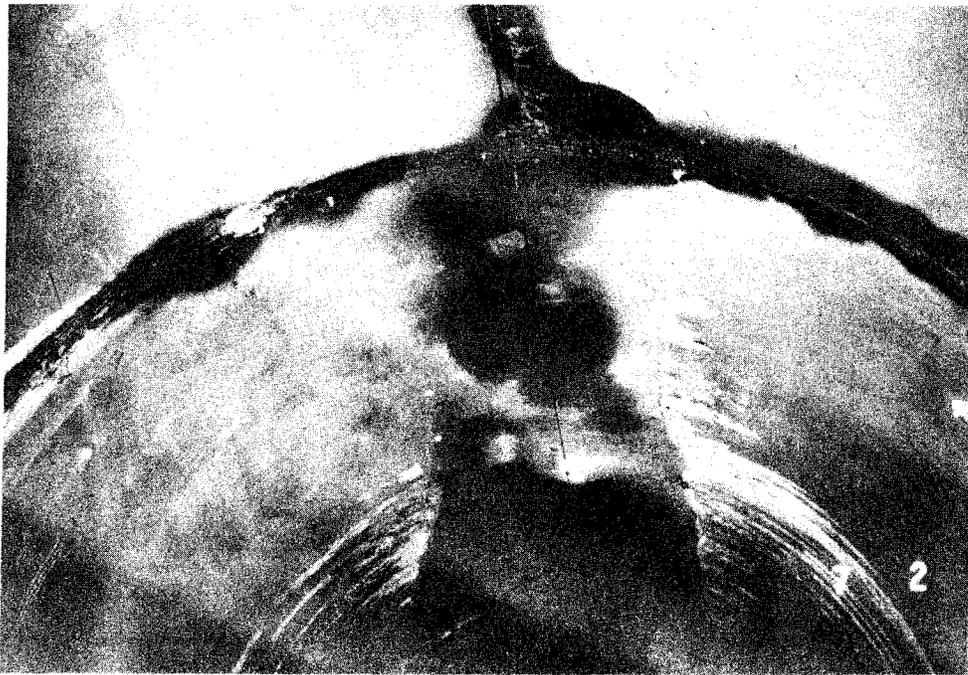
Figure 20. Monolith joint 4/5 after grouting, Blakely Mountain Dam, 1986

92. The flow from joint 4/5 had been nearly stopped on 6 February 1986. However, this joint was leaking again at 3 ft right of crown centerline. Also additional weeping was observed from cracks in the crown of both monoliths 4 and 5 (Figures 19 and 20). The seepage at joint 3/4 had increased some from 6 February 1986 with the seepage occurring at 3 to 5-ft right of the crown

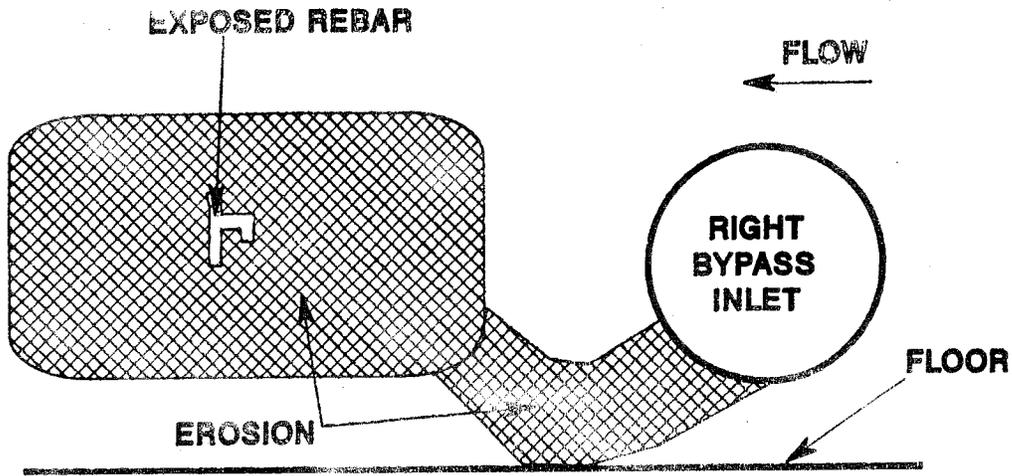
103. During a 1980 inspection, erosion damage was observed in the surface of the concrete in the two gate passages and transition of the outlet works. In the right passage, cavitation damage had occurred immediately downstream of the bypass outlet (Figure 26). The eroded area was approximately 6 ft long, 3 ft wide, and 8 in. deep at the deepest point with exposed reinforcing bars. In the left passage, cavitation damage (Figure 27) had also occurred immediately downstream of the bypass outlet and was approximately 4 ft long and 2 ft wide with a maximum depth of about 4 in. Abrasion damage had occurred in the transition between end of the passages and the beginning of the conduit. The damage consisted of two eroded areas downstream of the

Figure 26. Sketch of cavitation damage in wall of right passage, Cave Run Dam, 1982

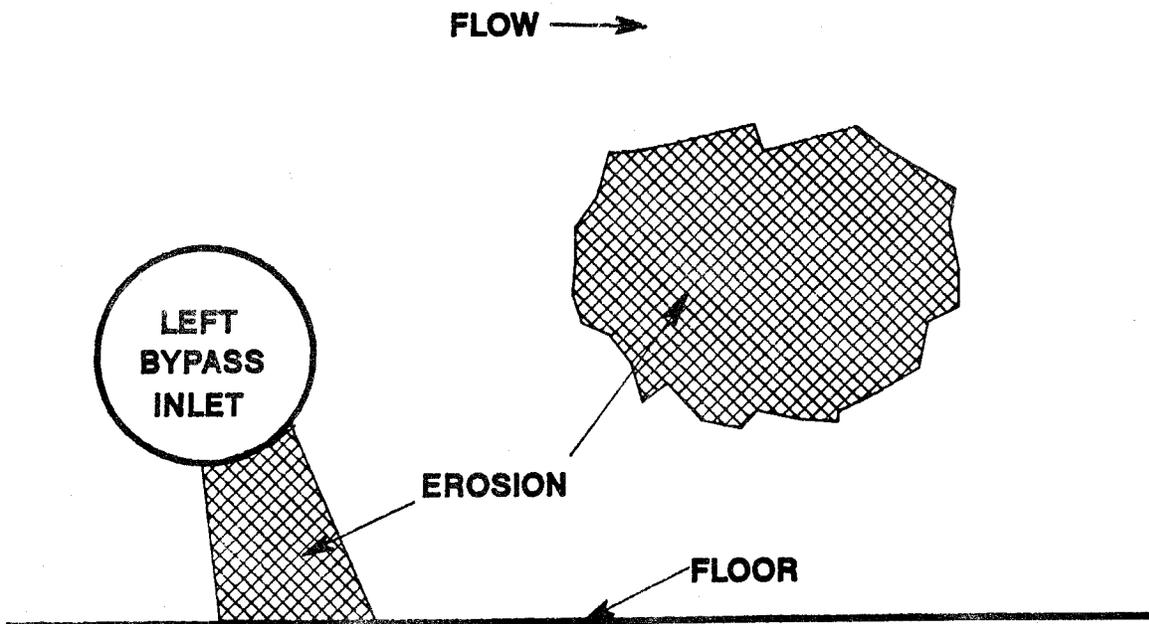
Figure 27. Sketch of cavitation damage in wall of left gate passage, Cave Run Dam, 1982

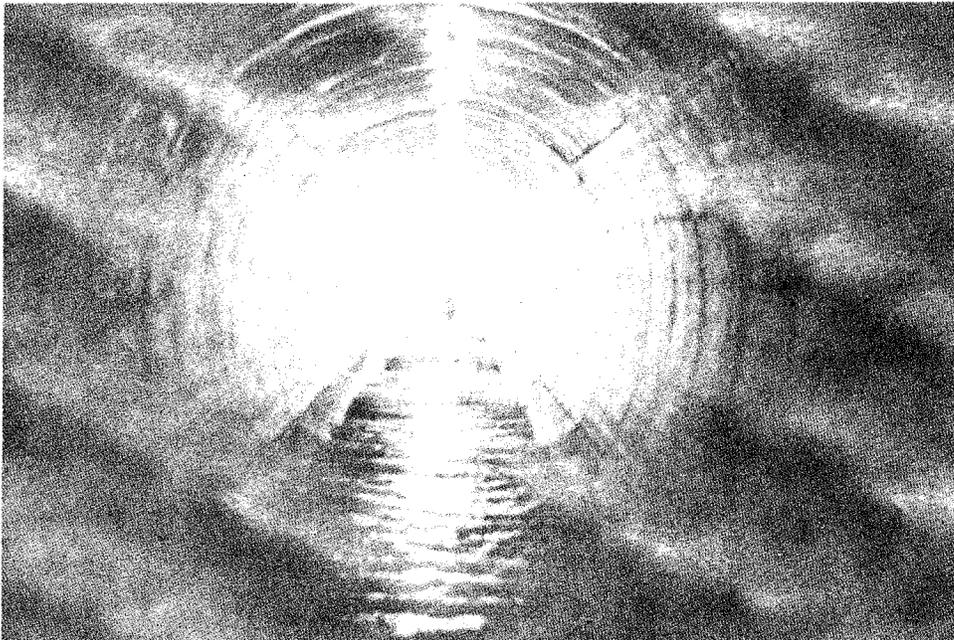
a. Longitudinal crack in crown

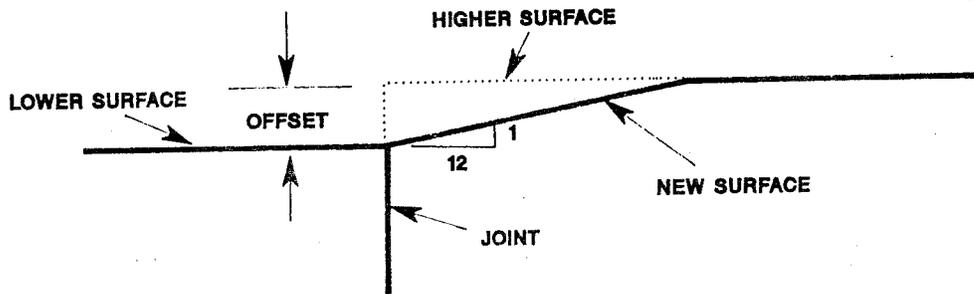
Figure 35. Sketch of repair of offset, Hidden Lake Dam

127. In 1984, district personnel rented a high-speed, car buffer type grinder with a diamond stone. The higher surface at each of the two joints was ground to the level of the lower surface at the joint and cut back on a 1 to 12 slope away from the joint (Figure 35). This produced a smooth surface transition across the joints, thereby, reducing the possibility of cavitation damage occurring during high-flow releases.

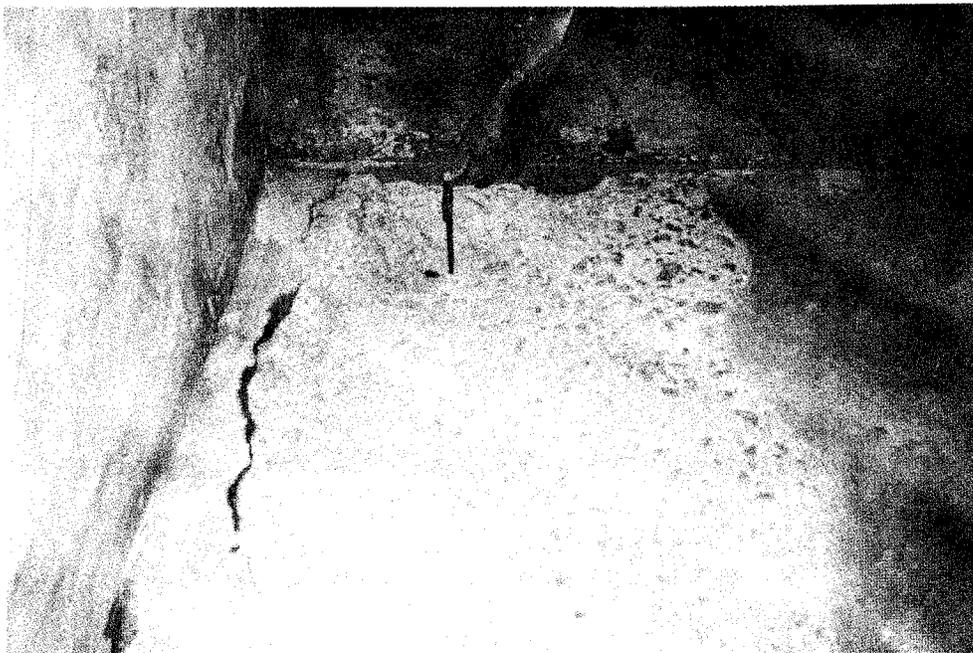
157. A delaminated section of the invert repair was pried loose and examined. The Quartz was firmly attached to the concrete indicating the bond was good and that the concrete beneath the bond had failed. It was speculated that seepage at the joint during the repair had reduced the bond causing the Magma Quartz at the joint to spall, thereby, setting up an abrupt surface irregularity for cavitation to occur. Water then progressively undermined the Magma

Figure 40. Erosion damage, Isabella Dam, December 1983

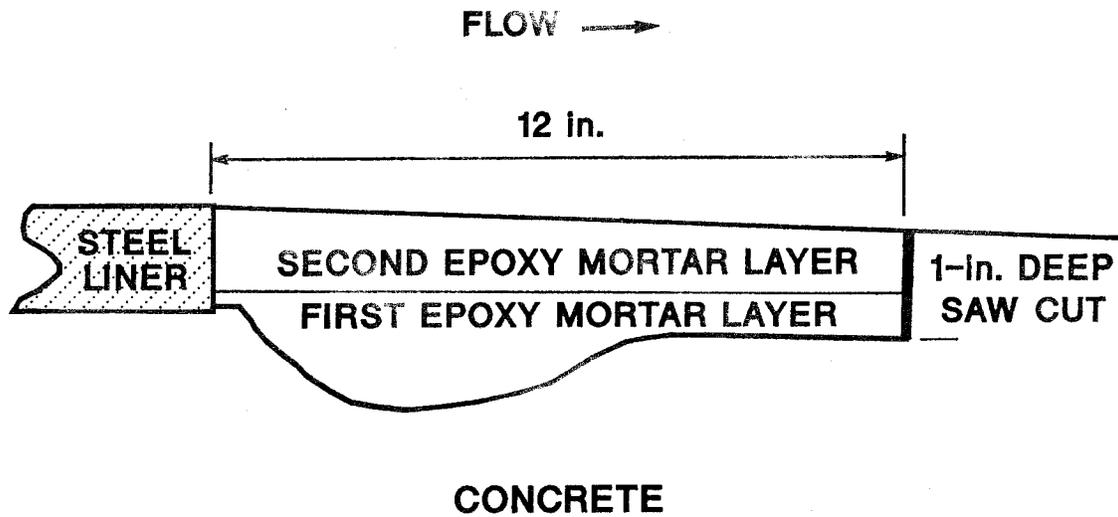
196. In May 1985, 21 months later, the patch was inspected. The epoxy mortar surface had settled or flowed, before hardening, to about 1/4 to 3/8 in. below the level of the steel. It appeared that the bond was still intact and that the mortar surface had little sign of wear.

Figure 45. Repair immediately downstream of steel liner, Milford Dam

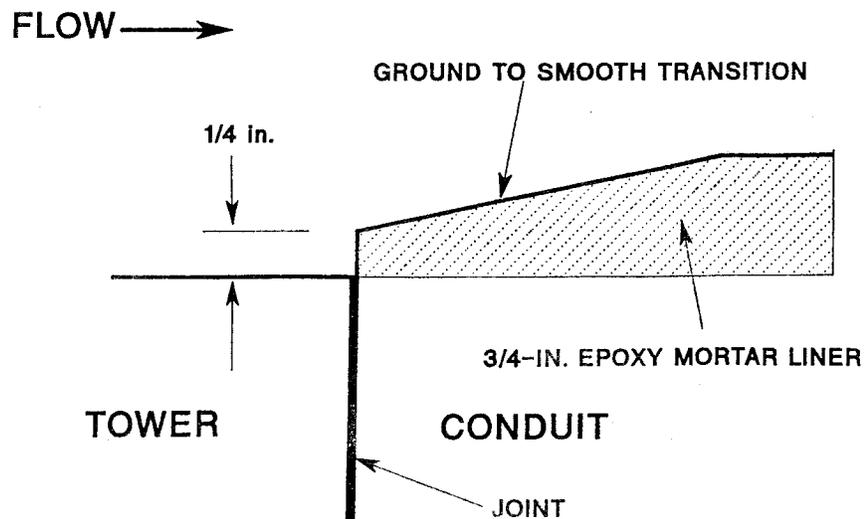
Figure 46. Edge ground to provide smooth transition at monolith joint, Milford Dam

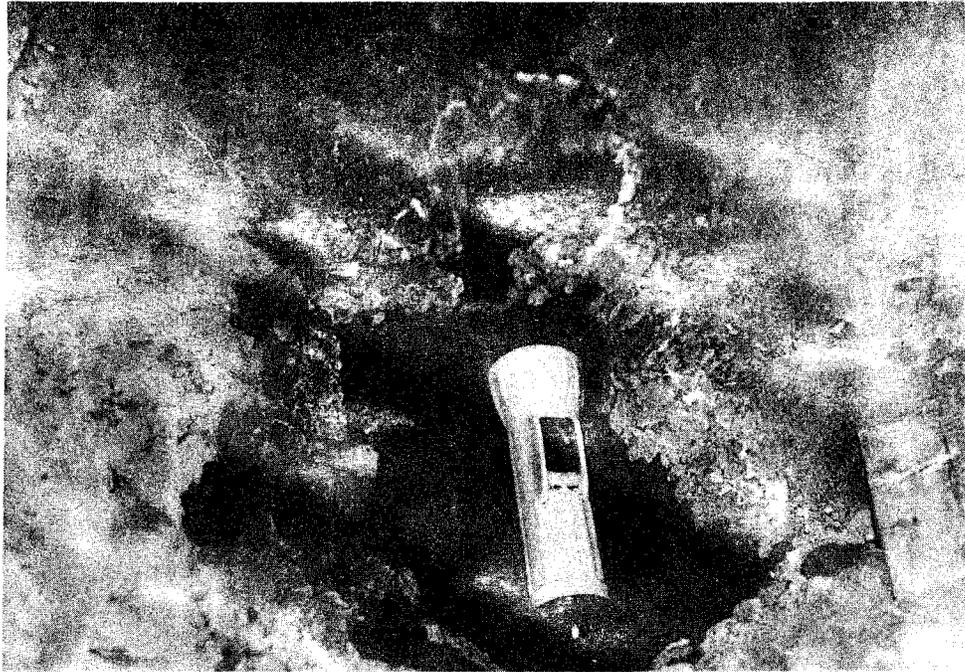
199. The metal forms that were used during placement were removed from the interior of the conduit for the first time in 1984. About two-thirds of the way up the conduit there was a 60 to 80-ft reach of honeycomb areas and cavities along the invert. In one spot there was a triangular shaped cavity partly covered with a piece of metal plate. The cavity extended through the full depth of the slab and appeared to be wider at the bottom. At another monolith upstream, there were two cavities that penetrated the full depth of slab. One cavity in the middle of the monolith (Figure 47) was about 6 ft long with a varying width of about 10 in. at the maximum. The second cavity located at the upstream end of this monolith was about 12 in. wide by 18 in. long. At the joint, the water stop was firmly embedded into the adjacent monolith, but fully exposed on the side of the cavity. There were two or three other V shaped cavities 5 to 7 ft long and varying in depth from about 1-1/2 to 8 in. About two-fifths of the way up the conduit, the end of a 3- by 3-in. piece of wood was embedded about 8 in. left of invert. Except for an area of scattered pits (approximately 1-1/2 in. in diameter by 1/2 in. deep)

Figure 47. Hole through conduit at invert, Mulberry Dam

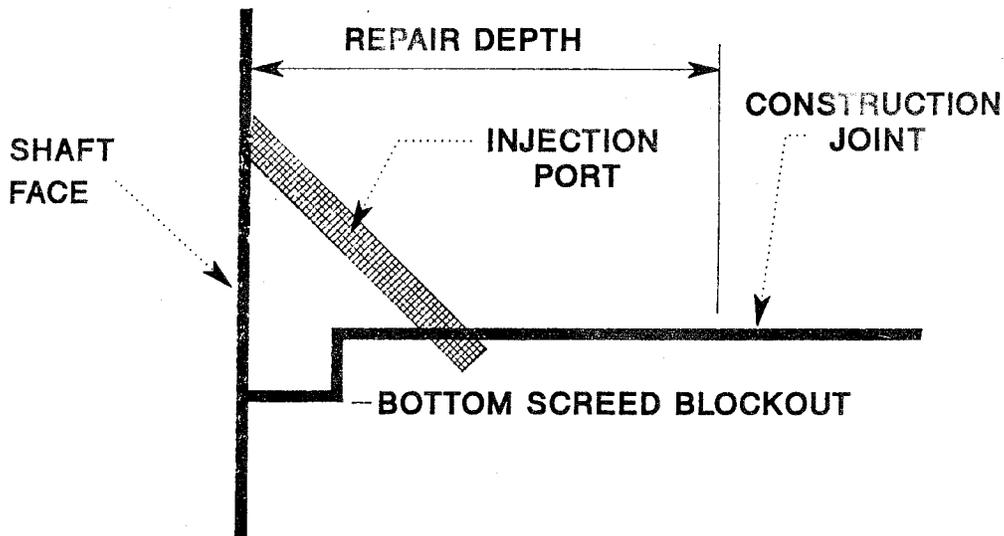
Figure 52. Sketch of epoxy injection joint detail, Warm Springs Dam

219. After the epoxy had cured long enough to preclude its draining out from the injected voids, the pipe nipples were removed and the ports patched with Waterplug. The ports and sealed surfaces were then ground flush with the adjacent concrete surfaces.
