TECHNICAL REPORT REMR-CS-6

**IN SITU REPAIR OF DETERIORATED
CONCRETE IN HYDRAULIC STRUCTURES:
FEASIBILITY STUDIES**

R. P. Webster, L. E. Kukacka

May 1987
Final Report

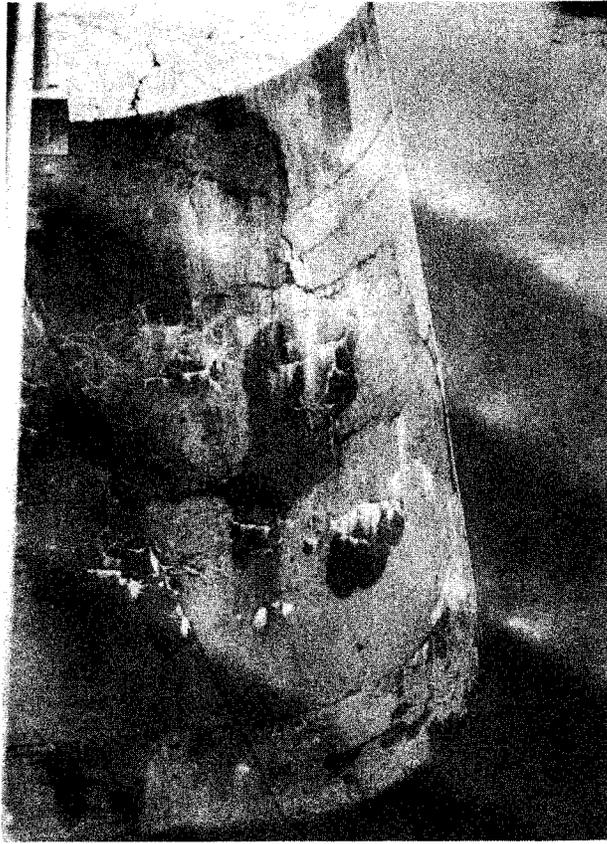
a. General view of deterioration due to cracking.

b. Closeup view of top of gate pier.

Figure 1. Typical cracking deterioration in concrete gate piers.

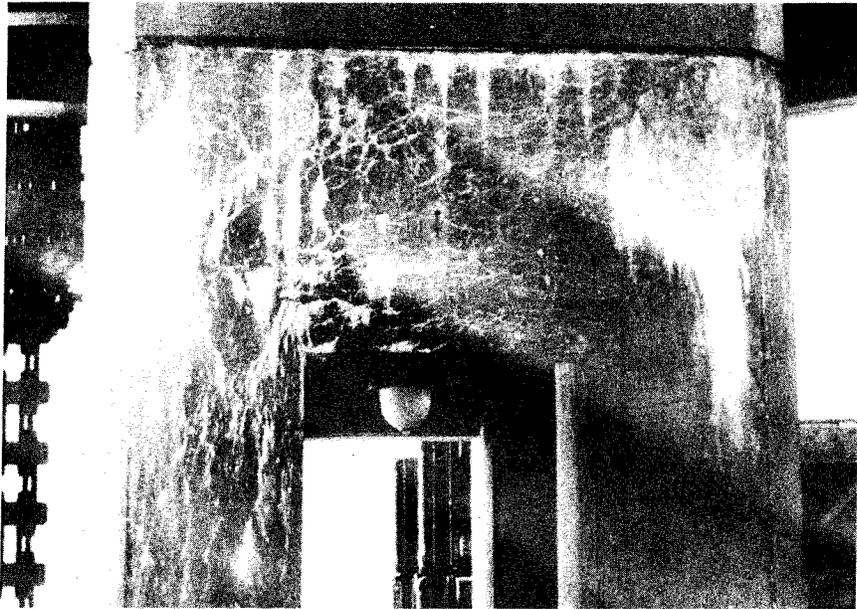
Figure 2. Typical cracking in concrete arch.

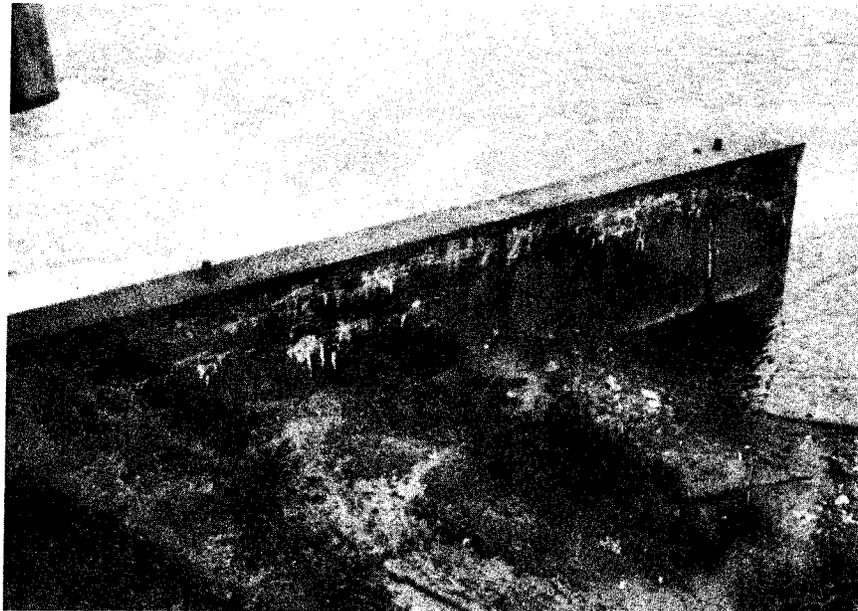
Figure 3. Typical cracking in concrete wall.

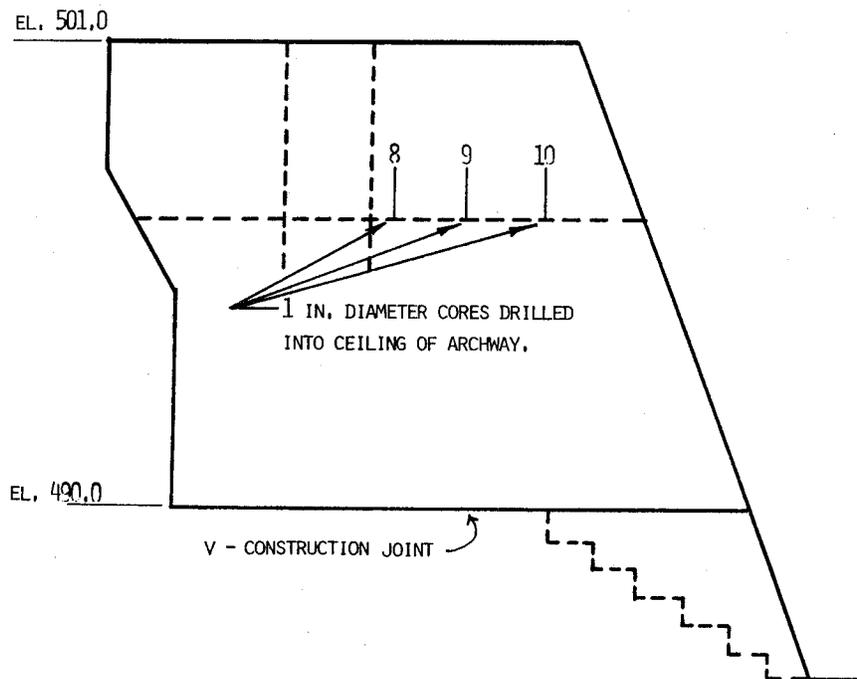
Figure 10. East elevation showing location of injection ports (Flock and Walliser, 1983).

Epoxy injection was started in the middle of the archway ceiling at Port No. 9 (refer to Figures 10-12). Pumping was continued, while the epoxy reached injection Ports Nos. 2, 3, and 12 on the downstream face. The operation was then moved to the upstream ceiling port (No. 8). The contractor had difficulty maintaining a seal around the injection packer. In addition, leakage of epoxy was noted at the bottom edge of the access manhole and adjacent to the electrical conduits embedded in the archway ceiling. An attempt was made to inject epoxy into Port No. 10; however, it was impossible, even at a pressure of 160 psi.

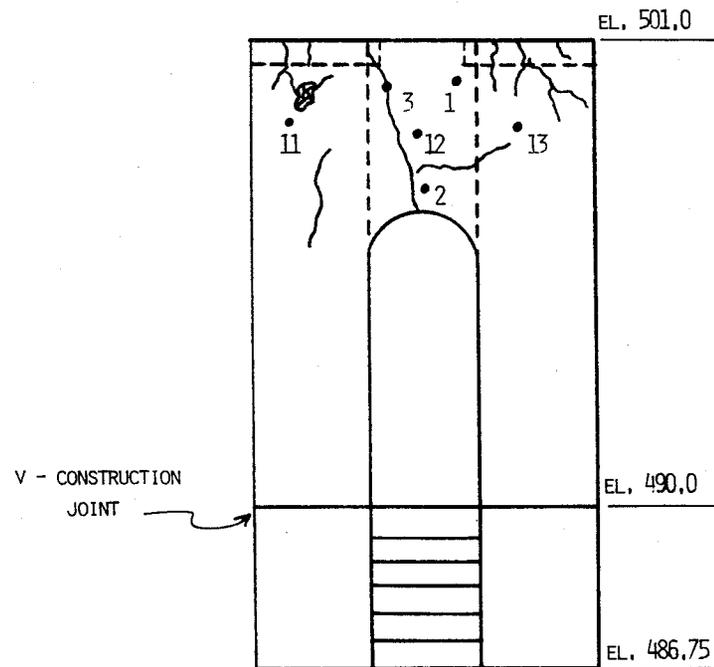
Figure 11. Downstream view showing major cracks and locations of injection ports (Flock and Walleser, 1983).

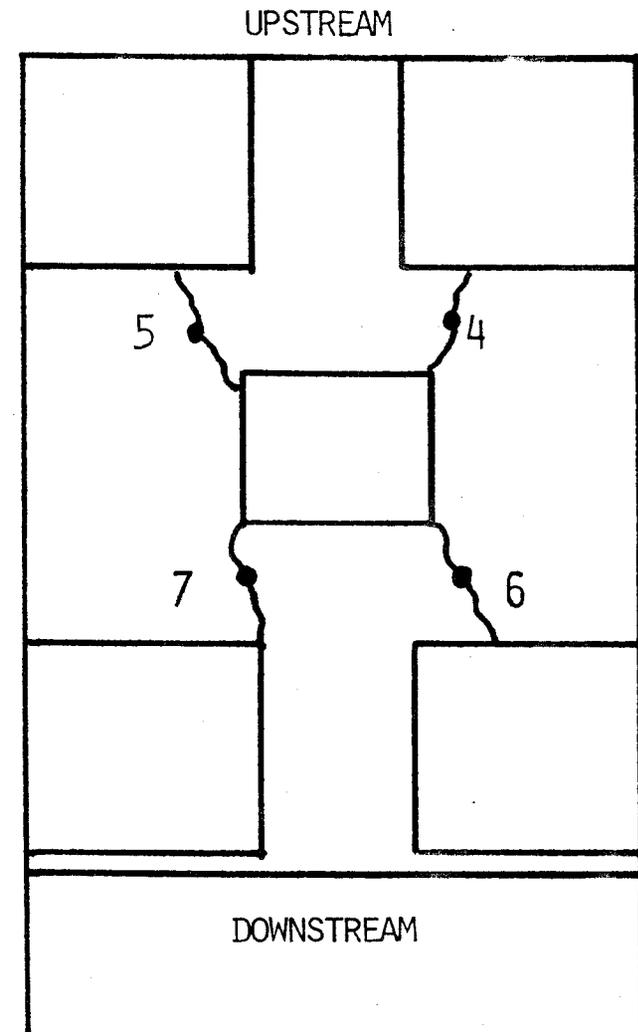
Figure 12. Top view showing major cracks and locations of injection ports (Flock and Walleser, 1983).

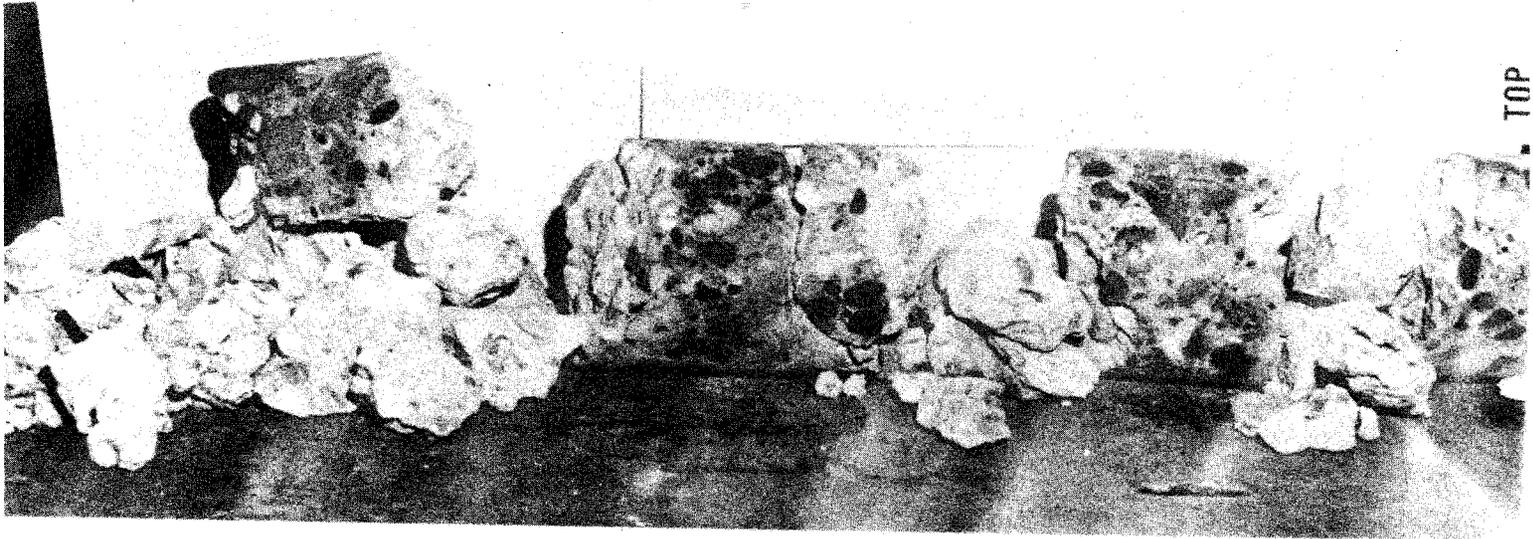
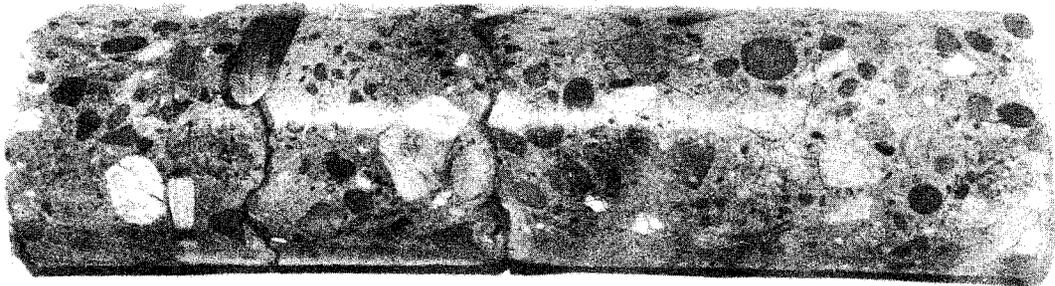
#2 10-14-82
EPOXY INJECTED
HORIZONTAL CORE
D/S FACE OF PIER

Upon completion of the pulse velocity tests, concrete cores were taken from various locations to further evaluate the effectiveness of the repair. Presented in Figure 13 are photographs of cores taken before and after the pier was repaired. Cores removed from the pier top contained numerous random and crudely parallel diagonal cracks as well as many fractured aggregate particles. Only 5 to 10% of the cracks were filled with epoxy, explaining the difficulty in obtaining pulse velocity readings.

Figure 13. Cores taken from Pier 39 before and after epoxy injection.

The cores taken from the downstream face were not as severely cracked as the core removed from the pier top. The cracks were finer and more randomly distributed throughout the length of the cores. Fifty to ninety-five percent of the cracks were filled with epoxy. Tests for resistance to freezing and thawing subsequently run on two of these cores indicated the epoxy injection was successful in rebonding the concrete and in holding it together under freezing and thawing conditions. Most of the failure observed in these tests resulted from crumbling of the non-air entrained mortar and cracking of the coarse aggregate particles. In general, it was concluded that the epoxy in the fractures tended to hold the concrete together during the freezing and thawing cycles and aided in slowing down the deterioration of the concrete. Based on the tests, the performance of the concrete in the structure cannot be predicted absolutely; however, it is expected that while the exposed concrete surface would be subjected to damage due to freezing and thawing, the deeper interior concrete may be cemented together well enough to form an integral whole and to perform satisfactorily.

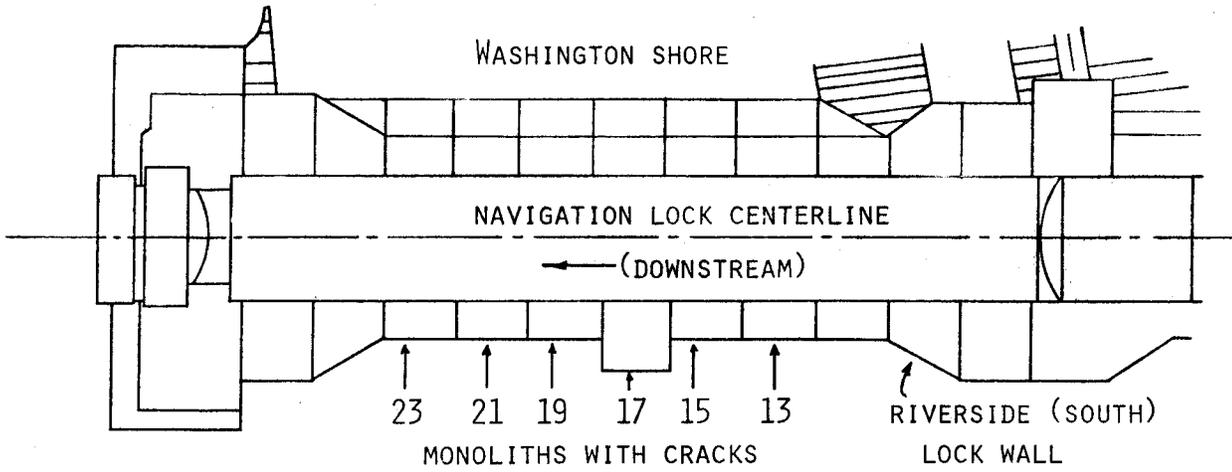
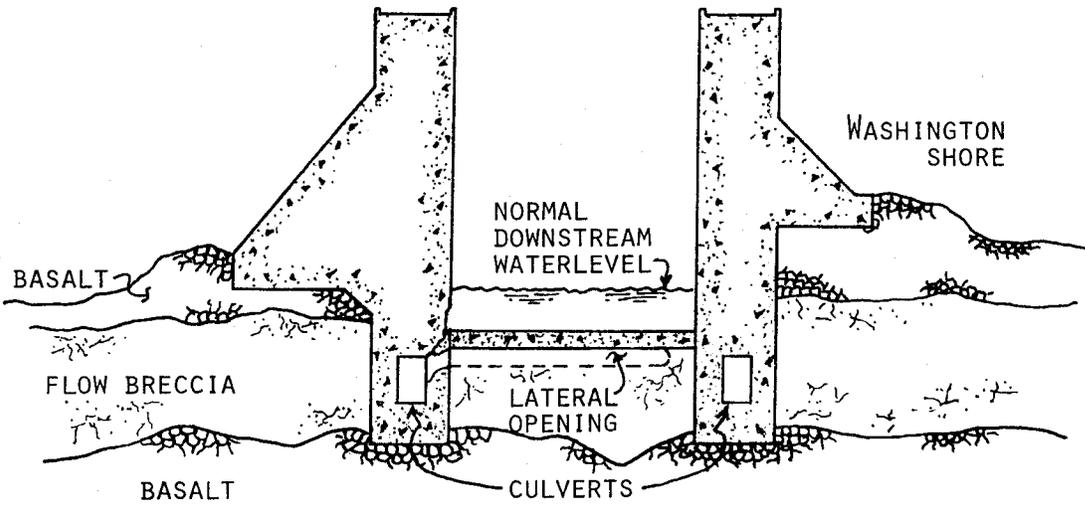
During an inspection in 1975, significant structural cracking and related spalling were discovered in two of the lock monoliths, monoliths 17 and 19. By 1979, cracking and spalling had been detected in four additional monoliths, monoliths 13, 15, 21, and 23. The structural distress in the monoliths consisted of cracks that originated at and propagated from the upper inside corner of the filling and emptying culvert and terminated at the surface of the wall in the lock chamber. Because of the continued progression of the cracking and spalling, a series of remedial repair procedures were devised and implemented to halt and correct the ongoing deterioration (Adhesive Engineering Bulletin, 1981b, Barlow, 1986, and Neuberger, 1982).

Figure 14. John Day Navigation Lock.

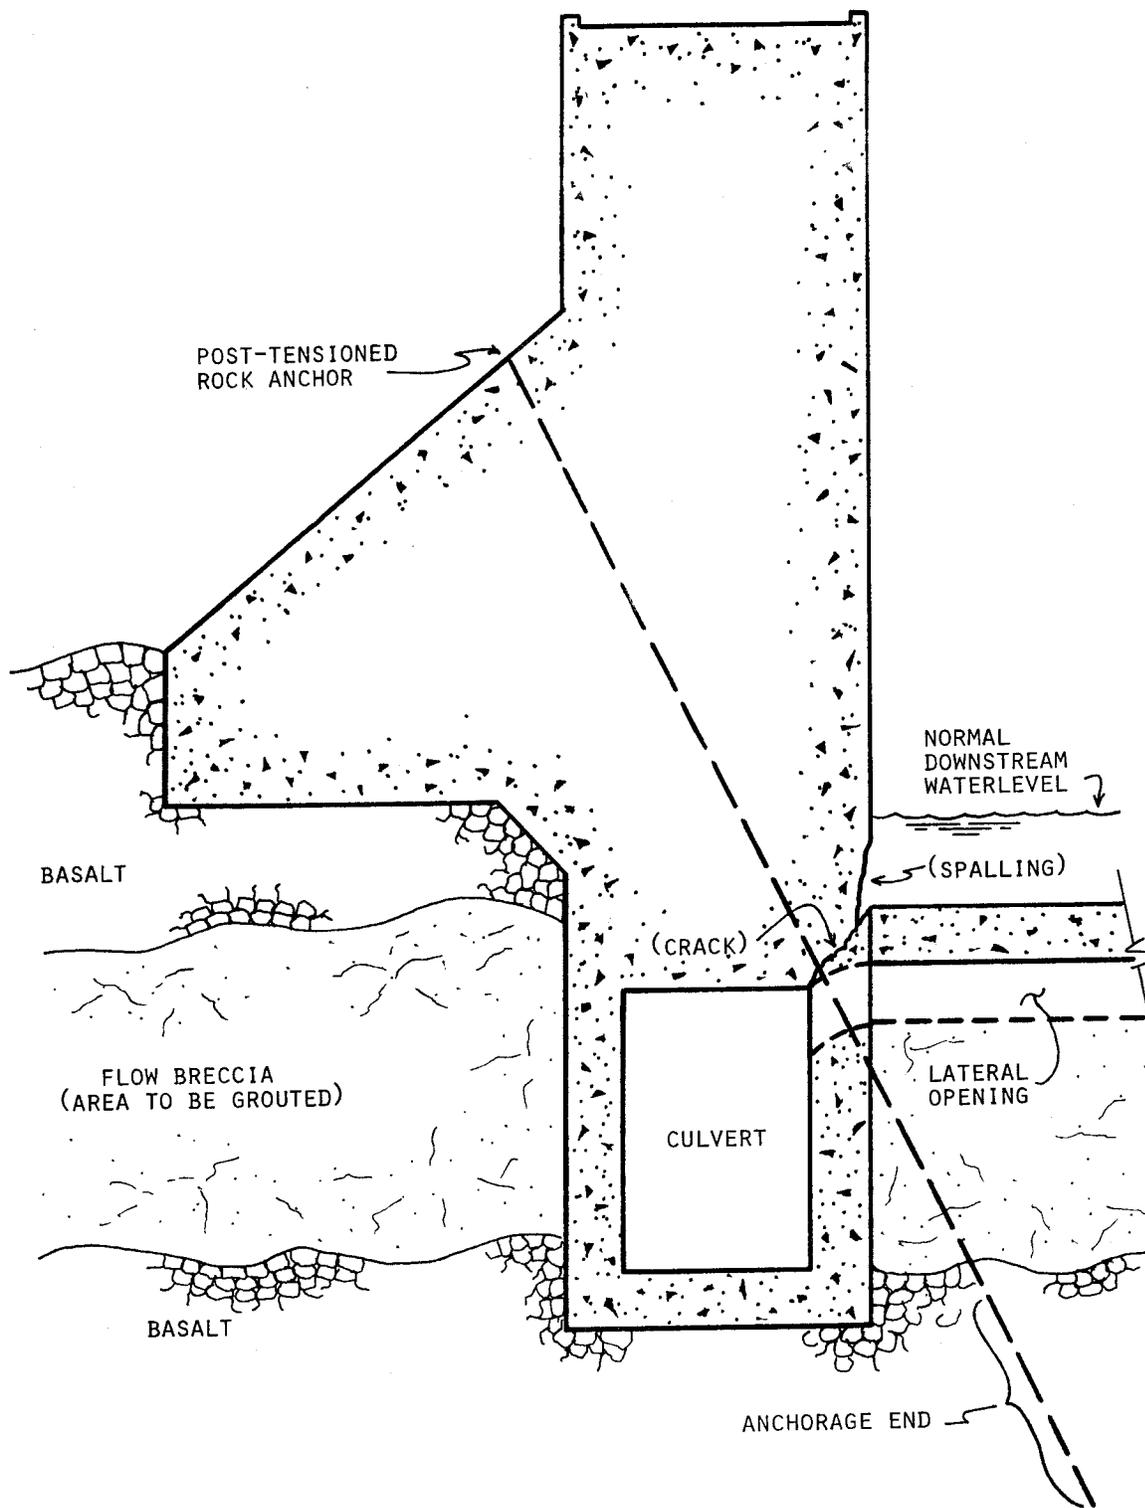
Figure 15. Cross-section of lock wall, showing details of crack location and supporting rock mass.

In 1981, Phase Two of the repair program was performed. This phase of the repair program involved the installation of 73 rock anchors and the injection of structural epoxy adhesive into the crack network. Finite element analysis had shown that the forces induced by the rock bolt anchors would substantially reduce the tensile stresses in the cracked areas at the top of the culvert.

Subsequent to the grouting of the foundation, 10-in. diameter rock anchor holes were drilled from the outside of the monoliths into the basalt rock below. This work was carried on without interrupting lock
