US Army Corps  
of Engineers

TECHNICAL REPORT REMR-CS-4

## REPAIR OF WATERSTOP FAILURES: CASE HISTORIES

James E. McDonald

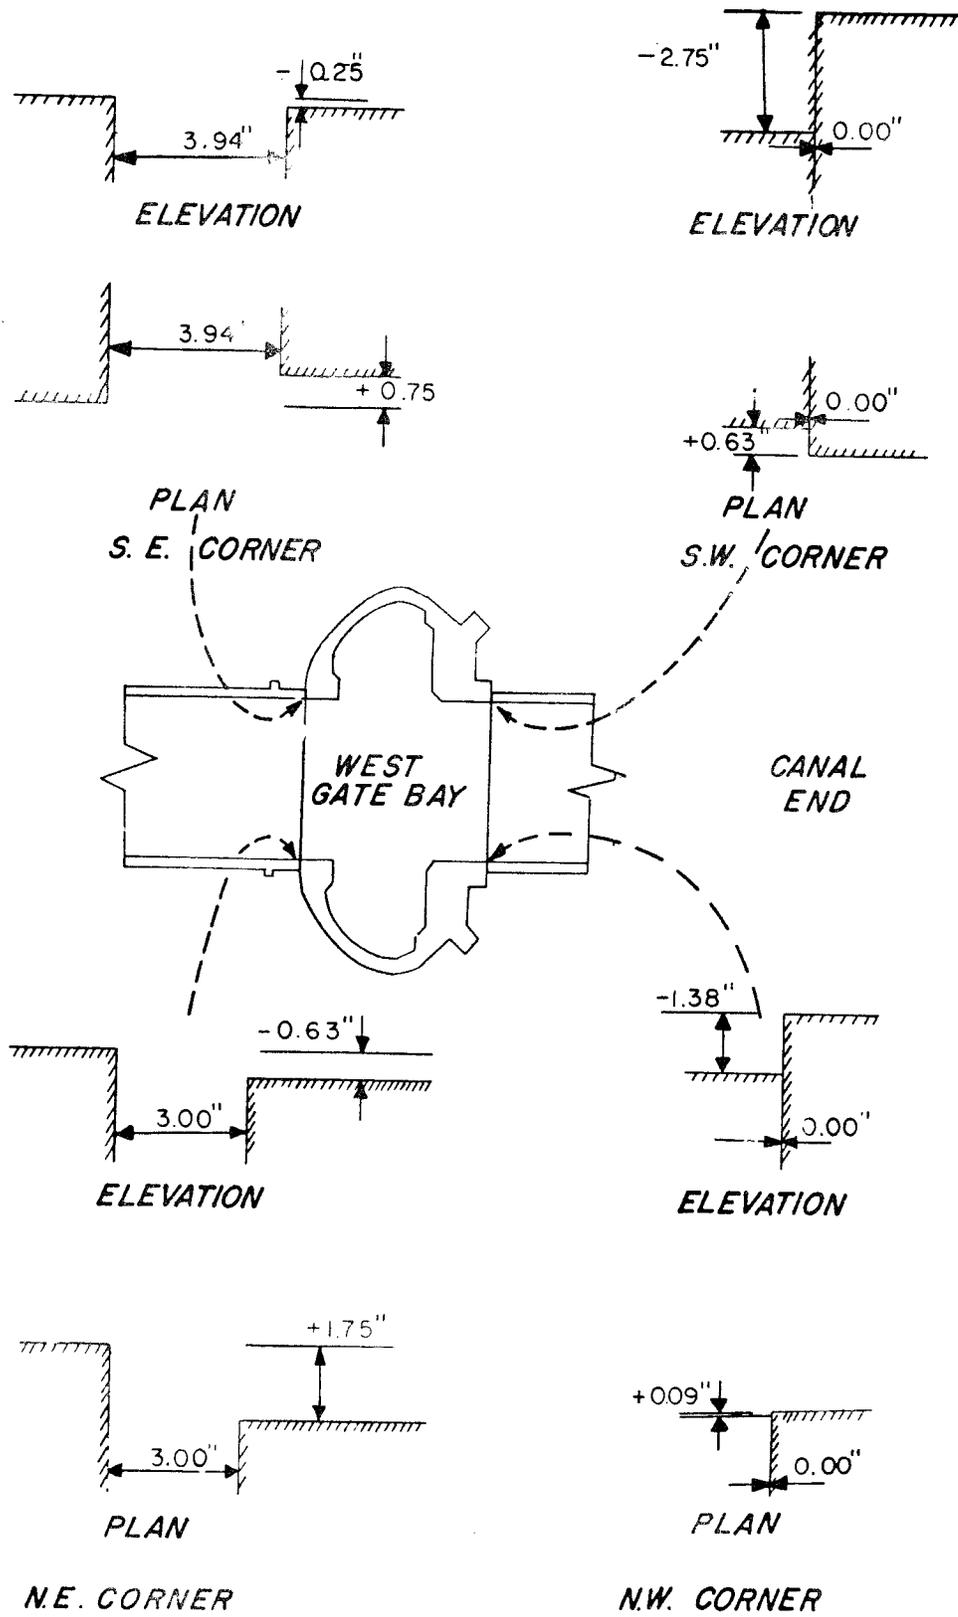
Figure 7. West gate bay joint movements, October 1973, Algiers Lock

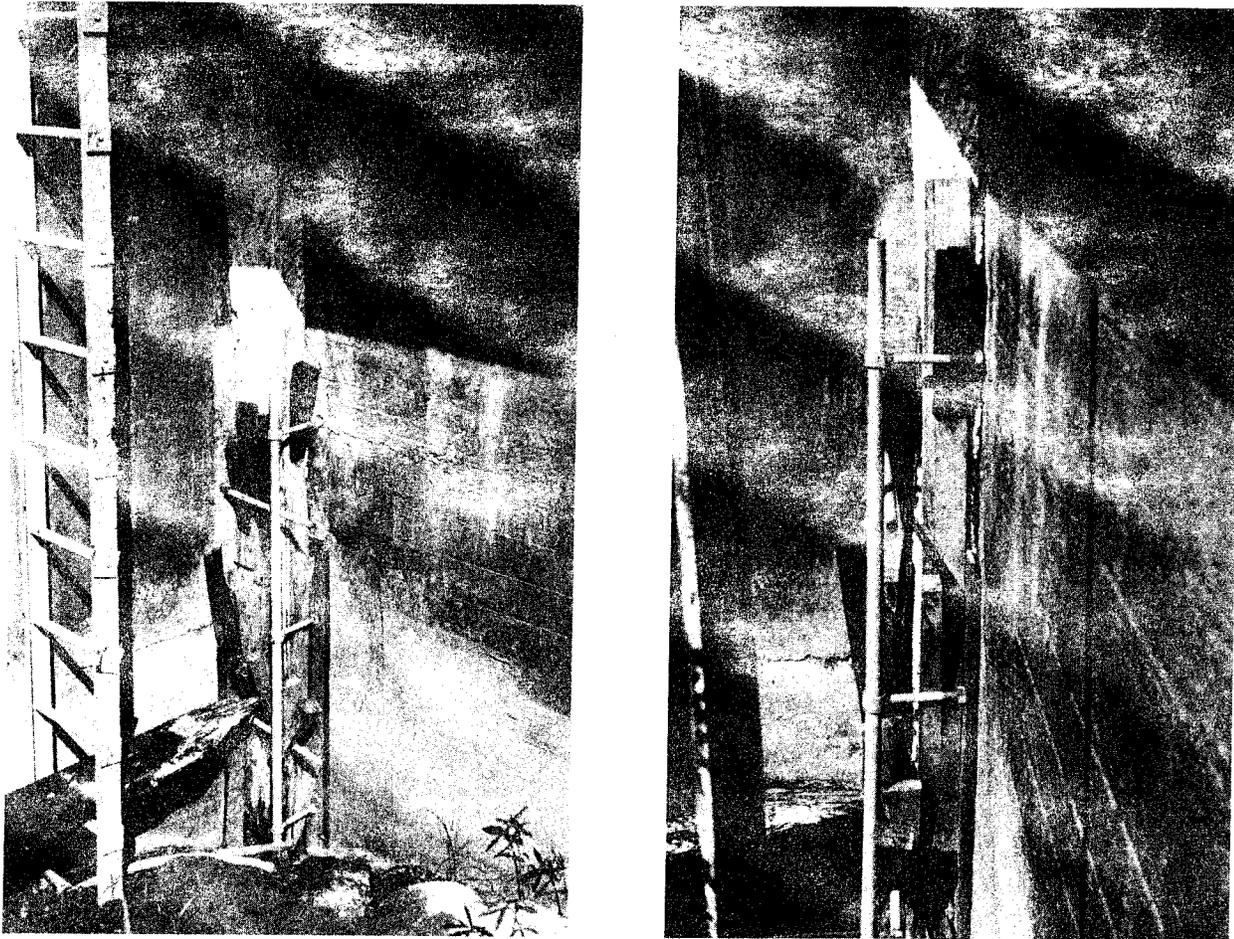
Figure 8. Styrofoam applied over existing rubber waterstop, Algiers Lock

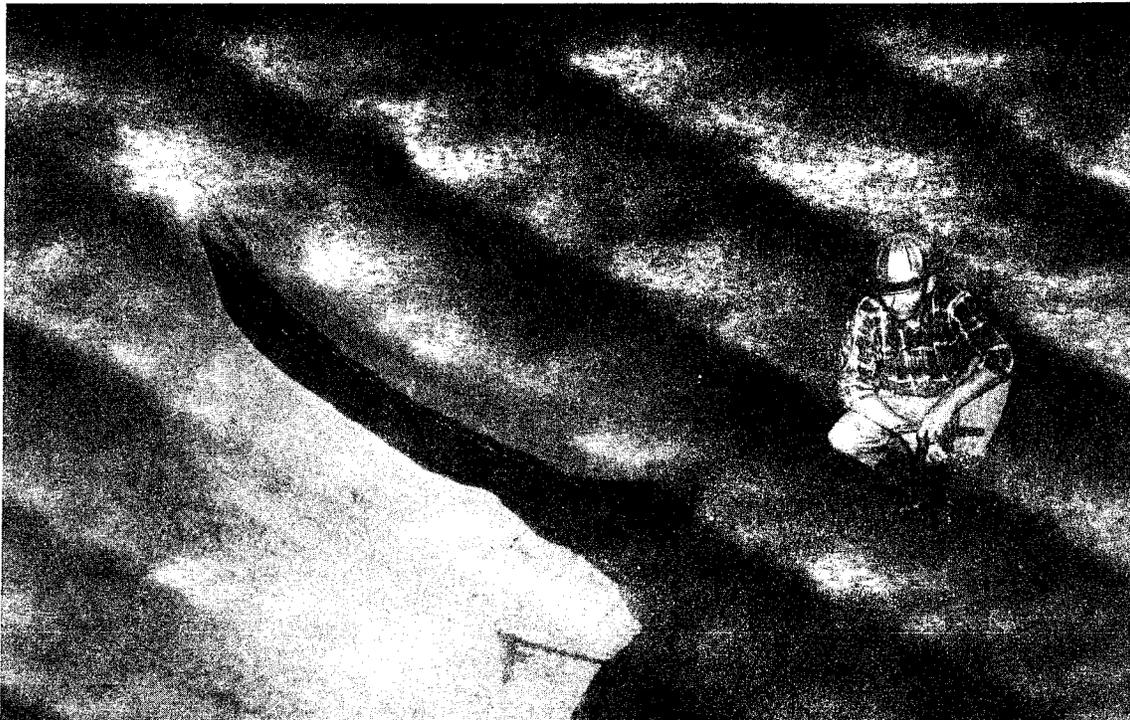
Figure 16. Leakage at conduit joint 4/5, Sardis Dam, 1966

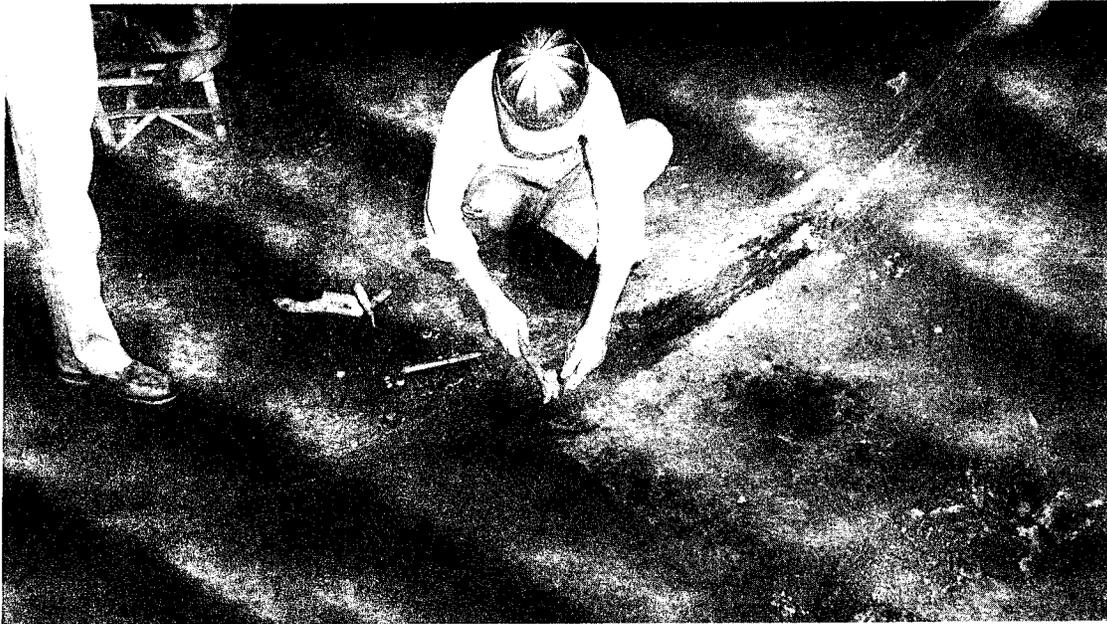
Figure 17. Removal of a portion of the remaining concrete key in preparation for repair, Sardis Dam

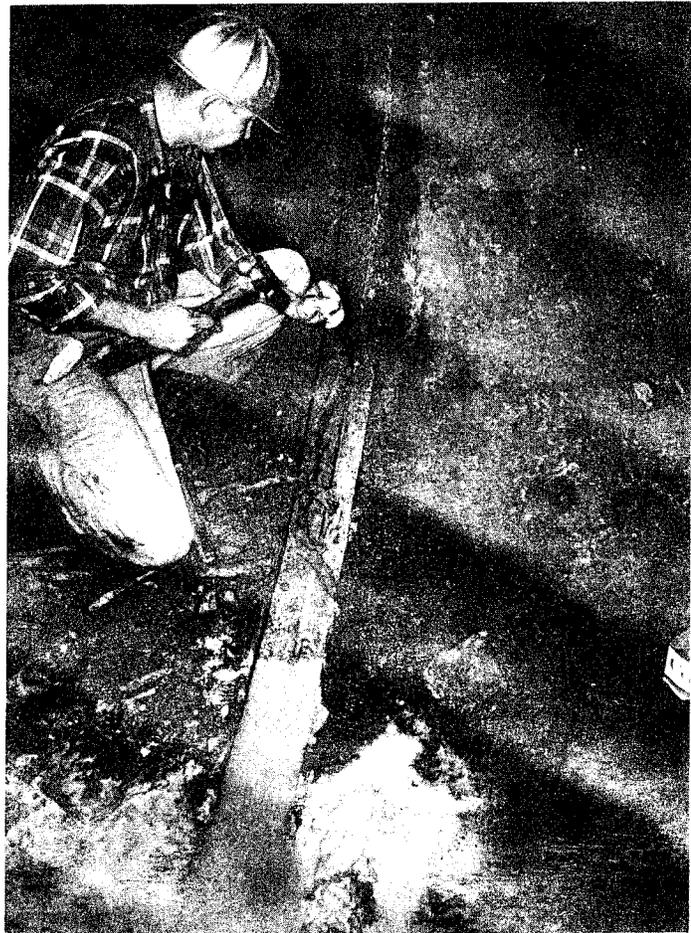
Figure 18. Packing a conduit joint, Sardis Dam

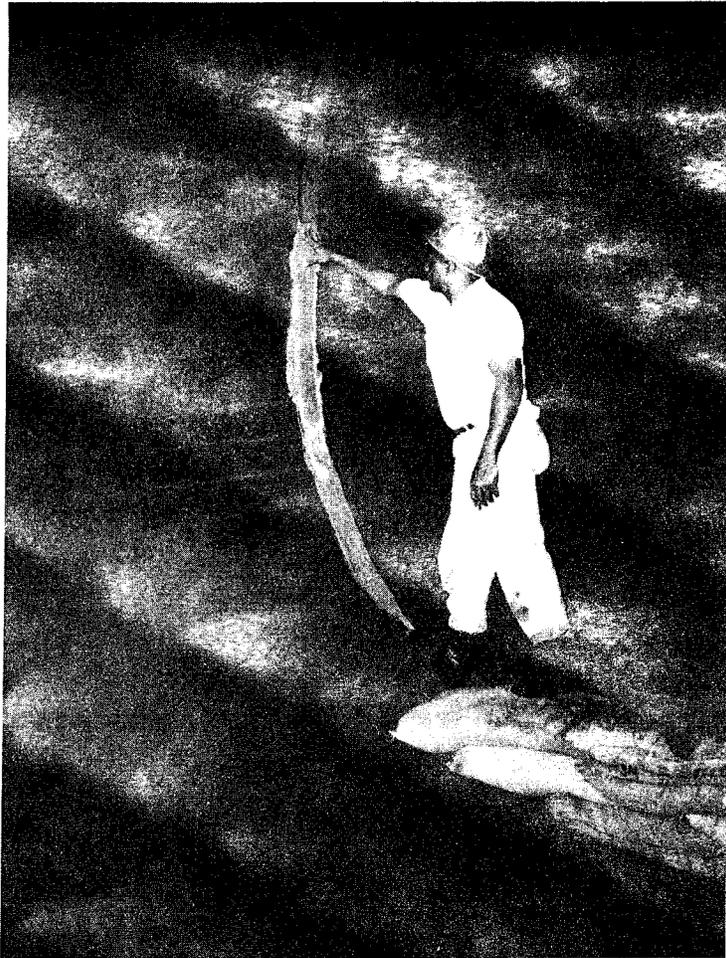
Figure 19. Partially replaced joint keyway,  
Sardis Dam

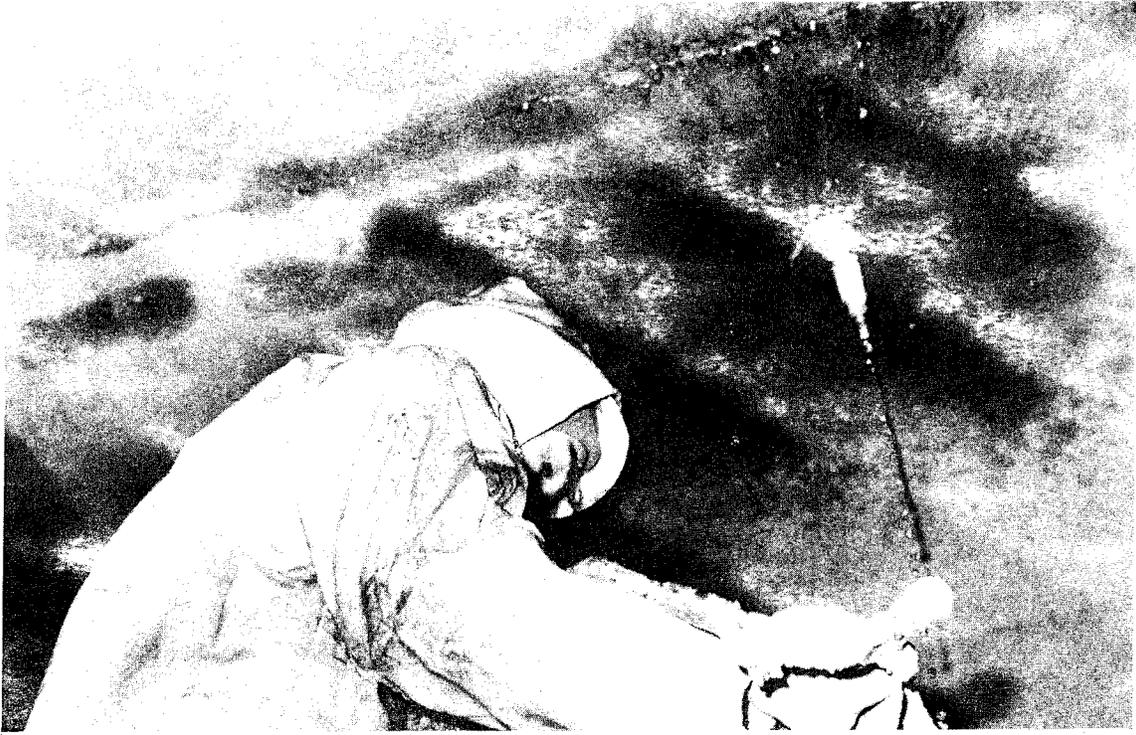
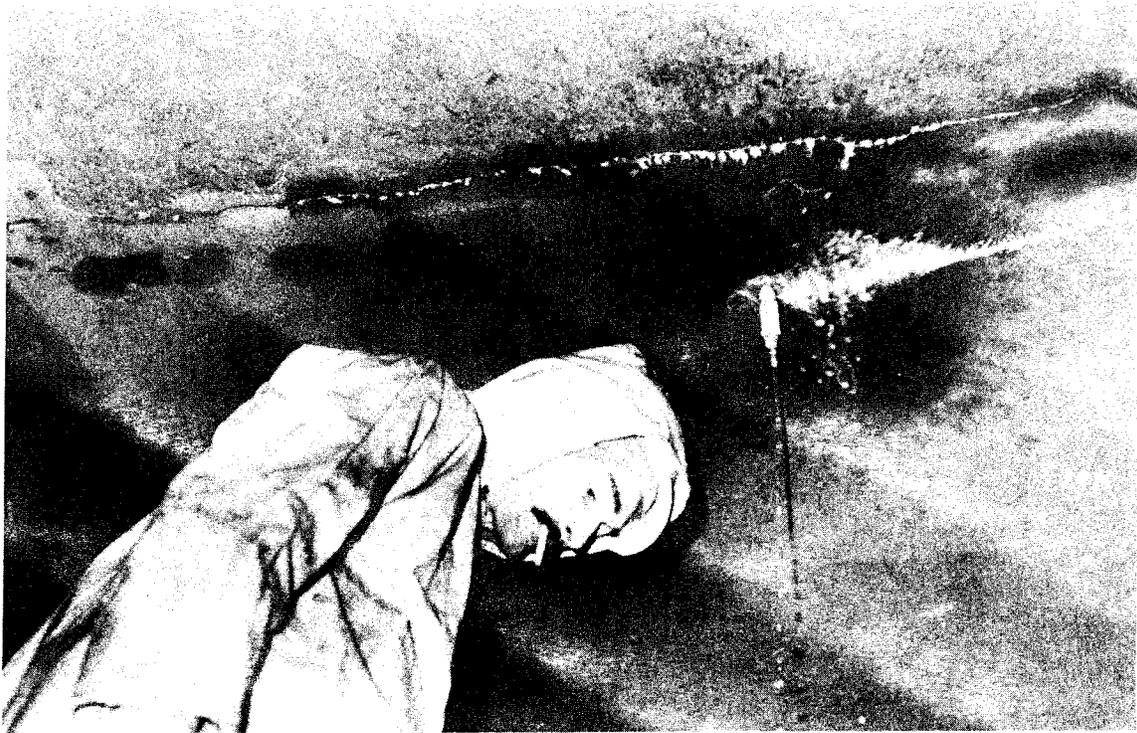
Figure 33. Monolith 10 crack grouting, John Day Lock

a. Prior to grouting

b. Following grouting

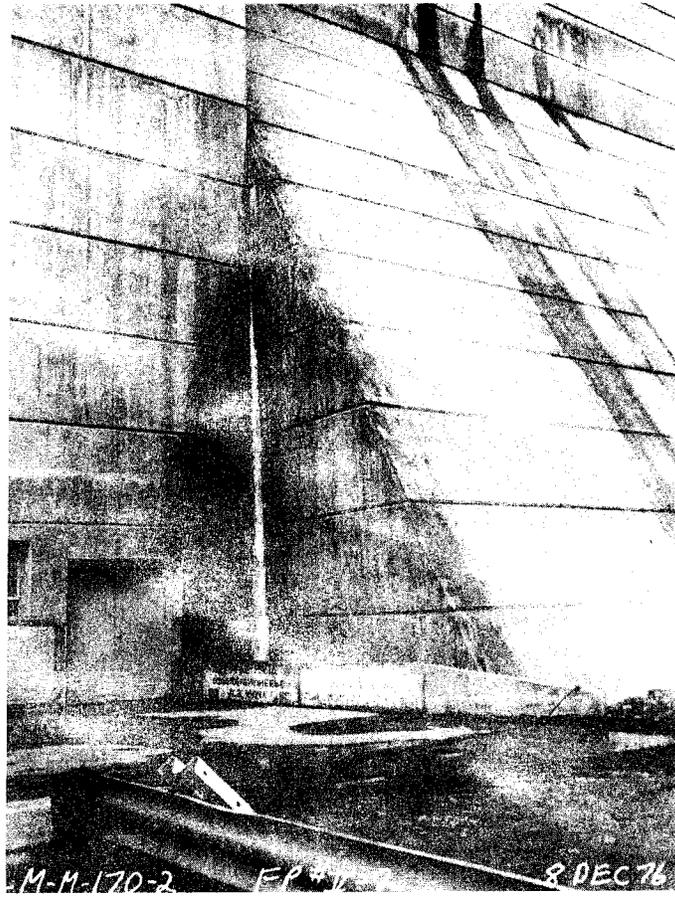
Figure 57. Joint 26/28 leakage, December 1976, Lower Monumental Lock

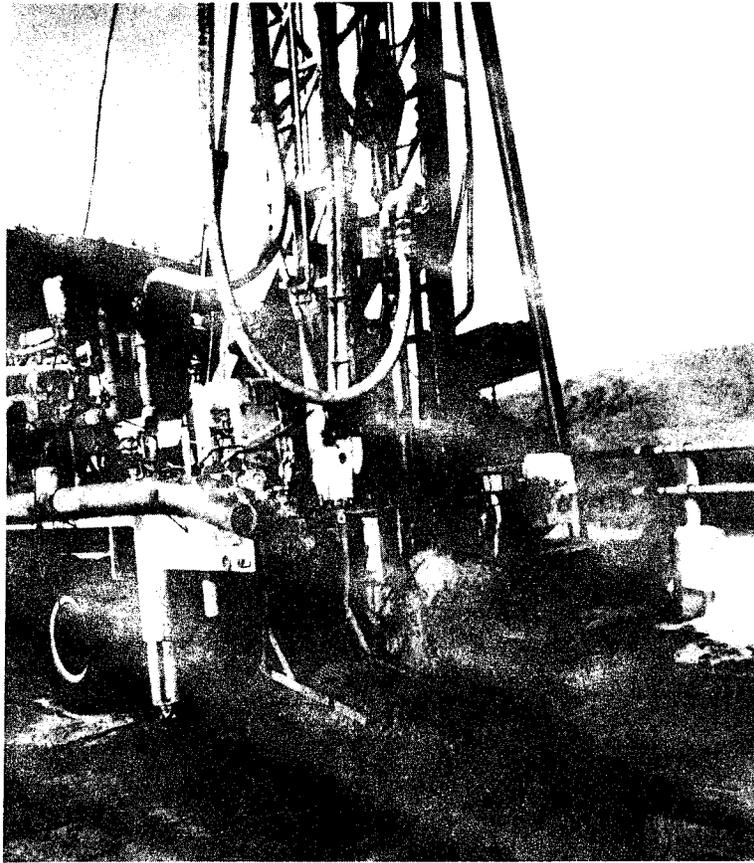
Figure 83. Removal of chemical grout waterstop,  
Pine Flat Dam

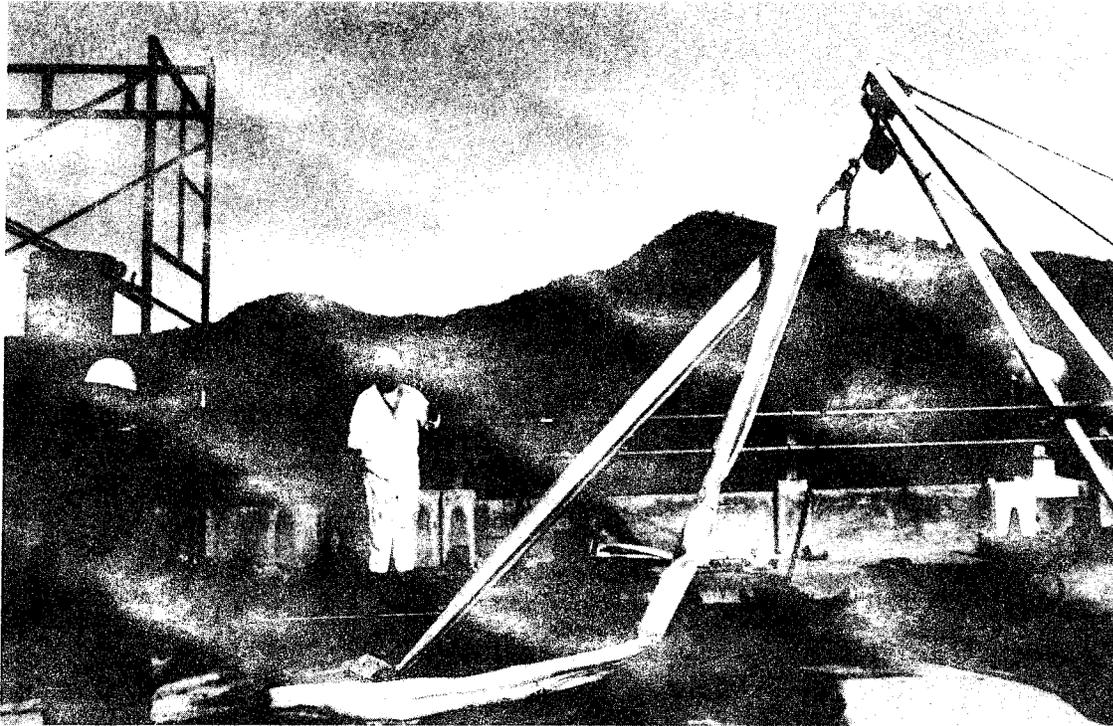
198. An examination of the liner indicated that a stitched seam had failed at a hole depth of approximately 145 ft. This allowed the water to

Figure 106. Removing the aborted tube from hole 29/30, Pine Flat Dam

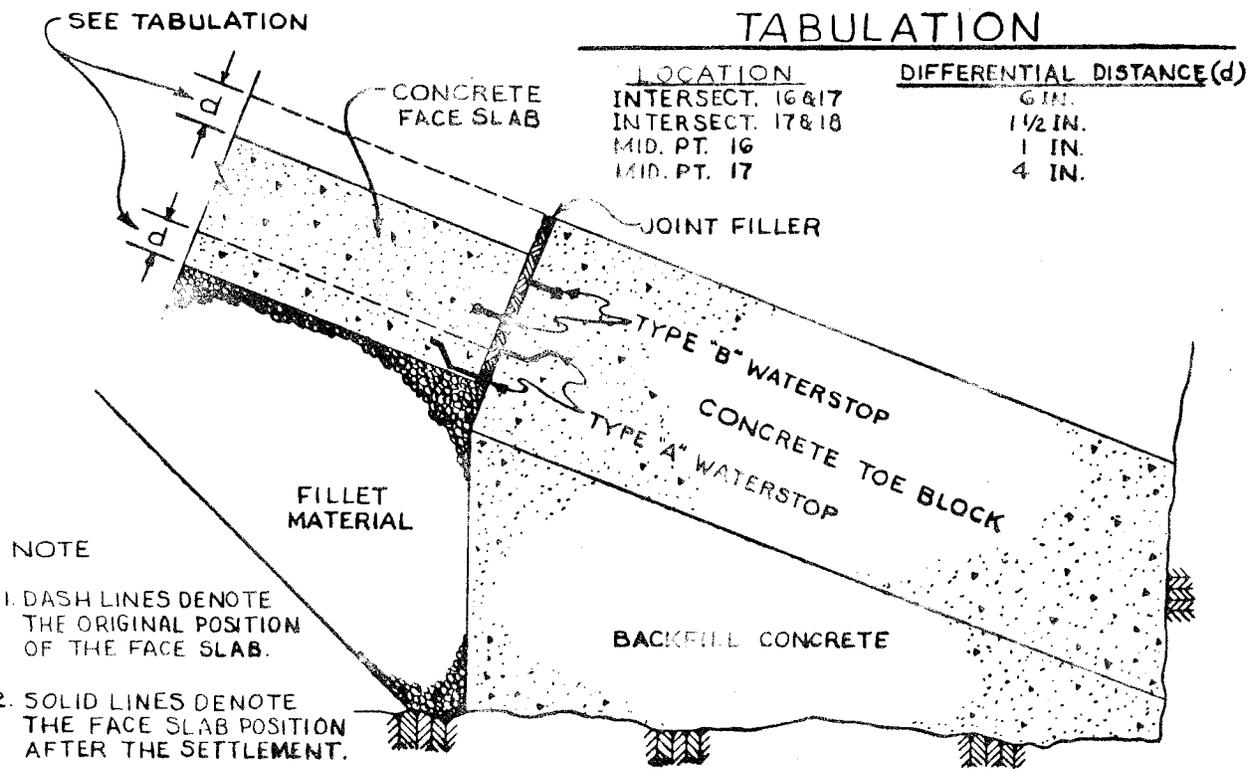
Figure 121. Displacement between face slabs and toe block, R. D. Bailey Dam
