NO. WAL 710/586

Metallurgical Examination of 20 M1 Helmets, Made by the
Schlueter Manufacturing Company, Which Cracked after Aging

29 January 1944

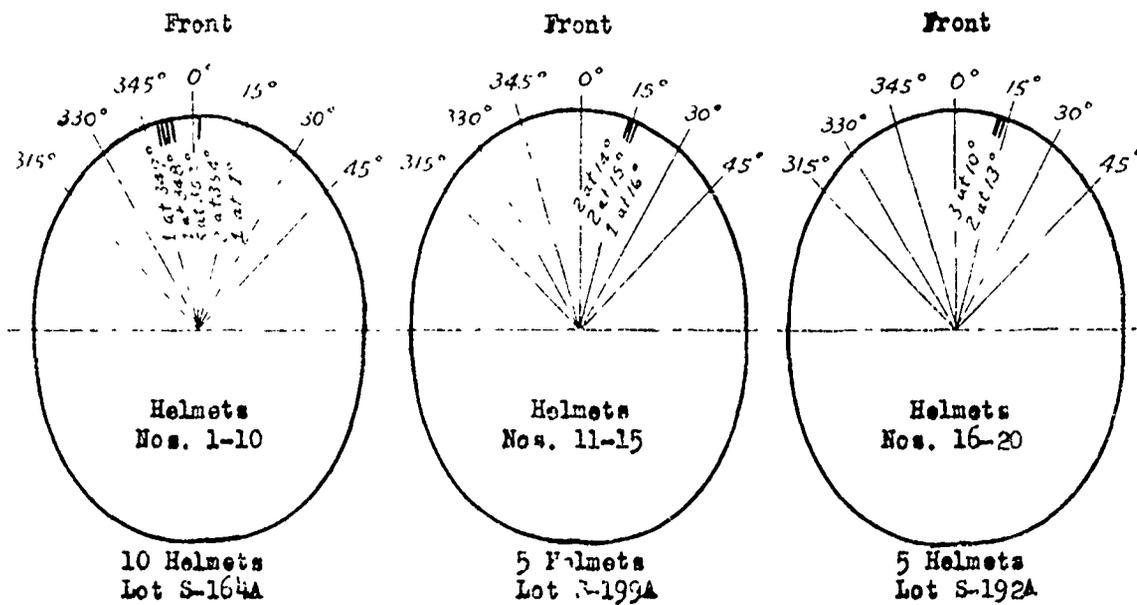
FIGURE 1

Except for one crack, located at 1°, all the cracks from the 10 helmets of Lot S-164A are located in a relatively constant position on each helmet, from 347° to 354°. The cracks on the 5 helmets from Lot S-199A are located from 14° to 16°, and those on the 5 helmets from Lot S-192A are located from 10° to 13°. The constancy of the locations of the cracks on helmets from one lot suggests a trimming die defect producing a notch or edge irregularity in a constant position on a series of helmets from one lot. The trimming dies apparently become quickly chipped, particularly in the region of the visor. This is indicated by the large number of notches and irregularities observed on hundreds of helmets.

Locations of Cracks on 20 Helmets Manufactured by the
 Schluster Manufacturing Company
