REPORT NO. 710/201

EXAMINATION OF SLUGS FROM ARMOR PLATE  
SUBJECTED TO HIGH VELOCITY BULLET IMPACT

June 30, 1937

WATERTOWN ARSENAL  
WATERTOWN, MASS.

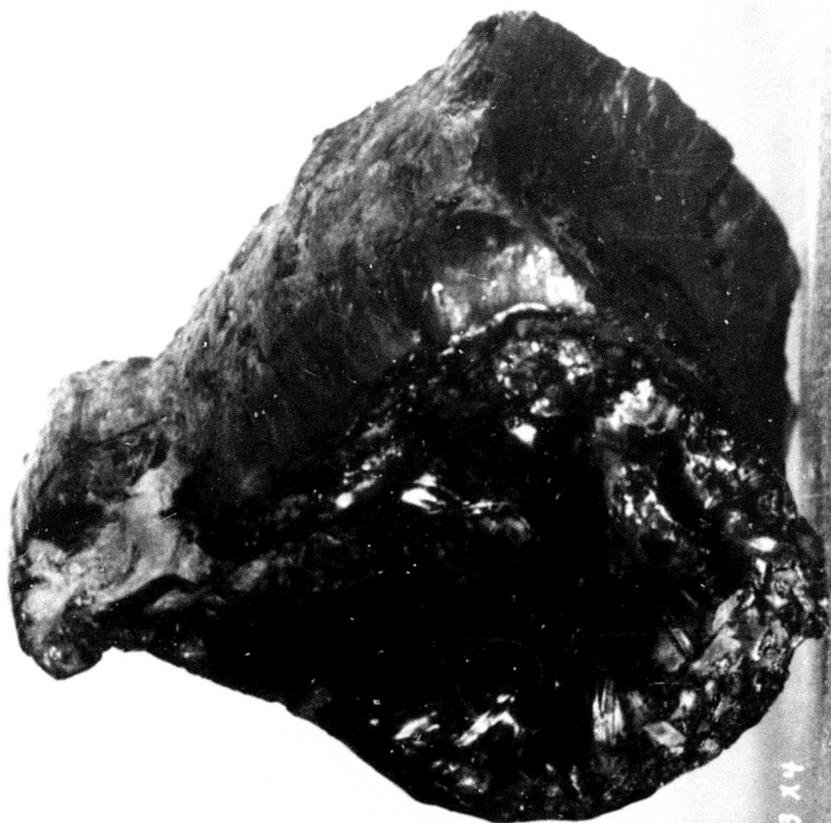
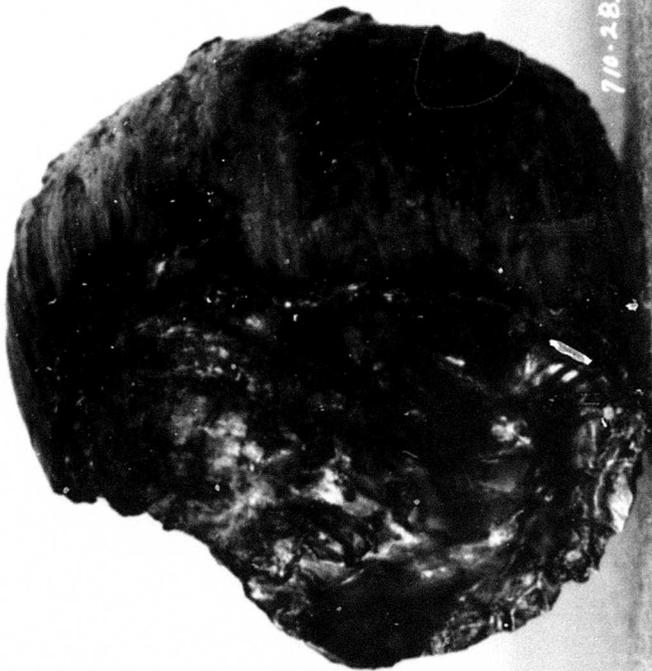
Figure 1

The appearance of the slugs as received is shown in Figure 1.

Photographs of Slugs

Showing battered surface of slugs  
attacked by bullet.

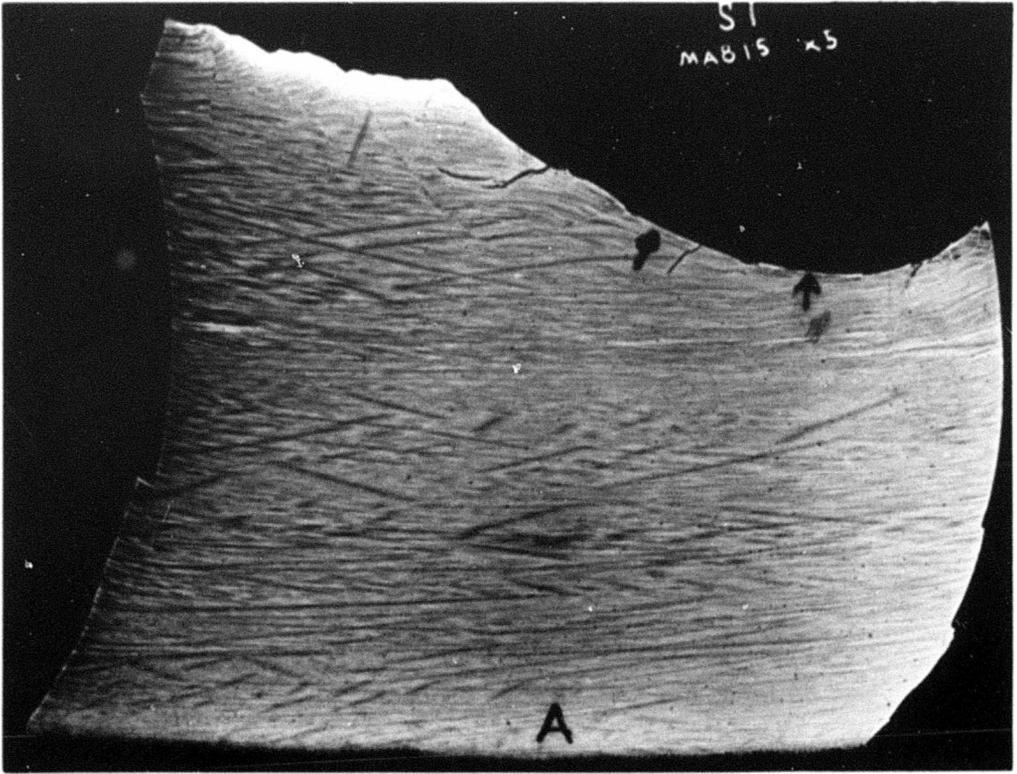
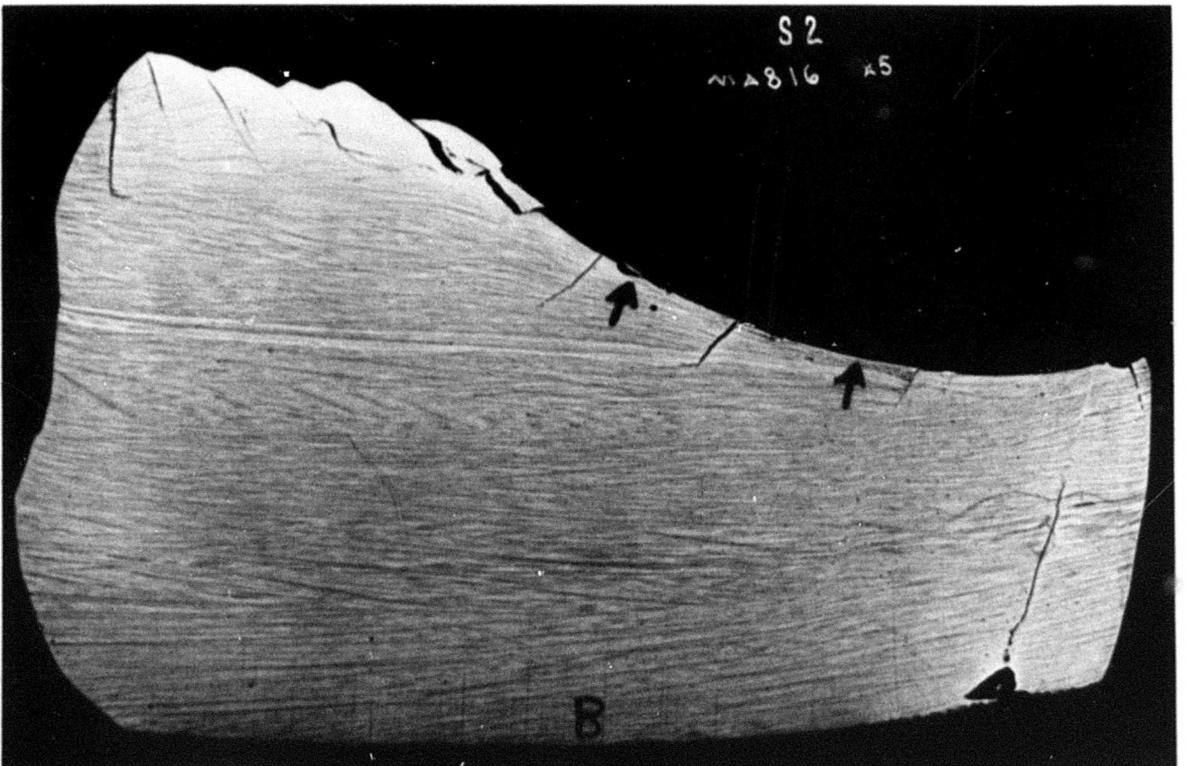
A macroscopic study of sections cut through the slugs shows the presence of dendritic segregation elongated in the direction of rolling, Figure 2. Also, faulting of the metal and white layer is evident near the face of impact and areas adjacent.

An examination of the macrostructures in Figure 2 shows failure occurring along some of the white layers which are oriented in many directions with respect to the direction of impact. In a few cases, however, the white layers associated with crack systems partially follow the contour of the sheared surfaces of the slugs. This indicates that the shearing out of the slugs may have occurred along the white layers.

(a) X5 Punching #S1. Etched Oberhoffer's  
Reagent. MA 815

(b) X5 Punching #S2. Etched Oberhoffer's  
Reagent. MA 816

In both samples, deformed dendritic segregation is evident in the direction of rolling. Also faulting of the metal and white layer is evident at area of impact. See arrows.

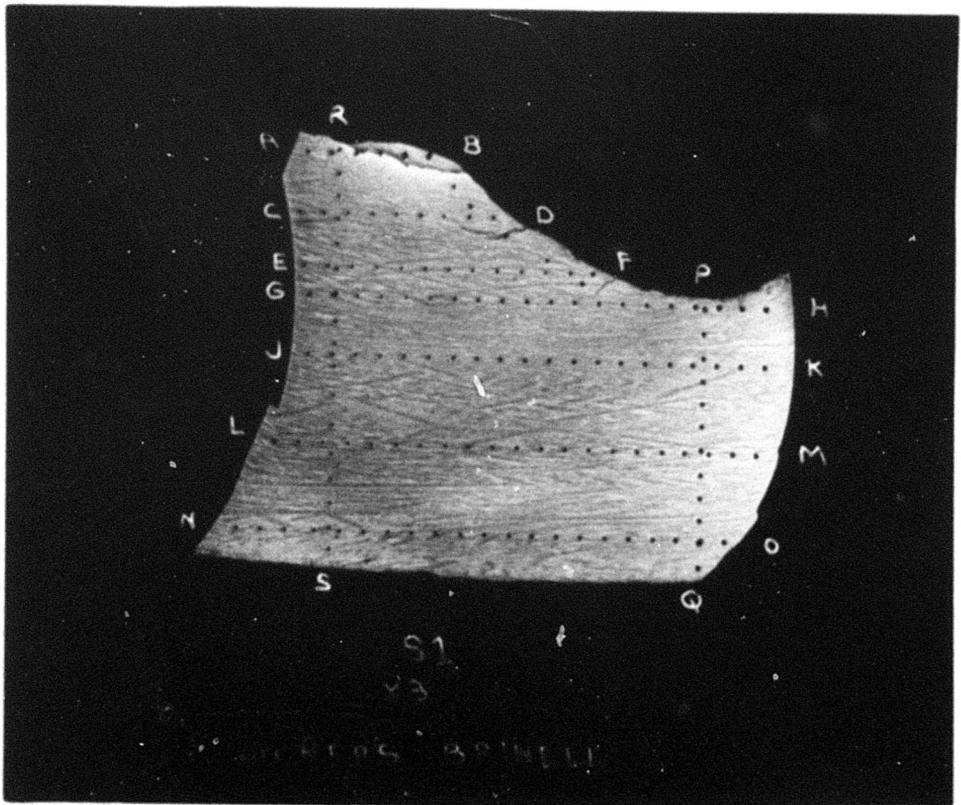
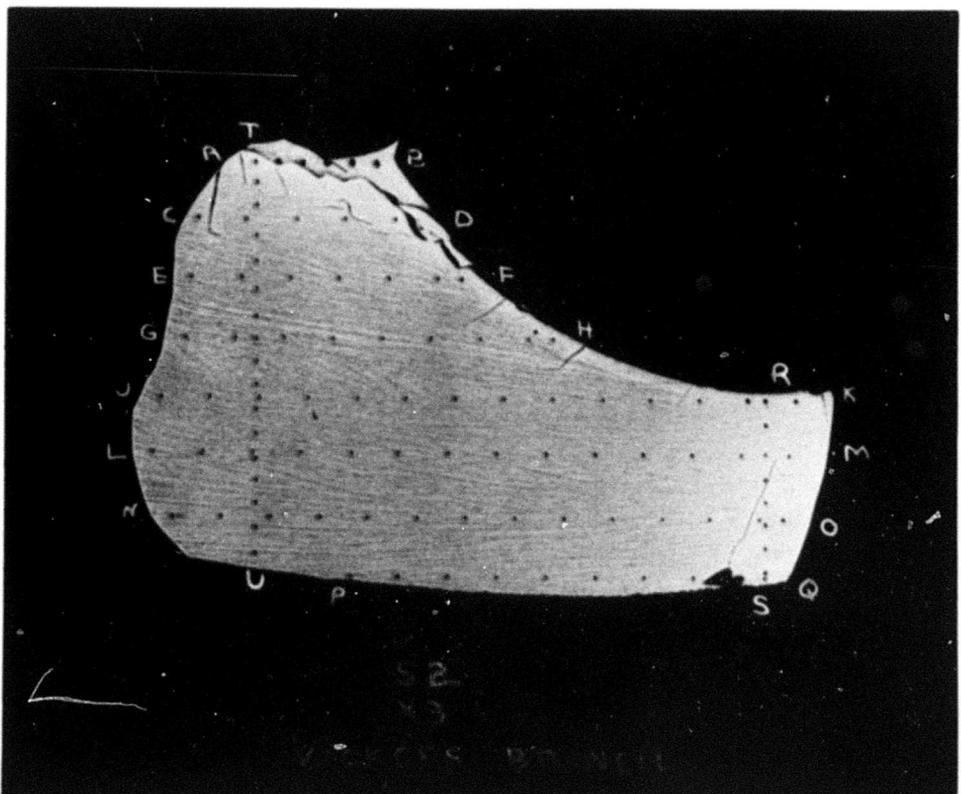
Figure 2a.

Small fragments of bullet core were attached to the slugs near the surface hit by the bullets, see Figures 2a-1, 2a-2. The structure of the fragments is typical of cold-worked medium high carbon steel, see Figures 3a, b, and d. The microstructure of the slugs in each case is typical of acicular troostite (see Figure 3c). The grain size is relatively coarse.

- (1) X3 #S1. Showing hardness surveys, results of which are given in Figures 6 and 7. Also remnant of bullet core shown at R-B.

- (2) X3 #S2. Showing hardness surveys, results of which are given in Figures 7 and 8. Also remnant of bullet core shown at T-B.

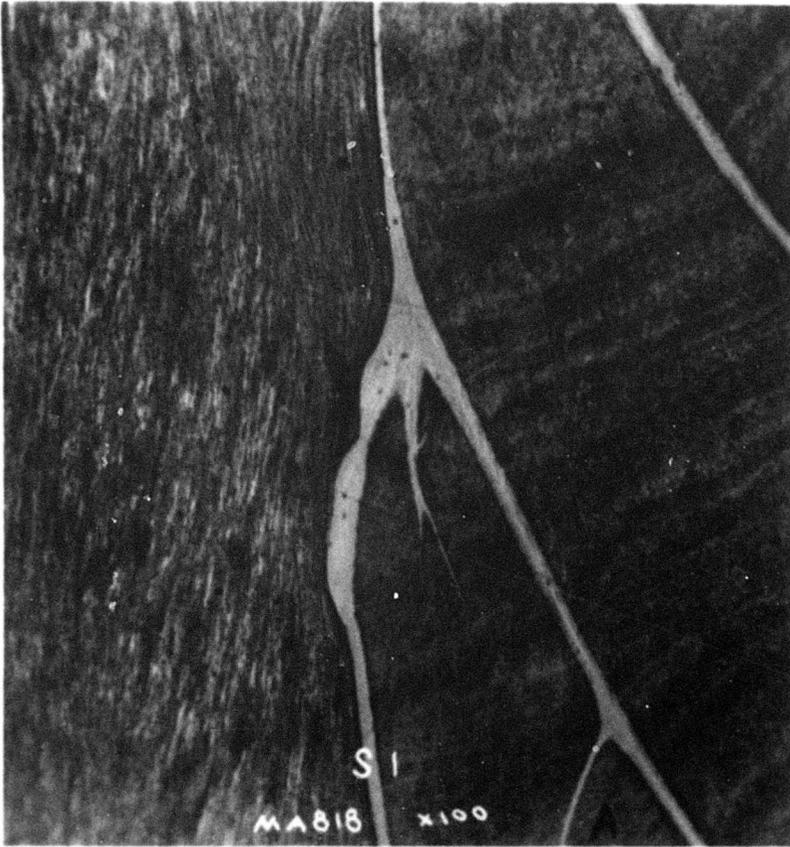
(a) X100 #S1. Base metal of slug to right of white layer, with layer branching into it. At the left, a foreign matter coating parts of the penetration, and not shown in Figures 1a and b, because of etching difficulties. We assume this material to be part of the bullet core which adhered to the plate.

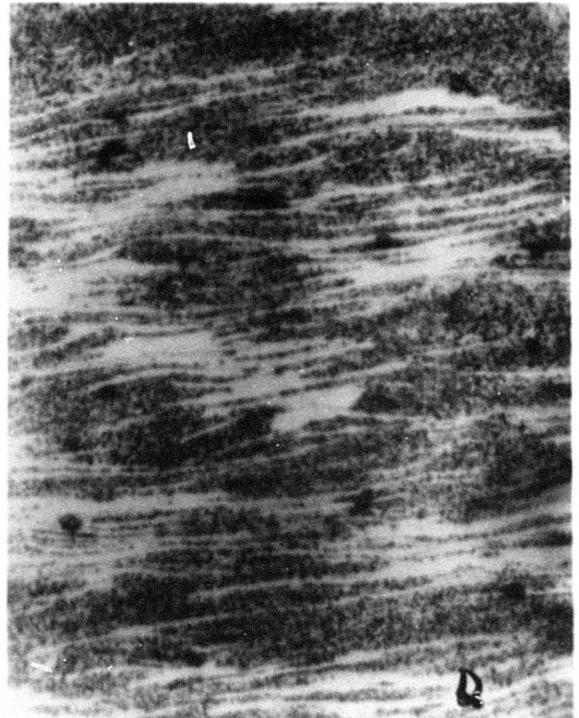
(d) X1000 #S1. Bullet core, badly distorted by cold work. Lower carbon, possibly poorly heat treated because of the considerable ferrite areas present in the sorbite. Scattered nonmetallic inclusions. This is typical of both specimens.

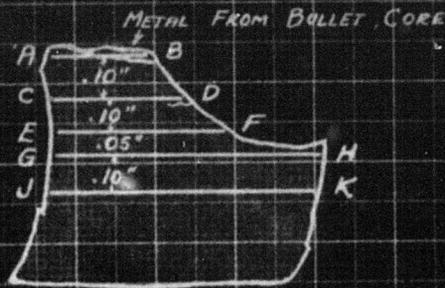
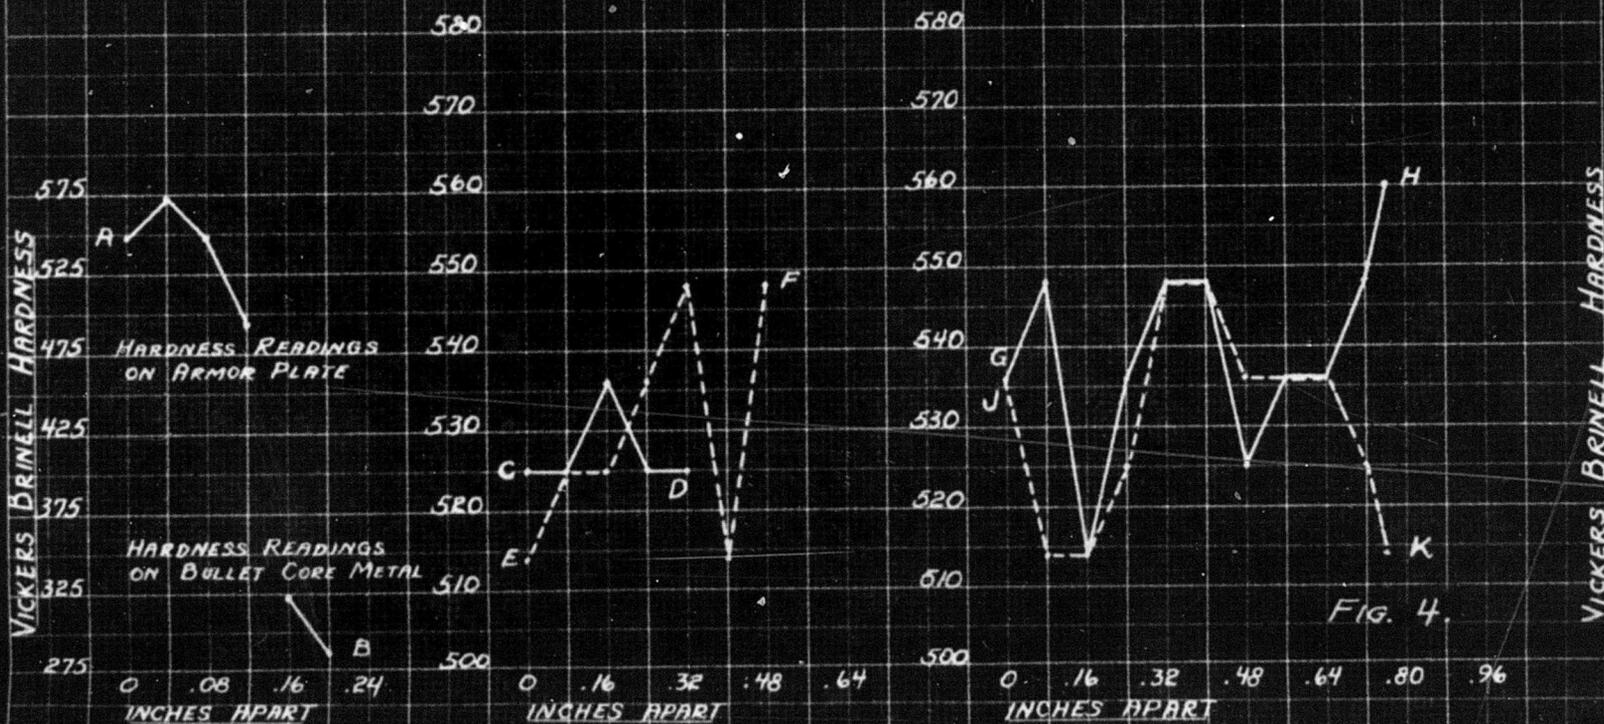
FIG. 4.

The hardness surveys of slugs S-1 and S-2 are given in Figures 4, 5, 6 and 7. It is evident that the metal was severely work hardened at the area of impact. Hardness surveys reveal the presence of the remnant of the medium high carbon bullet core stock at the surface of impact.

HARDNESS SURVEY OF SLUGS SHOT  
FROM ARMOR PLATE

SLUG No. 51

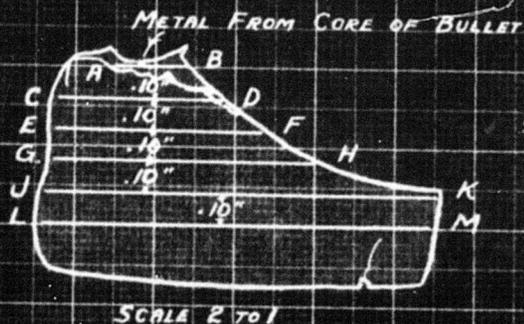
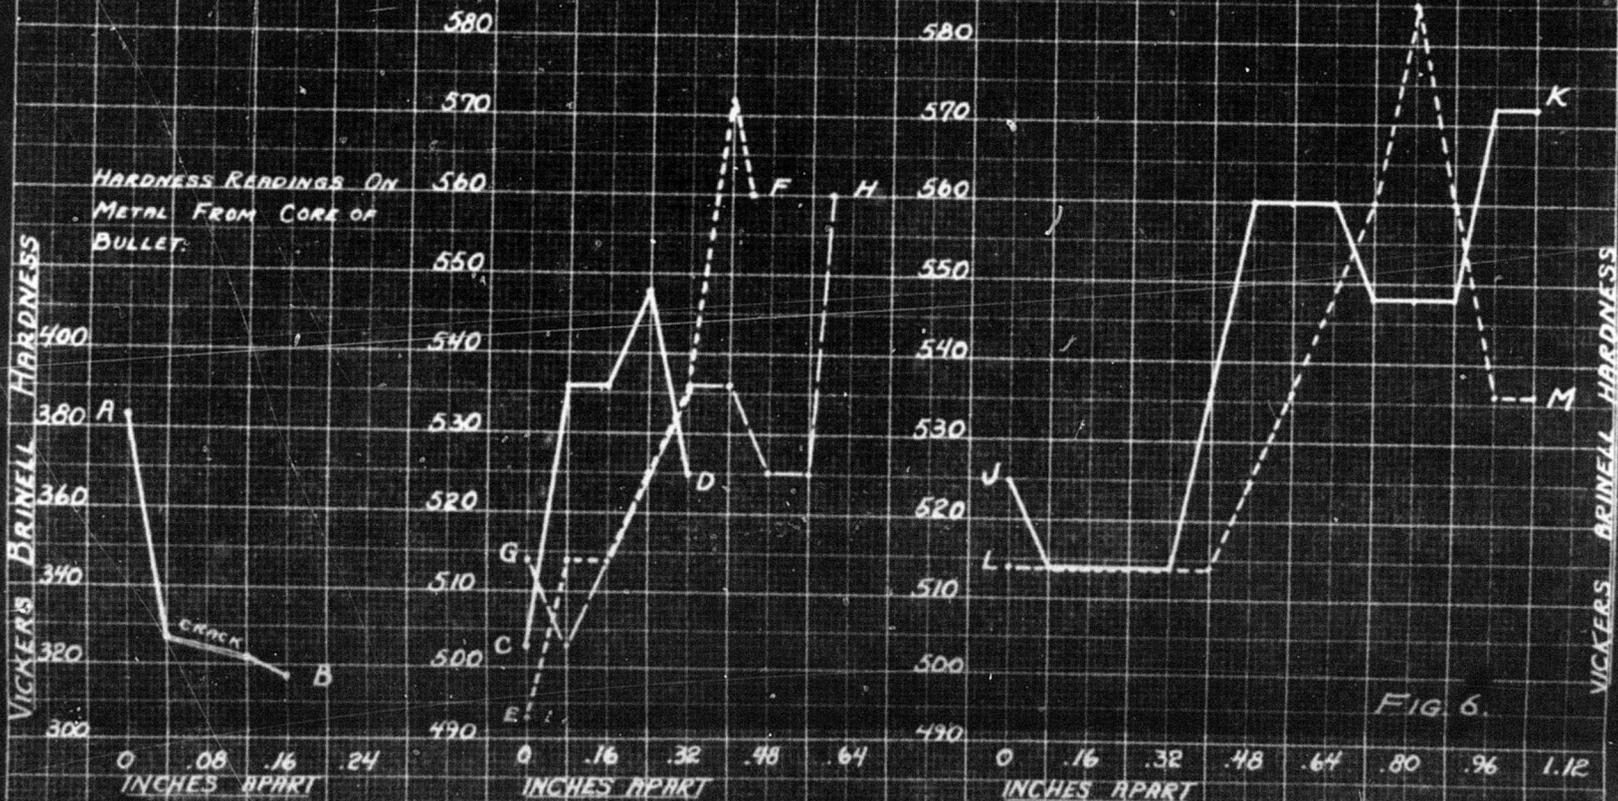
FIG. 6.

HARDNESS SURVEY OF SLUGS SHOT  
FROM ARMOR PLATE.

SLUG No. 52.
