1. Report No. NASA TM-X-71867		2. Government Accession No.		3. Recipient Catalog No.	
4. Title and Subtitle OH-58 HELICOPTER TRANSMISSION FAILURE ANALYSIS				5. Report Date

OH-58 HELICOPTER TRANSMISSION FAILURE ANALYSIS

by D. P. Townsend, J. J. Coy, and B. R. Hatvani

Lewis Research Center and
U.S. Army Air Mobility R&D Laboratory

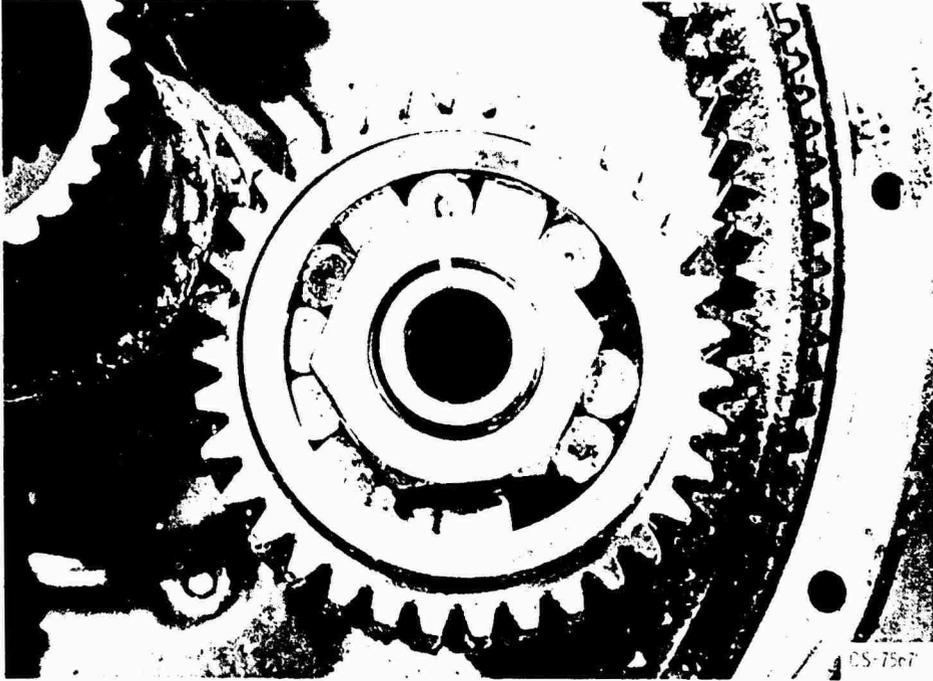
The rate of increase of the pinion temperatures slowed until at approximately 14 minutes the rate began to increase again (figs. 8(a) and (b)). These increases in temperature were caused by additional planet bearing cages melting which allowed the spherical rollers in the planet gear bearings to tumble and slide within the bearings (fig. 11).

Figure 11. - Planet gear support bearing. Badly misaligned and skewed rollers caused high vibration and temperature levels.

3. Change the spherical roller bearings to cylindrical roller bearings with rigid straddle mounting to replace the overhung mounting. This change would reduce the heat generation in the planet bearing up to 30 percent. Further testing would be required.

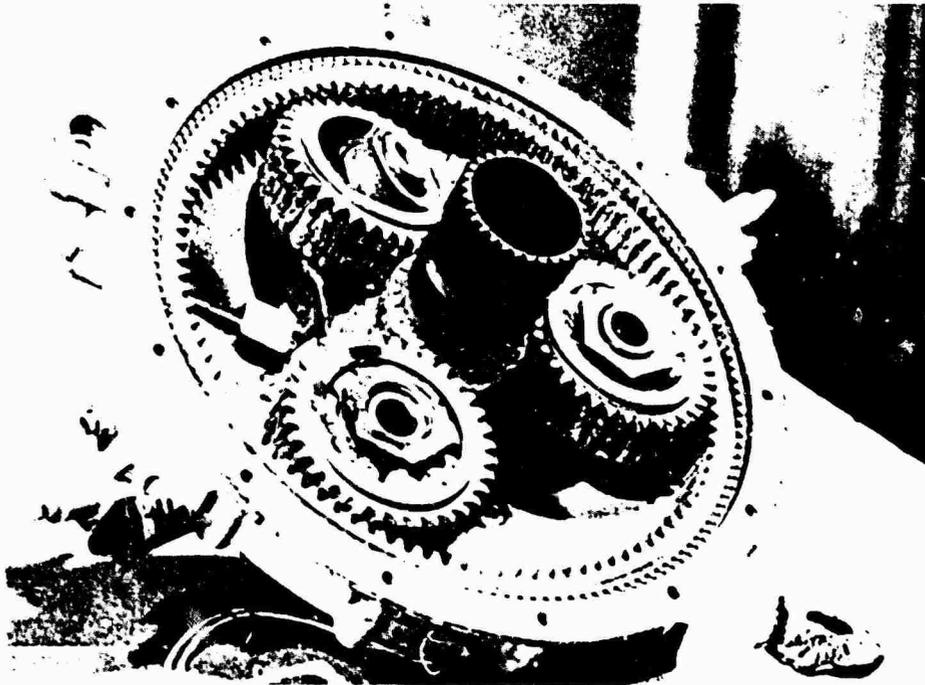
At approximately 27 minutes there is an additional increase in the rate of temperature rise as seen in the planet and (fig. 8(c)), the pinion area (figs. 8(a) and (b)) and to a lesser extent in the bevel gear bearing area (fig. 8(d)). At this point in time the gearbox is approaching complete failure. At these temperatures, the planet gears have very little strength. The lock nut on the planet bearing was being machined by the bevel gear bolt heads (fig. 12). The pinion

Figure 12(a). - Transmission top case with planet gear assembly. Planet lock nut (lower right) was machined to one-fourth original thickness.

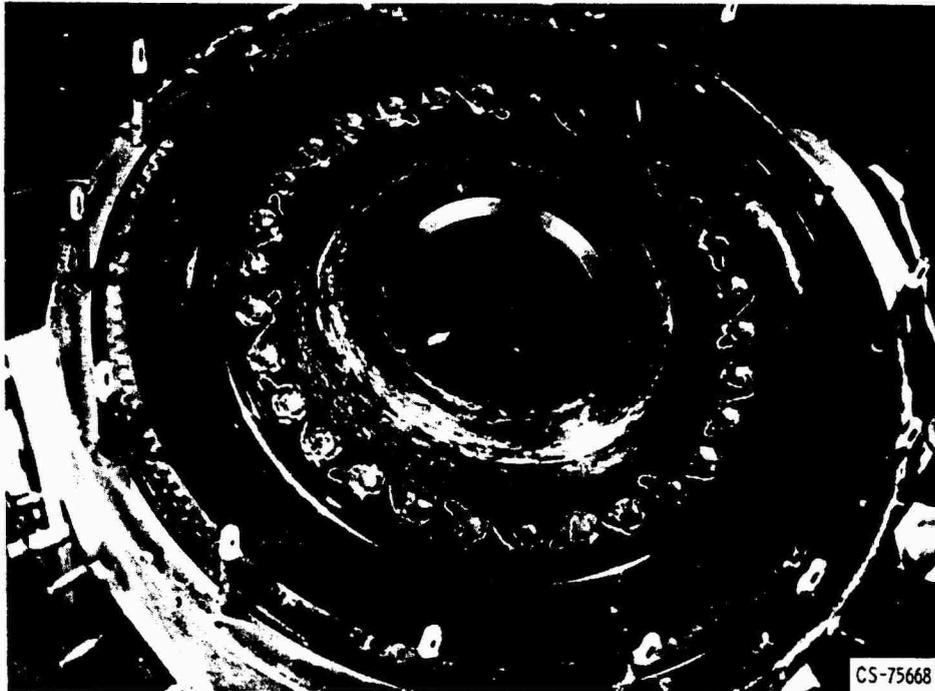
At 27 minutes the vibration levels again increased at the ring gear to the 30 to 40 g level. At that time the shaft nut was being struck by the bevel gear support bolts which were immediately below and on the gear shaft. The relative rotational speed of the planet carrier and the gear shaft was 1300 rpm. The retaining nut was rapidly machined away by the gear shaft bolts. Subsequently, an inner race of one of the spherical roller bearings came off the shaft allowing the spherical rollers to drop out of the bearing. One of the rollers wedged into the ring gear-planetary gear mesh. This caused the planet carrier to lock up. As a result, the teeth on the sun gear were destroyed by the torque overload. At 30 minutes after the oil drain was opened, complete transmission failure occurred.

Figure 12(b). - Transmission lower case with bevel gear shaft and bevel gear mounting bolts showing. Scored area caused by scraping lock-nut is visible.

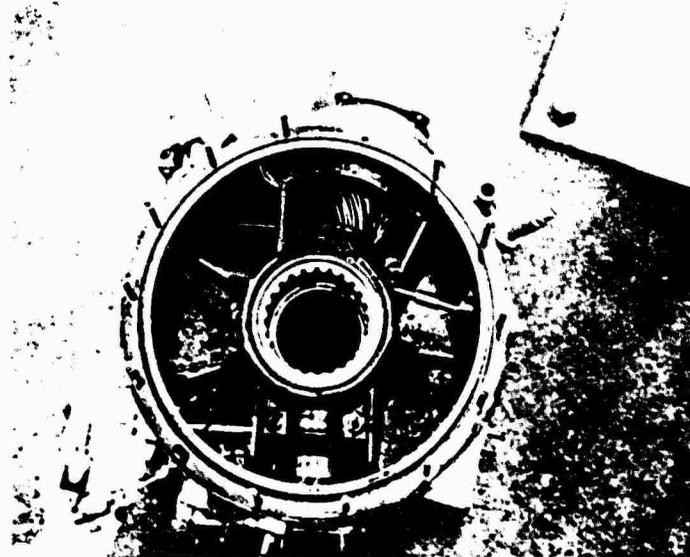
The lower gearbox assembly which comprises the input spiral bevel gear set was not damaged during the survivability test (fig. 19). The maximum temperatures within the lower gearbox assembly were in the range from 325° to 525° F. It would appear from the condition of gearing and bearing components after the survivability test that the materials were adequate for the time duration of the test which was 30 minutes. However, for longer time periods both the bearing and gear materials may be marginal. Consideration should be given to replacing all the bearing materials within the transmission which are AISI 52100, CVM 52 CM, and CVM AISI M-50 with vacuum-induction melted vacuum-arc remelted (VIM-VAR) AISI M-50 steel. This steel has high temperature bearing operating capability to 600° F (refs. 5 and 6) and rolling-element fatigue lives of approximately 20 times current design requirements (ref. 4). Manufacturing specifications incorporating the technology of reference 4 is contained in reference 7.

Figure 19. - Lower gear assembly after survivability test.

Insufficient gear data exists to recommend a high-temperature gear material in place of the AISI 9310 steel currently being used for the bevel gear set. Endurance testing of currently used and prospective gear materials are being performed at the NASA-Lewis Research Center. Out of those potential high-temperature materials studied, Super Nitralloy exhibited lives exceeding AISI 9310 (refs. 8 and 9). Nitralloy N (AMS 6475) is a material which also has high temperature characteristics but has not been endurance tested in rolling-element fatigue. However, this material has found acceptance as a gear material and is used for the sun and ring gear material in the OH-58 transmission. Consideration should be given to changing all the gear materials except as noted below to Nitralloy N (AMS 6475).
