REPORT NO. AML NAM AE 540001

AERONAUTICAL MATERIALS LABORATORY REPORT ON

OPERATION CROSSROADS, TARGET AIRPLANE,
MODEL TEM-3E, SERIAL NO. 69169;
TEST OF

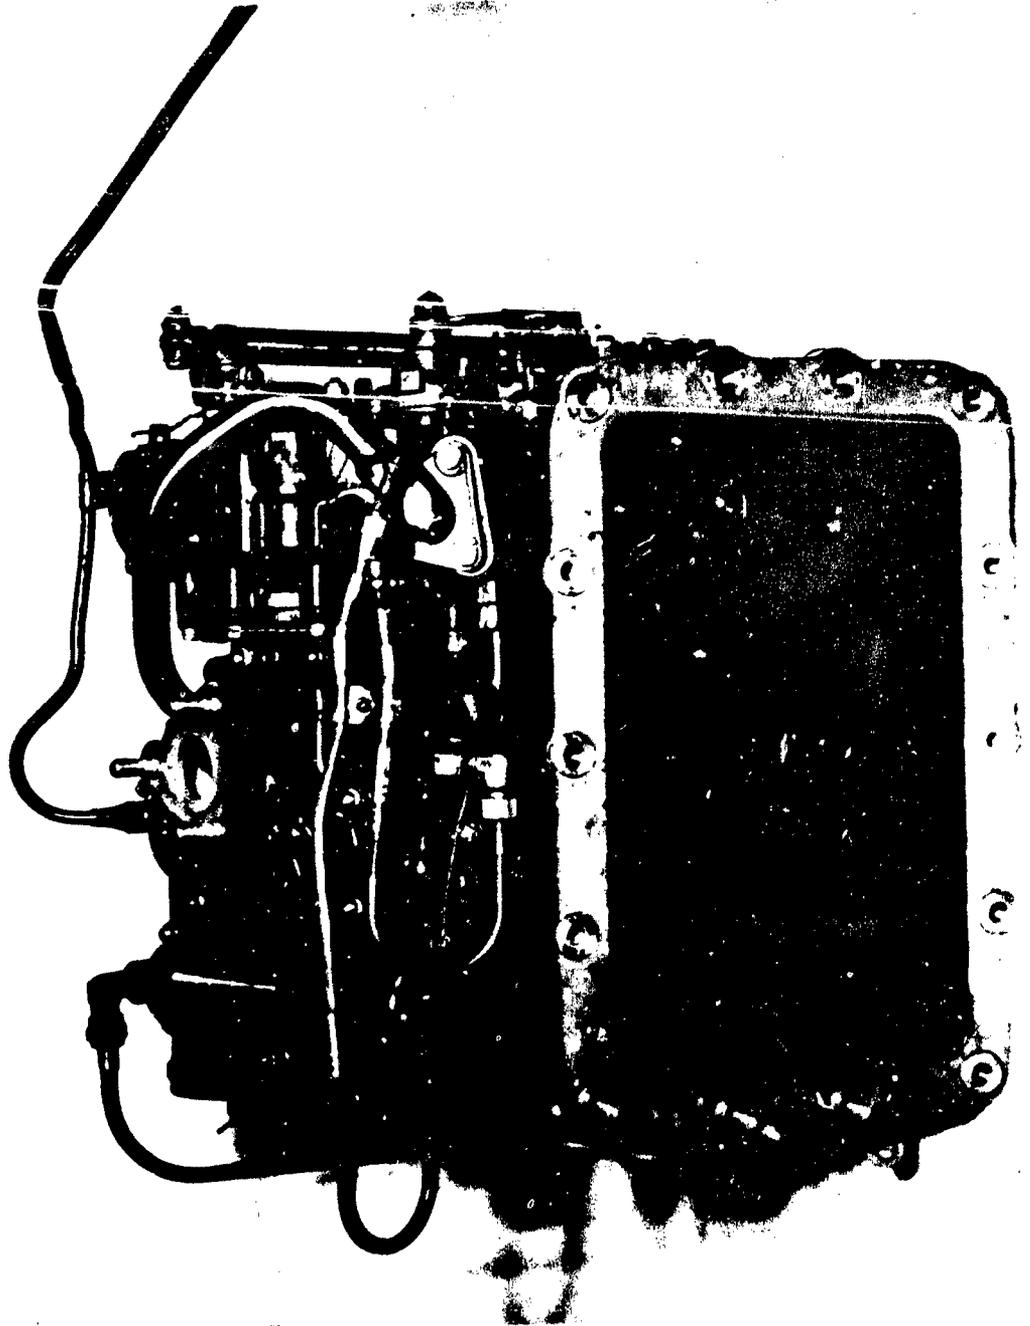
(e) As reported in para 5, ref (e), the overall external appearance of the PR48A2 carburetor, Ser. No. 702552, Parts List No. 395600-2 from the subject airplane was satisfactory with the exception of the corrosive action (appeared to be salt water corrosion) which had taken place in the carburetor main venturi and around the manual mixture control unit. Plates 11 and 12 are general views of the carburetor showing the extent of this corrosion. Disassembly of the carburetor fuel regulator system and a visual inspection of the various component parts and diaphragms indicated these parts to be in good condition. Altitude chamber tests of the automatic mixture control unit showed the unit to be within the specified travel limits and less than 1.0 percent off from the flow bench specified setting at 20,000 ft. altitude. It is concluded that this carburetor is in operable condition and no detrimental effects were produced upon or within the carburetor other than the corrosive action.

C NP(3)-259206(L)-4-49
CARBURETOR FROM TBM-3E TARGET AIRPLANE
SHOWING GENERAL CORRODED CONDITION

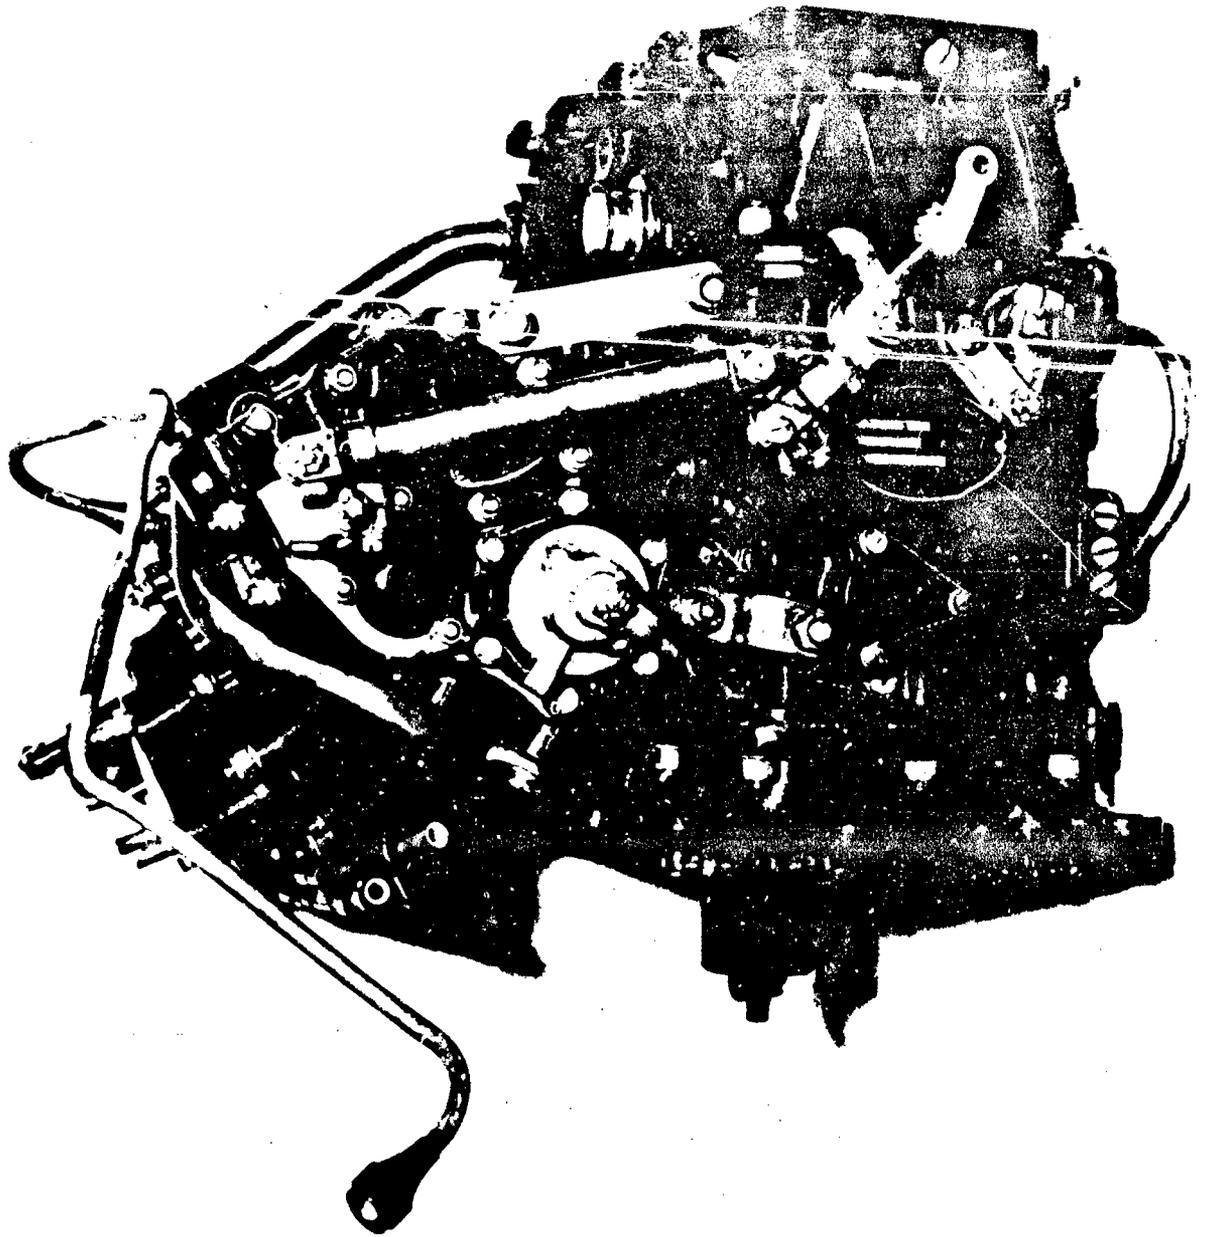
NP(3)-259207(L)-4-49
CARBURETOR FROM TBM-3E TARGET AIRPLANE
SHOWING GENERAL CORRODED CONDITION

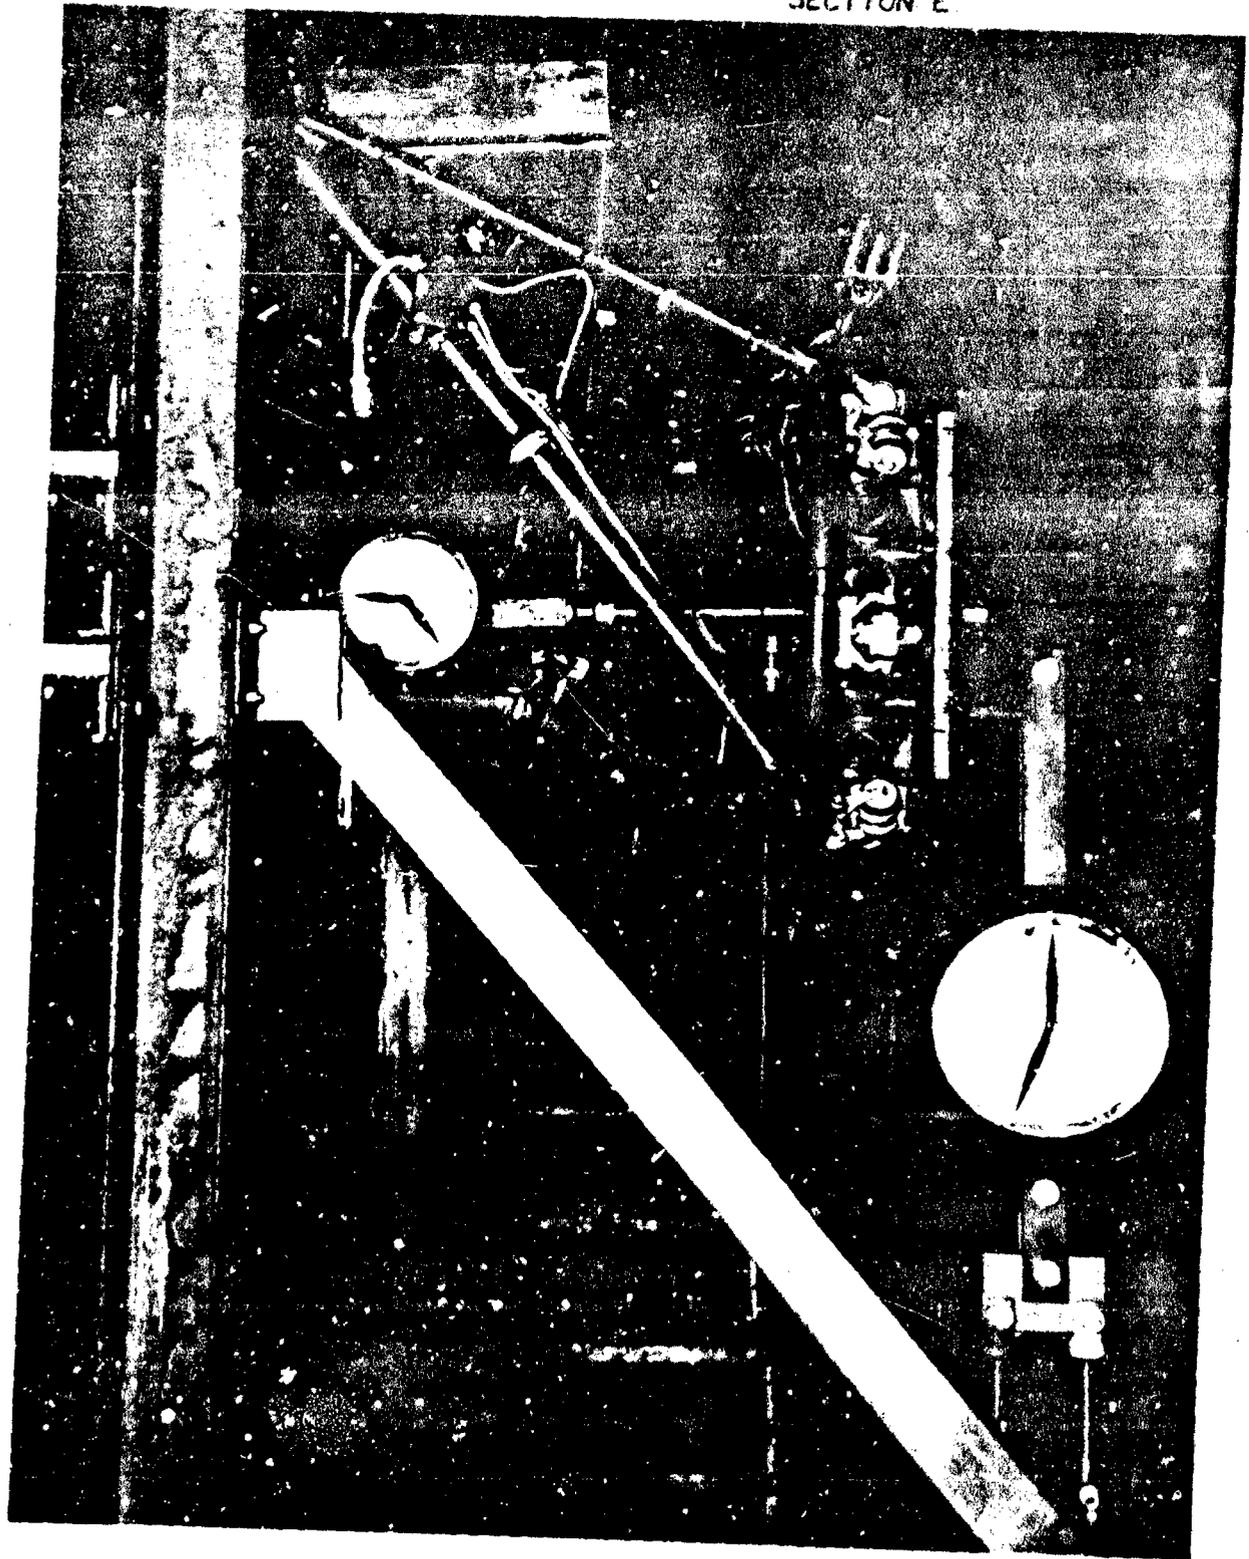
7. Section E is the report by the Aeronautical Structures Laboratory of tests conducted on the engine mount, tail section and one wing panel of the aircraft. These tests were, in the main, inconclusive. The engine mount failure was as predicted from studies of the contractor's stress analyses (no comparable test data available); the rudder, after repair, failed normally; the tail section gave indication of normal failure; the wing, after extensive repair, failed at the repair, making the test inconclusive.

NP(3)-262399(L)-3-48
TBM-3E TARGET AIRPLANE - ENGINE MOUNT TEST
TUBE D FAILURE
