NWC TP 5942

F-14A Fire Protection Test Program

by
George E. Moncsko
and
Herman J. Hoffman
Systems Development Department

FEBRUARY 1977

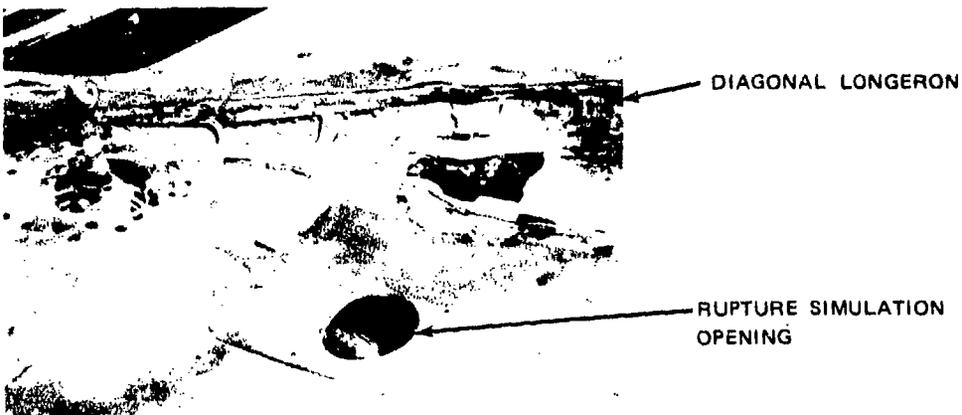
FIGURE 36. Fire-Damaged Diagonal Longeron.

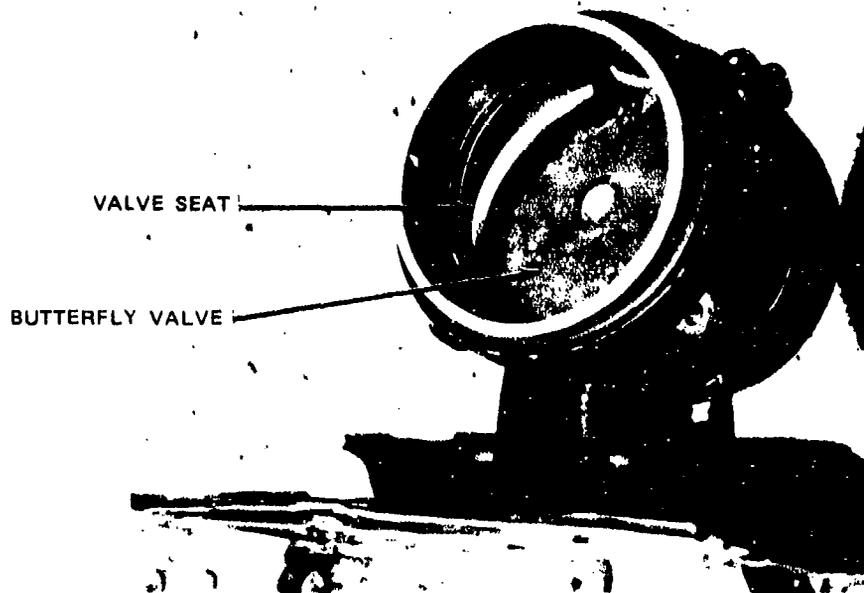
FIGURE 40. Fuel Shutoff Valve Showing Butterfly Overtravel Malfunction.

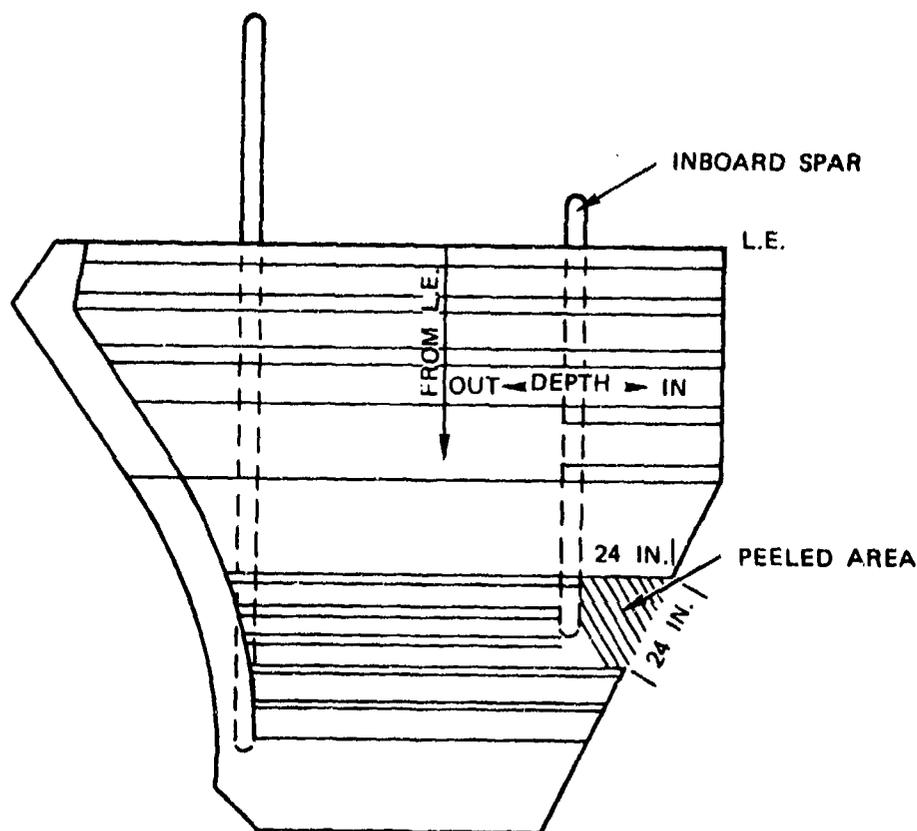
DAMAGE ASSESSMENT MEASUREMENTS

leading edge of the overwing fairing was charred and the center section showed surface buckling and heating effects. Damage assessment measurements for the underside of the overwing fairing are given in Figure 43. The measurements shown are from the leading edge to the center of the damaged area.
