AFML-TR-78-160
Volume I

COST EFFECTIVE REPAIR TECHNIQUES FOR TURBINE AIRFOILS

GENERAL ELECTRIC COMPANY
AIRCRAFT ENGINE GROUP
CINCINNATI, OHIO 45215

NOVEMBER 1978

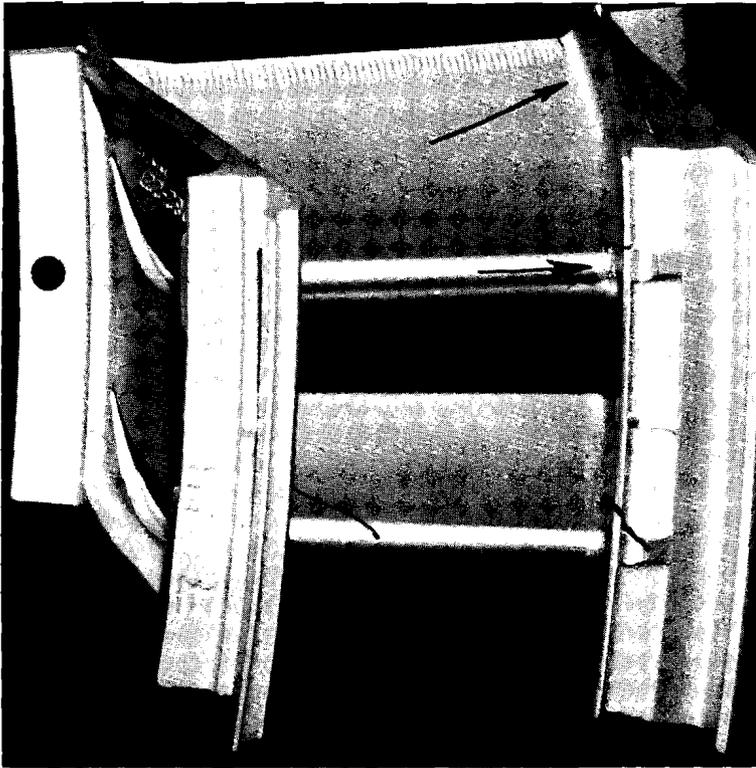
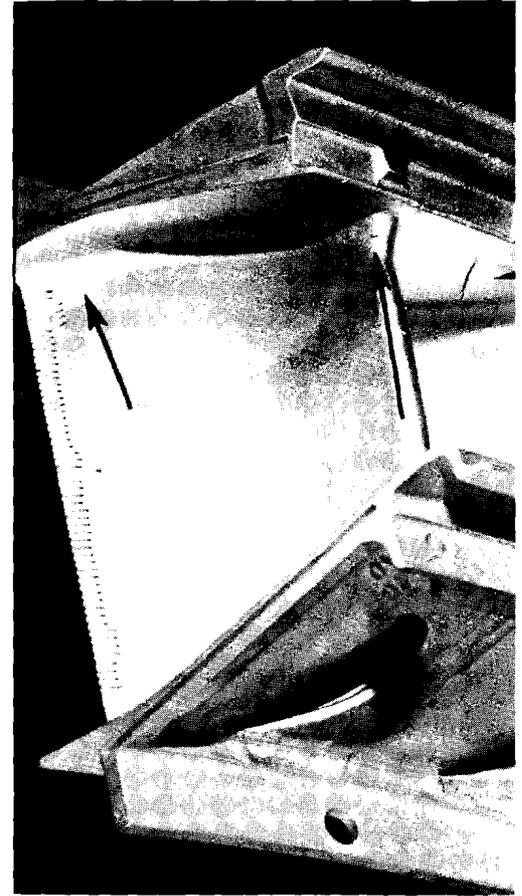
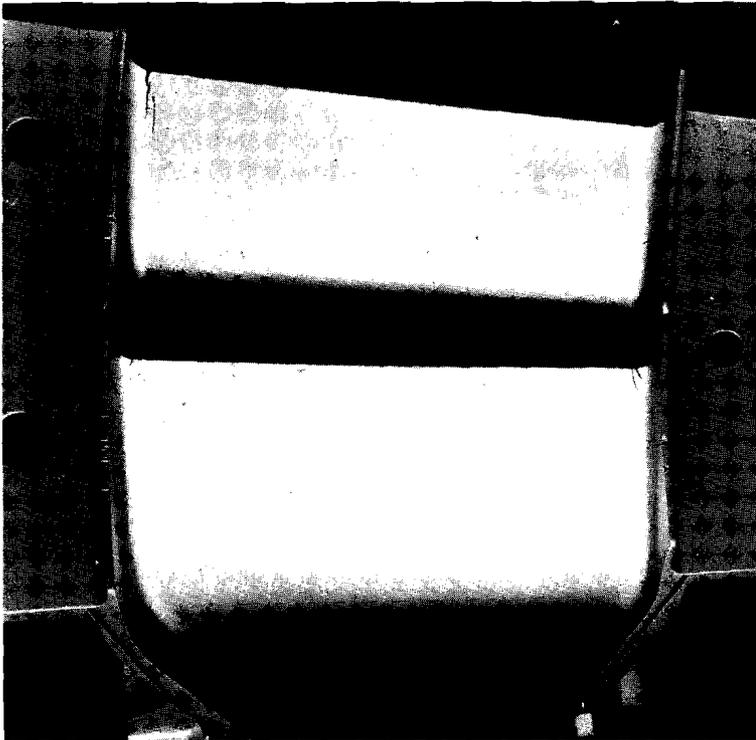
Figure 15. Appearance of Engine Run TF39 Rene' 80 Stage 2 HPT Vanes After Grit Blast Clean

Typical service induced distress is shown in Figure 15. Standard repair procedures call for weld repair with Inco 625 filler. Areas of weld repair are limited in length and location due to (1) low weldment strength relative to the Rene' 80 parent metal, (2) weld distortion, and (3) cracking tendencies of the parent alloy. On a survey sample of 1450 vanes inspected, 37% had defects in excess of the then current weld repair limits.

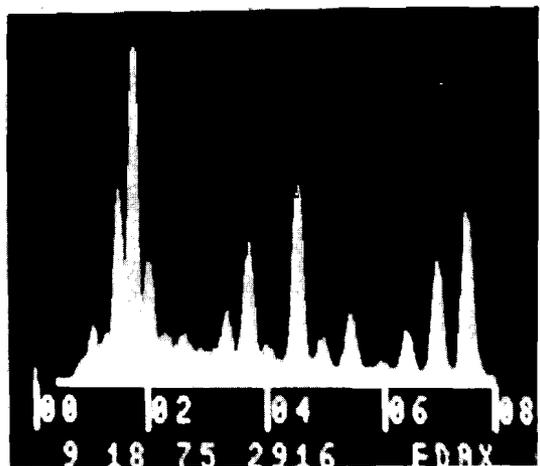
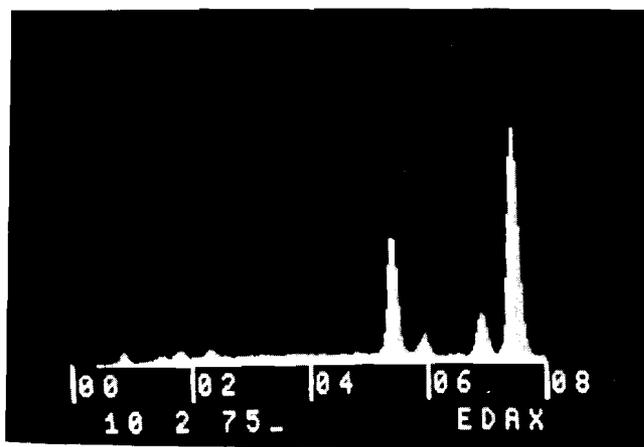
RENE' 80 CRACK SURFACE APPEARANCE. LEFT: AS ENGINE RUN,
RIGHT: FLUORIDE ION CLEANED

Figure 25. SEM Analysis of Rene' 80 Crack Surface Before and After Fluoride Ion Clean

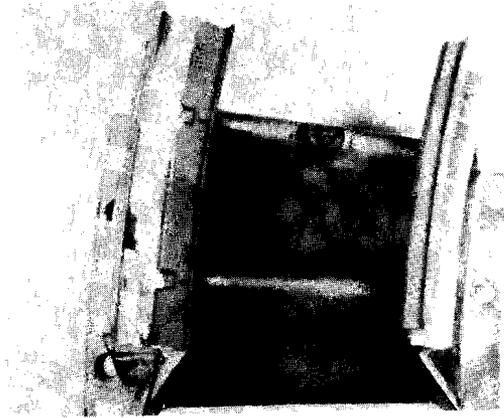
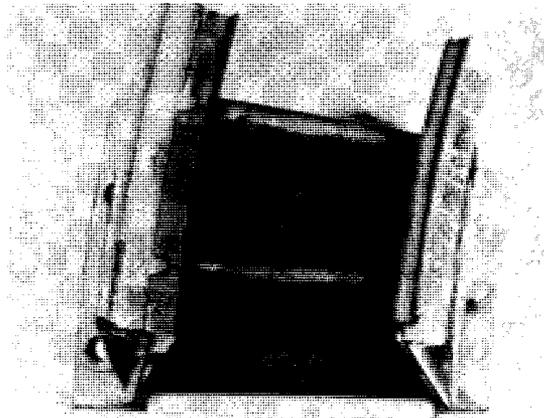
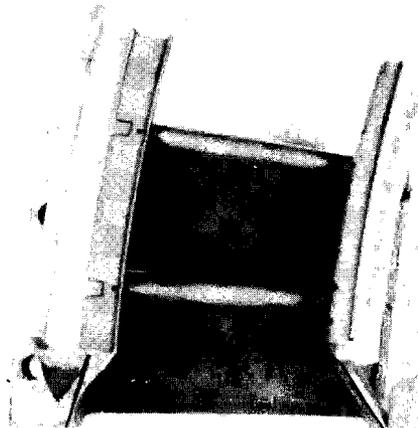
Figure 27. Stage 2 vanes after 100 cycles engine test. All three parts had been stripped F-Cleaned at 1800°F w/CrF₃ plus 2200°F/2 hrs in vacuum, then ADH repaired and CODEP coated.

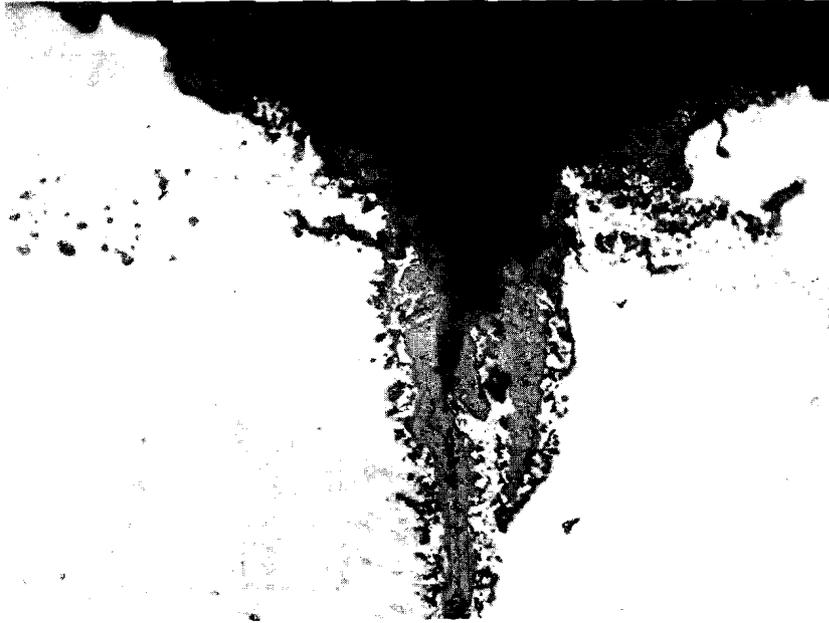
Figure 28. Fluoride Ion Cleaned Vane After 1000 Cycles Engine
Test 500x

A controlled process evaluation was initiated to study this phenomena. Kirkendall voids were not observed immediately after the F⁻ cleaning portion of the process; however, after both subsequent vacuum clean and/or Codep coating, they were observed. This indicated that a diffusion mechanism became operative during the subsequent thermal exposure and affected a rapid diffusion of substrate elements to the alloy depleted surface leaving the observed Kirkendall voids. The oxidation characteristics of the resulting surfaces are shown in Figure 29 along with the normal oxidation of R80 on a stripped and oxidized component. The depleted alloy layer left by F⁻ cleaning and subsequent oxidation testing resulted in catastrophic oxidation attack. Additional thermal exposure in the vacuum clean cycle allowed more diffusion and thus reduced the amount of oxidation attack.

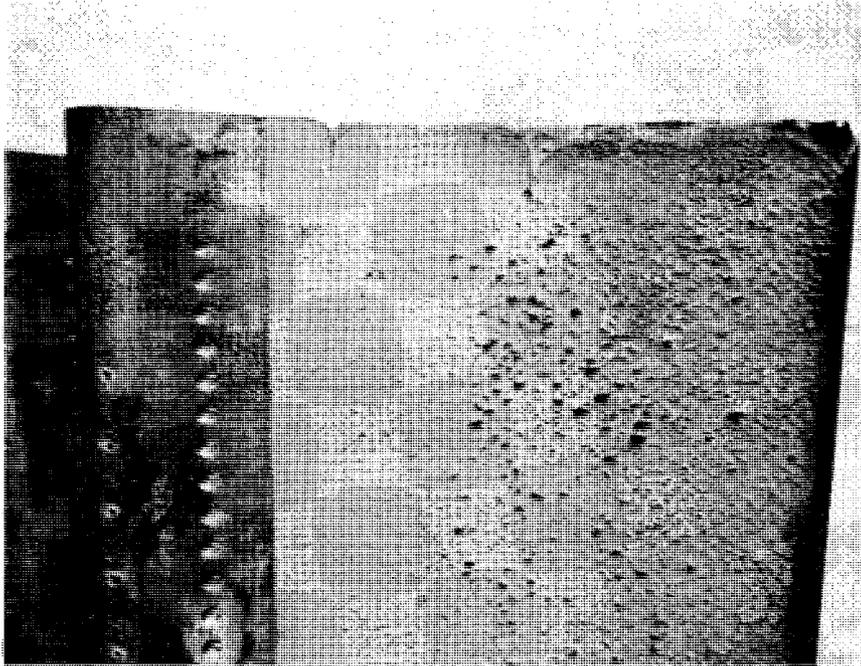
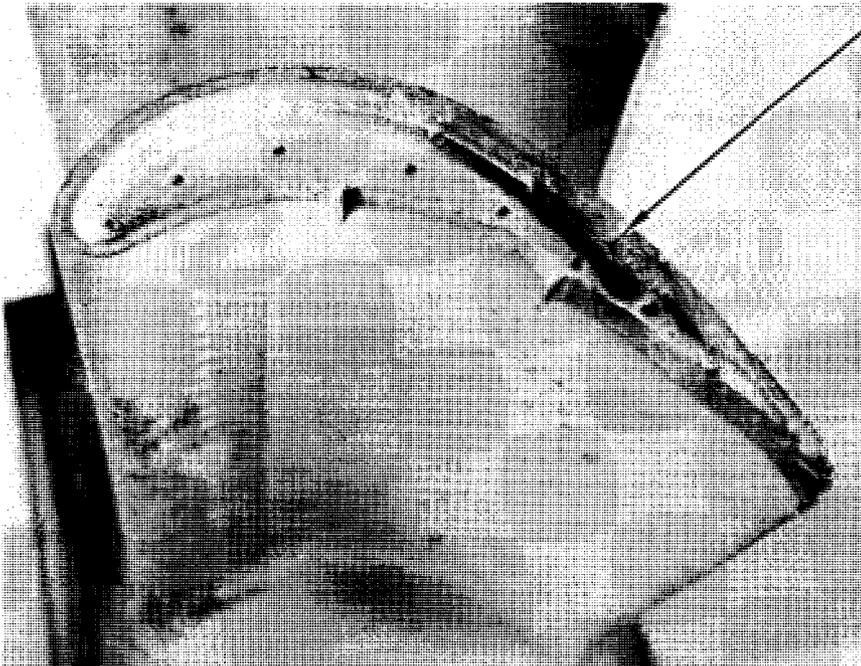
CRACKS THROUGH TIP CAP

Figure 37. HPTR Stage 1 Blade with Squealer Tip
Cracks Extending Below Tip Cap
