AL/CF-TR-1994-0056

**A HUMAN FACTORS EVALUATION OF
THE MH-60G PAVE HAWK HELICOPTER COCKPIT (U)**

JANUARY 1994

FINAL REPORT FOR THE PERIOD APRIL 1993 TO JANUARY 1994

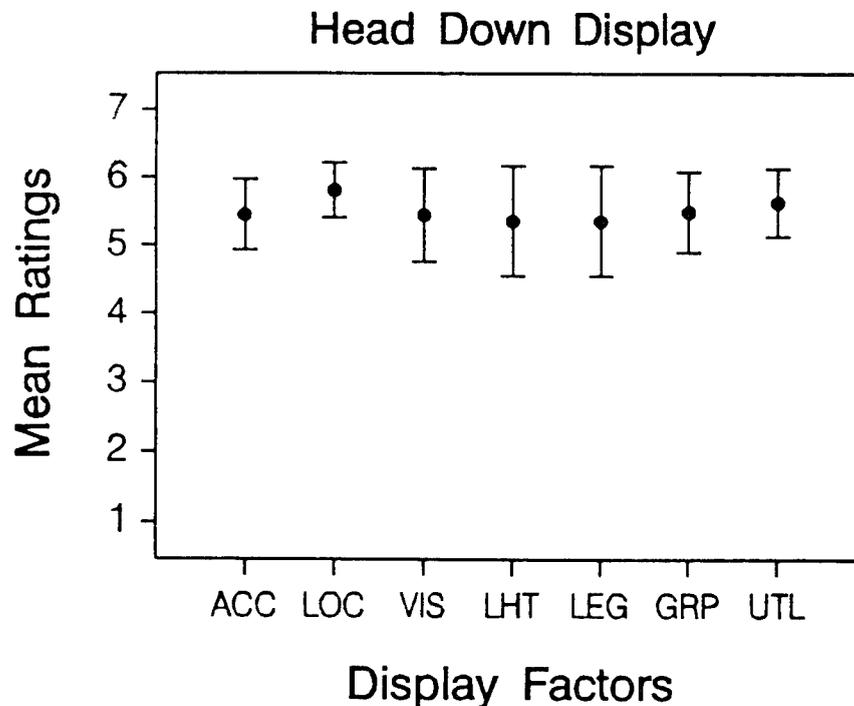
Figure 3. Mean Display Factor Rating for the Head Down Display.

The mean rating for the Head Down Display averaged across Display Factors was 5.51, the highest of all Display Type ratings. All the display factors were rated highly for this display. The pilots had very few negative comments except one pilot said that the torque power setting was hard to read, the HDD needed a Barometric Altimeter in the FLIR mode and it needed a good trim indicator. Some pilots reported that the controls should be backlit in order to make it easier to find the knobs.

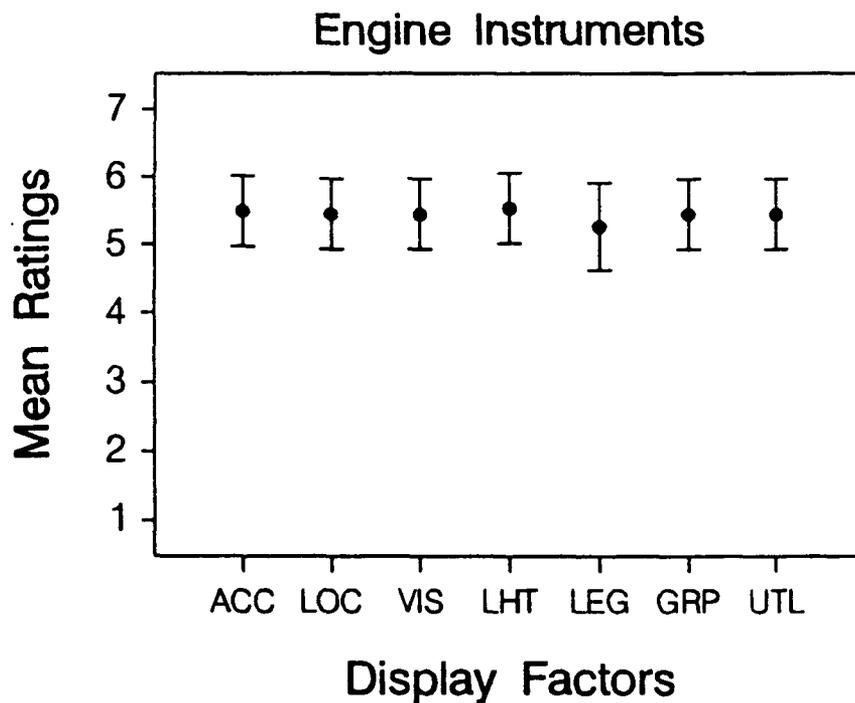
Figure 4. Mean Display Factor Rating for the Engine Instruments.

The mean rating for the Engine Instruments Display was 5.45. All the display factors were rated highly for this display. The Legibility Display Factor (5.27) was rated slightly lower than the other Factor ratings but not significantly so. The comments reflected this slightly lower mean in that pilots reported the legends were too small to read easily.

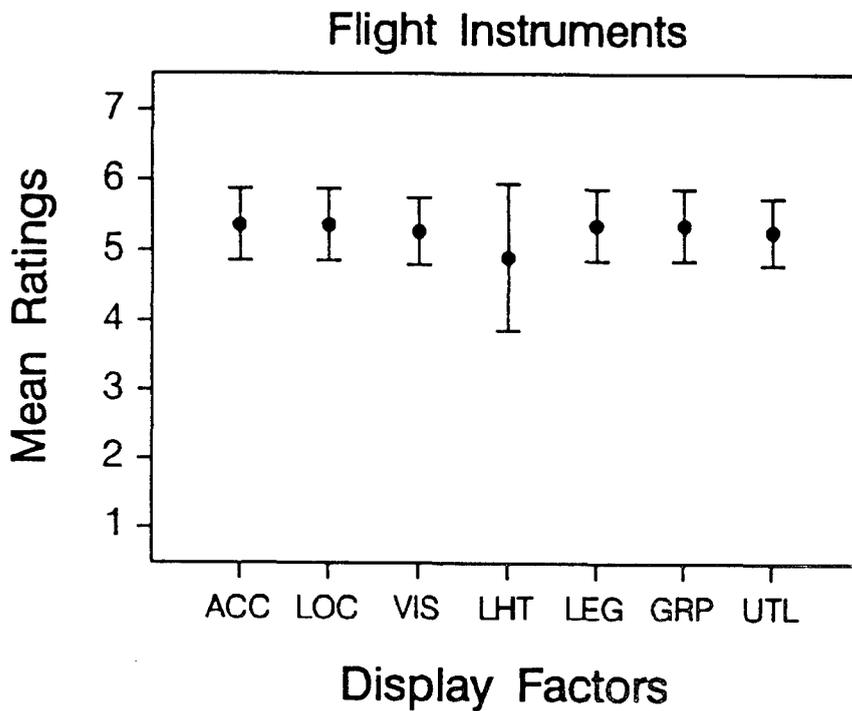
Figure 5. Mean Display Factor Rating for the Flight Instruments.

The flight instruments are located on the front console of the cockpit. The Course and Heading Select controls are used frequently. The mean rating for the Flight Instruments Display was 5.27. All of the Display Factor ratings (Avg. = 5.33) were approximately the same except for Lighting (4.90). Two pilots reported that the trim ball was poorly lit. Since it was indicated that the trim indicator on the HDD was not adequate, one of these indicators needs to be corrected to provide trim information. Trim calls are vital during hover and aerial refueling. This display must be easy to see in all conditions.

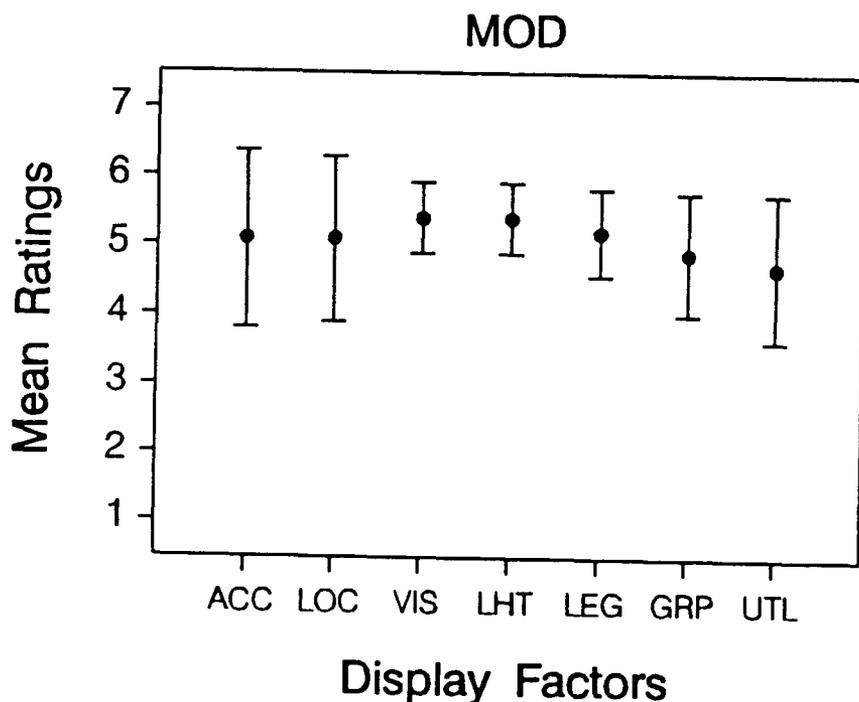
Figure 6. Mean Display Factor Rating for the Mode Select Panels.

The mean rating for the Mode Select Panels was 5.11 indicating a high level of satisfaction with these panels, overall. None of the Display Factors was significantly different from each other within these panels. Comments concentrated on the fact that the NAV Mode Select shows "ILS" when flying a TACAN approach. Pilots thought this was both confusing and dangerous. They also reported that a problem resides in the fact that the CIS Mode Select panel used to select NAV/HDG/ALT was not accessible to the left-side pilot. There is adequate space to install CIS Mode Select Panel on the co-pilots side of the front console. The pilot has priority in selection, but he must deselect in order for the co-pilot to engage his CIS Select switches.

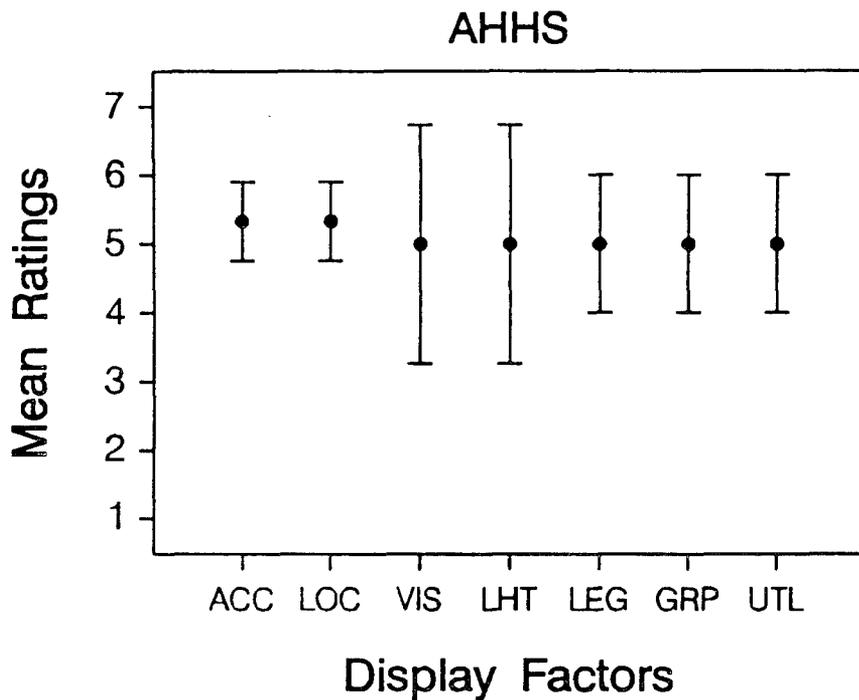
Figure 7. Mean Display Factor Rating for the Altitude Hold Hover Stabilator.

Only three of the eleven pilots queried responded to this panel because the others had never used this new system before. The three that did respond, however, gave it a mean rating of 5.09. None of the Display Factors was significantly different from one another. Those that have used the AHHS report that they liked it. Most of the other pilots reported that they were looking forward to the installation of this system because it will help reduce the difficulty of hovering steadily over water at night. This is reported to be one of the most difficult high workload tasks for the MH-60G pilot. The installation of this system will greatly reduce the workload associated with this highly critical task. However, as with any other subsystem, the system must be integrated intelligently into the cockpit. The logical place for this control is on or near the collective. The placement of the control in the cockpit should not be on a "space available" basis.

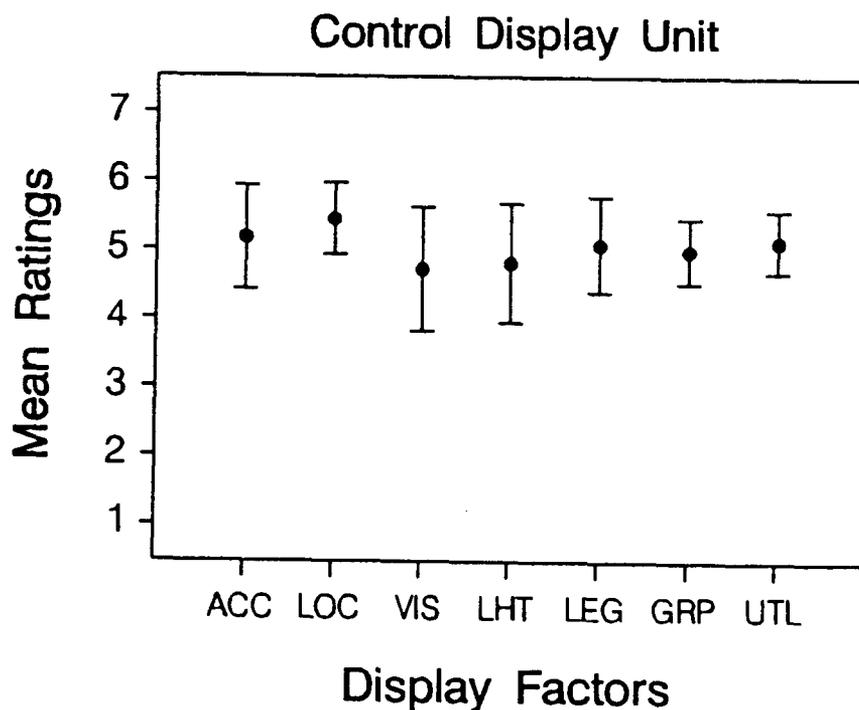
Figure 8. Mean Display Factor Rating for the Control Display Unit.

The overall mean rating for the CDU was 5.06. Within this Display Type the Location Factor was rated highest at 5.45. Visibility and Lighting were rated the lowest at 4.73 and 4.82, respectively. These means were not significantly different. One problem reported by the pilots was that the keypad for data entry was a non-standard keypad which necessitates learning new key positions and could affect data input performance in times of high stress. Several reported that they had to lean over and position their head directly above the display to read it and they still had to use finger lights. Suggestions were: 1) tilt the display toward the pilot/copilot and 2) improve lighting so finger lights would not be necessary.

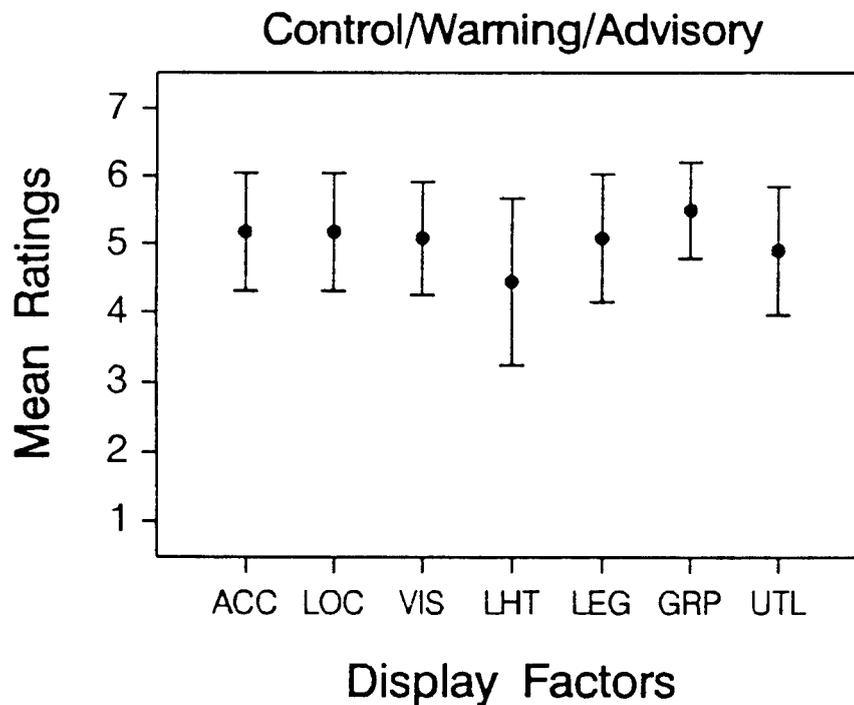
Figure 9. Mean Display Factor Rating for the Caution/ Warning/Advisory Panel.

The overall mean rating for the CWA was 5.05. Both the Lighting and Utility factor means (4.45 and 4.91, respectively) were found to be significantly lower than the functional grouping mean (5.50). Several lighting factors were considered inadequate by the pilots. The blinking of the "Auxiliary Fuel" light was called "unacceptable, distracting and sometimes dangerous." Pilots report that poor lighting and legibility made the panel difficult to read in bright sunlight or low level lighting. Several pilots indicated this panel needs to be made NVG compatible. Proper lighting of this panel is critical. This is a safety of flight issue that needs to be corrected.

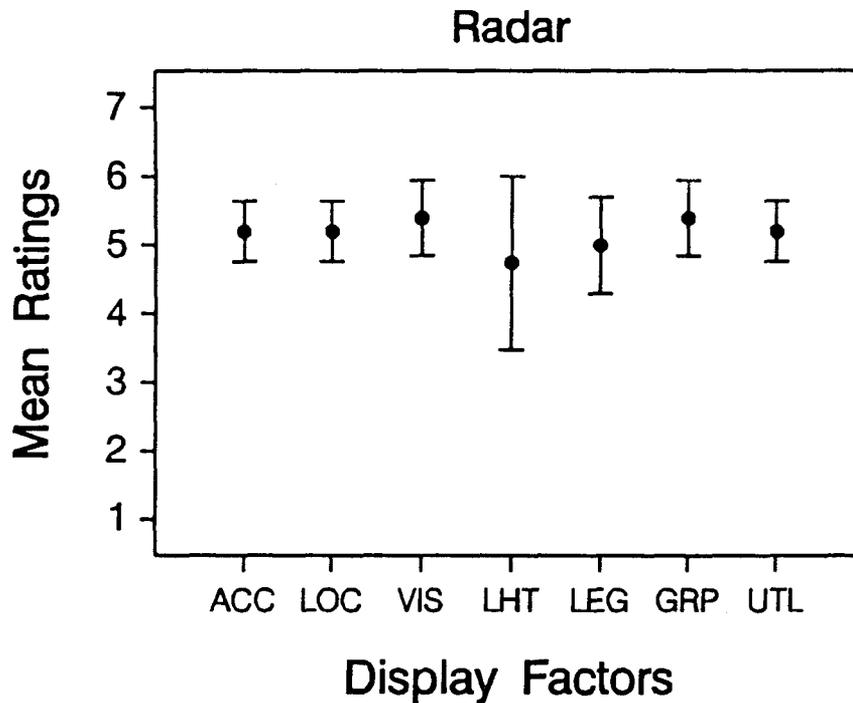
Figure 10. Mean Display Factor Rating for the Radar panel.

The overall mean rating for the Radar panel was 4.96. None of the means associated with the display factors was significantly different from one another. Lighting was rated the lowest (4.75) and Grouping and Visibility were rated the highest at 5.40 each. Most pilots comments indicated they had no problems with this panel, although a couple said it was not lighted and should be.

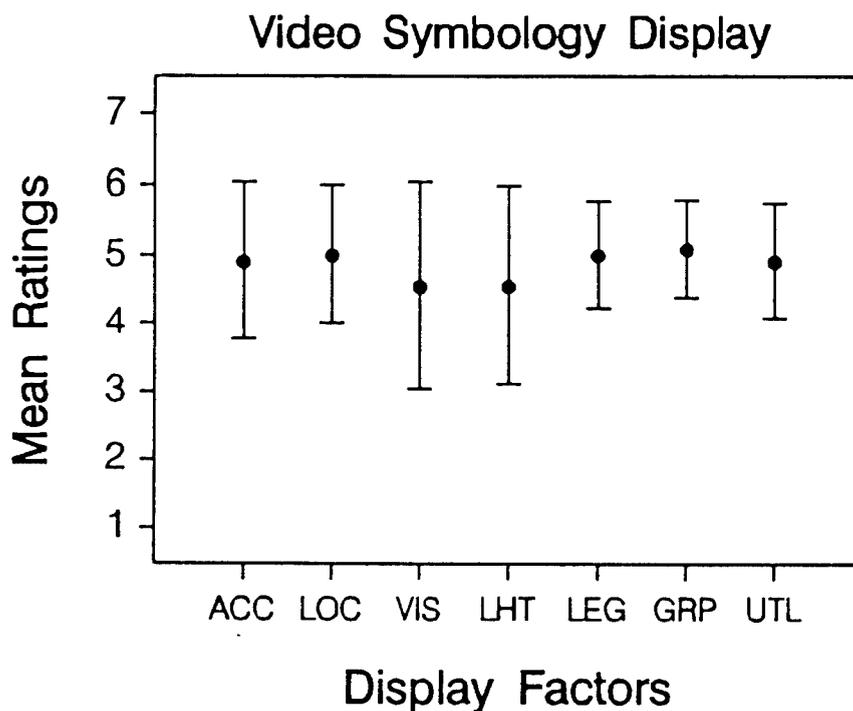
Figure 11. Mean Display Factor Rating for the Video Symbology Display System.

The overall mean rating for the Video-Symbology Display System was 4.86. None of the display factor means was significantly different from one another. Both Lighting and Visibility were rated the lowest (4.54 each) and Functional Grouping was rated the highest (5.09). One pilot commented that having to take his hands off the control stick to switch the VSDS into declutter mode was unsafe. Most other pilots reported no dissatisfaction with this panel.

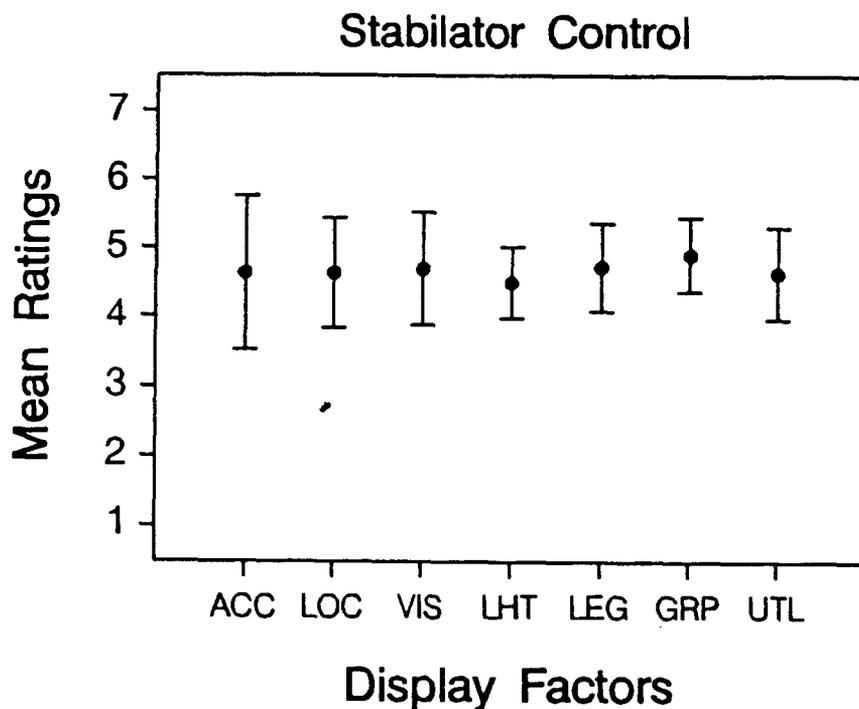
Figure 12. Mean Display Factor Rating for the Stabilator Control Panel.

The overall mean rating for the Stabilator Control panel was 4.68. None of the Display Factor means was significantly different from one another. Lighting was rated the lowest at 4.50 and Functional Grouping the highest at 4.91. Comments for this panel indicated that most pilots thought there were no problems except that the panel itself was not standardized among aircraft. A couple of pilots said that the accessibility was a problem for the pilot. Accessibility and Location were both rated second lowest (4.64) among the Display Factors.

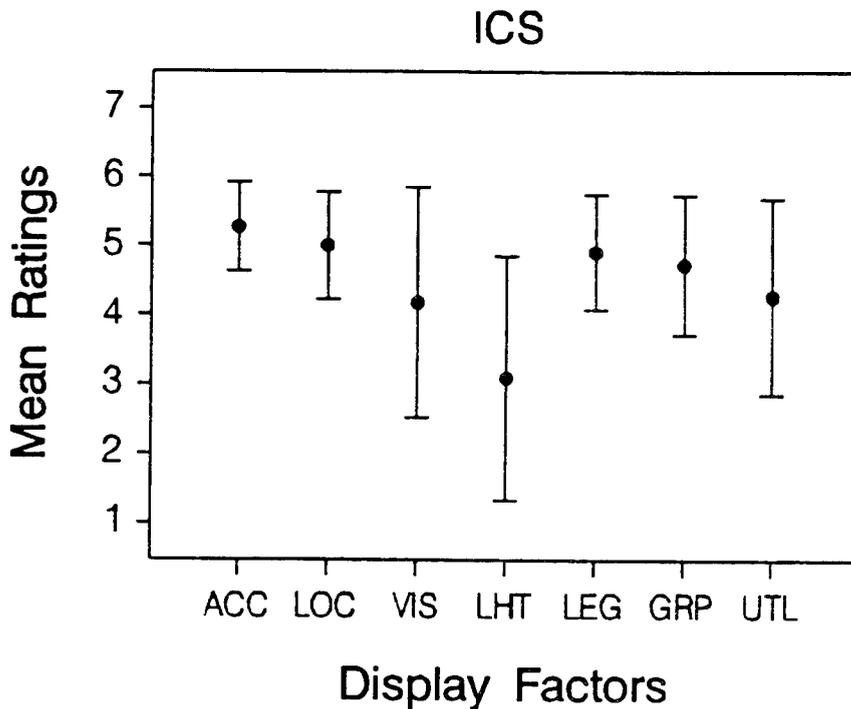
Figure 13. Mean Display Factor Rating for the Inter-communication System.

The overall mean rating for the Intercommunication System was 4.49. As can be seen in Figure 13 below, the mean rating for the Lighting factor (3.09) was lower than all the other factor means (4.18 - 5.27). These differences were significant ($p = 0.024$ through 0.002). Utility was significantly lower than Accessibility ($p = 0.0014$). A majority of the pilots complained that this panel was not backlit and therefore, could not be read at night. They considered this condition to be dangerous and mission threatening. Another complaint was that the volume could not be turned up loud enough and that the audio transmission needed to be a lot clearer (free of noise). One pilot reported that 20 - 30% of the time he doesn't completely hear what is transmitted. These are problems that must be addressed as soon as possible. The amount of crew coordination and communication required in the Pave Hawk mission demands a reliable intercommunication system.

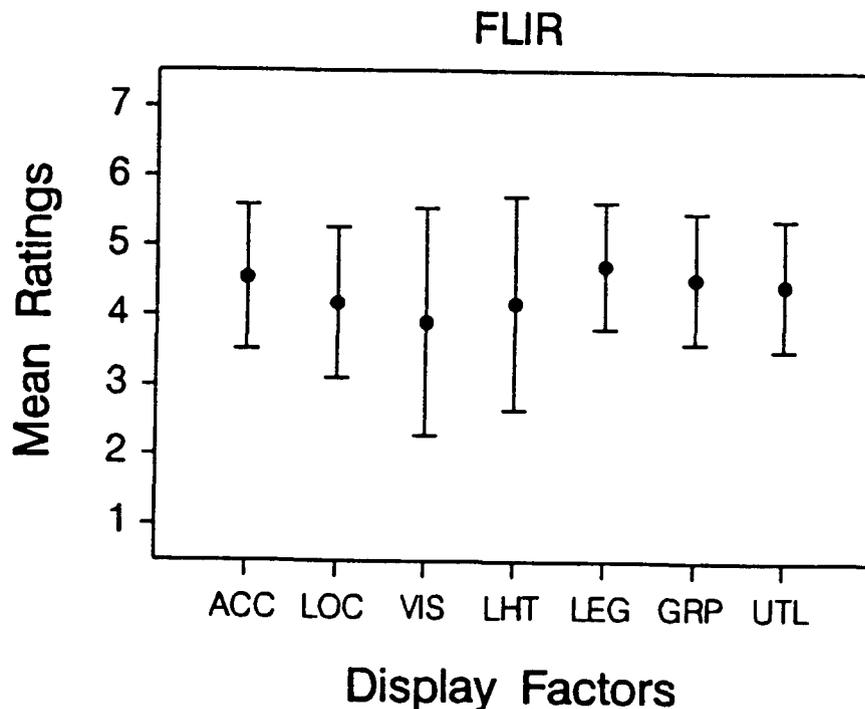
Figure 14. Mean Display Factor Rating for the Forward Looking Infra-Red Panel.

The overall mean rating for the FLIR control panel was 4.36. No Display Factor means were significantly different from one another. Visibility was rated the lowest (3.91) and Legibility the highest (4.73). This control panel is located on the aft panel, which makes it hard to access both physically and visually. Also, new capabilities have been added to the panel which has resulted in a relabeling of several buttons. This has required more memorization on the part of the pilots. Increased memorization requirements plus any carry over effects from previous configurations could very likely increase the cognitive workload associated with operating this panel. The control panel should be moved to a more accessible location. Crew members should receive additional ground training to become familiar with the new FLIR system capabilities to alleviate the negative transfer of training effects.

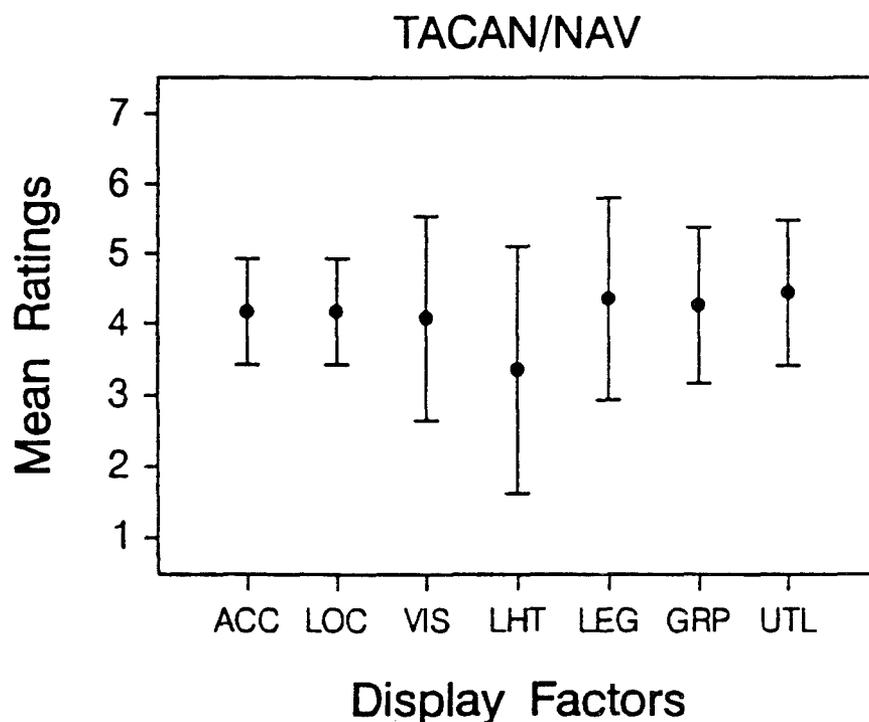
Figure 15. Mean Display Factor Rating for the TACAN/NAV Panel.

The overall mean rating for the TACAN/NAV panel was 4.13. Lighting was the lowest rated factor at 3.36. The difference between Lighting (3.36) and Visibility (4.09) was significant ($p = 0.012$). The difference between Lighting and the other factors was just as great or larger, however, the variability of those mean ratings was too great for them to be significantly different in the statistical sense. The largest complaint was that the lighting was very poor for night operations. The lighting is presently not NVG compatible but needs to be. Another complaint was that the steps required to provide a TACAN, VOR or ILS guidance update combined with the way the switches are marked make this task too difficult. The pilot said it was easy to forget or miss a switch.

Modify the steps necessary to provide a TACAN, VOR or ILS guidance and the switch markings to reduce both the task difficulty and likelihood of forgetting or missing a switch.

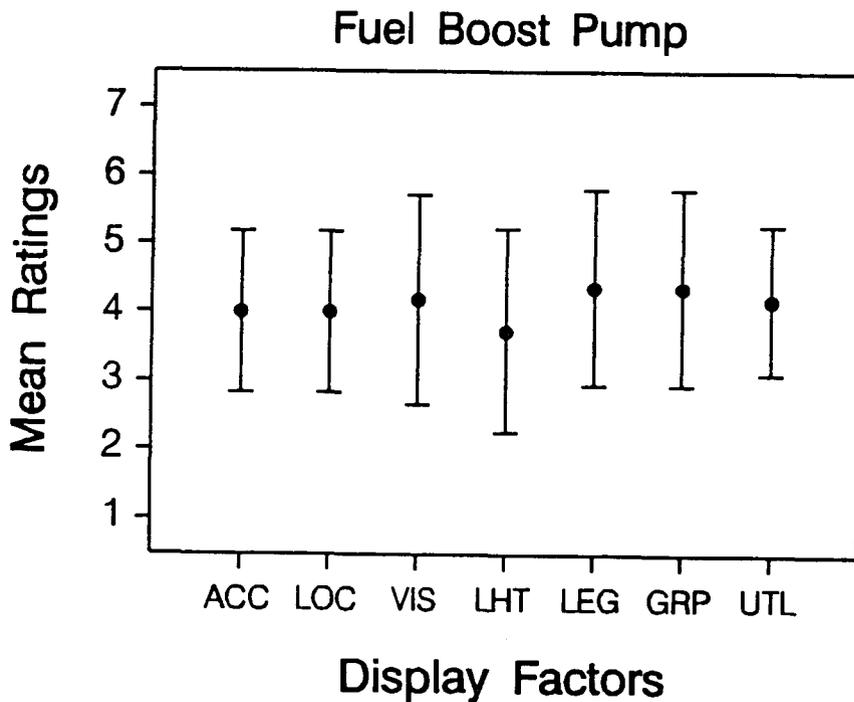
Figure 16. Mean Display Factor Rating for the Fuel Boost Pump panel.

The overall mean rating for the Fuel Boost Pump panel was 3.71. Lighting was again the lowest rated factor (3.72) while Legibility and Functional Grouping were the highest (both 4.36). None of the Display Factor means were significantly different from one another. Location was rated second lowest of the Display Factors at 4.00. Pilot comments reflected this in that most of the complaints centered around the poor location of this panel. Most complained that it was difficult to reach. Others complained that it was mounted upside-down so the labels would match the right engines.

Although the location might not be an issue due to the fact that the panel is not used much, one pilot reported that during Emergency Engine Shutdown/Failure with the Fuel Direction in "cross-feed" it was easy to turn off the wrong switch. This could be a fatal error. Another consideration is that during fuel supply system specific emergencies it becomes a critical control and must be accessed quickly and easily. It's location should be changed to one that is more accessible.

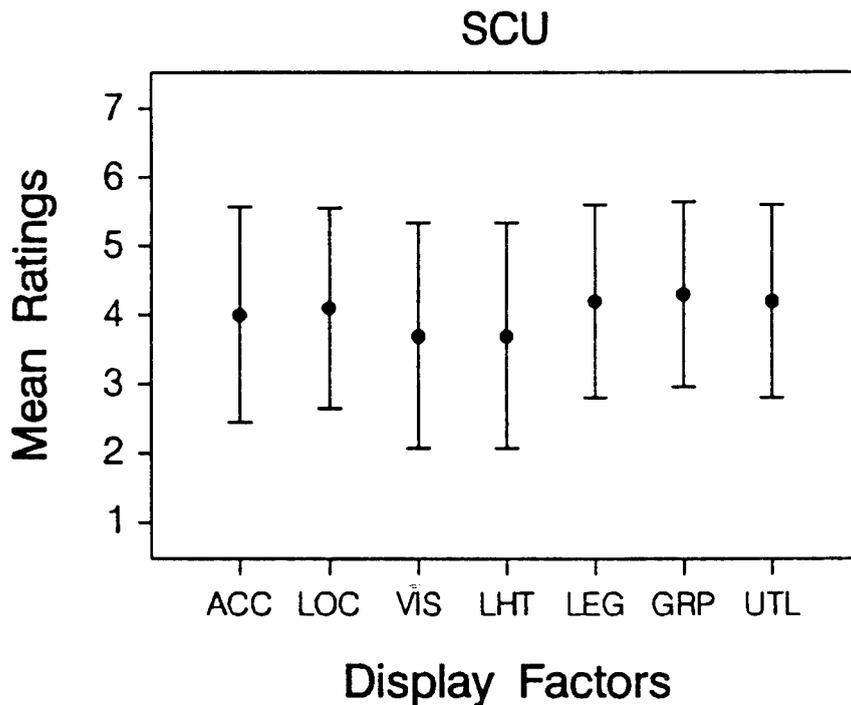
Figure 17. Mean Display Factor Rating for the System Control Unit.

The overall mean rating for the System Control Unit was 4.03. Lighting and Visibility were the lowest rated Display Factors at 3.70 each. Functional Grouping was the highest at 4.30. None of the Display Factor means were significantly different from each other. Comments concerning this panel indicated that the pilots thought that it needed back lighting for night operations and that the location of the panel (on the aft console) was bad. This control panel needs to be moved to a more forward location and the lighting needs to be improved.

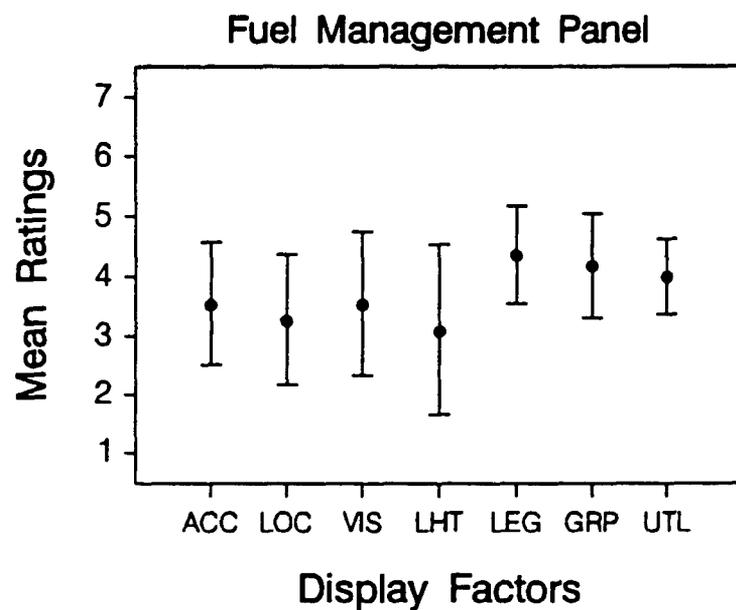
Figure 18. Mean Display Factor Rating for the Fuel Management panel.

The overall mean rating for the Fuel Management Panel was 3.71. The ratings for the two lowest rated display factors for this panel, Lighting (3.09) and Location (3.27), were both significantly lower than the two highest rated factors (Functional Grouping (4.18) and Legibility (4.36)) (Lighting: $p = 0.04, 0.02$; Location: $p = 0.005 \& 0.006$, respectively). Accessibility was found to be significantly lower than both the Legibility ($p = 0.01$) and Functional Grouping (0.026) factors. It was found, however, that only five of the 11 respondents actually rated Grouping higher than Accessibility while the remaining six rated Grouping and Accessibility the same. This casts some doubt on whether the two group means are truly different from each other for this particular panel. A graph of these results is located in Figure 18 on page 27.

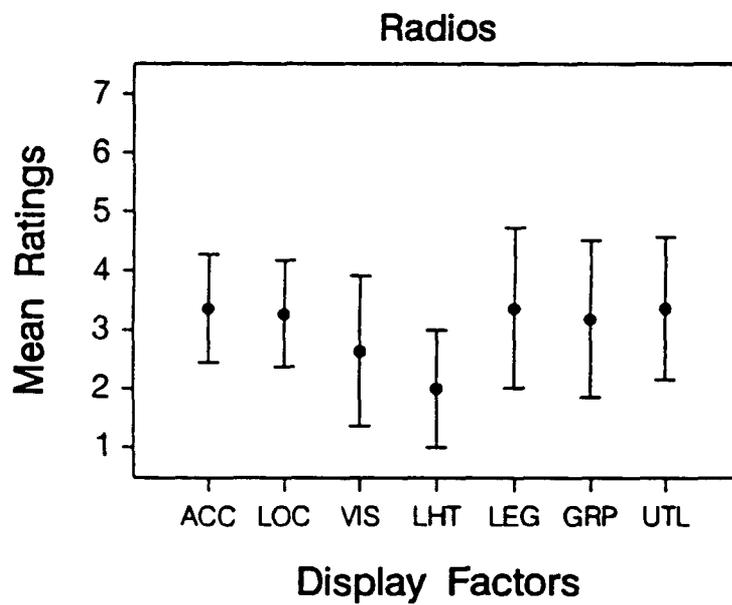
Figure 19. Mean Display Factor Rating for the Radios

There were several complaints about this panel. The most prevalent complaint concerned the location of the radios. Most pilots reported that the radios were spread out all over the cockpit. Pilots presently have to turn their heads to the back to operate most of the radios, which takes their eyes away from the "outside." This is extremely hazardous when flying low level at night. All the pilots recommended that the radios be integrated into one communication unit. This would not only reduce the difficulty of finding and operating the radios but also create more space on the forward section of the aft console. The integrated communications unit could be placed on the forward section of the aft console. This would leave space on the back portion of the aft console for displays and controls that are not used frequently and/or are not critical to mission completion.

The second most prevalent complaint was the radio controls were very difficult to read during night operations. The poor Lighting rating was reflective of the pilot's desire to have controls and display backlit at an NVG compatible level for night operations.

The obvious solution to the problem is to integrate the radios with the CMS-80 and access them through the CDU. Another solution which is in place in the Army MH-47E is to integrate the communications and have a control on the cyclic to select radios with a small display located on the forward console to indicate the selected radio. Integrating the communication systems would not only alleviate the problems associated with radio access, but also free up considerable space on the center and aft consoles. Reconfigured lower and aft consoles with the radios integrated into the CDU are shown in Figures 20 & 21. This reconfiguration would drastically reduce the size of the aft console. The reconfigured aft console would also provide an alternate egress route for pilots and give the flight engineer visual access to controls and displays in the cockpit.
