260-SL-3 MOTOR PROGRAM

VOLUME I: 260-SL-3 Motor Internal Insulation System

FINAL PHASE REPORT

28 April 1967

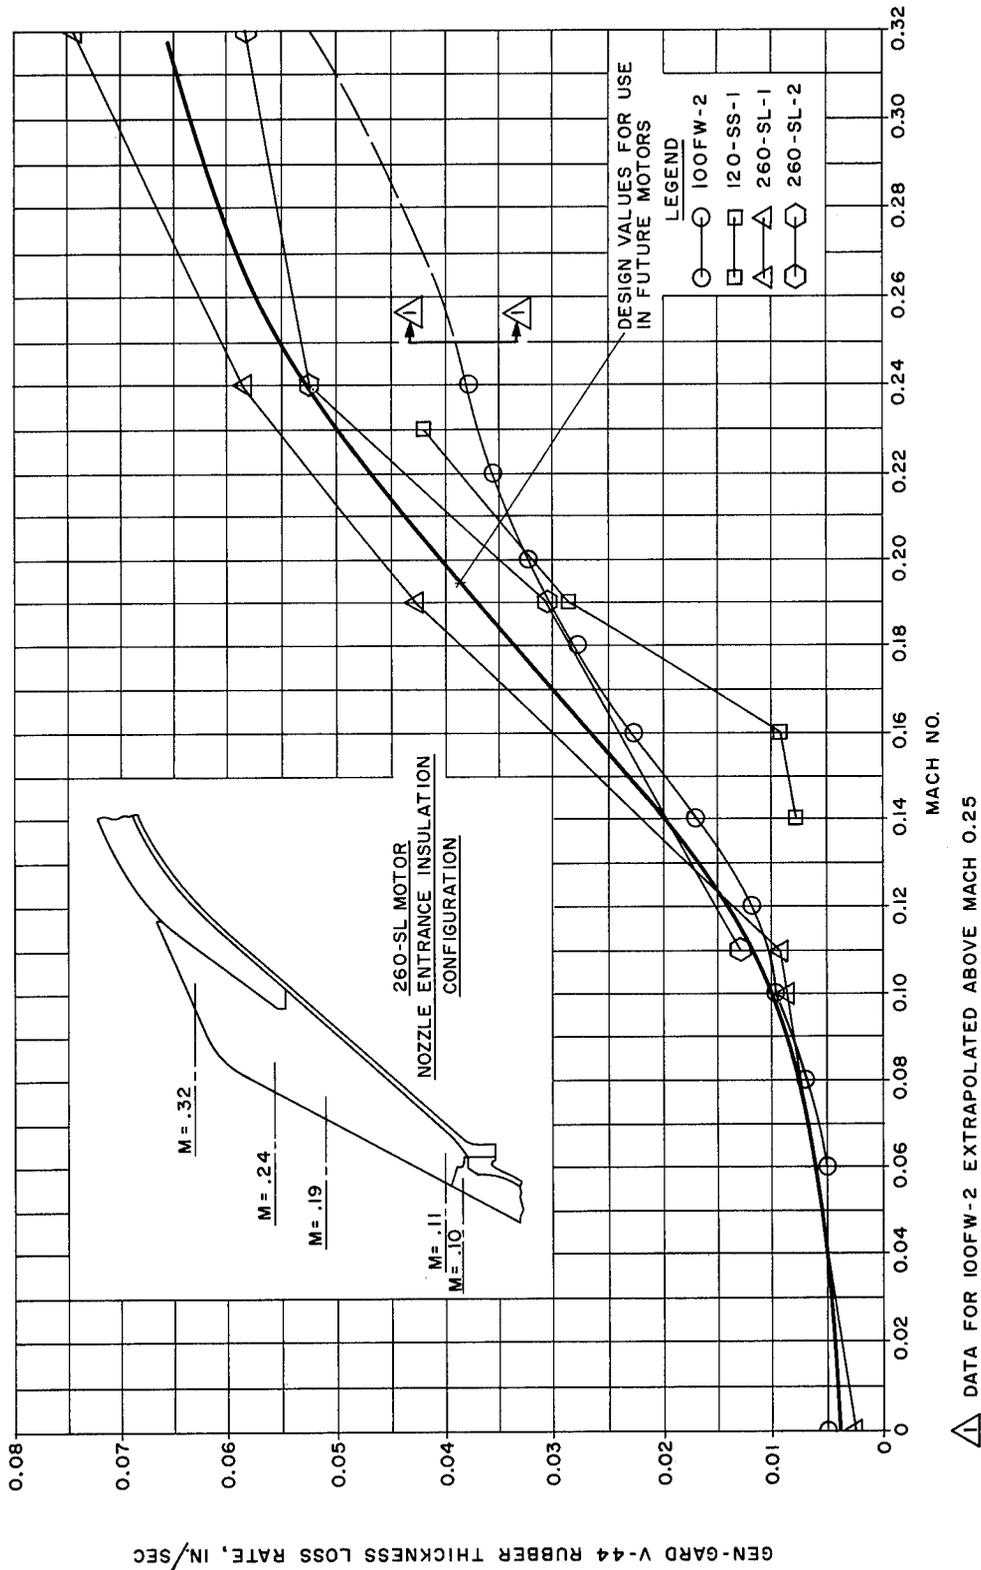
Figure 1

Gen-Gard V-44 Thickness Loss Rate Versus Gas Flow Mach Number

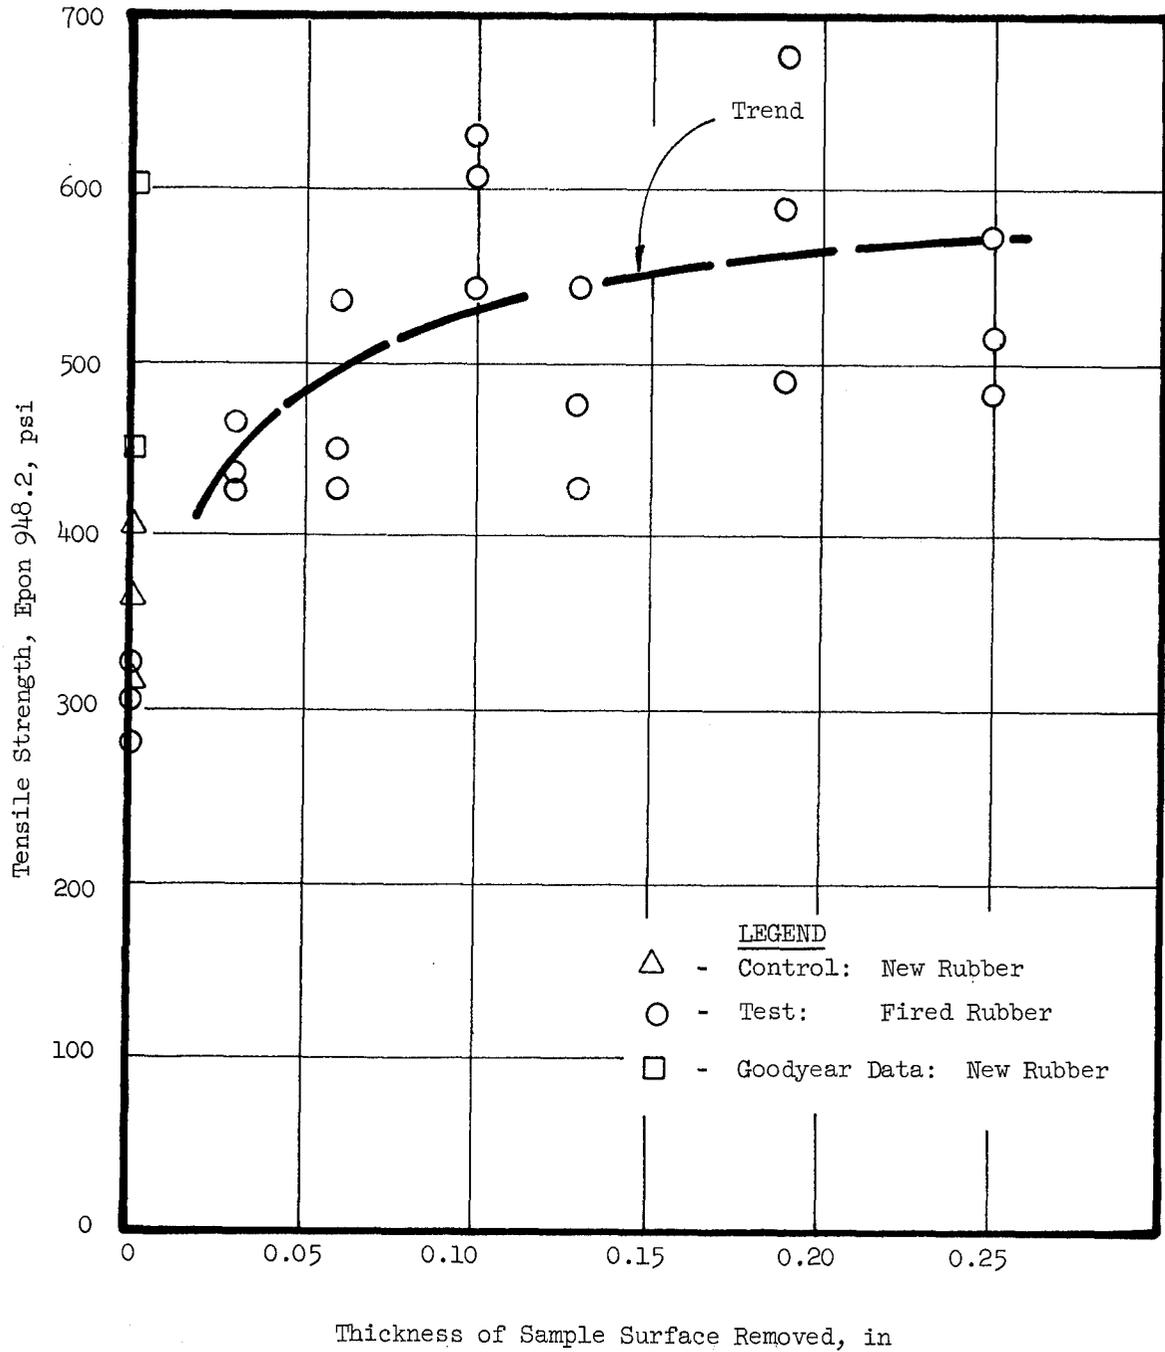
Figure 5

As shown in Figures 5 and 6, the Epon 948.2 bond-strength values for the control samples were unusually low (319 to 407 psi), and were not significantly greater than the values obtained with the essentially unabraded fired rubber specimens. However, the control samples failed in the rubber and not at the rubber-to-adhesive interface, indicating the possibility that the rubber used in the control samples tended to delaminate during the DPT test. Unfired rubber samples were obtained from the warehouse at A-DD. As a result, the

Plot of Epon 948.2 Adhesive Bond Strength as a Function of Fired Rubber Surface Thickness Removed

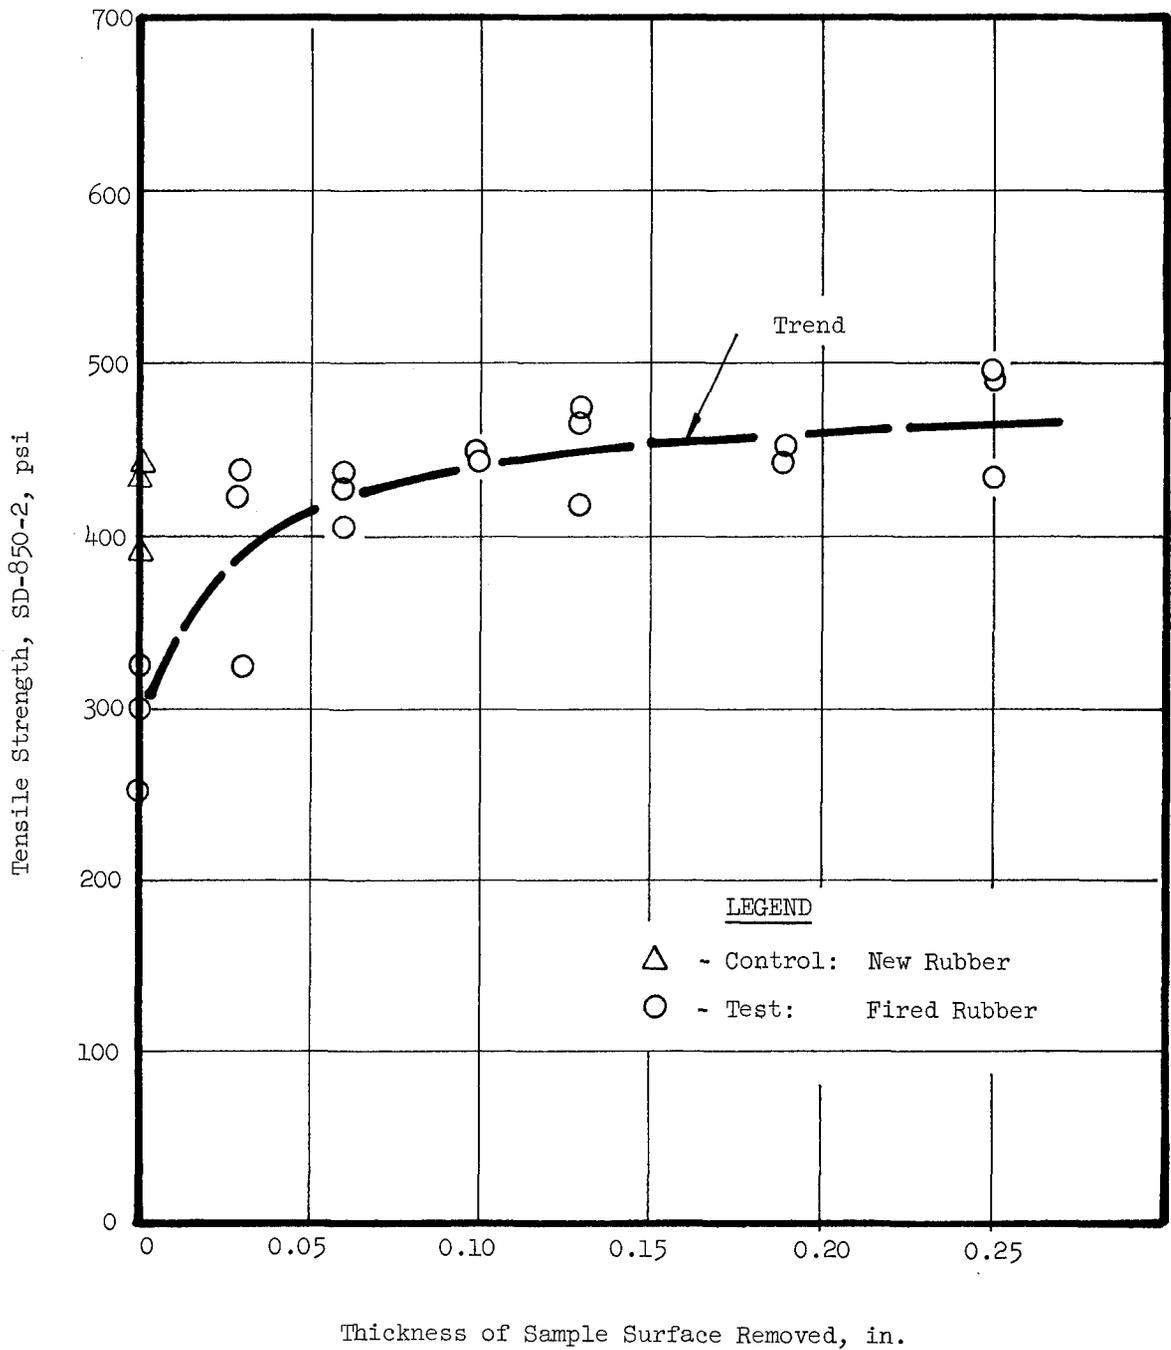
Figure 6

Plot of SD-850-2 Liner Bond Strength as a Function of
Fired Rubber Surface Thickness Removed

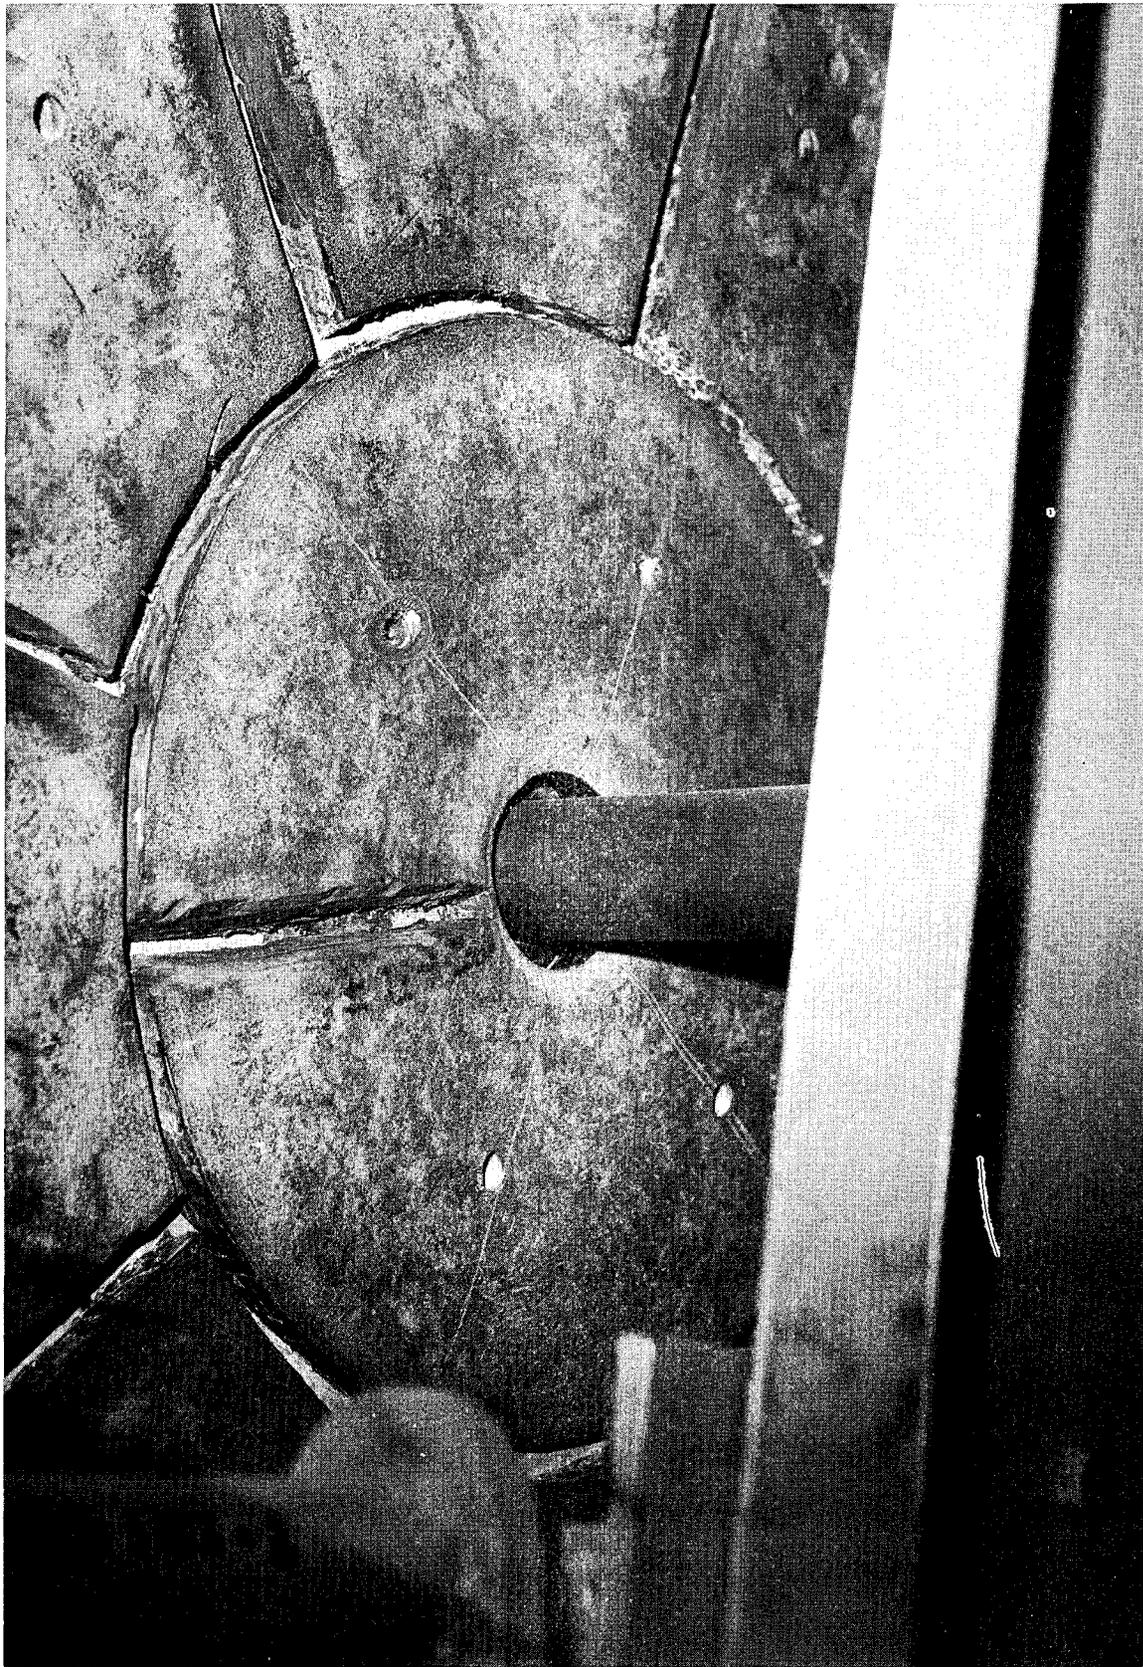
Figure 10

The first operation after the chamber was returned to the General Processing area was to remove the V-61 potting insulation from the forward and aft insulation segment V-grooves. This proved to be the most difficult operation. To use routers would be time consuming, and the use of electric saws presented the hazard of inadvertently contacting the metal surface. Hence, the material was manually removed by using rubber mallets and aluminum chisels. This technique resulted in cuts and gouges in the sides of the rubber V-groove, and total removal of the V-61 was not possible. A power sander was equipped with an aluminum saddle, extending approximately 0.13-in. beyond the abrasive wheel. The aluminum saddle was indexed on the chamber wall at the base of the V-groove and prevented the abrasive wheel from contacting the metal surface. This method was successful in removing almost all of the V-61 in the grooves. In inaccessible areas close to the chamber wall or where the V-groove base was narrow, traces of V-61 remained. Completed forward V-grooves are shown in Figures 10 and 11. After acceptance of V-61 removal, the metal at the base of the V-grooves was gritblasted to remove the primer, cleaned, and reprimed with Fuller 162-Y-22. In this limited access area, the primer was brush-applied to prevent contamination of the adjacent rubber.

Forward Insulation V-Grooves After V-61 Removal

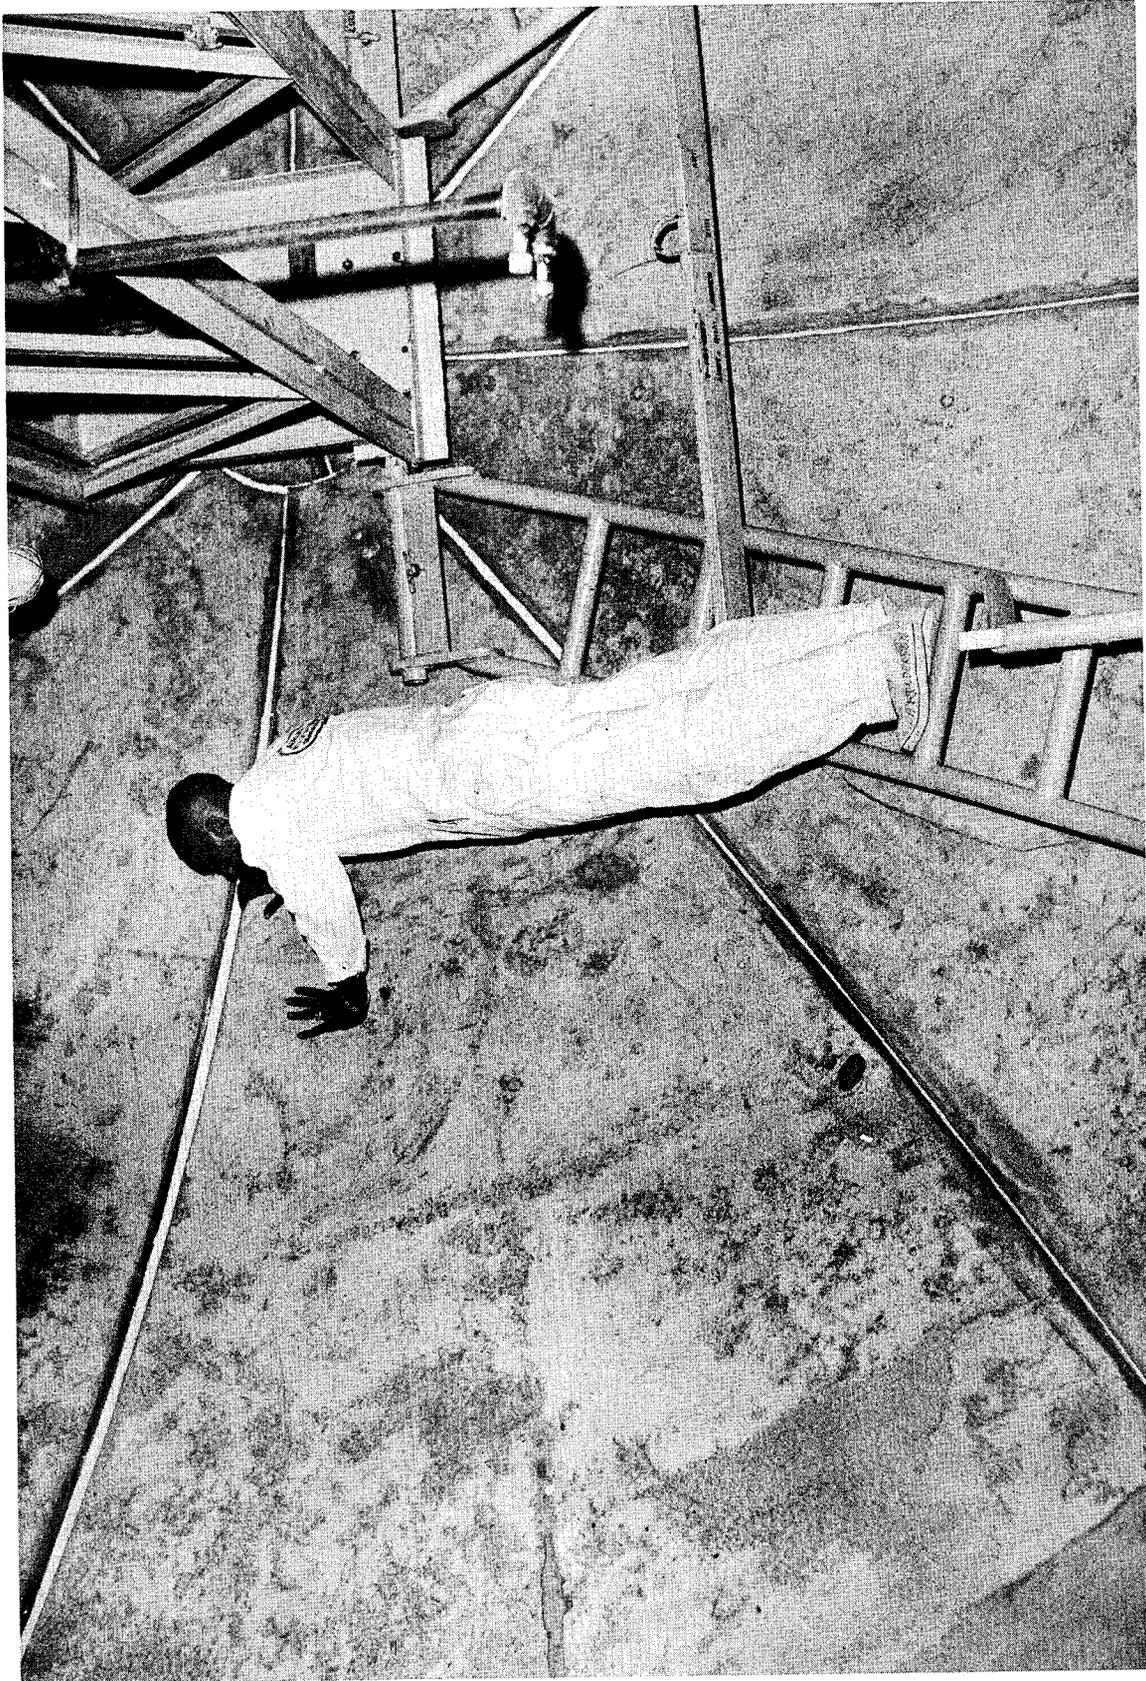
Figure 11

Forward Insulation V-Grooves After V-61 Removal

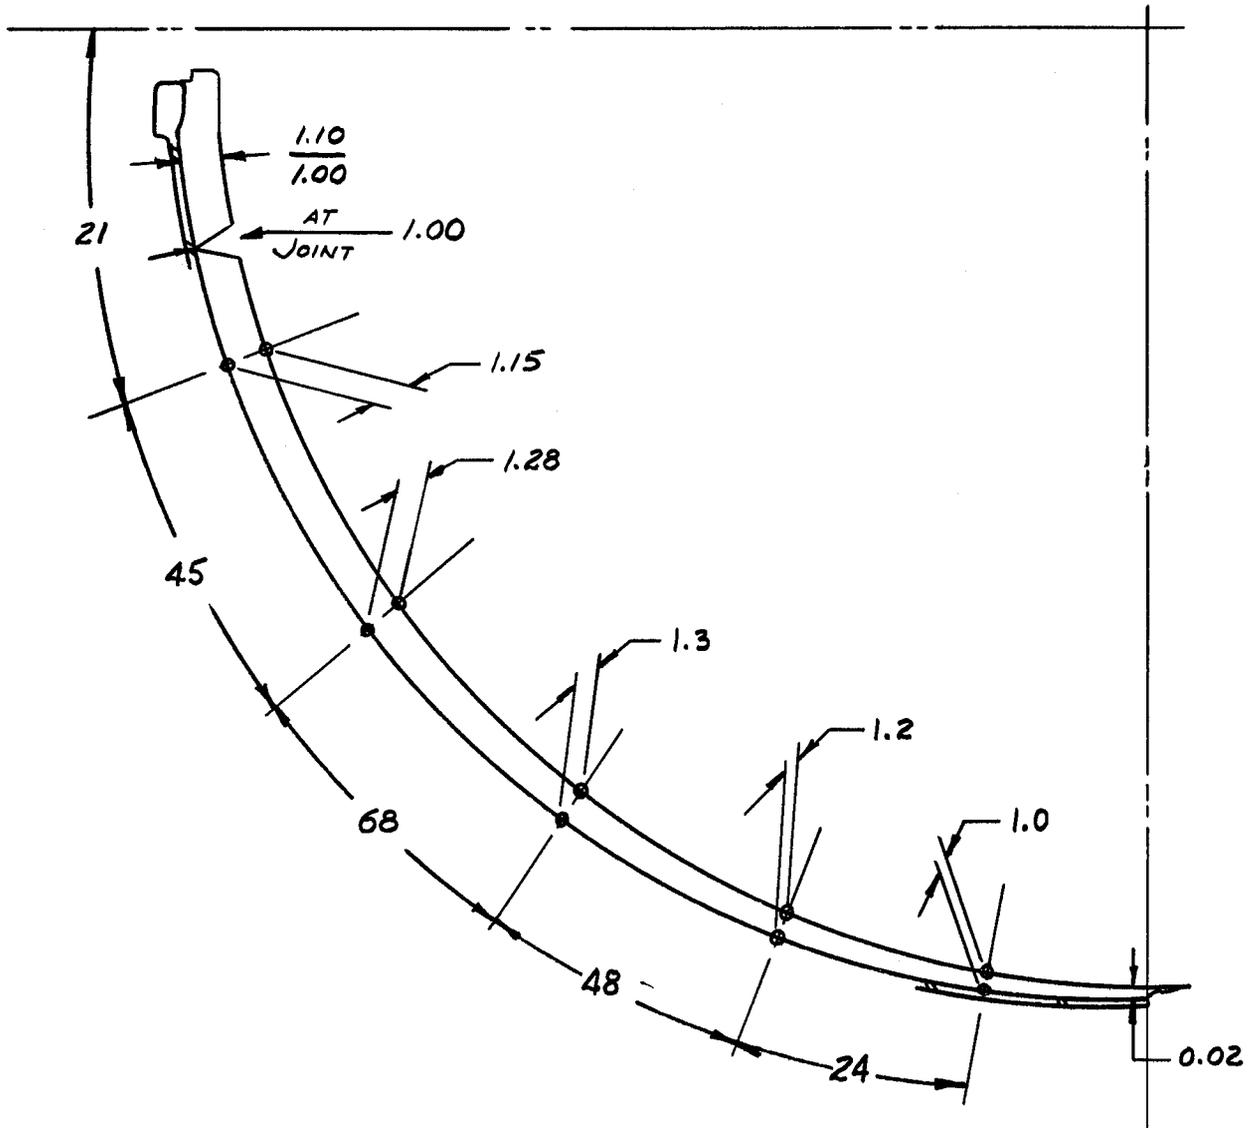
Figure 12

Final 260-SL-3 Rehabilitated Forward Insulation Contour

The areas in the forward and aft insulation where damaged rubber had been removed were repaired with V-44 strips. Residual cylindrical-section strips were cut to the required dimensions and bonded into the areas with Epon 948.2 adhesive. Additional insulation sheets were bonded over the initial layer until the area being repaired was built up flush with the adjacent insulation surfaces. The laminated steps were buffed to eliminate sharp corners and smooth out the contour. A router was used to grind out the surface defects in the aft insulation.

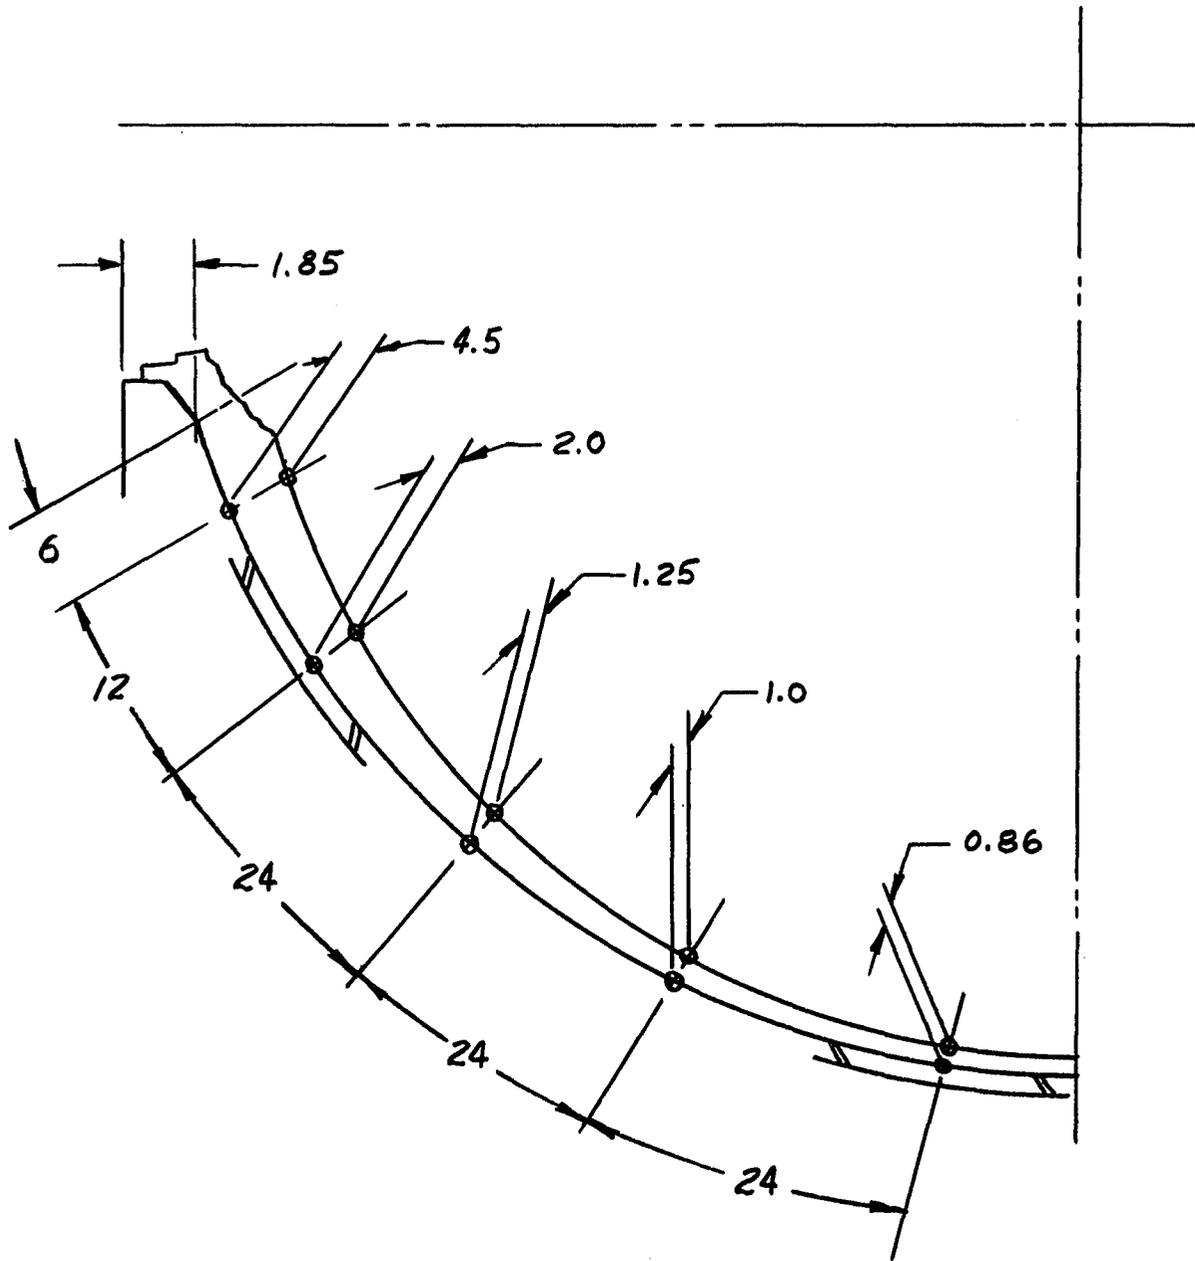
Figure 13

Final 260-SL-3 Rehabilitated After Insulation Contour

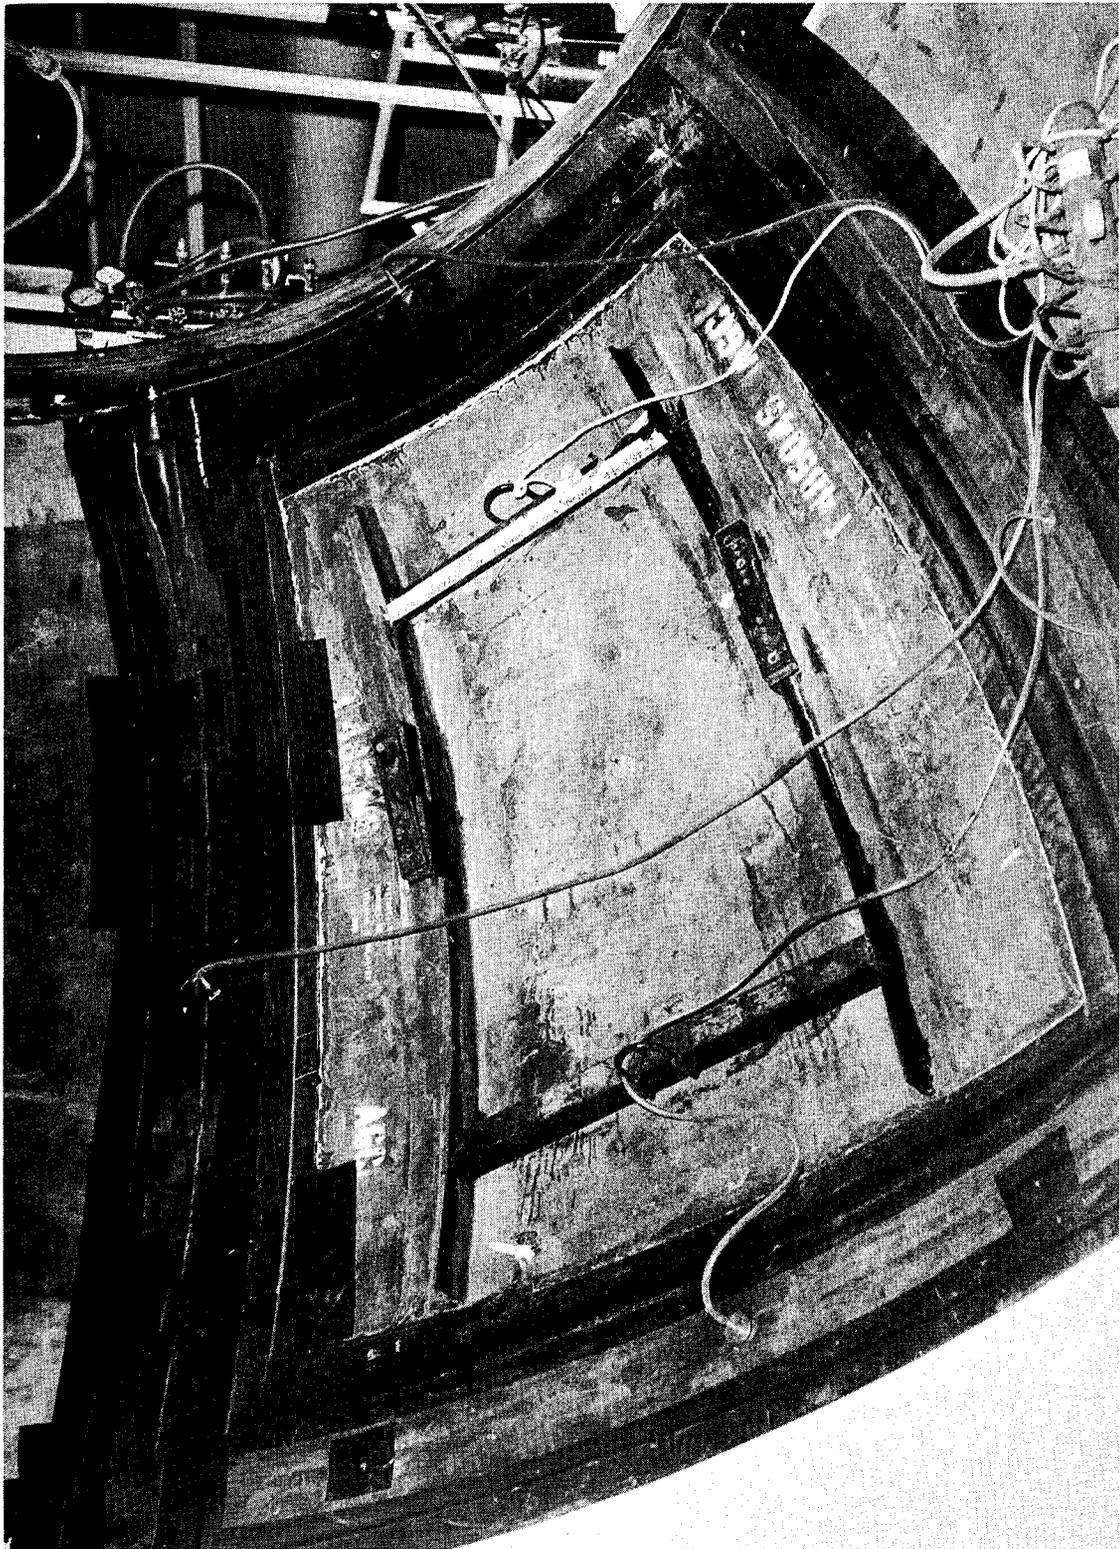
Figure 14

Replacement Aft Insulation Segment Under Vacuum Cure

Installation of the replacement segment, S/N 260A-6, was accomplished as planned. A heavy-gage aluminum-foil template was laid up in the area where the segment was to be installed. The template was removed, placed over the replacement aft insulation segment, and the segment was trimmed to the template configuration. The trimmed segment was moved into the chamber and checked for final fit. The sides of the segment were retrimmed where necessary, skived to 30 degrees using a power sander, and the bonding surface was abraded. Fifty lb of Epon 948.2 was mixed and applied to both the segment and chamber bonding surfaces. No. 1502 cotton bleeder cloth was applied to the chamber epoxy surface, and the segment was installed. Blankets were installed and dealed around the periphery, and vacuum was drawn. The adhesive was cured for 12 hr under 25-in.-Hg vacuum, as shown in Figure 14.

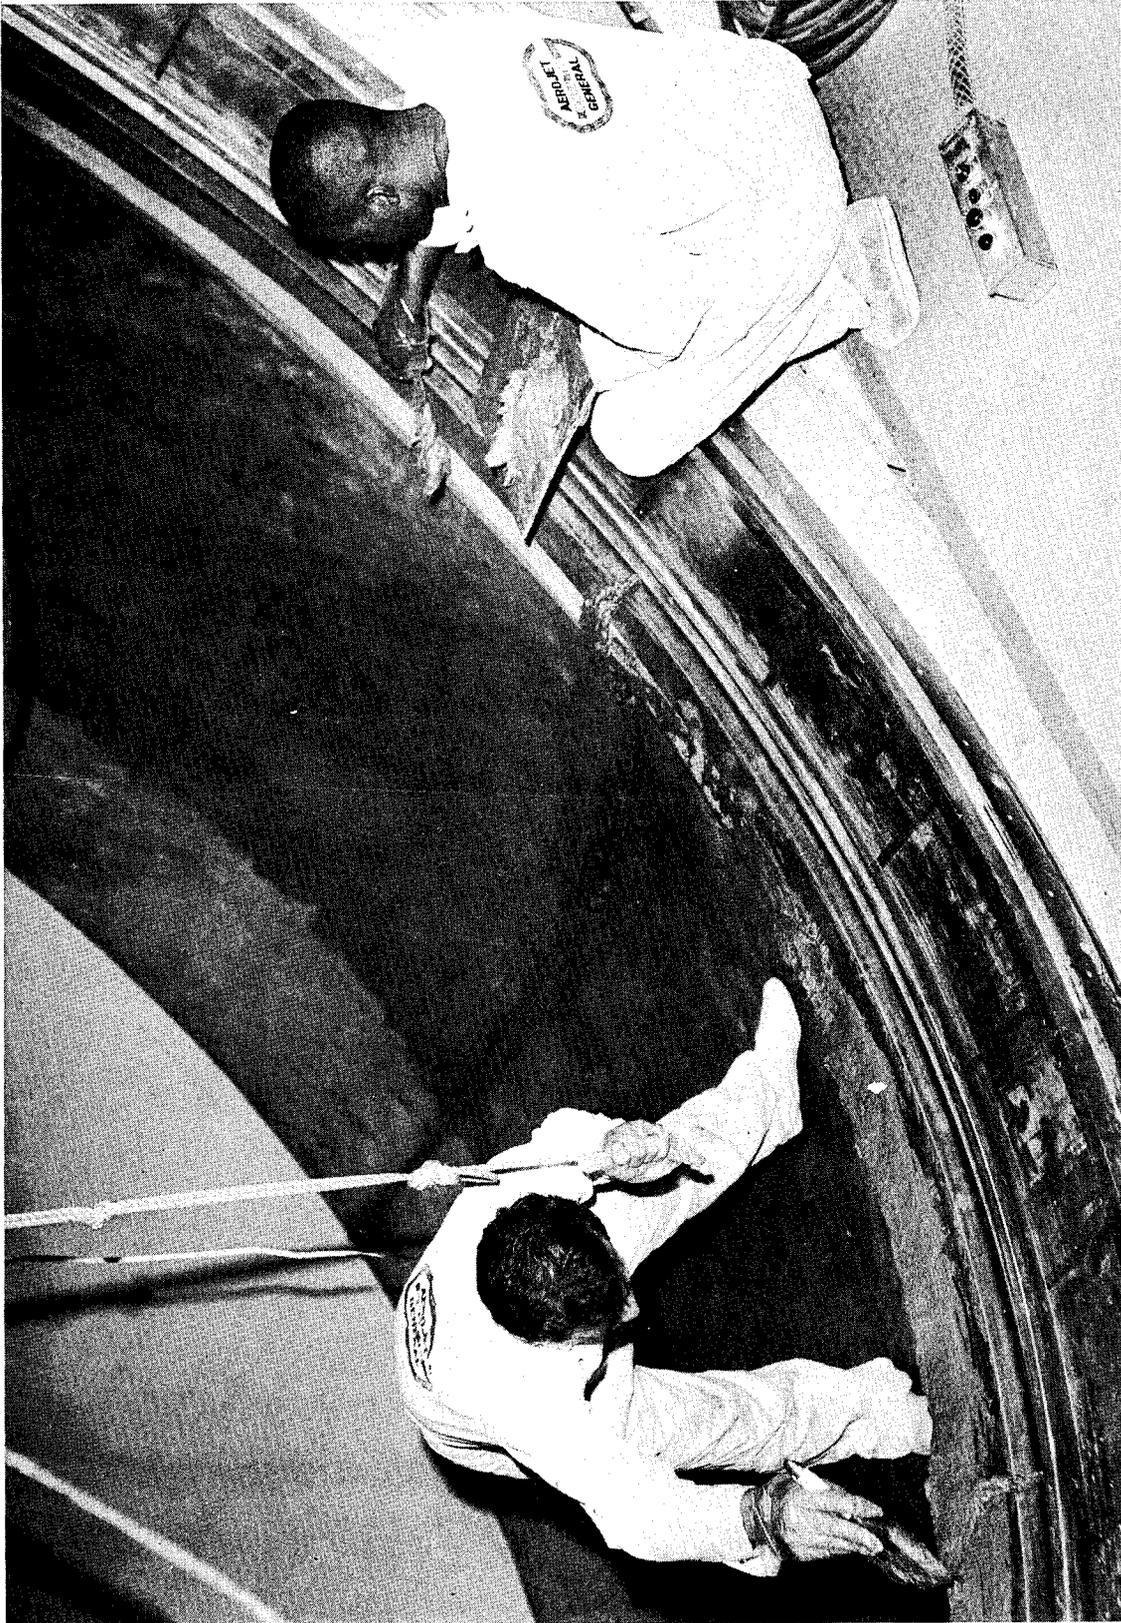
Figure 15

Since none of the lot No. 2618/2619 material cured properly, while all of lots No. 2440/2441 and 2568/2569 material did cure properly, it was evident that the problem was related to the material rather than the processing procedure. The material in the V-grooves and replacement aft-insulation segment buildup was rejected and removed.

Aft Step-Joint Build-Up with V-61 Potting Insulation
