EFFECT OF DEFECTS ON AIRCRAFT COMPOSITE STRUCTURES

R. A. Garrett

McDonnell Aircraft Company

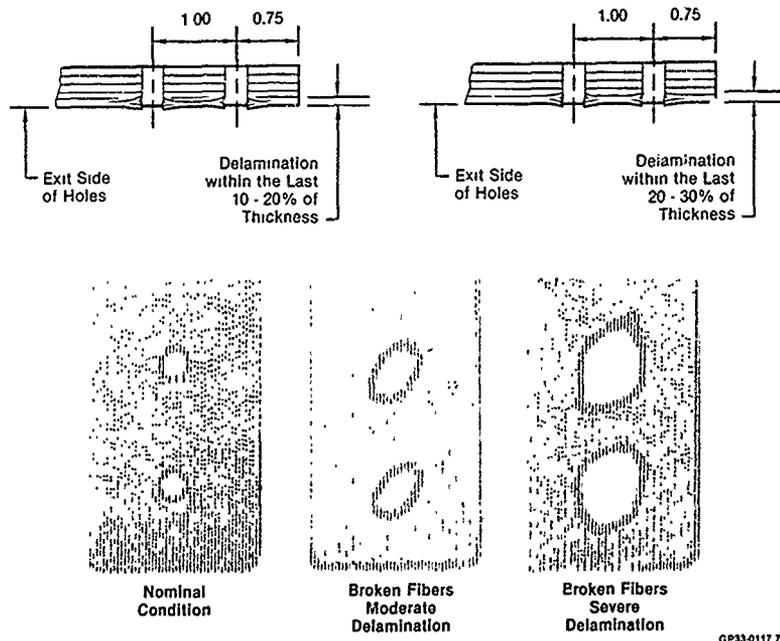
Figure 4. C-Scans of Laminates with Delaminations at Fastener Holes

Delaminations were detected visually and with ultrasonic C-scan. Delaminations were defined as "moderate" when they extended 10-20 percent (2-4 plies deep) into the laminate thickness on the exit side. Delaminations were defined as "severe" when they extended 20-30 percent (4-6 plies) of the laminate thickness on the exit side. Non-destructive C-scans in the area of the fastener holes with moderate and with severe delaminations are illustrated in Figure 4 and compared with a nominal condition.

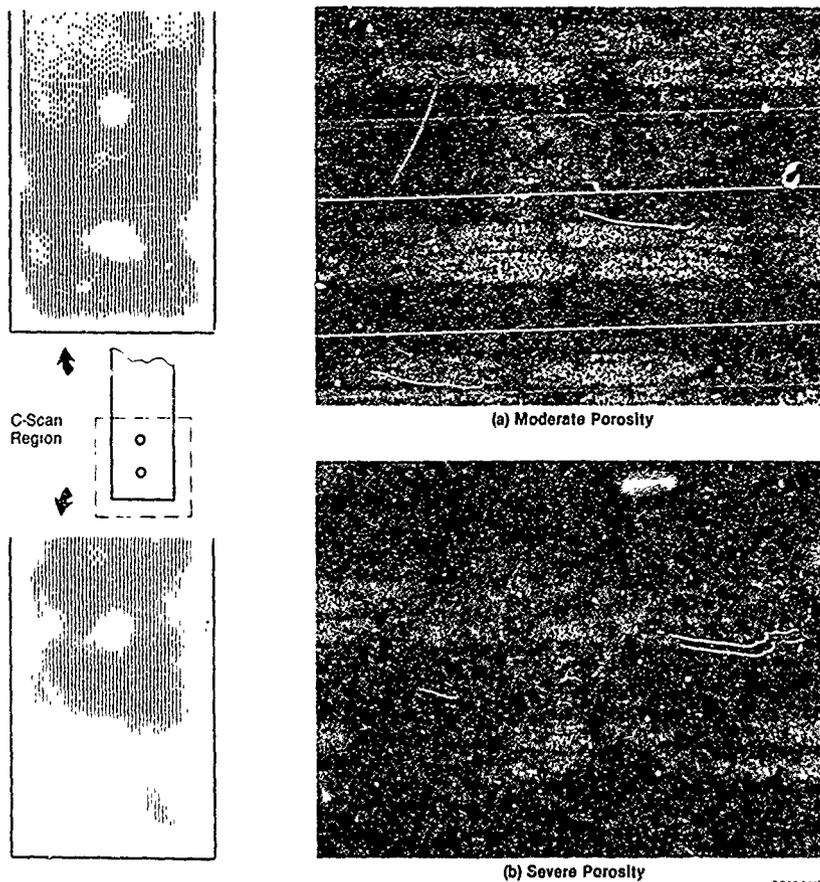
Figure 7. Examples of Panel Porosity

Strengths of baseline specimens and specimens with porosity are compared in Figure 8. Little sensitivity to severe porosity was indicated under tensile loading. Under compressive loadings, strength reductions ranged from 7-13.3 percent for specimens with moderate porosity and 10-30.8 percent for specimens with severe porosity. The greatest reductions occurred at 250°F test condition.

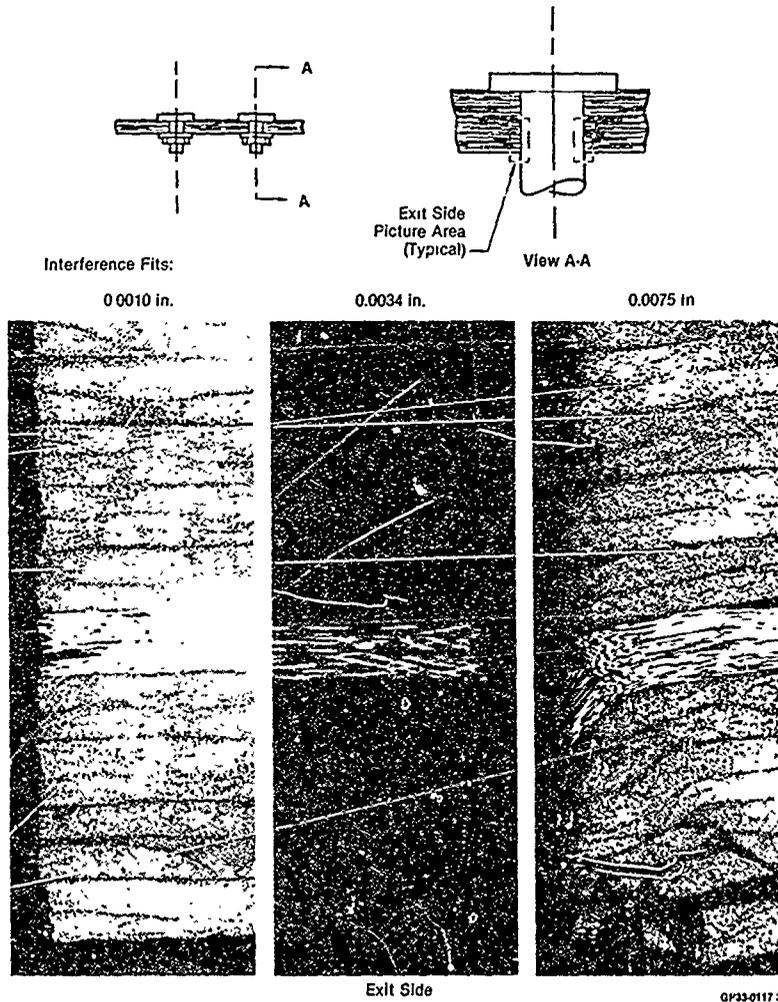
Figure 12. Photomicrograph Examination of Laminates with Interference Fit Holes

Laminate damage due to fastener installation at interference fits ranging from .002 to .008 inch were further evaluated for fasteners requiring pull-through installation techniques. Representative photomicrographs are shown in Figure 12. Little or no damage resulted from a fastener interference of .0035 inch or less; however, damage is indicated at the fastener exit side as well as along the entire fastener length for interference fits from .004 through .008 inch.

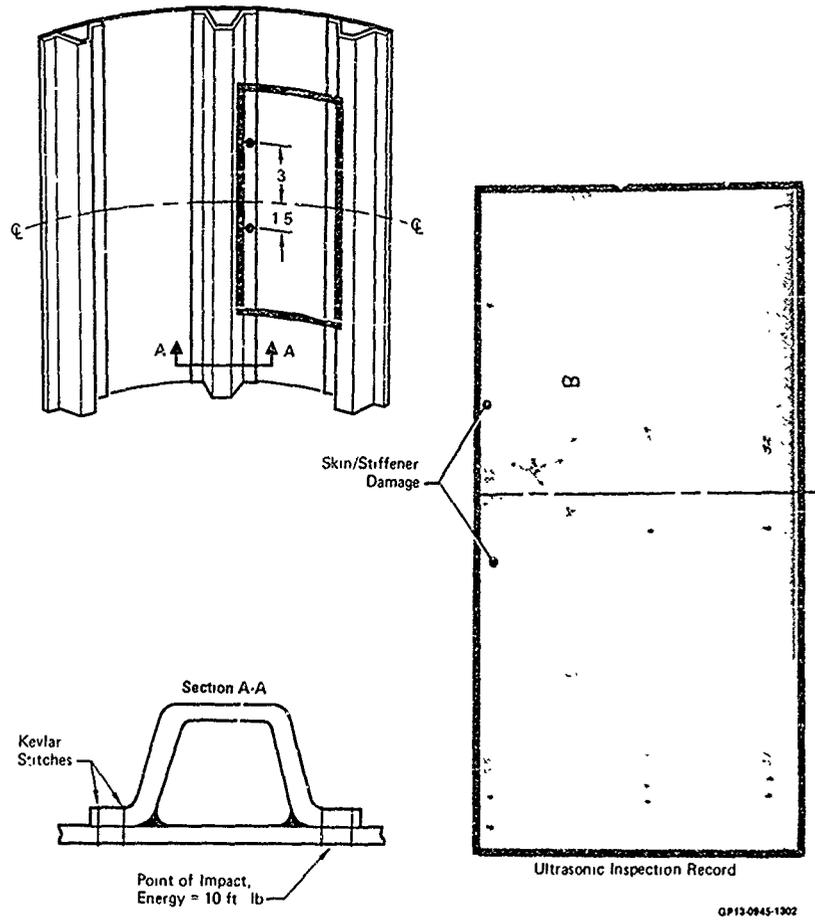
Figure 32. Damage Containment in Stitched Skin-to-Stiffener Joints

The damage containment capability of Kevlar stitches was significant. An unstitched, undamaged baseline panel suffered failure after 3,500 load cycles where the peak load was -55 kips. A stitched, undamaged panel was cyclically loaded without failure for 280,000 cycles to -50 kips followed by an additional 280,000 cycles to -55 kips. This test sequence using a stitched, damaged panel was repeated; again the reinforced panel survived both groups of 280,000 load cycles. In addition, ultrasonic inspections conducted after each block of 140,000 cycles indicated good containment of the impact damage with no disbond growth. Reinforcement with Kevlar stitches was, in this case, an effective means of assuring durability of cocured joints having nonvisible impact damage.

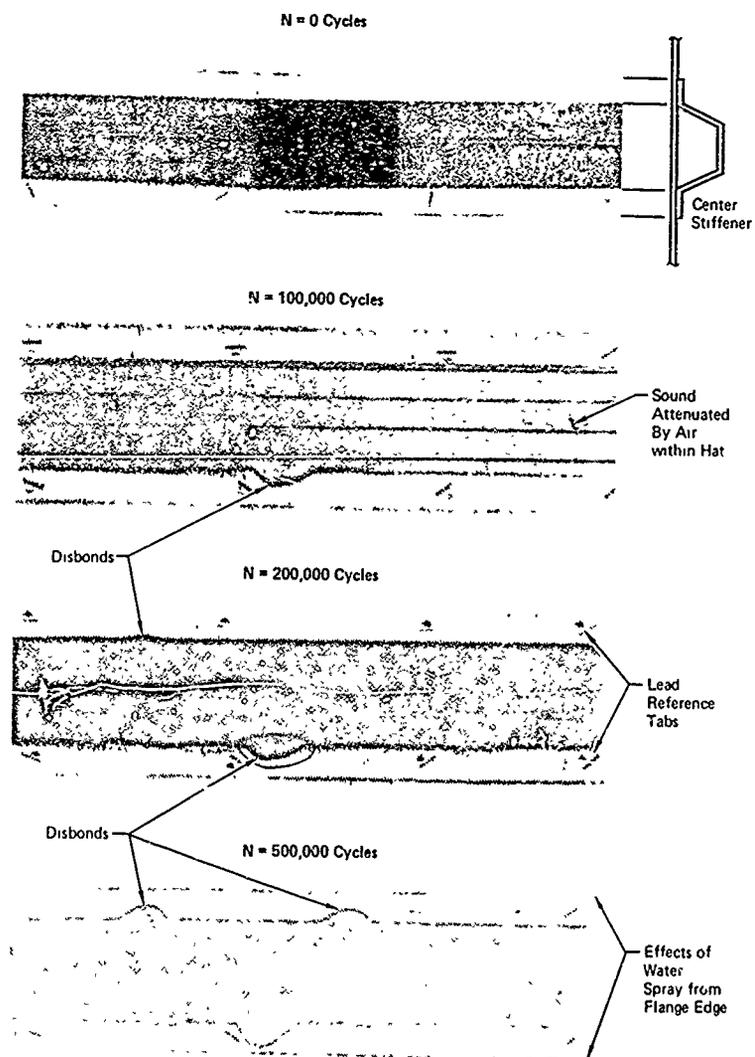
Figure 33. Growth of Disbonds in Flange-to-Skin Joint

The baseline behavior of curved stiffened panels under compression postbuckling loads was determined in a previous test program (Reference 3). Fatigue failures were precipitated by local disbonds occurring in undamaged skin-stiffener joints.

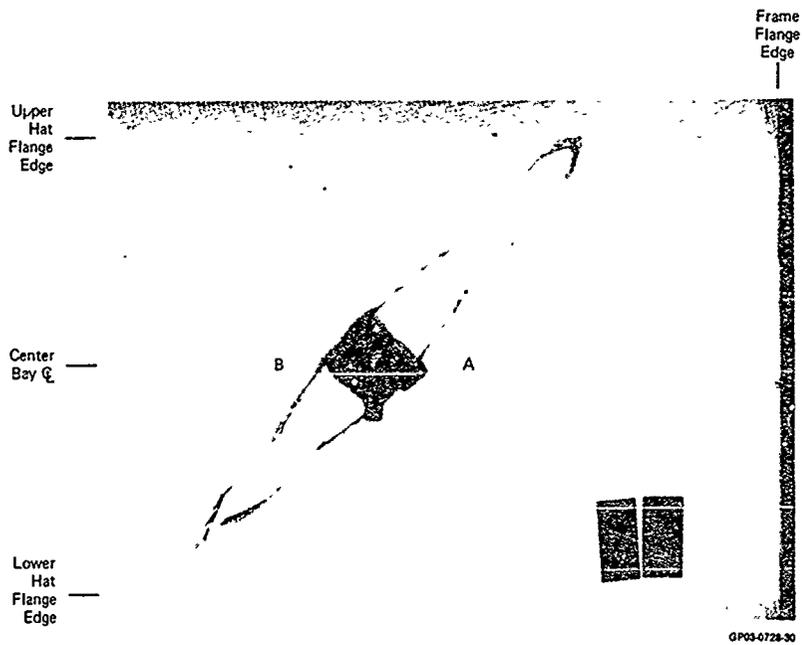
Figure 43. Radiographic Inspection of Initial Impact Damage

The impact damage sustained by the first fatigue test panel was similar to that observed both in the exploratory tests and in the static test panel. This panel survived 100,000 cycles with no visible stiffener separation or significant decrease in initial buckling strength observed. Radiographic inspections of the impact region prior to fatigue testing, after 50,000 cycles, and after 100,000 cycles are shown in Figures 43, 44, and 45 respectively. The damaged region did not grow during fatigue loading. Residual strength for the panel was 778 lb/in with sheet rupture occurring across the tension diagonal through the impacted region similar to that observed for the static test panel.
