TITLE: Minutes of the Explosives Safety Seminar (22nd) Held in Anaheim,  
California on 26-28 August 1986, Volume 1.

DEBRIS HAZARD AT A ROCKET  
MOTOR TEST CELL FACILITY--  
AN "ACCIDENTAL" STUDY

Patricia Moseley Bowles  
and  
Michael A. Polcyn

Southwest Research Institute  
San Antonio, Texas

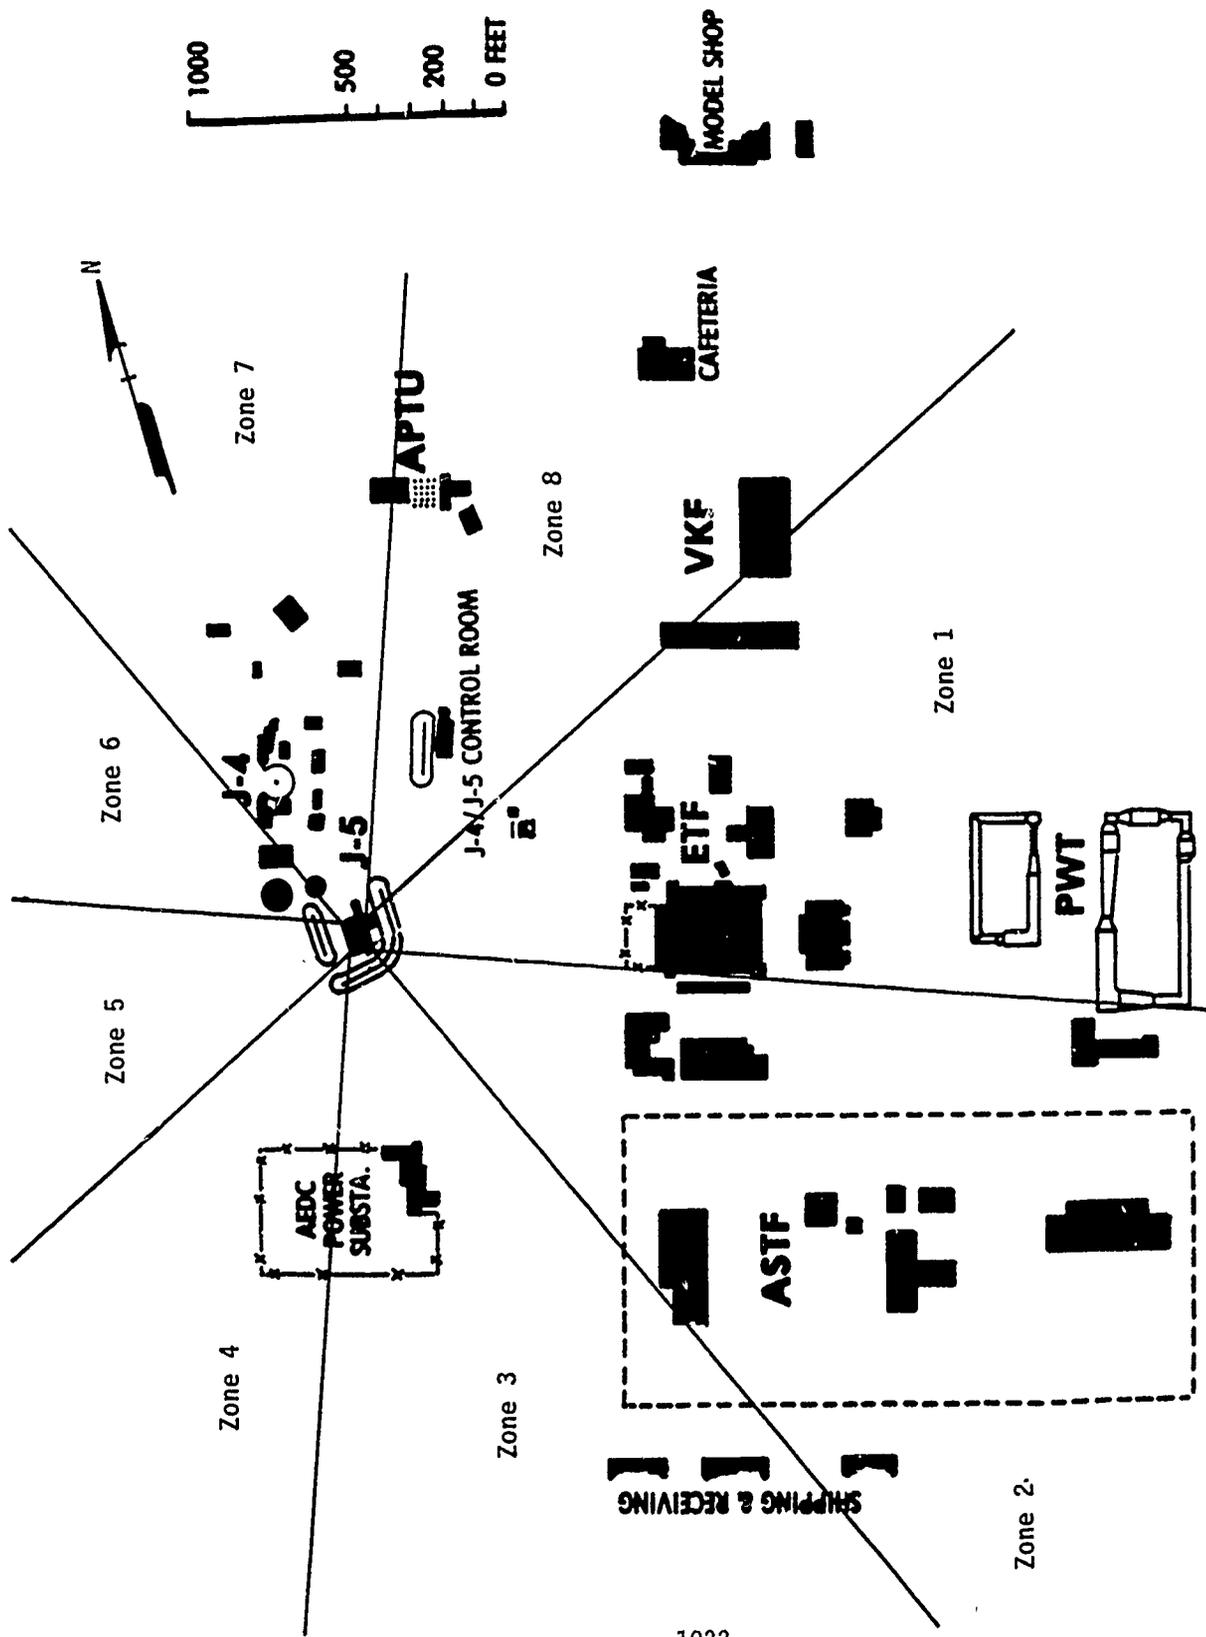
Figure 5. Debris Zones for an Explosion in J-5

Elevations of the J-5 enclosure building and an expanded detail of the test cell are shown in Figures 2-4. Since the J-5 test cell and enclosure building are similar to the configuration described in Reference 1, debris were expected to be similarly distributed in zones around the enclosure building. The zones which were established for examining hazardous debris densities are shown in Figure 5. Debris densities were estimated in zones 1, 3, 5 and 7 since the number of debris landing in the other zones was assumed to be minimal. Building debris will be dispersed in directions normal to the walls of the enclosure building. The heaviest concentration of motor casing and test cell fragments was predicted in zone 5 because it extends perpendicular to the horizontal axis of the test cell. Approximately 70% of the total fragments and debris will land in zone 5. Although zone 1 extends in the direction opposite of zone 5, fewer casing and cell fragments will land there since a 5 foot thick seismic mass (see Figure 2) supports the test cell on that side. The seismic mass will stop all but high trajectory fragments. About 20% of the total debris will land in zone 1. The remaining 10% of the debris will be distributed in zones 3 and 7, with slightly more debris landing

in zone 3. The percentage of debris landing in zones 2, 4, 6 and 8 is insignificant. It should be noted that while the percentage of fragments landing in zones 3 and 7 is relatively low, the cell endcaps and hatch covers will most likely impact in these areas. Thus, the damage potential of these large debris is a more important consideration than hazardous debris density in the immediate J-5 area. In summary, the distribution of fragments and building debris was expected to be highly directional with heavy debris concentrations in zones normal to the walls of the enclosure building. Debris paths and concentrations of major debris observed during the mishap investigation lend new support to this theory.

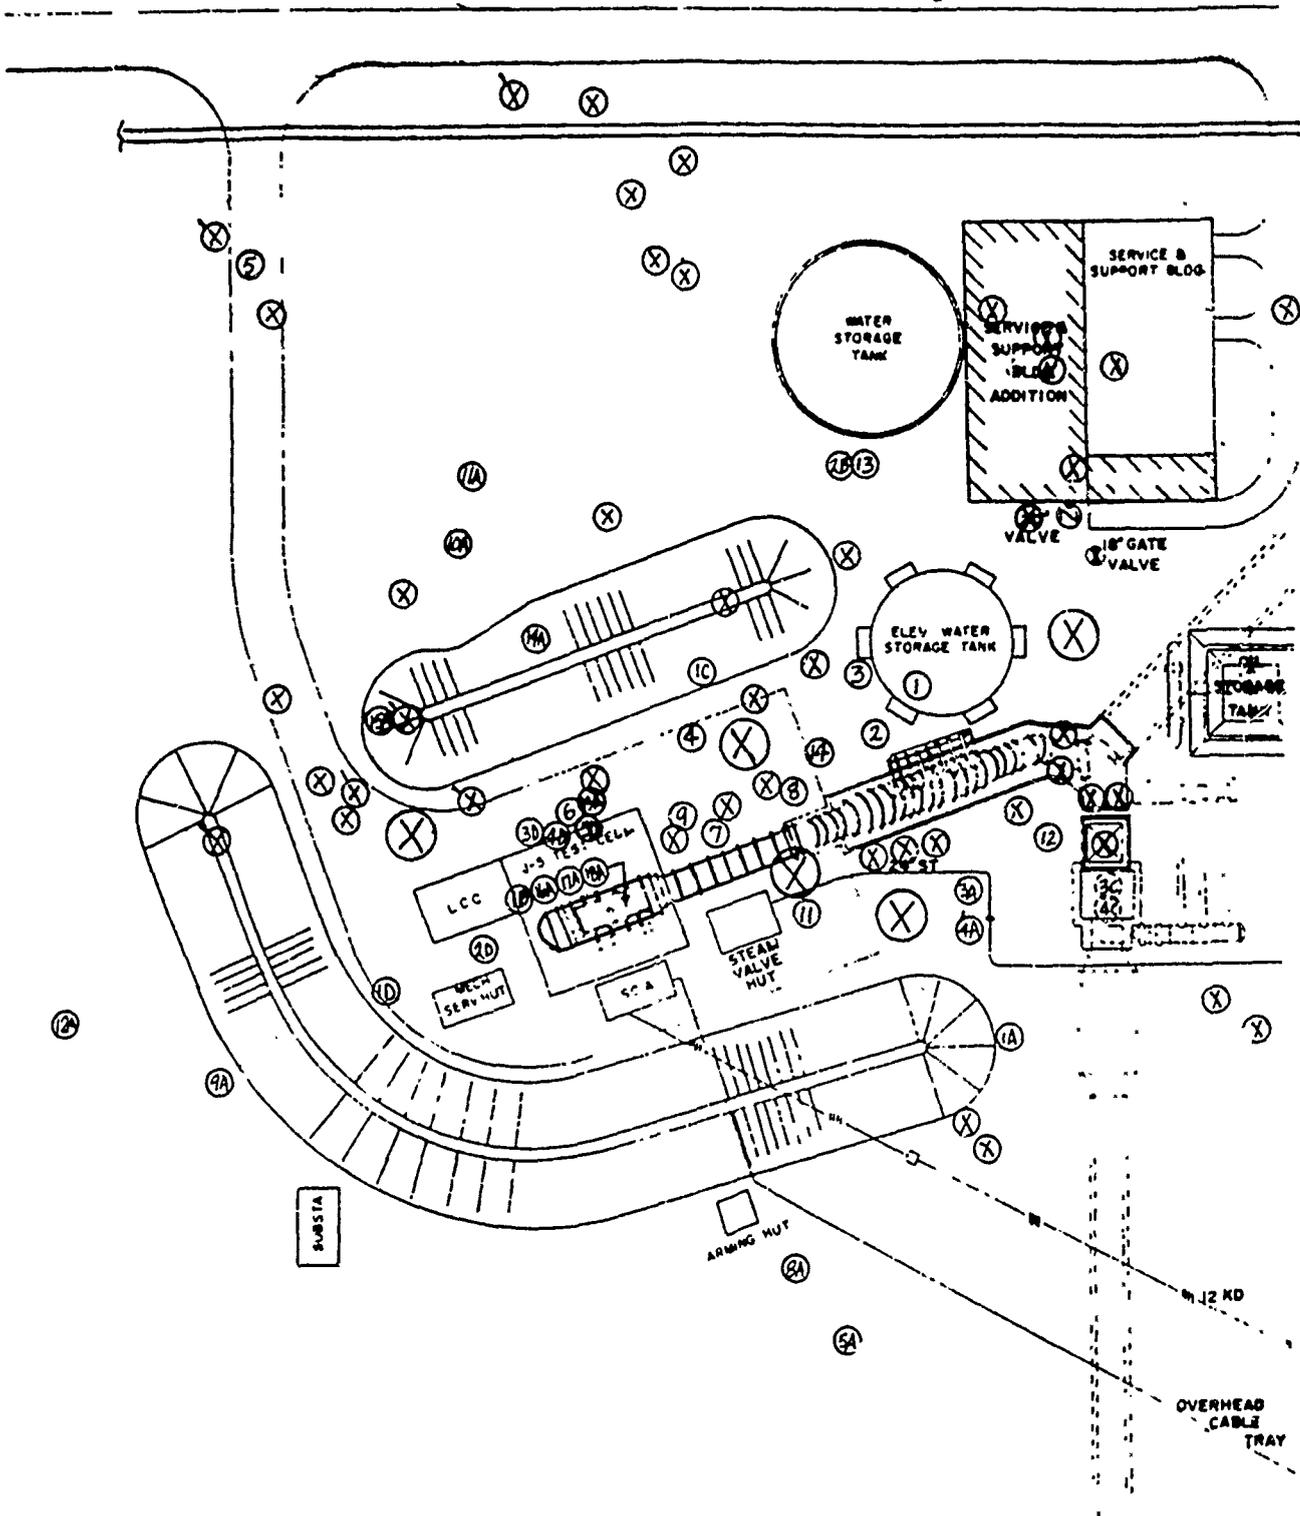
Figure 6. Missile Map Showing Motor Casing Fragments and Unburned Propellant

An AEDC mishap investigation team was immediately set to the task of determining the cause of the mishap. Their activities included review of manufacturing, shipping and test preparation records, a test procedures review, review and analysis of physical evidence at the site, and interviews of mishap witnesses. In addition to these activities, an SwRI team was allowed to study the site and collect data related to the distribution of debris caused by the mishap. Data collected included the type, size, and origin of debris, along with the impact characteristics and angles of debris throw. Although all identifiable motor casing parts were previously removed from the site, SwRI was provided with a missile map (shown in Figure 6) showing locations of retrieved motor casing fragments (numbered circles) and unburned propellant (circles with an "X" in them). SwRI also used post-mishap photographs (including aerial shots) to help summarize observations on debris and other physical evidence or damage indicators noted during the site investigation.

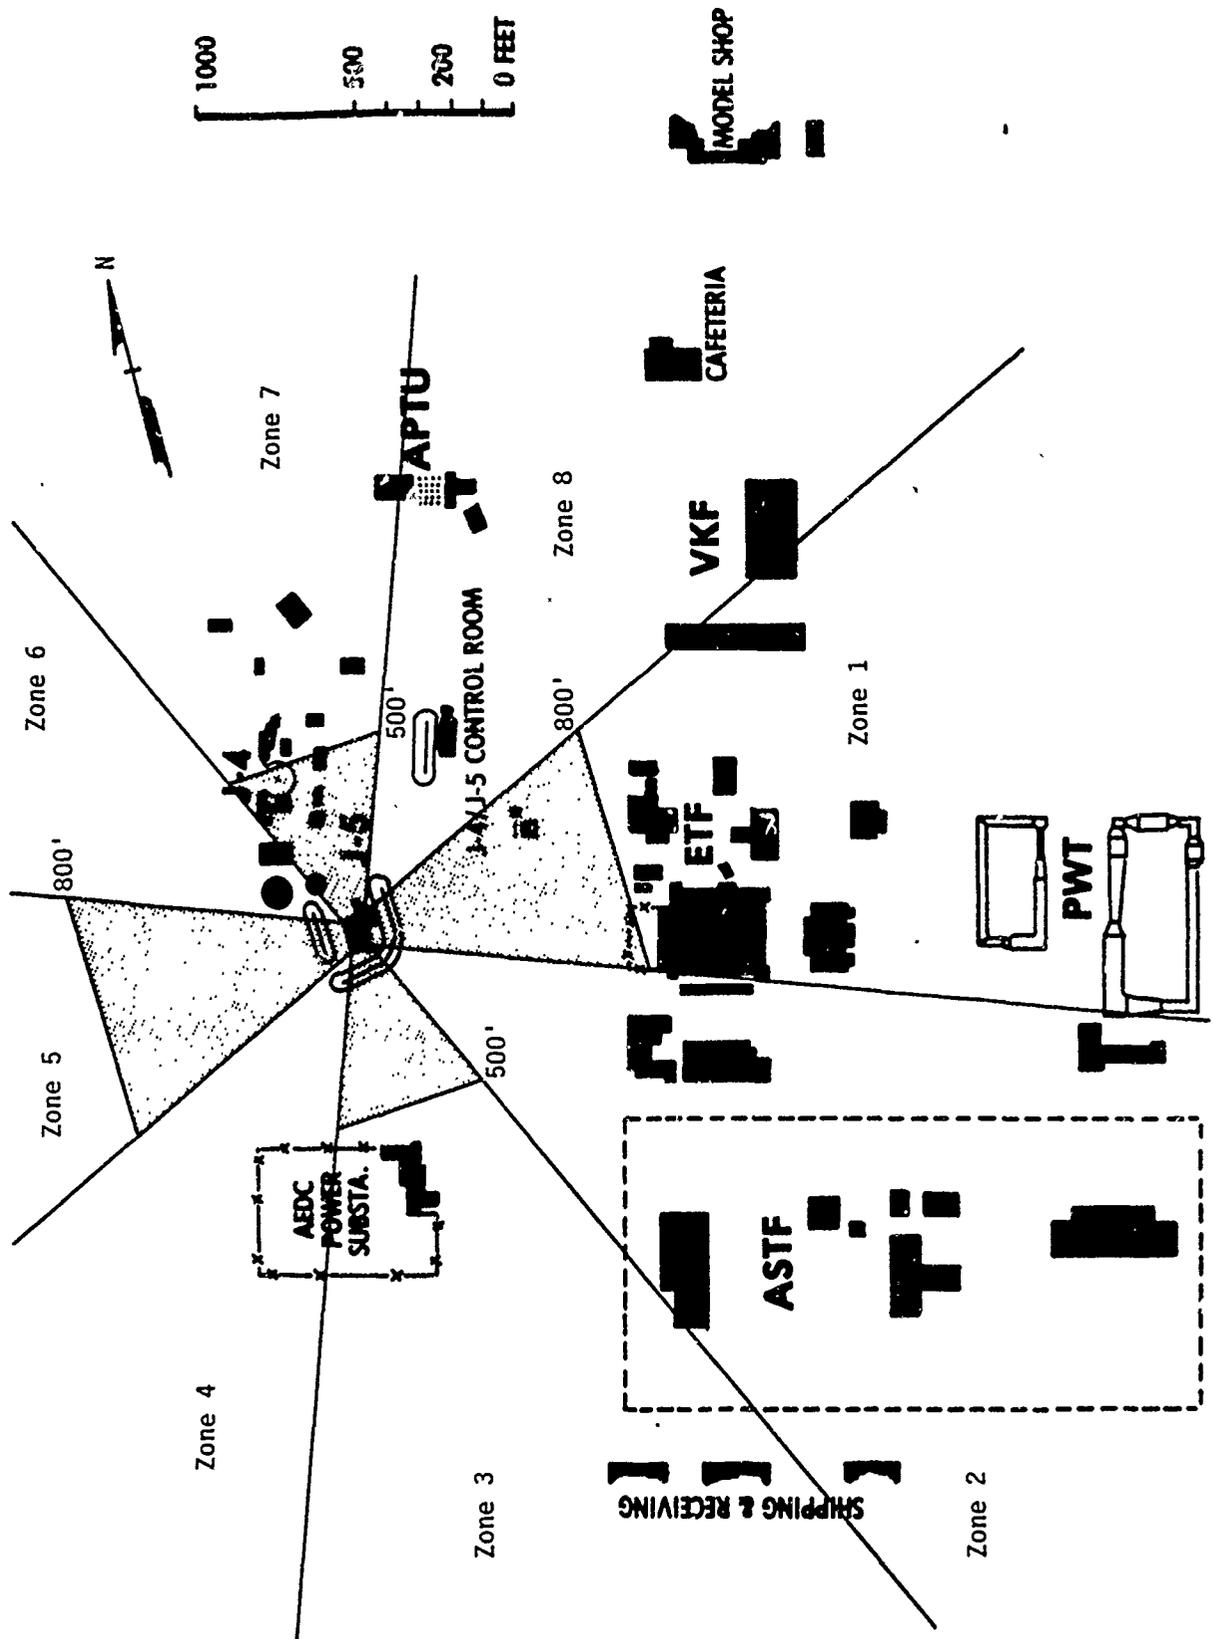
Figure 7A. Hazardous Debris Areas for a 20,000 lb TNT Equivalent Detonation

The hazardous zones predicted for a 20,000 lb TNT equivalent propellant detonation are shown in Figure 7A. The limit distances indicate the threshold of hazardous fragment density, defined as more than one fragment with kinetic energy greater than 58 ft·lb per 600 square feet. Impact locations of a few of the larger cell and building debris from the mishap are shown in Figure 7B. The location of the impacts furthest from the test cell in each zone are indicated on the figure. Note that these are locations of single fragments and do not correspond to the limit distances for hazardous fragment density for the mishap. The hazardous density for the mishap was limited to the bermed J-5 area.
