FLIGHT SERVICE ENVIRONMENTAL EFFECTS  
ON COMPOSITE MATERIALS AND STRUCTURES

H. Benson Dexter  
NASA Langley Research Center  
Hampton, VA USA 23665-5225

Donald J. Baker  
U.S. Army Aviation Research and Technology Activity (AVSCOM)  
Aerostructures Directorate  
NASA Langley Research Center  
Hampton, VA USA 23665-5225

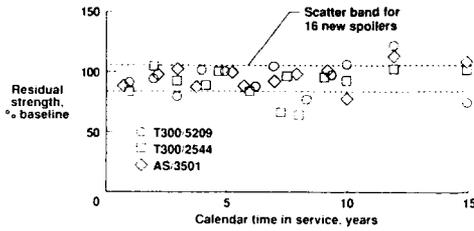
Residual strength tests were conducted on 37 graphite/epoxy spoilers to establish the effects of service environments. The spoilers were tested with compression load pads on the upper surface to simulate airloads. Trailing edge tip deflection was measured as a function of applied load for each spoiler tested. The test results are compared with the strength of 16 new spoilers in figure 8. The strength for each spoiler through 6 years of service generally falls within the strength scatter band for the baseline spoilers. However, spoilers with significant corrosion damage which were tested after 7 and 8 years of service, respectively, indicated a 35 percent strength reduction. An additional T300/2544 spoiler with no corrosion damage was tested after 7-1/2 years of service, which verified that the 7 year strength reduction was related to corrosion damage. Three spoilers tested after 9 years of service with little or no corrosion damage exhibited strengths equal to the strength of the baseline spoilers. An AS/3501 spoiler with 10 years of service and known corrosion damage failed at 78 percent of the average strength of the baseline spoilers. Two other spoilers with 10 years of service with no corrosion damage failed within the baseline strength scatter band. Spoilers tested after 12 years of service failed at or above the average strength of the baseline spoilers. One spoiler that had known corrosion damage after 15 years of service failed at about 75 percent of the strength of baseline spoilers.

Figure 8. Residual strength of B737 graphite/epoxy spoilers.

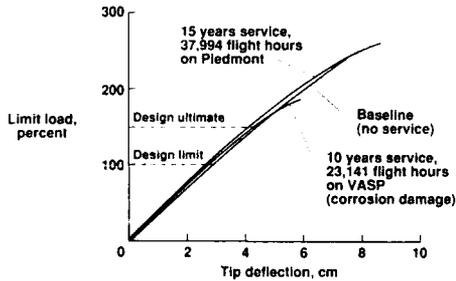
Load-deflection response of spoilers with 10 years and 15 years of service time are compared with the response of baseline spoilers in figure 9. The 10 year spoiler with known corrosion damage failed at about 78 percent of the baseline strength. However, the 15 year spoiler with almost 38,000 flight hours failed at about 8 percent above the baseline strength. Additional details of service experience with the spoilers can be found in reference 7.

Figure 9. Load-deflection response of AS/3501 graphite/epoxy spoilers for B737 aircraft.

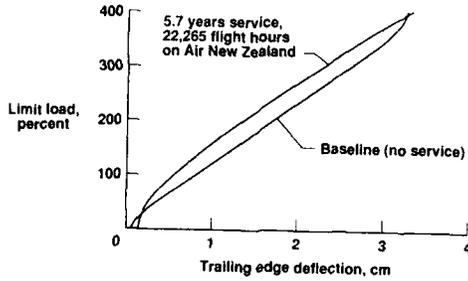
A graphite/epoxy rudder was removed from service for residual strength testing after 5.7 years and 22,265 flight hours on Air New Zealand. The load-deflection response shown in figure 13 indicates that the 5.7-year rudder had an initial stiffness higher than the baseline rudder, but the overall response is similar for the two rudders. The baseline and the 5.7-year tests were stopped at approximately 400 percent limit load because of an instability of the loading apparatus. Although the rudders are designed by stiffness considerations and only one residual strength test has been conducted, the overall response of the rudder indicates that no degradation has occurred as a result of over 22,000 flight hours.

Figure 13. Load-deflection response of T300/5208 graphite/epoxy rudders for DC-10 aircraft.

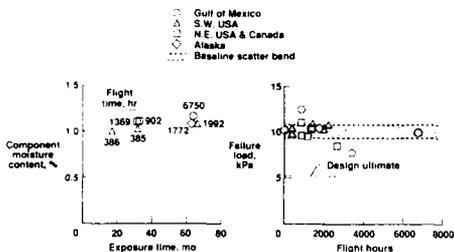
T300/E-788 vertical fins are shown in figure 19. The moisture content was determined by drying plugs removed from the fins. The plugs included painted graphite/epoxy skins, adhesive, and honeycomb core material. The average moisture content measured for the fins is approximately 1.1 percent by weight. The fins operating in the humid Gulf of Mexico had moisture contents slightly higher than those for fins operating in other exposure locations. The residual strengths for 15 fins removed from service exceeded the design ultimate strength requirement. Failure loads for 12 of the fins fall within the baseline scatter band for five fins selected at random. One of the fins operating in the northeast USA and Canada was struck by lightning. This fin was damaged at the top but no apparent damage was inflicted on the structural box. This damaged fin failed below the baseline scatter band, but well above the design ultimate requirement.

Figure 19. Moisture absorption and strength retention of T300/E-788 Bell 206L vertical fins.

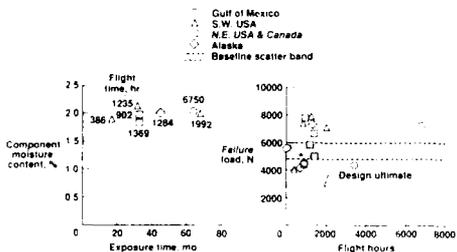
Moisture absorption and strength retention data for Kevlar-49/F-185 litter doors are shown in figure 20. Average moisture content for the litter doors is approximately 2.0 percent. This high moisture content was expected since laboratory tests and other outdoor exposure tests indicated that Kevlar/epoxy composites absorb about twice the moisture of graphite/epoxy composites. There is considerable scatter in the strength data for the 15 litter doors that were removed from service and tested. All the litter doors exceeded the design ultimate strength requirement. Seven litter doors failed above the baseline scatter band and five litter doors failed below the baseline scatter band. The large scatter is expected since some of the failures were a result of metal hinge failures and latch pins slipping from the test fixture.

Figure 20. Moisture absorption and strength retention of Kevlar-49/F-185 Bell 206L litter doors.
