- *Title:* Technology Showcase: Integrated Monitoring, Diagnostics and Failure Prevention.
Proceedings of a Joint Conference, Mobile, Alabama, April 22-26, 1996.

PREVENTION OF CRANKCASE EXPLOSIONS IN RECIPROCATING COMPRESSORS

V. A. Cox

Shell Research Ltd
Thornton Research Centre
P.O. Box 1
Chester CH1 3SH
United Kingdom

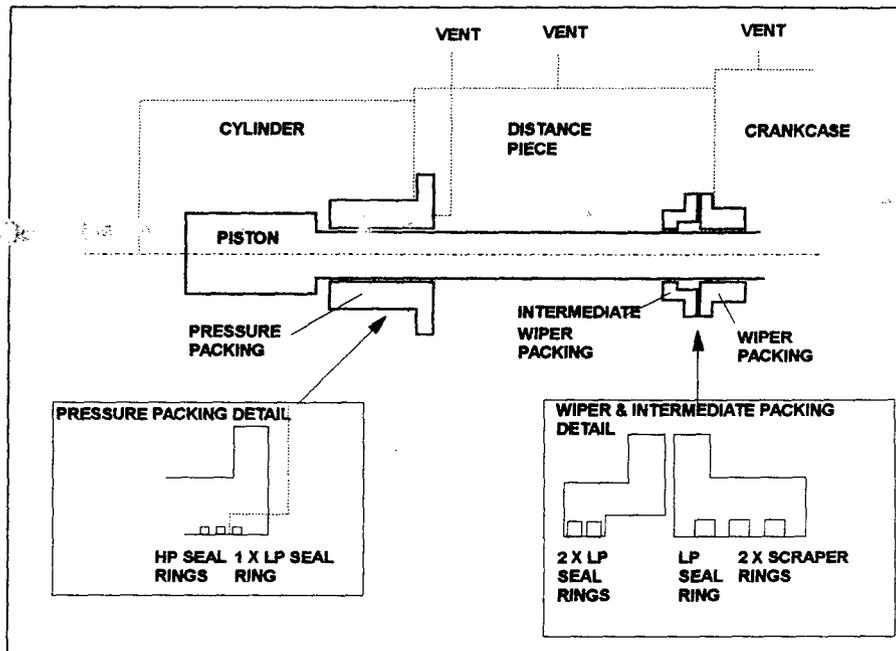
Figure 1. Arrangement of sealing components

The source of gas within the distance piece and crankcase was considered to be inefficiency of the low-pressure (LP) axial seals. All four LP seals fitted in the locations shown in Figure 1 were of the type shown in Figure 4(a).

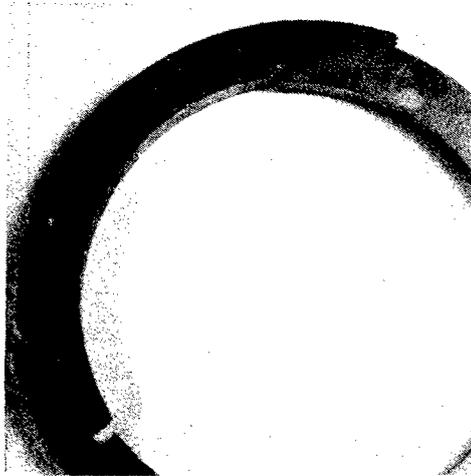
Examination of the elements from the piston rod wiper packings found unusual markings on those taken from one cylinder but not on the others. Damage observed on the mating faces of the oil scraper rings is shown in Figure 2. No damage was seen on the faces adjacent to the containers, nor on the containers themselves. Metallographic examination of a cold-mounted section of a typical damaged wiper element showed shallow areas of microstructural transformation typical of the localised pitting that results from electrical discharge. Such transformation indicated that the local temperature had been raised to at least 240°C. A

Identical damage was later identified on wiper packing elements of two sister reciprocating compressors.

Figure 2. Appearance of damaged rings

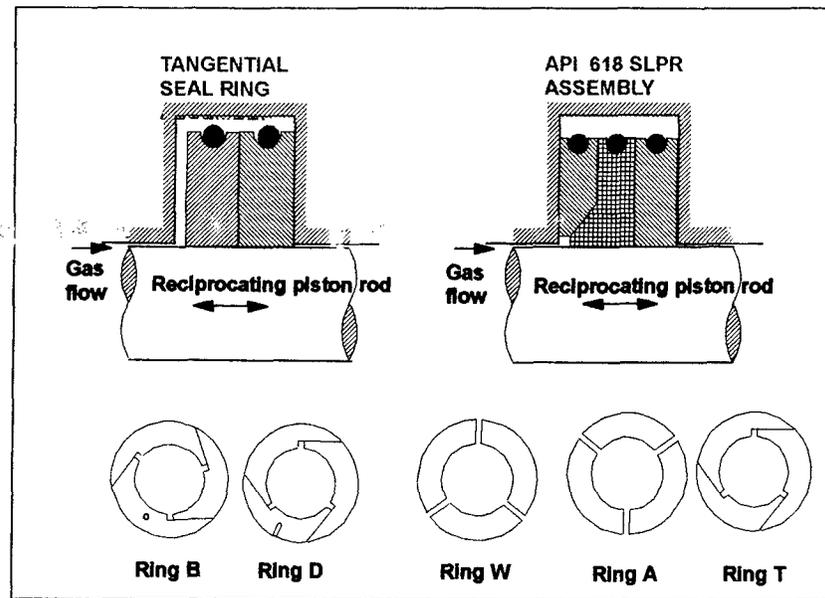
The double tangential seal is designed to operate with a small axial clearance, which allows the ring to reciprocate slightly with rod motion. The volume displaced by a ring on each stroke equals the product of the ring's cross sectional area and the axial clearance, 1244 mm³. Provided that a differential pressure exists across the seal, gas will pass it solely due to the effects of reciprocating motion. Leakage of gas to the crankcase by this mechanism could total 134 litres/hour when all six cylinders are taken into consideration.

Figure 4. Low-pressure axial seal types, (a) double tangential, (b) SLPR

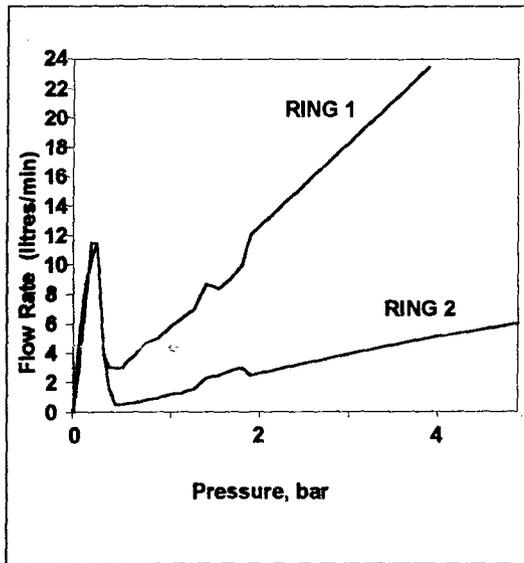
Initial testing was concentrated on the evaluation of commercial quality, LP seals. The early findings were that sealing performance was very dependent upon the quality of manufacture. As shown in Figure 6, whereas some rings sealed with reasonable efficiency others, of apparently equivalent manufactured quality, performed poorly. Immediate improvements to the surface finish of all rings were agreed with the manufacturer.

Also shown in Figure 6 is an important finding of this phase of the work. The performance of all seals was poor at the range 0 to 0.5 bar, i.e. the very range within which it would be called upon to operate in practice. This is believed to be a function of friction between the seal and

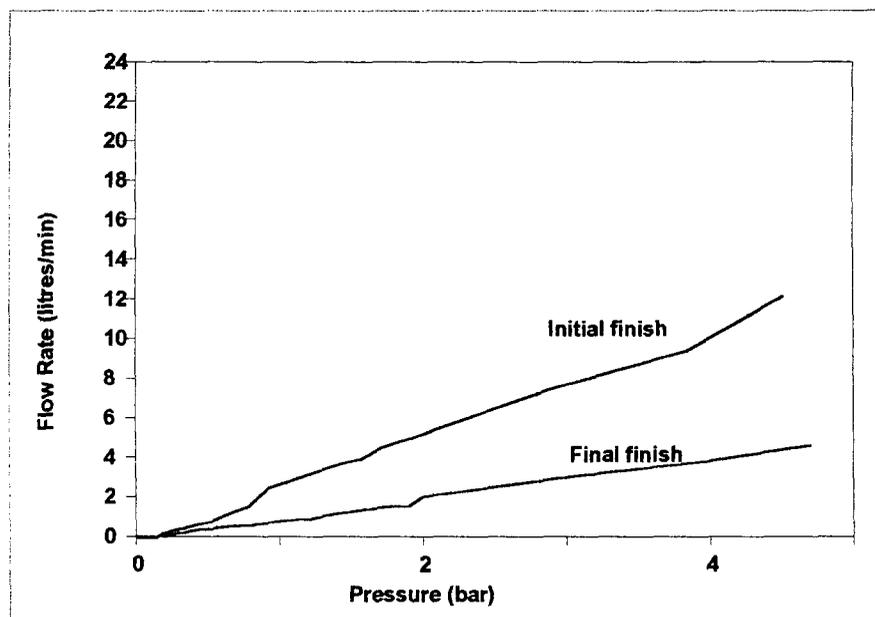
The test rig was next used to evaluate API 618 SLPR type seals, with a view to replacing the LP seals. The first rings tested were made to the finish standards of those in service in other applications, but these were found to have leakage rates considerably exceeding those of the later LP seals. Examination of these rings after testing showed the main cause to be coarseness of the turned finish of the 45 degree face. The least grooving that remained after machining led to friction between rings, inhibiting the even and constant conversion of radial spring tension to axial thrust. Discussions were held with the manufacturer to define the best repeatable commercial finish that could be provided on sealing surfaces. Agreement was reached that the chamfer faces would be fine-turned to a very high standard and that all radial seal faces would be lapped to 6-12 micro-inch CLA. A second set made to this standard was evaluated, giving the improved results shown in Figure 8.

Figure 8. Leakage of leaded bronze SLPR rings to vent.
