FAILURE ANALYSIS OF A PITCH LINK SELF-LOCKING NUT MS 17825-10

Scott Grendahl

U.S. Army Materials Research Laboratory
Aberdeen Proving Ground, MD 21005-5059

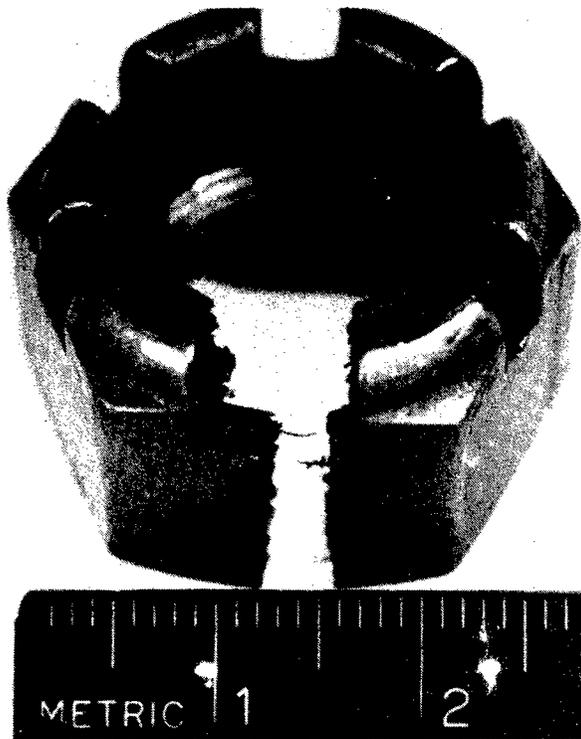
Light Optical Microscopy: The self-locking nut received was split open approximately 1/8 of an inch along its longitudinal axis as shown in Figures 1. The cadmium plating was relatively intact with no evidence of general corrosion or pitting observed. The fracture surface contained slight discoloration from post fracture corrosion. This discoloration from corrosion can be seen in Figures 2 and 3. Upon sectioning, it was determined that the crack originated from a slightly subsurface area of the nut near the O.D. as seen in Figures 4 and 5 (arrows denote origin and inclusion band). The radial lines and chevron pattern converge to an area adjacent to the O.D. of the nut opposite the castellated end. A long narrow band was noted on the fracture surface traveling parallel to the O.D. edge of the nut opposite the threads as shown in Figures 2 - 5 (arrows denote band). This region displayed a distinctly different appearance from the remaining fracture. It was decided that this artifact was a result of an elongated inclusion from primary processing. The inclusion encompassed the entire length of the nut. The fracture likely progressed under uniform loading conditions as evidenced by the lack of distinct crack arrest marks in the origin area. The fracture surface morphology was generally ductile throughout with a considerable amount of inclusions aligned along the longitudinal axis, remnant of the extruding direction of the part. There was a shear lip on the thread tips and on the castellated end of the nut which indicated final fracture.

Figure 1. As received condition of failed component, scale in centimeters.

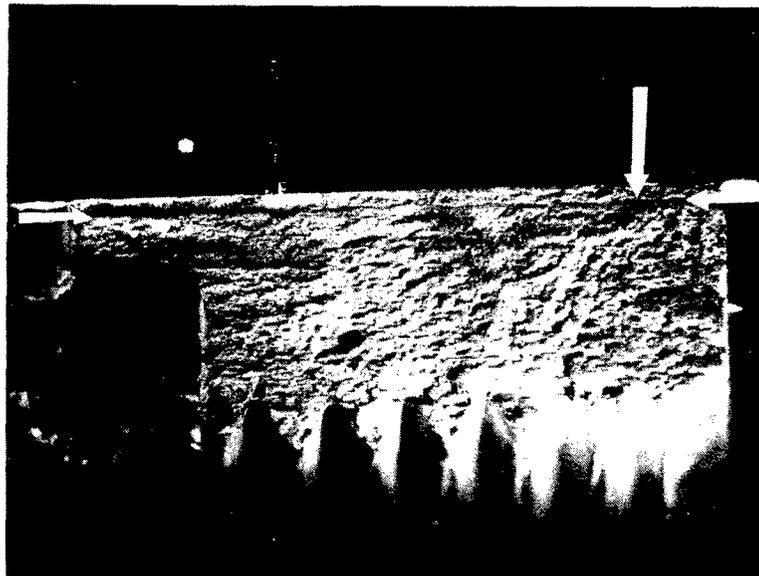
Figure 4. Micrograph of fracture half "A", arrow denotes origin. Mag. 10x

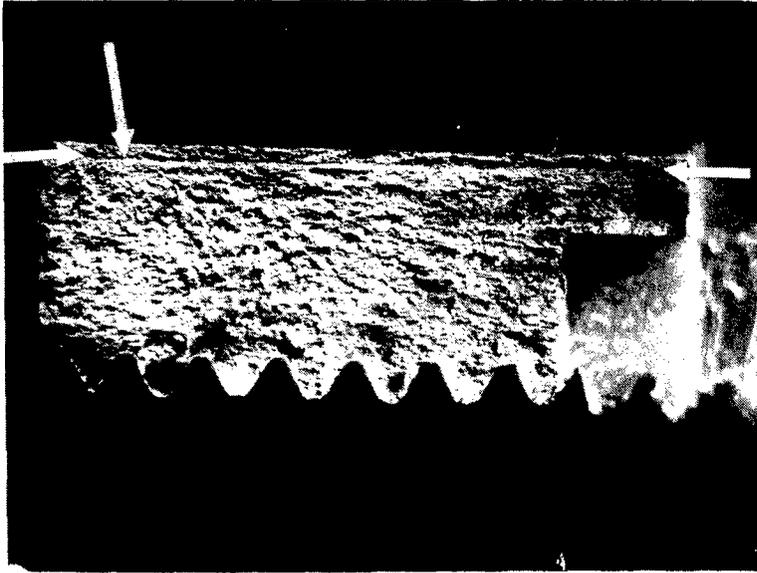
Figure 5. Micrograph of fracture half "B", arrow denotes origin. Mag. 10x

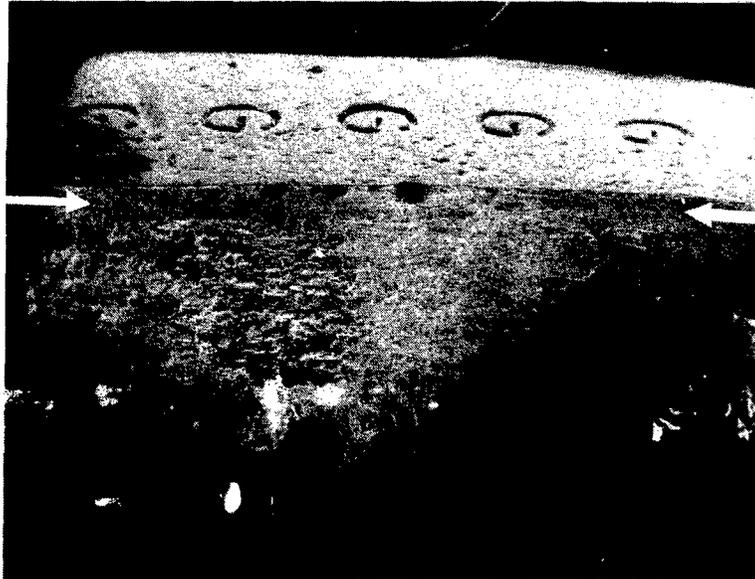
Scanning Electron Microscopy and Energy Dispersive Spectroscopy: The fracture surface of the failed nut was characterized utilizing Scanning Electron Microscopy (SEM) and Energy Dispersive Spectroscopy (EDS). The surface, with the exception of origin area and the inclusion that caused the failure, was composed entirely of ductile dimples (D) with elongated stringers characteristic of an overload failure of an extruded part. The fracture surface is shown in Figure 7, note the inclusion band that caused failure denoted by arrows. Figure 8 shows the origin area (arrow denotes origin). It can be observed at higher magnification in Figure 9 and 10. The Mn-S stringer

Figure 7. SEM fractograph of the nut, arrows denote line of inclusions. Mag. 10x

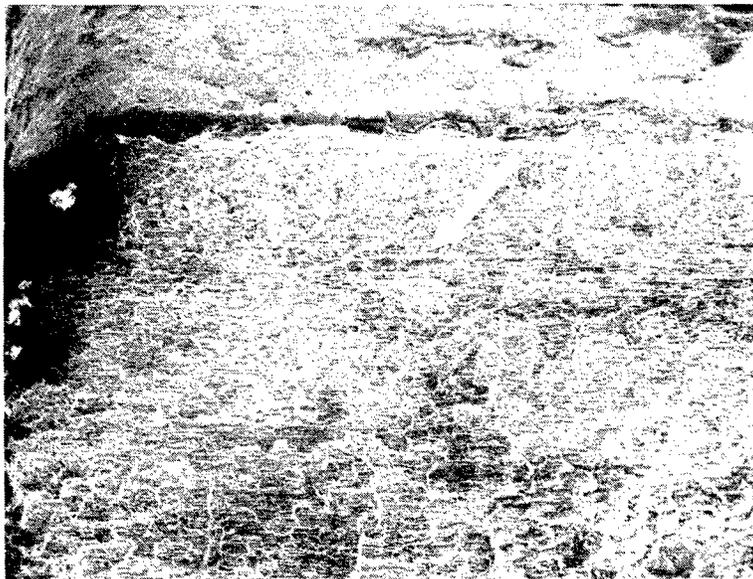
Figure 8. SEM micrograph of the origin area, arrow denotes origin. Mag. 75x

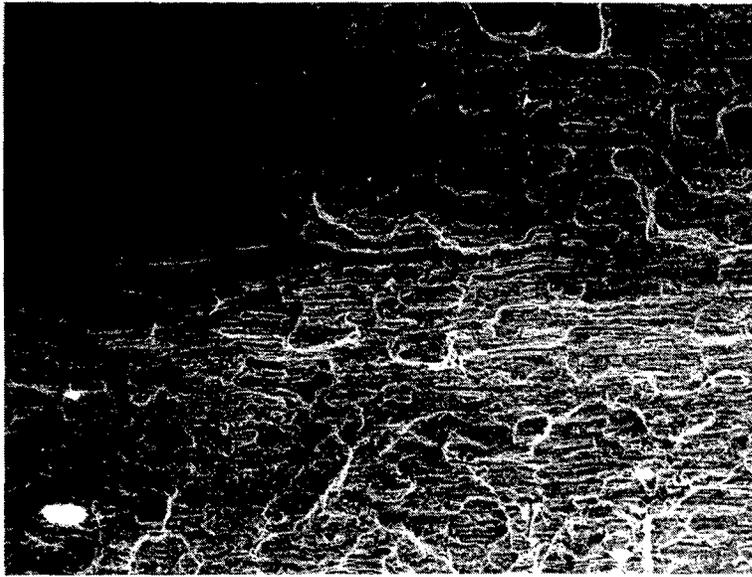
Figure 9. SEM micrograph of the inclusion that caused failure. Mag. 200x

that caused this cavity was not present at the origin but the inclusion must have measured at least 0.0015 inches in diameter as is approximately 0.013 inches in depth from the surface. Fracture morphology near the origin was mixed-mode, both transgranular (T) and ductile (D) modes of fracture are shown in Figure 11. Cadmium rich areas were found along the Mn-S stringer that caused failure indicative of a path open to the outside surface may have existed while the nut was in the plating bath. These cadmium deposits are shown in Figure 12 denoted by arrows. Figure 13 depicts the fracture surface morphology of the majority of the nut and the ductile dimples aligned along the extrusion direction. Shear lips (SL) were also noted on the tips of the threads and the castellated end indicating that these areas were the last to fail. The fracture morphology of the shear lips is shown in Figure 14. The inclusions on the fracture surface were identified to be manganese-sulfide through Energy Dispersive Spectroscopy (EDS) utilized in conjunction with the SEM. Inclusions of this severity can be deleterious to the mechanical properties of the material. Inclusions of the magnitude of the one causing this failure may obviously be catastrophic to the component. Figure 15 maps out the entire fracture surface morphology indicating the respective fracture modes. EDS aided in determining the fact that the inclusion band contained cadmium. This provided evidence that the defect may have been open to the surface during the cadmium plating process and occurred as a result of primary processing operations as opposed to a service or installation related anomaly. The use of EDS also helped identify that the nut contained lead as verified by chemical analysis.

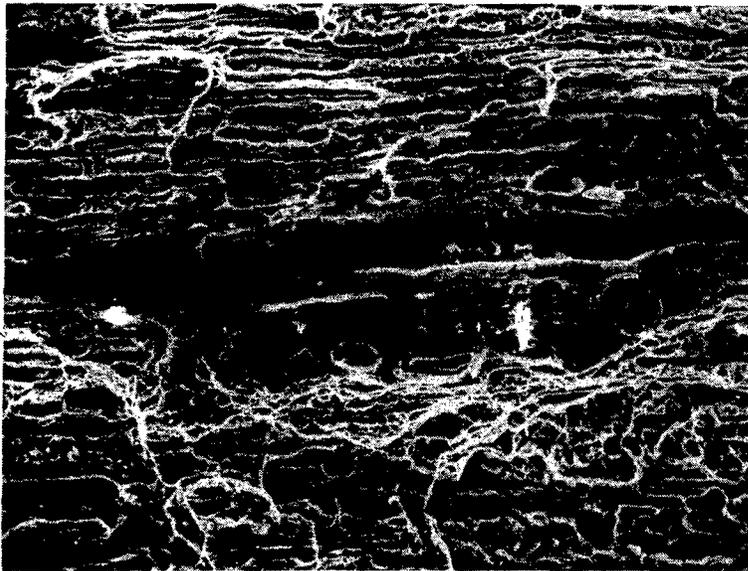
Figure 10. SEM micrograph showing Figure 9 at high magnification. Mag. 500x

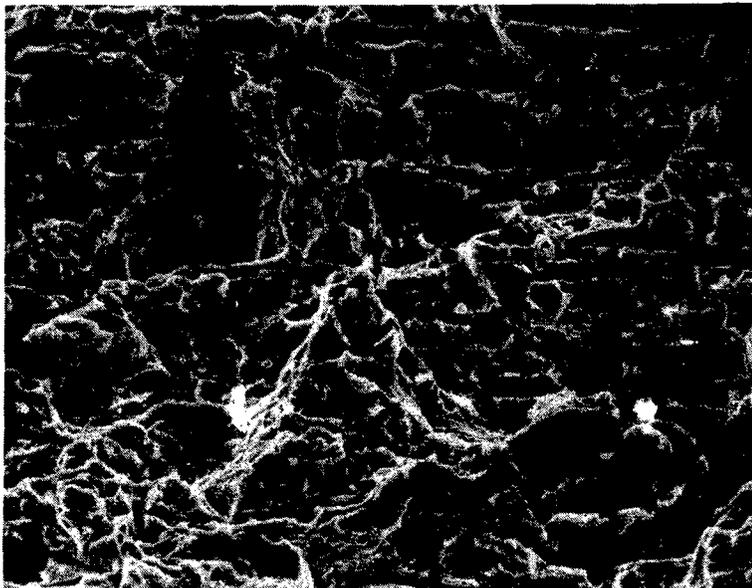
Figure 11. SEM micrograph of transgranular-ductile morphology at origin. Mag. 1000x

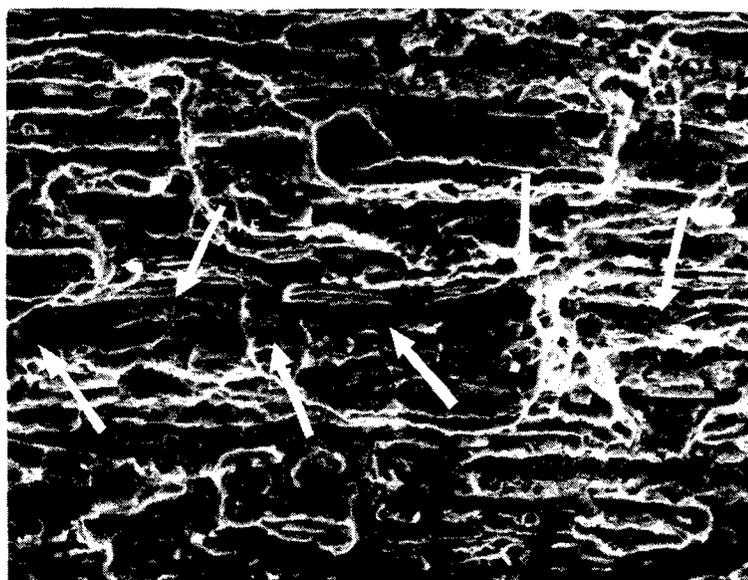
Figure 12. SEM micrograph of cadmium line along inclusion line. Mag. 1000x
Arrows denote existence of cadmium.

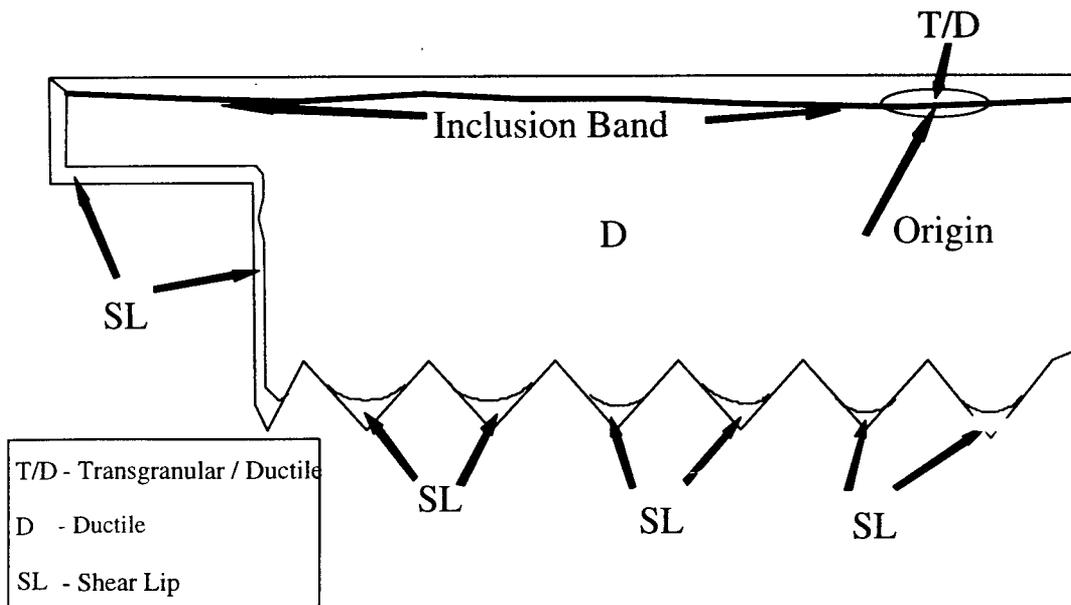
Figure 15. Map of fracture surface morphology for the failed component.
