FAILURE ANALYSIS OF MODULAR LIFT LINK, LUG MOUNTING, SELF-LOCKING NUTS

Scott Grendahl

U.S. Army Research Laboratory
Aberdeen Proving Ground, Aberdeen, MD

Abstract: The U.S. Army Research Laboratory-Materials Directorate (USARL-MD) conducted a failure analysis of two self-locking nuts from an army attack helicopter, at the request of the U.S. Army Aviation and Troop Command (ATCOM). Light optical and scanning electron microscopy were utilized to characterize the fracture halves of the broken nuts. The self-locking nuts are governed by Specification MS21042, *Nut, Self-Locking, 450°F, Reduced Hexagon, Reduced Height, Rivet Base, Non-Corrosion Resistant Steel*. During phase maintenance on the lift beam in the pylon area, maintenance crews noticed the bolts securing the lift link support lug were not properly seated. Further inspection showed that the left side self-locking nuts were cracked and/or missing. The right side nuts were also cracked.

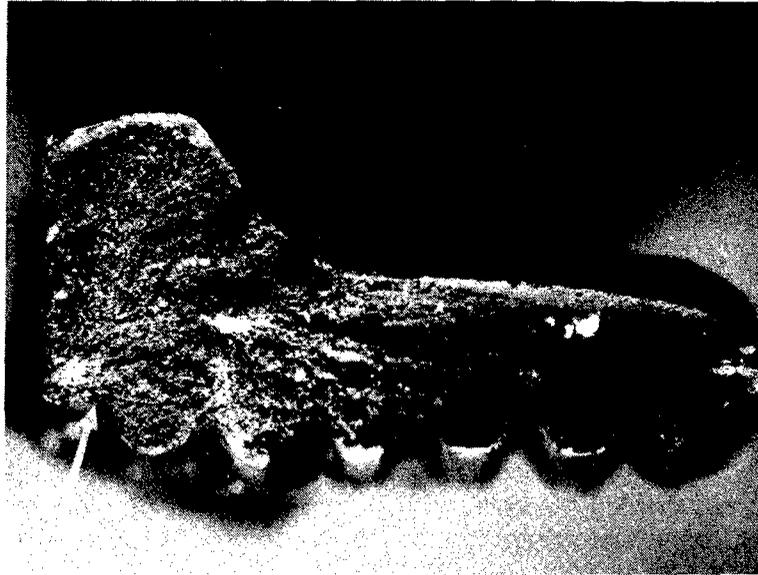
Visual Examination and Light Optical Microscopy: The two failed components were further designated as failures "A" and "B". Nut "A" was sectioned such that the fracture surfaces could be examined. The fracture origins were determined to be at the root of the first thread for both Nuts "A" and "B", and are shown in Figures 1 - 4 (arrows denote origins). Nut "B" contained two separate fracture surfaces, and subsequently both were examined. These two fracture surfaces of Nut "B" can be seen in Figures 3 and 4. They were further designated as fracture "B1" and "B2" for convenience. Note the radial lines which emanate from the fracture origins. The cadmium plating adjacent to the fracture surfaces was worn and damaged but no evidence of significant corrosion was observed. There was also no corrosion visible on the remaining fracture surfaces. A shear lip region was observed extending around one end of Nut "A", however no such failure mode was observed on Nut "B". In addition, beyond the third or fourth threads of both nuts the fracture morphologies revealed the direction of extrusion. This was evidenced by the sets of parallel lines (which represent grain flow) running perpendicular to the threads. The threads of both nuts were slightly damaged in that the tips of the threads were worn away, however this was determined to be post-fracture induced.

Figure 1. Micrograph of the fracture surface of Nut "A". Mag. 20x

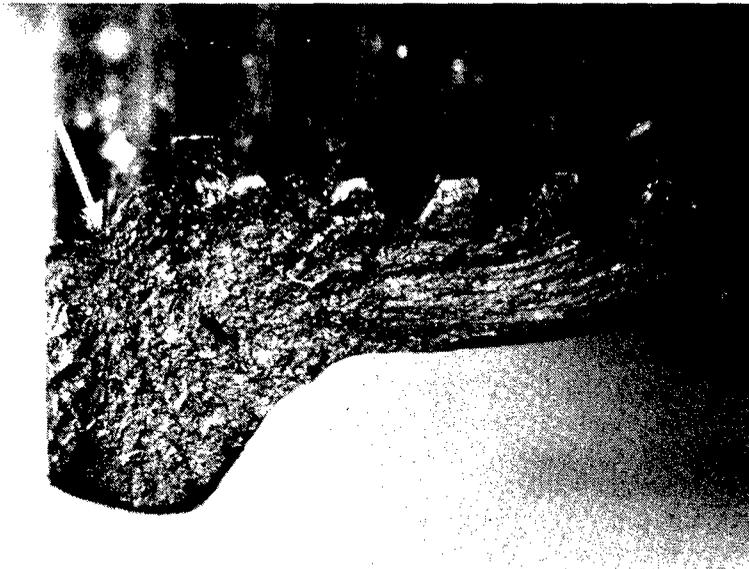
Figure 2. Micrograph of the mating fracture surface of Figure 7. Mag. 20x

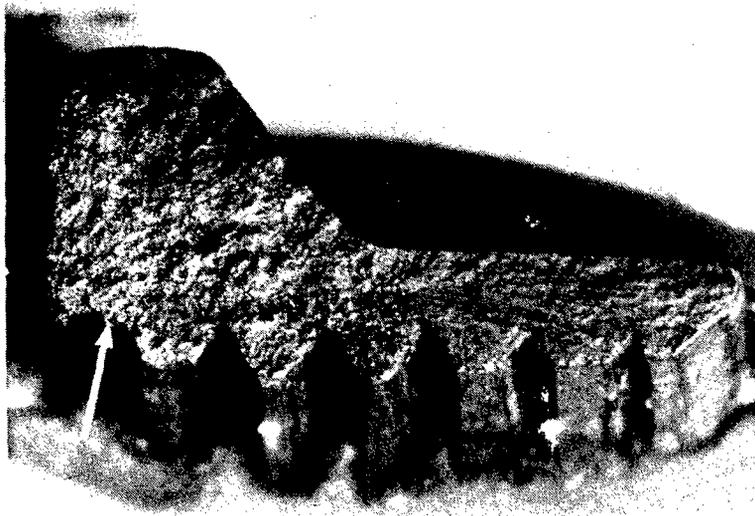
Figure 3. Micrograph of the fracture surface of Nut "B1". Mag. 20x

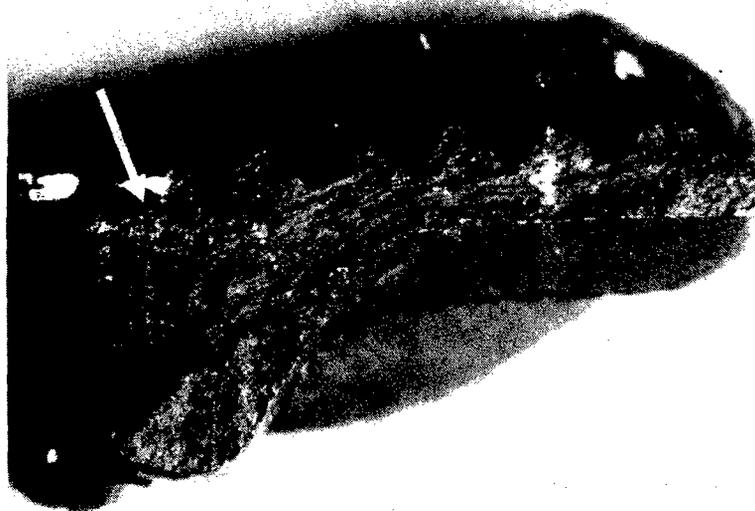
Figure 4. Micrograph of Nut "B" fracture surface "B2". Mag. 20x

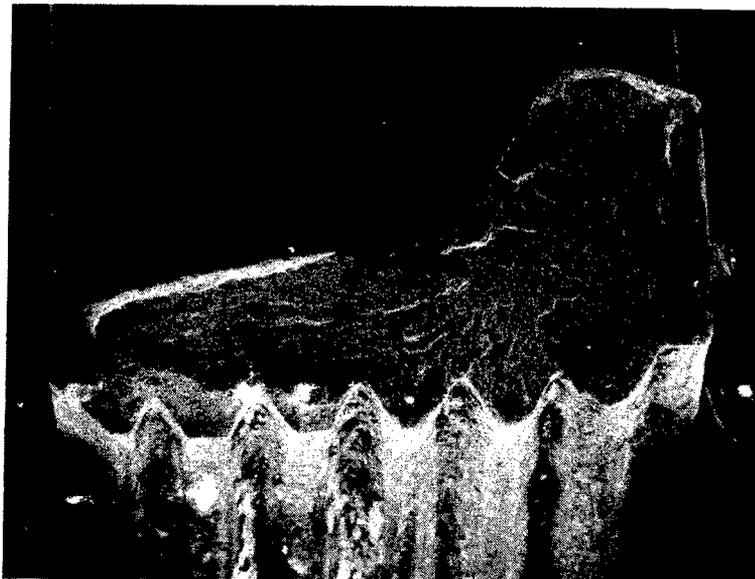
Scanning Electron Microscopy and EDS: The fractures of Nut "A" and Nut "B" were classic cases of HAC with service stress related failure. SEM fractographs of Nut "A" and "B" failures are shown in Figures 5, 6 and 7, 8 respectively. The fracture morphologies at the crack origins of Nuts "A" and "B" were intergranular (I) as shown in Figures 9 and 10. These SEM micrographs show the traditional "rock candy" features, as well as some secondary cracking. X-ray mapping (utilizing energy dispersive spectroscopy) of the entire fracture surfaces did not reveal a layer of cadmium on or near the fracture origins. The absence of a cadmium film suggests the cracking most likely occurred in service rather than in the plating bath. The intergranular regions transitioned to large mixed-mode (D/I) regions consisting of intergranular decohesion and ductile dimples covering nearly half of the fracture surfaces. These mixed mode morphologies are shown in Figures 11 and 12. The mixed-mode morphologies transitioned abruptly to ductile dimples (D) as shown in Figures 13 and 14. This abrupt change in morphology represents the areas of fast fracture beyond the third or fourth threads. Figures 13 and 14 also show the ductile dimples aligned in the extrusion direction of the components. Shear lips (SL) were also noted on Nut "A", indicative of the last region to fail. Light optical and scanning electron microscopy did not reveal any gross anomalies at the fracture origin. The schematics shown in Figure 15 and 16 outline the different

Figure 5. SEM micrograph of the fracture surface of Nut "A". Mag. 15x

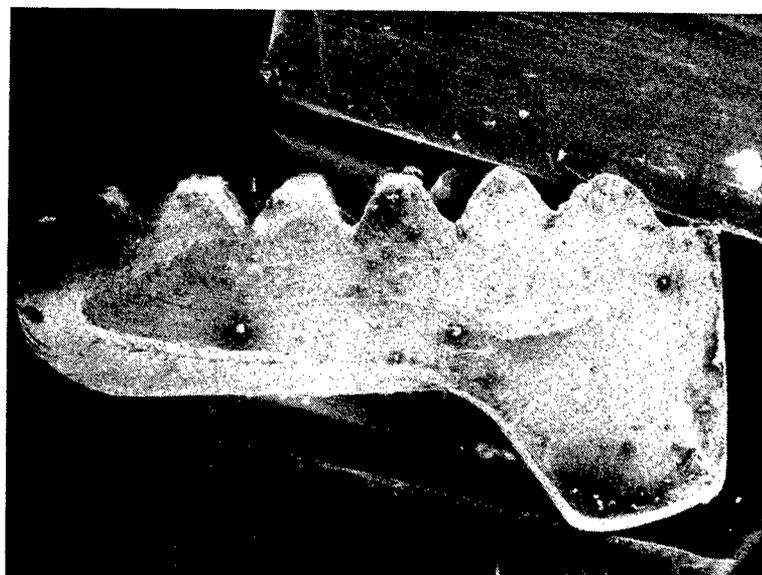
Figure 6. Mating fracture surface of Nut "A" Figure 19. Mag. 15x

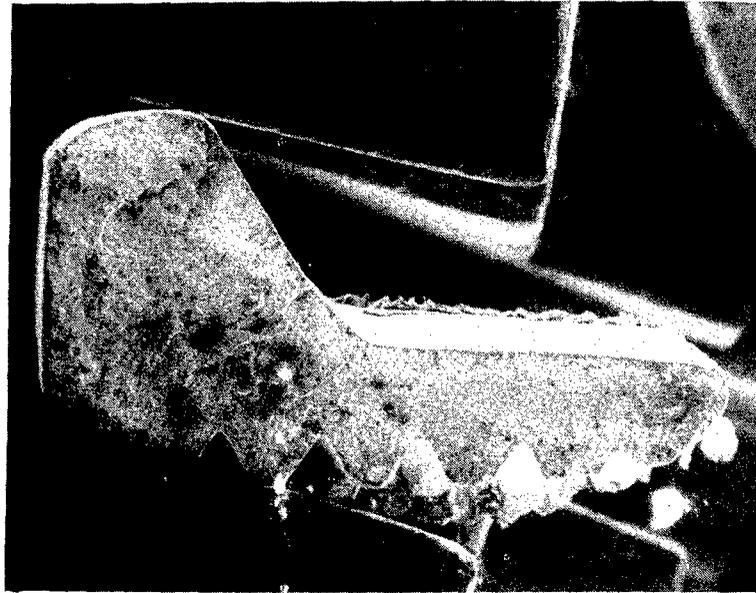
Figure 7. SEM micrograph of the fracture surface of specimen "B1". Mag. 15x

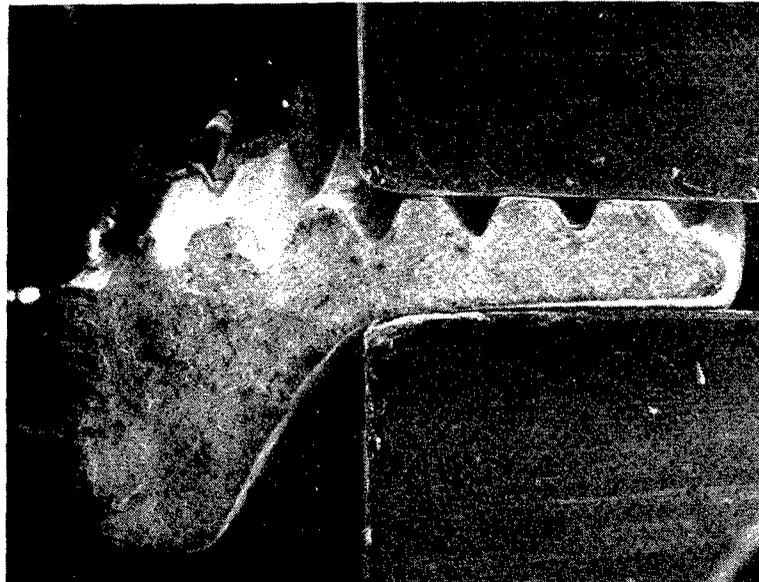
Figure 8. SEM micrograph of the fracture surface of specimen "B2". Mag. 15x

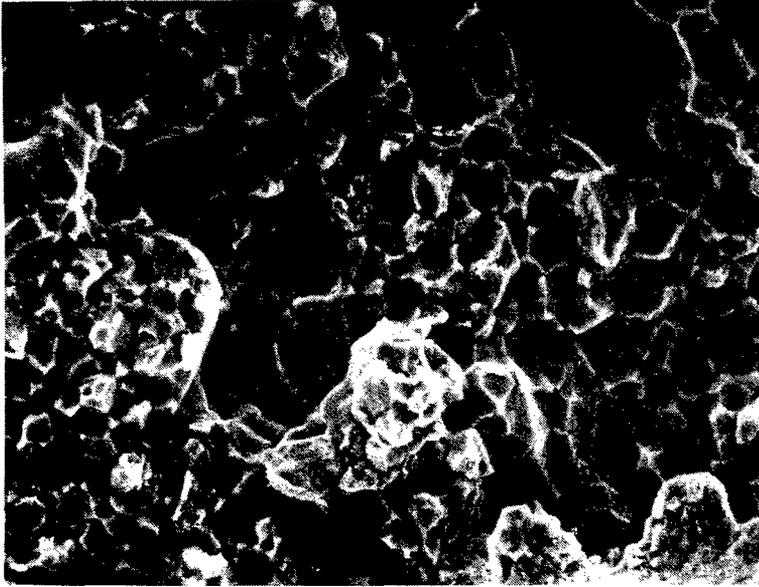
Figure 9. SEM fractograph of morphology at the origin of Nut "A". Mag. 1000x

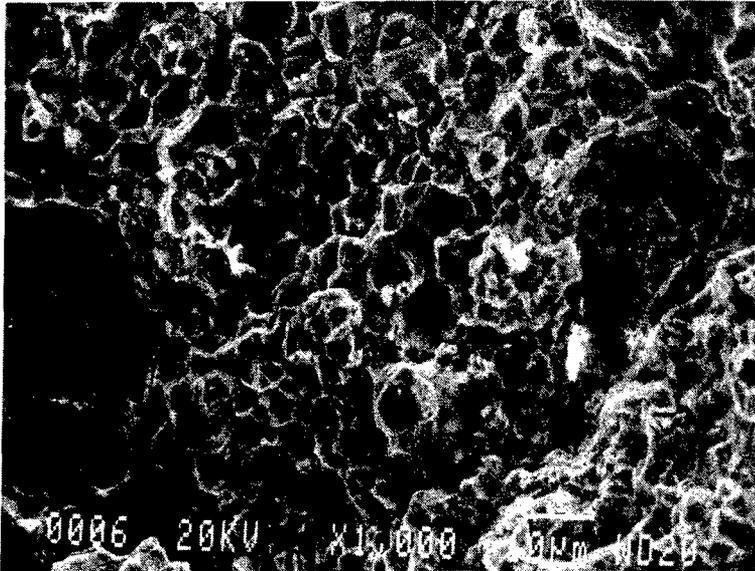
Figure 10. SEM fractograph of morphology at the origin of Nut "B". Mag. 1000x

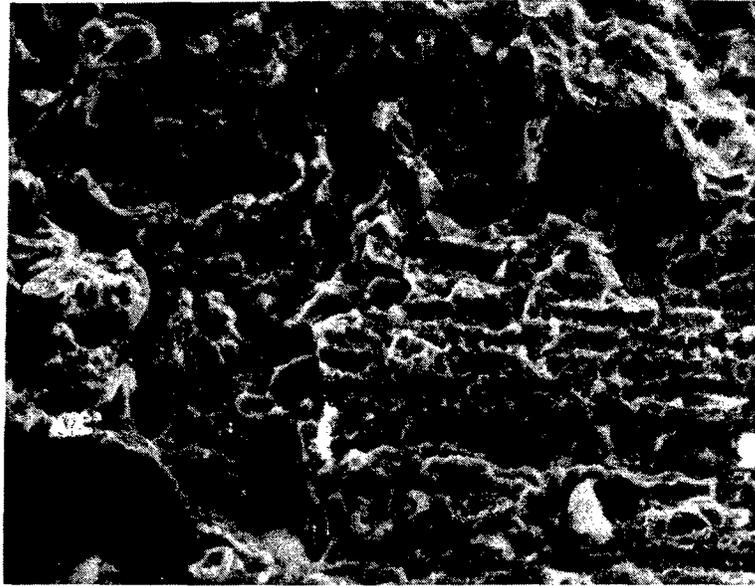
Figure 11. SEM fractograph of mixed-mode morphology of Nut "A". Mag 1000x

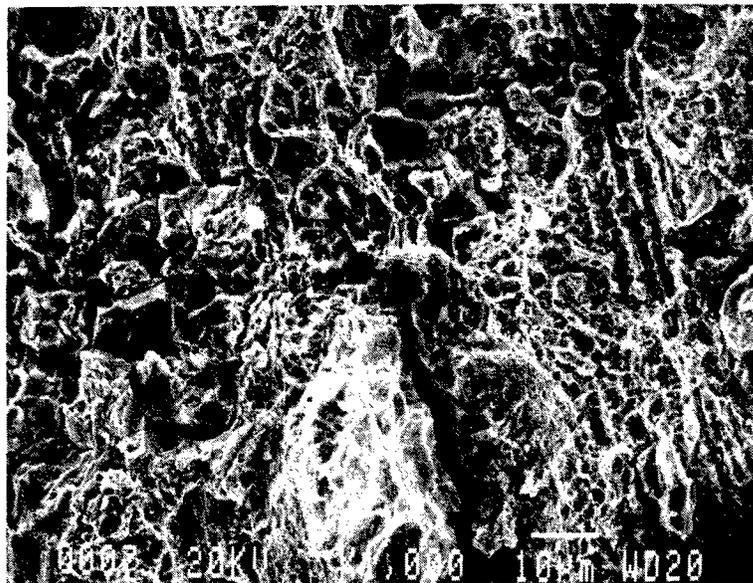
Figure 12. SEM fractograph of mixed-mode morphology of Nut "B". Mag 1000x

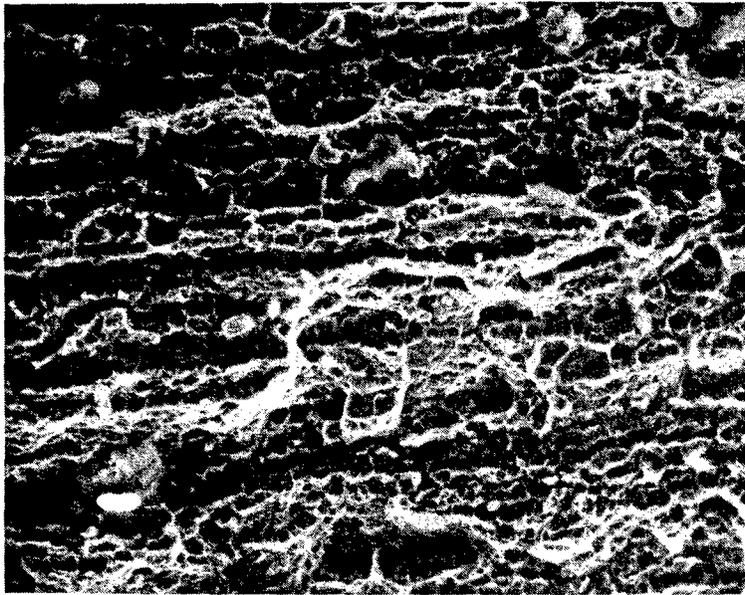
Figure 13. SEM fractograph of ductile dimple morphology of Nut "A". Mag 1000x

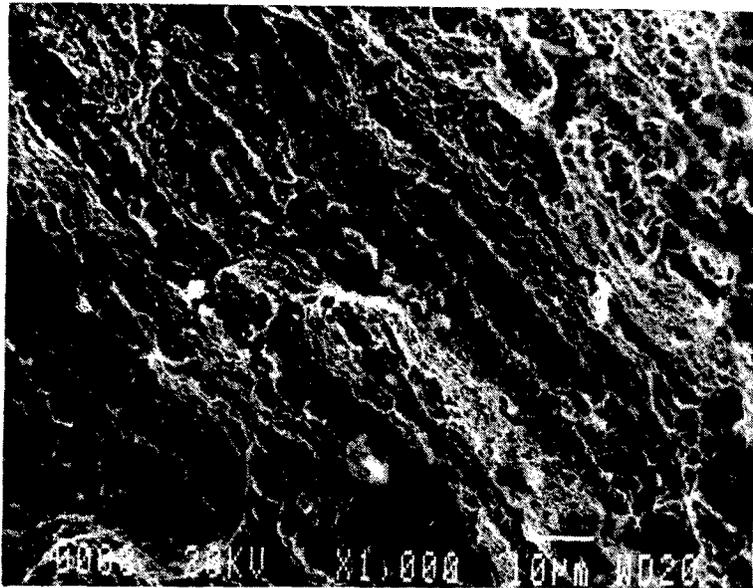
Figure 14. SEM fractograph of ductile dimple morphology of Nut "B". Mag 1000x

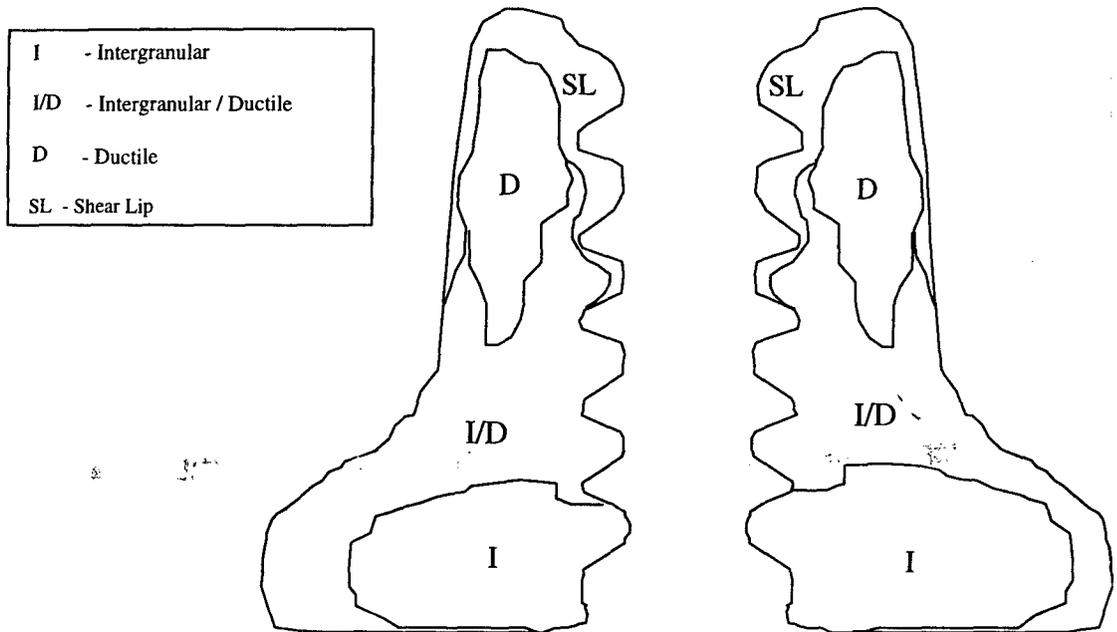
morphologies noted on the mating fracture surfaces of Nut "A" and the two different fracture surfaces of Nut "B", respectively.

Figure 15. Map of failure modes for mating fracture halves of Nut "A"

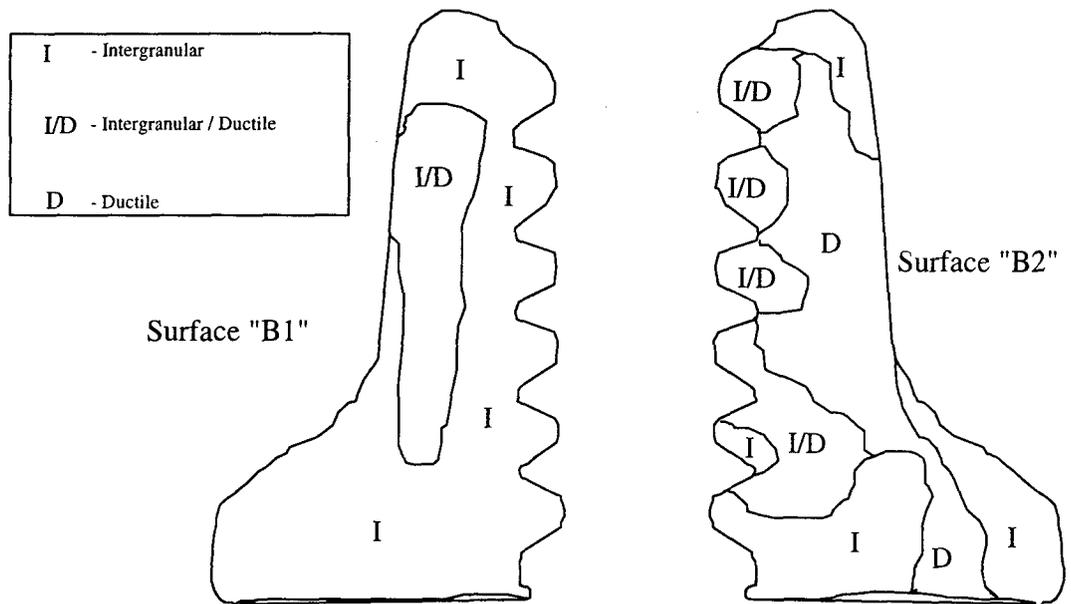
Figure 16. Map of failure modes of fracture surfaces of Nut "B"
