AFWAL-TR-81-3096

## **EVALUATION OF SEVERAL BONDING PARAMETERS ON THE RANDOM BENDING FATIGUE LIFE OF ADHESIVELY BONDED ALUMINUM JOINTS**

AUGUST 1981

TECHNICAL REPORT AFWAL-TR-81-3096  
Final Report for Period June 1978 — November 1980

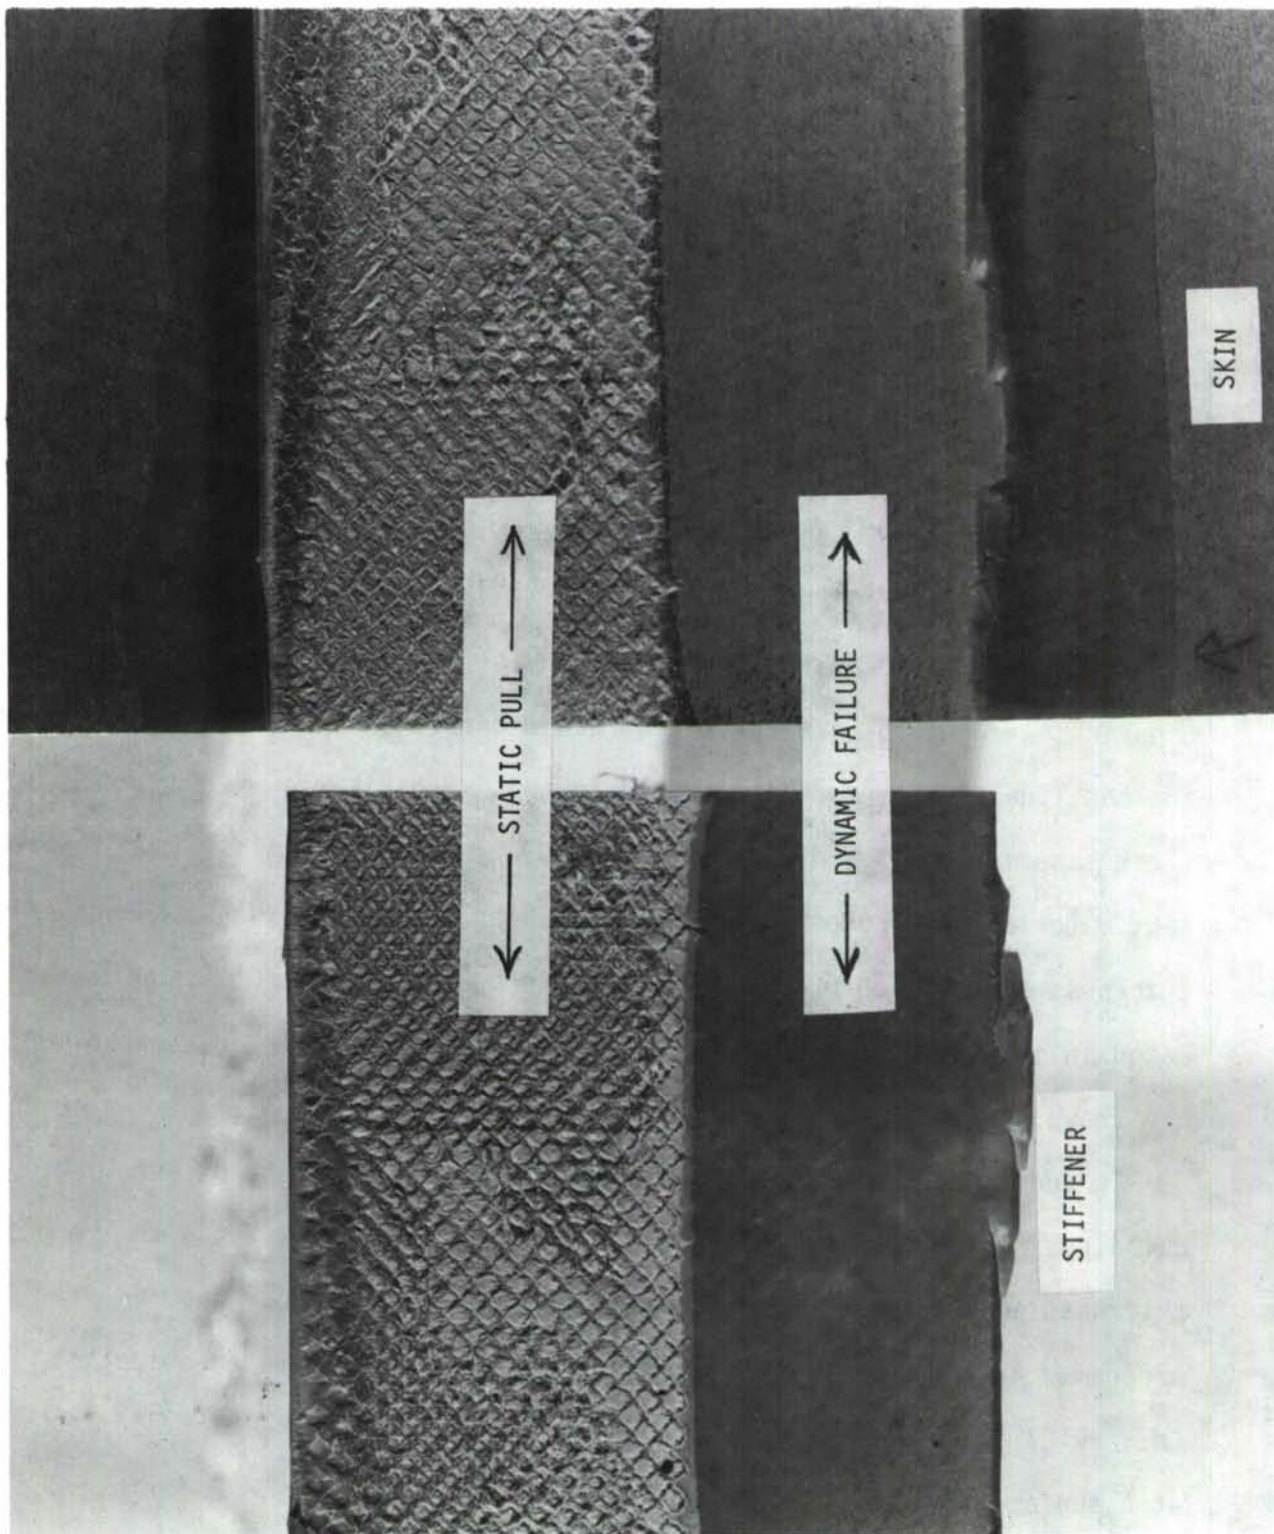
Figure Nr. 1 - Surfaces of Bonded Joint after Failure

Most of the cantilever beam coupons were tested only until the fatigue crack propagated part way through the bond area. The bond area was examined after static loading the adhesive joint until it completely separated. It could be seen that initial cracking in the adhesive under dynamic loading was different than that produced by the static pull. The static pull generally was characterized by a separation midway through the thickness of the adhesive film; whereas, under dynamic load the adhesive separated closer to the

surface of the adherend. The difference in these two mechanisms observed under dynamic loading and static loading are shown in Figure 1. To determine the sonic fatigue life of a bonded structure, the behavior of the adhesive under dynamic loading must be defined and predictable.

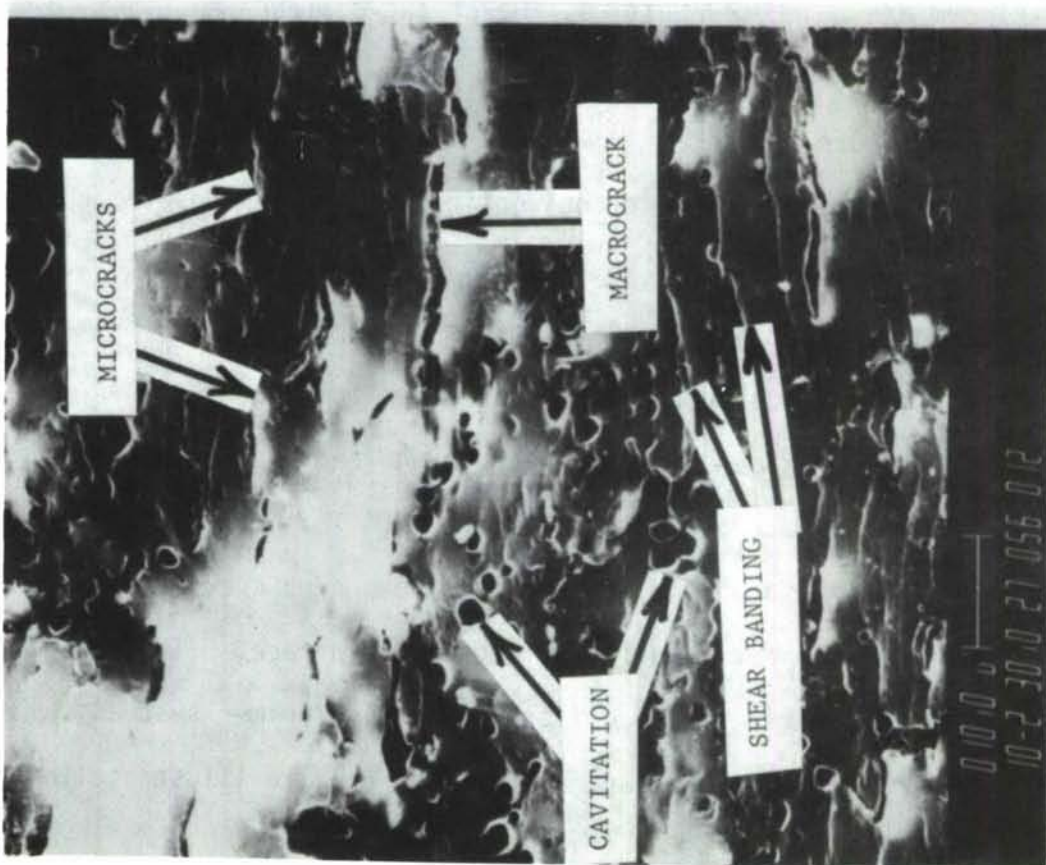
Figure Nr. 15 - Example Photomicrograph of  
Adhesive Failure

The adhesives, primers and oxide layers investigated in this program have distinct morphological features which are easily distinguishable in the scanning electron microscope. Therefore, the determination of locus of fracture was a relatively straightforward matter. For example, the FM73 adhesive is a two phase material, consisting of elastomeric particles (precipitated during the curing reaction) in an epoxy continuum. Under combined shear and tensile loading such as the adhesive was subjected to in the fatigue tests, the adhesive fractures by cavitation around the elastomeric particles and by "shear banding," which has the appearance of thin layers, displaced stepwise from each other. Under repetitive loading or increasing magnitude of load, cracks form around these cavities, the cracks coalesce together forming macro-cracks, and then gross fracture occurs. An example of such "cohesive" fracture is shown in Figure 15.

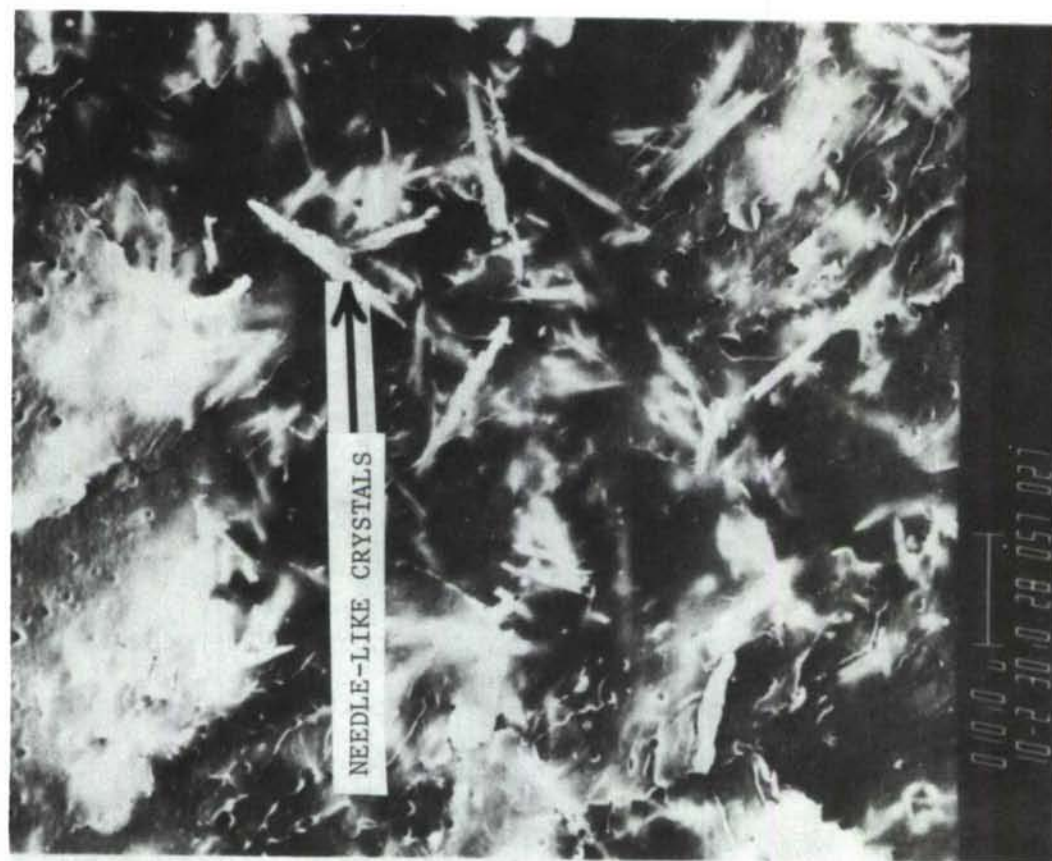
Figure Nr. 16 - Example of Photomicrograph of  
BR127 Primer Layer

The BR127 primer, used in conjunction with FM73 adhesive, contains a chromate corrosion inhibitor in the form of needle-like crystals. This gives the primer layer (and interfacial regions incorporating the primer) a distinctive, easily recognizable appearance as shown in Figure 16.

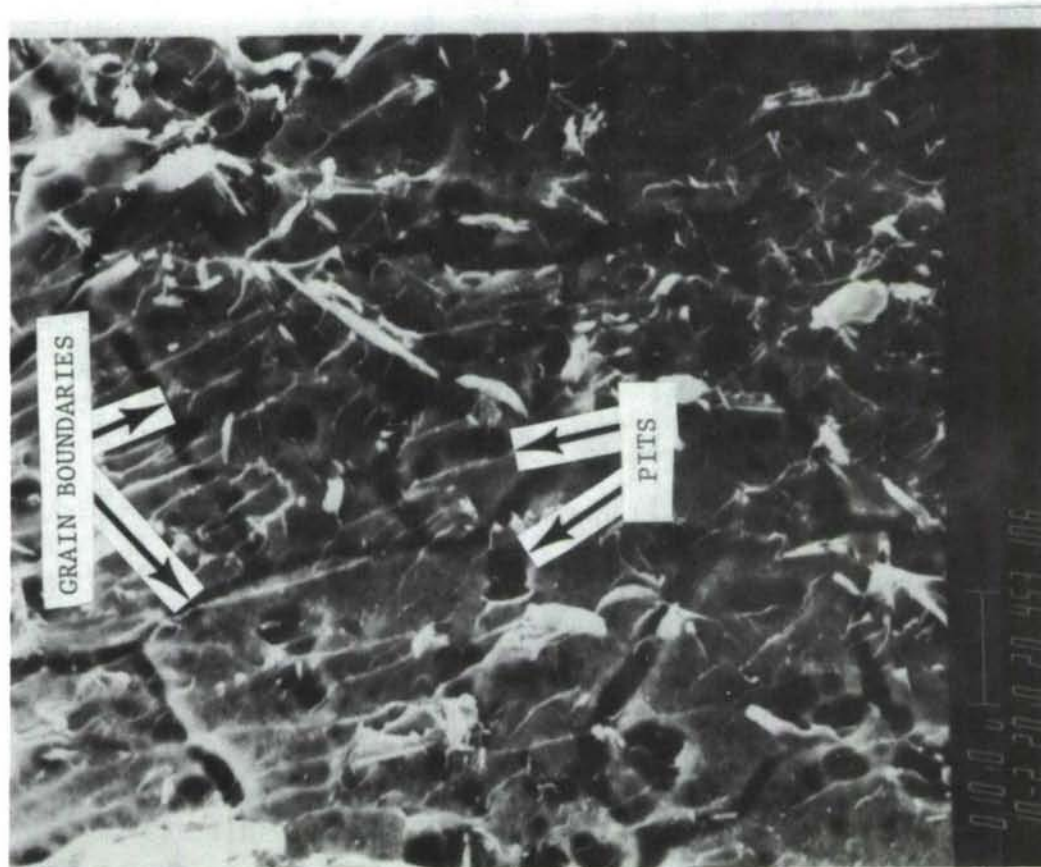
Figure Nr. 17 - Example Photomicrograph of Aluminum Oxide Surface

The aluminum oxide surface can be recognized by grain boundaries and pitting in the surface as shown in Figure 17. This particular photomicrograph of the fracture surface of a primed adhesive bonded specimen shows a very thin layer of primer polymer adhering to the oxide surface. (This photomicrograph is of a fracture surface of a different adhesive/primer system from that investigated in this program and is included only to illustrate this specific type of fracture).

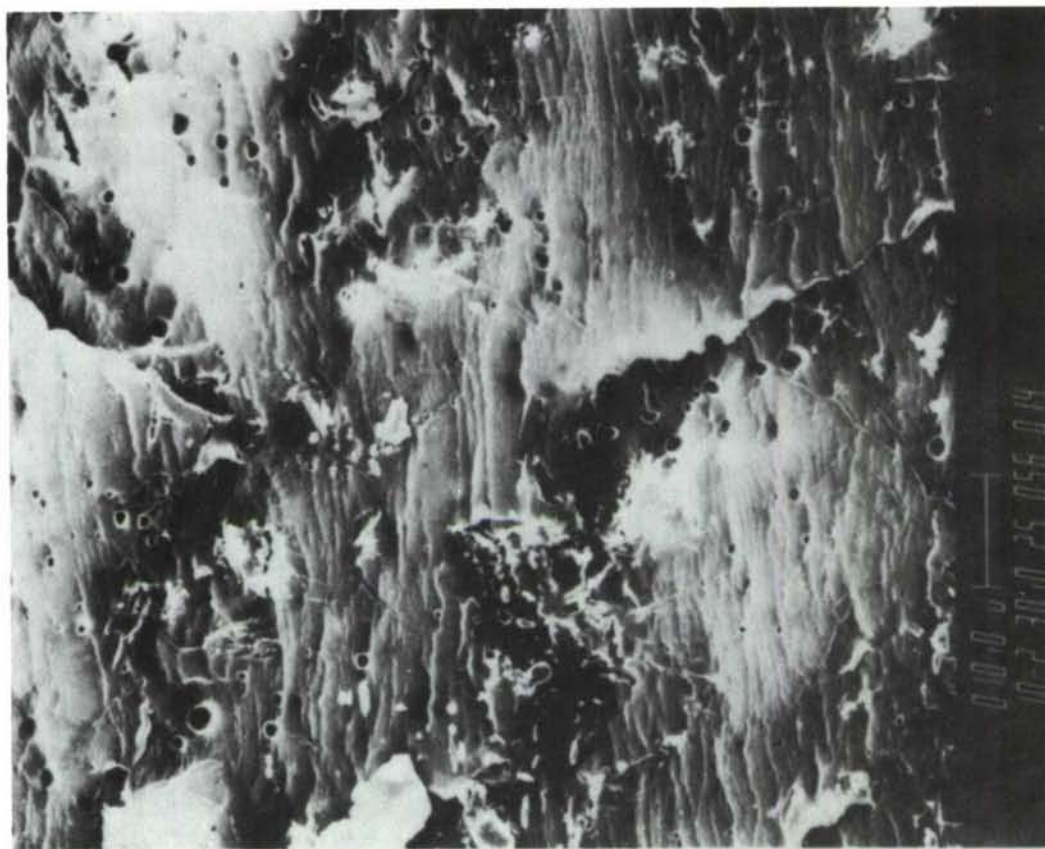
Figure Nr. 18 - Photomicrograph of "Fresh" Fracture Surface (Skin Side), Group A, Specimen Nr. 1

For the standard PABST material system, (Group A Specimen Nr. 1) fracture was typically cohesive but very close to the primer on the tee. This was indicated from a series of photomicrographs of fracture surfaces, several of which are shown for illustrative purposes. Figure 18 shows the fracture surface of the skin side, clearly revealing the classical cavitation and shear banding typical of FM73 adhesive. There is little evidence of primer on the fracture surface except for small regions at the upper left and lower right. Figure 16 (previously referred to as illustrating a representative chromated primer surface) shows the mating fracture surface of the tee. The needle-like crystals of the chromate primer are very prominent. A thin layer of adhesive adhered to the primer, as clearly evidenced by the micro-cavitation in this layer. Therefore, the net conclusion was that fracture occurred in the adhesive very close to the primer on the tee.

The fracture shown in Figure 18 is immediately adjacent to a region which was intact (still bonded) when the fatigue test was terminated and, therefore,

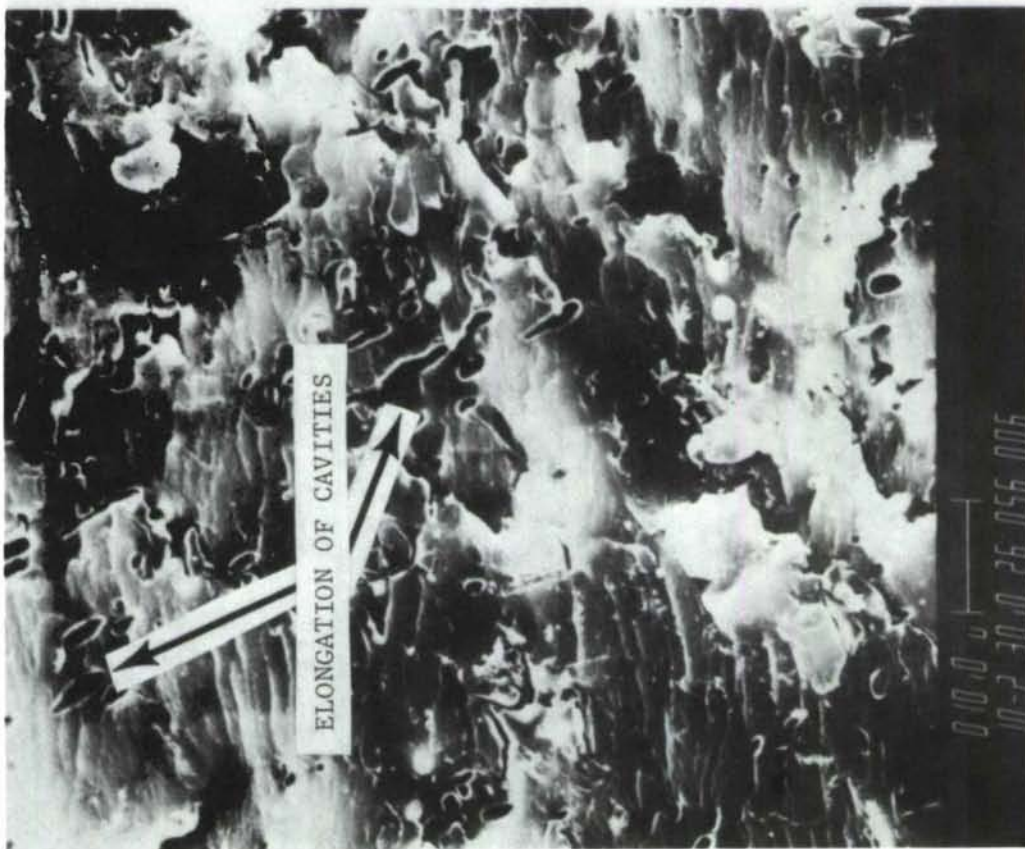
Figure Nr. 19 - Photomicrograph of "Early" Fracture Surface (Skin Side)  
Group A, Specimen Nr. 1

represents a "freshly fractured" surface. The fracture surface in Figure 19 is about 1/8 inch (0.318 cm) further outboard (away from the tee) from that shown in Figure 18. Here, fracture occurred earlier since it was subjected to greater dimensional excursion. This caused elongation of the cavities and subsequent microcracks connecting the cavities.

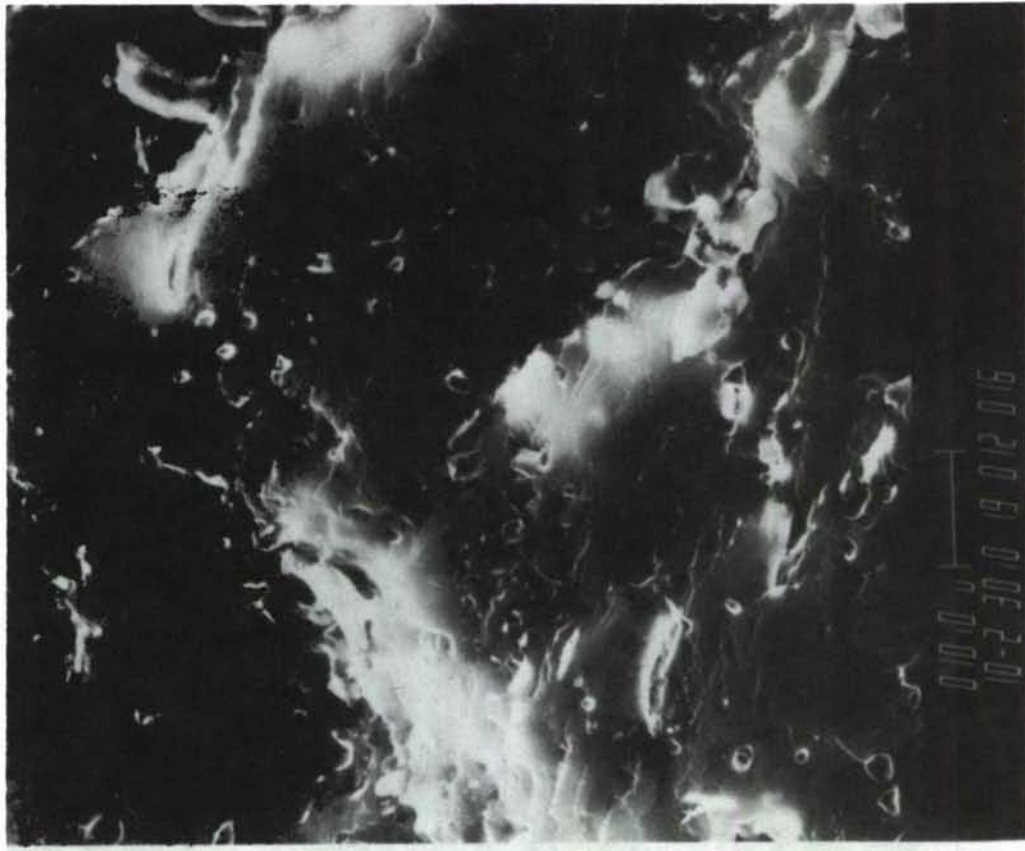
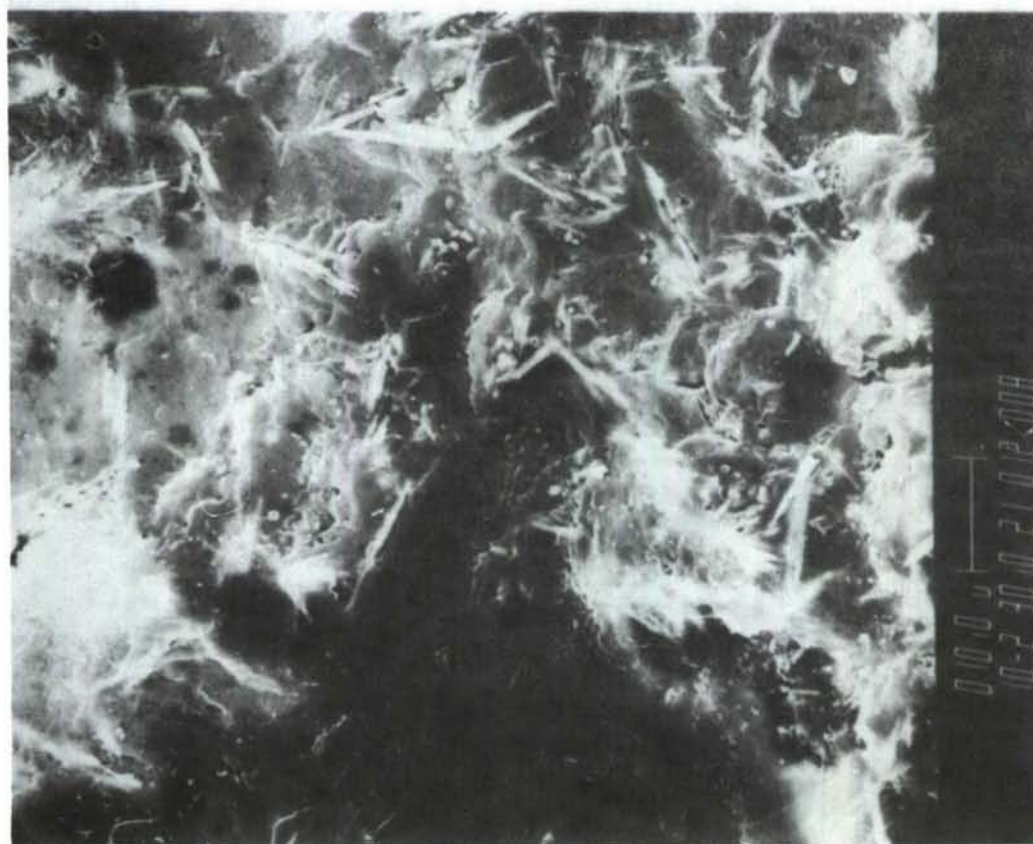
Figure Nr. 20 - Photomicrograph of Fracture Surface (Tee Side), Group B, Specimen Nr. 2

Figure Nr. 21 - Photomicrograph of Fracture Surface (Skin Side), Group B, Specimen Nr. 2

For a representative specimen from Group B (Specimen Nr. 2, the standard PABST system but with a thinner primer than normal), fracture was cohesive within the adhesive, but close to the primer on the skin. This is illustrated by Figure 20 showing the fracture surface of the tee, and Figure 21 showing the fracture surface of the skin, both near the fracture initiation zone. Figure 20 shows the classical cohesive failure mode for FM73, whereas Figure 21 shows the needle-like chromate crystals from the primer under a thin layer of adhesive.

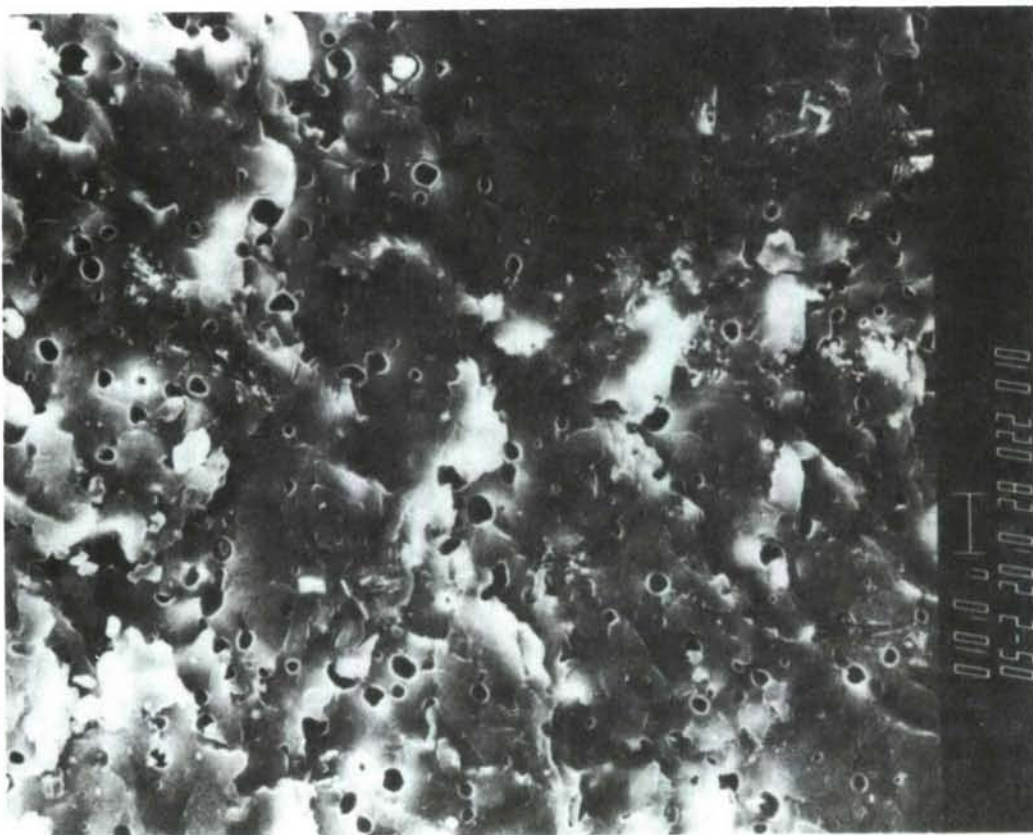
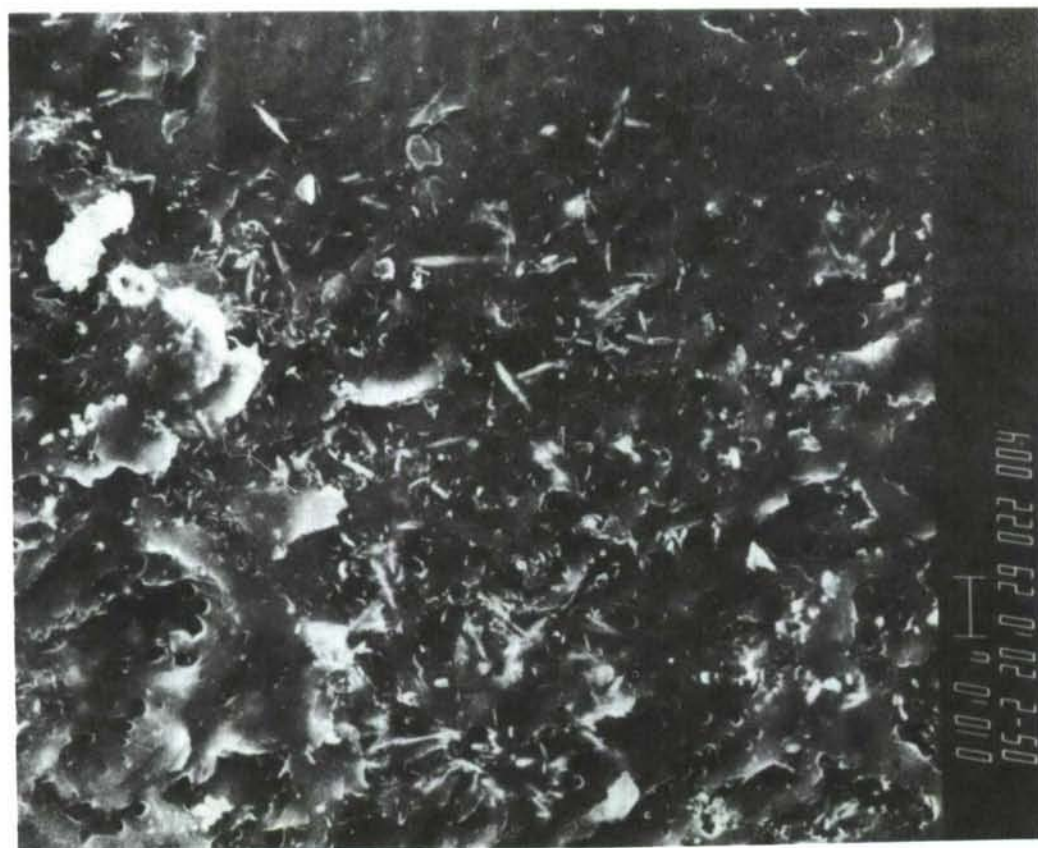
Figure Nr. 22 - Photomicrograph of Fracture Surface (Tee Side), Group C, Specimen Nr. 2

For a specimen from Group C (Specimen Nr. 2, the PABST system but with three layers of adhesive and a thinner than normal primer), the locus of fracture was predominantly cohesive within the adhesive but there were also zones of interfacial failure, namely, adhesive to primer failure, and primer to oxide failure. The interfacial failures were on the skin side. This is illustrated by Figure 22 for the tee and Figure 23 for the skin, both showing fracture surfaces near the zone of fracture initiation. Figure 22 shows the classical cohesive failure for FM73, whereas Figure 23 shows a combination of failure modes both cohesive and interfacial.

Figure Nr. 23 - Photomicrograph of Fracture Surface (Skin Side)  
Group C, Specimen Nr. 2

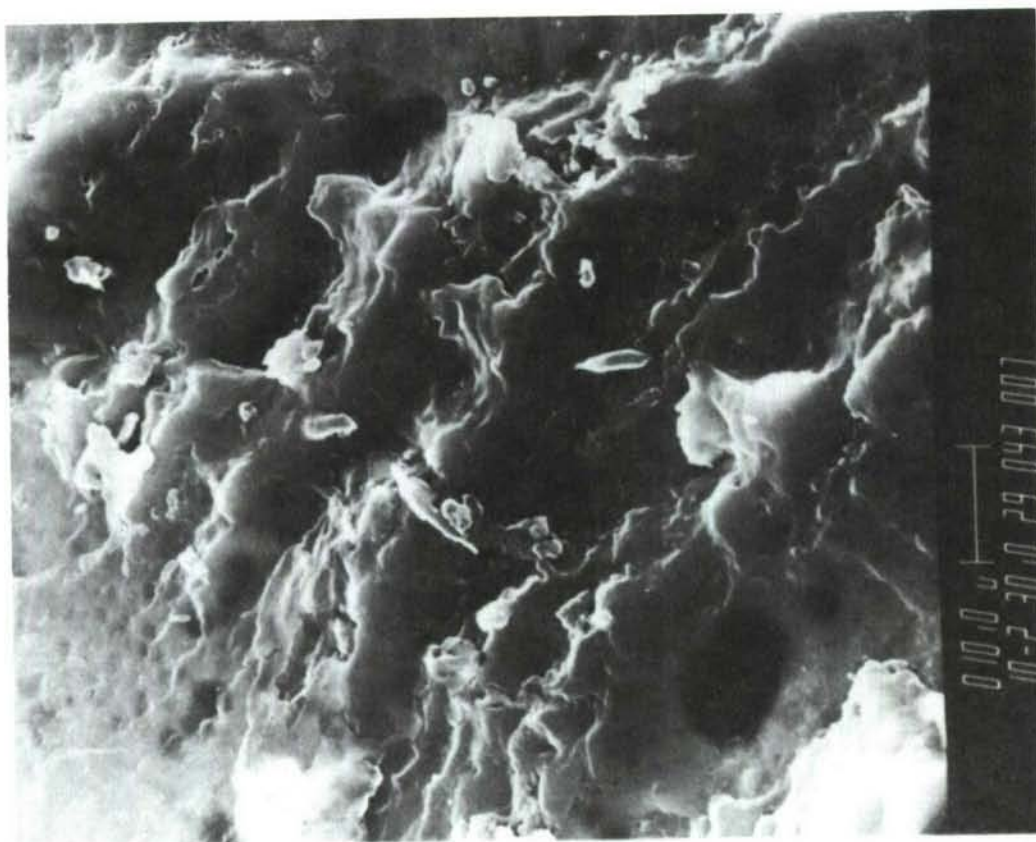
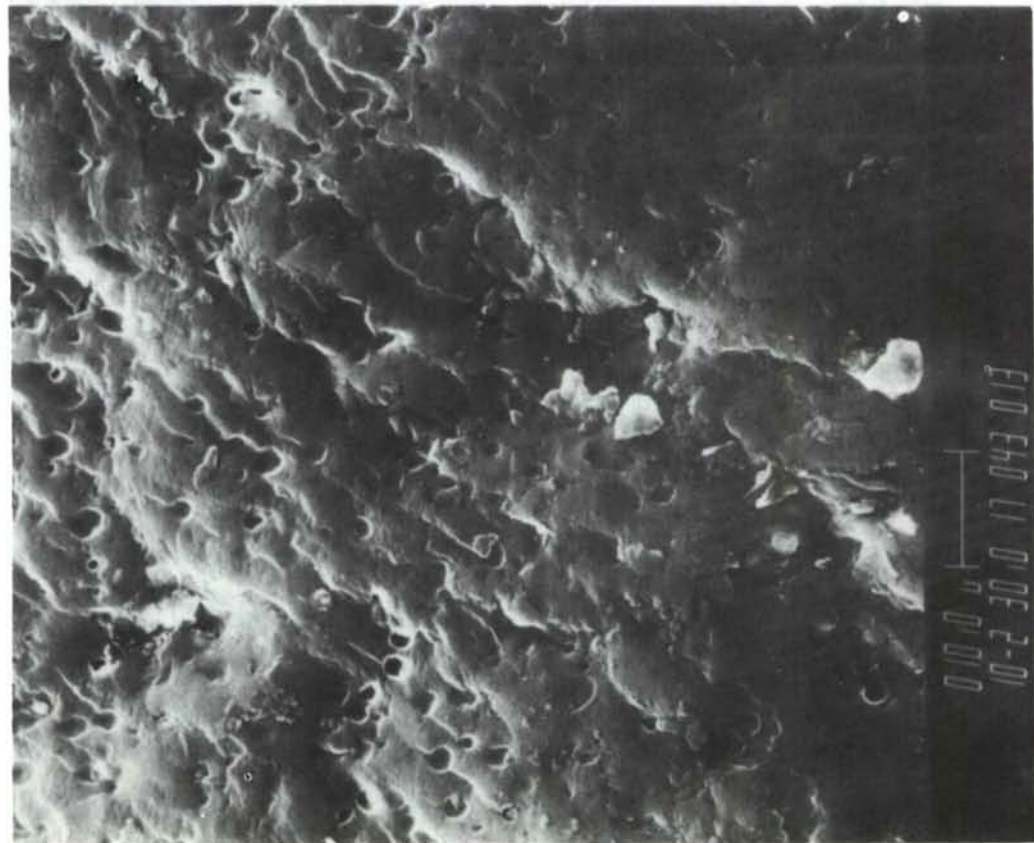
For a representative specimen from Group D (Specimen Nr. 3, FM73 adhesive on phosphoric acid anodize without a primer), failure initiated cohesively but then propagated interfacially toward the skin. Figures 24 and 25 show, respectively, the fracture surfaces of the skin and of the tee along the outer edge of the tee where the fracture initiated. The classical cohesive fracture morphology is clearly seen on both surfaces. However, as the fracture progressed,

Figure Nr. 24 - Photomicrograph of Fracture Surface (Skin Side),  
Group D, Specimen Nr. 3

Figure Nr. 25 - Photomicrograph of Fracture Surface (Tee Side), Group D, Specimen Nr. 3

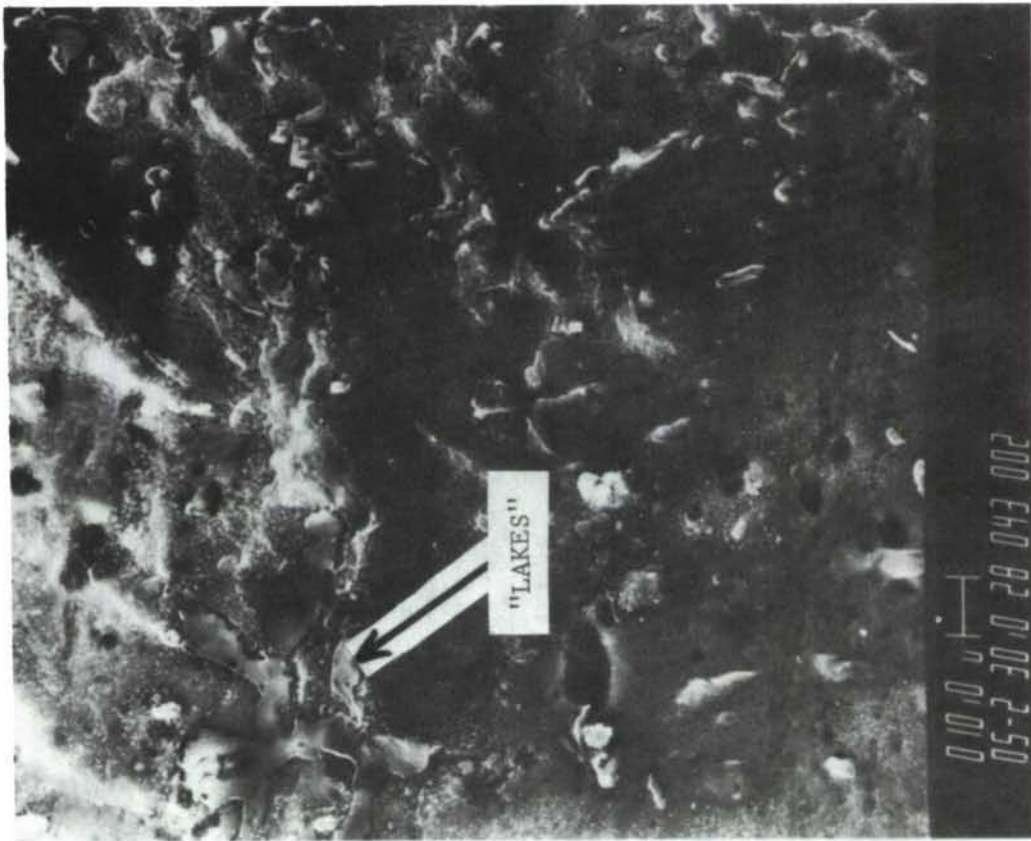
Figure Nr. 26 - Photomicrograph of Fracture Surface (Skin), Group D, Specimen Nr. 3 Near Initiation 500X

it veered toward the skin. Figure 26 shows the fracture surface of the skin about 1/8 inch (0.318 cm) from the point of initiation. This photomicrograph at 500X shows a thin layer of polymer adhering to the oxide. The pits in the adherend surface are evident, indicating that the fracture is very close to the oxide surface. One interesting feature in this photomicrograph is the presence of "lakes" of a dispersed phase in the polymer layer, rather than spherical particles. A clearer view of these "lakes" is shown at 1000X in Figure 27. The reason for the lakes is not known. However, it is speculated that they may have resulted from the high surface energy of the aluminum oxide causing sufficient spreading of the adjacent polymer layer to transform the elastomeric second phase of the adhesive into a planar, rather than a spherical configuration.

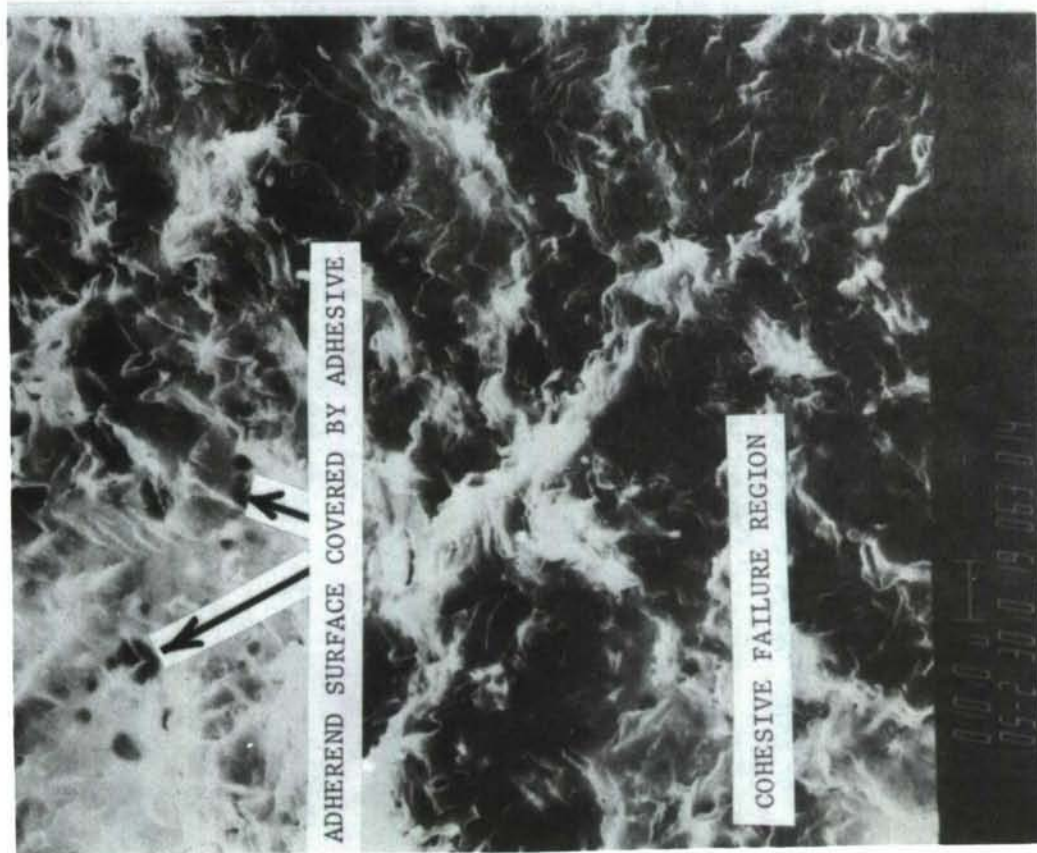
Figure Nr. 29 - Photomicrograph of Fracture Surface (Skin Side), Group E, Specimen Nr. 3

For a specimen from Group E (Specimen Nr. 3, the PABST system except using FPL etch instead of phosphoric acid anodize), the locus of fracture was purely cohesive within the adhesive, but close to the skin side. This is illustrated by Figure 28 for the tee and Figure 29 for the skin, both showing fracture surfaces near the zone of initiation. Figure 28 shows the classical cohesive failure for FM73. Figure 29 also shows cohesive failure, but along a diagonal line from upper left to lower right one can see the adherend surface through a thin layer of adhesive.

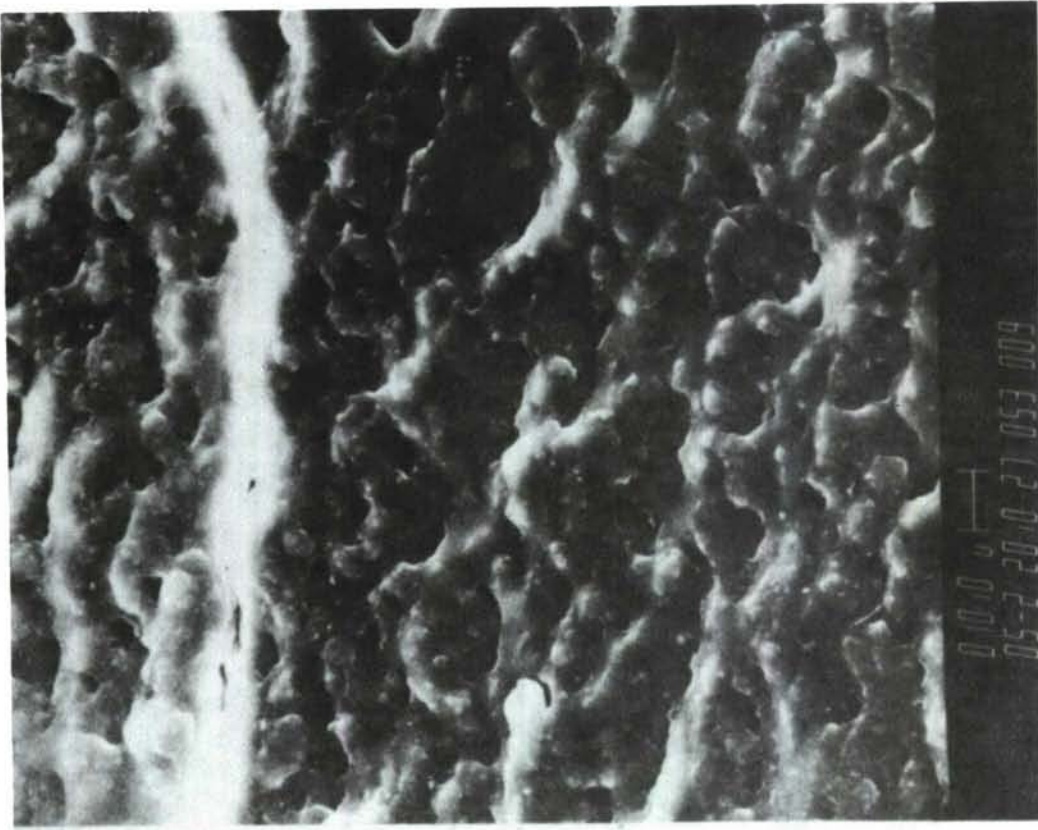
Figure Nr. 30 - Photomicrograph of Fracture Surface (Skin Side), Group F, Specimen Nr. 3

Photomicrographs of the fracture surfaces of a specimen made with AF30 (Group F, Specimen Nr. 3), a nitrile rubber phenolic adhesive, indicated predominantly cohesive fracture, but with a morphology different from that of FM73 adhesive. Figure 30 of the fracture surface of the skin shows a continuous phase which appears to be elastomeric. The elastomeric nature is indicated by local regions of "necked-down" material and the undulating, highly deformed overlapping layers. Figure 31, a photomicrograph of the

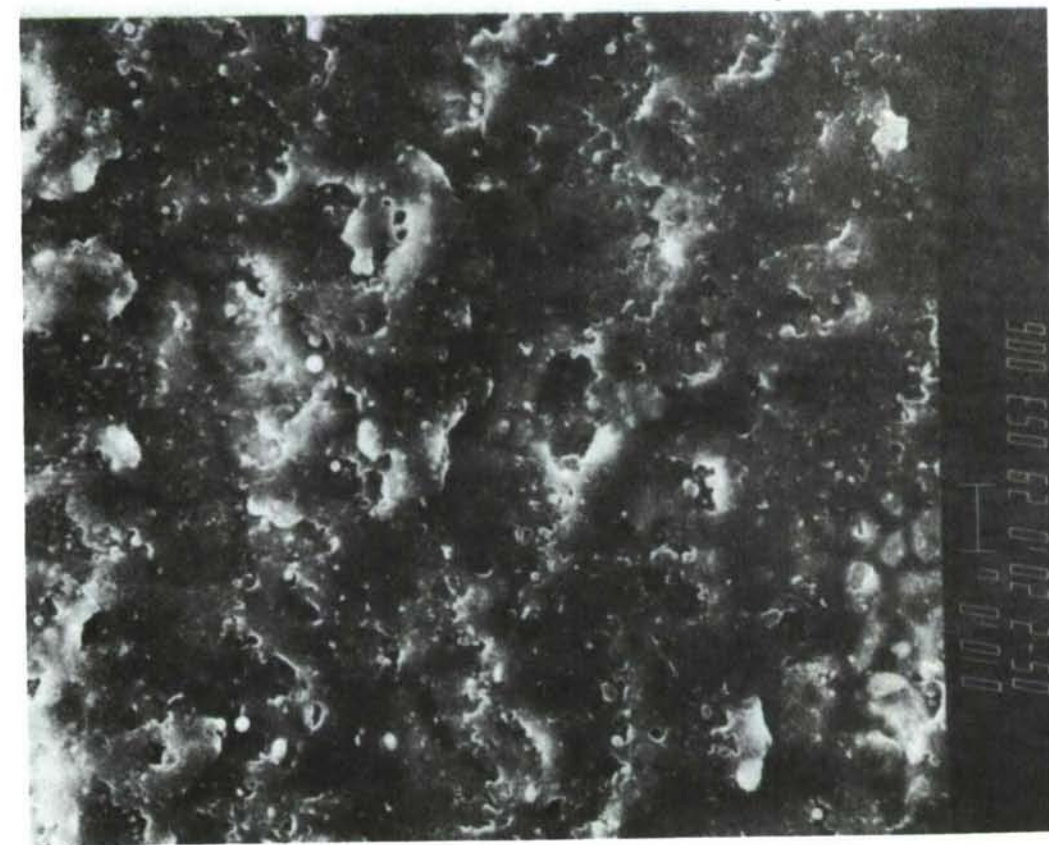
Figure Nr. 31 - Photomicrograph of Fracture Surface  
(Tee Side), Group F, Specimen Nr. 3

fracture surface of the tee from the same specimen, but closer to the initiation region, shows similar morphology. The presence of many loose particles may have resulted from a higher dimensional excursion during test, resulting in higher energy input and greater damage to the adhesive. Figure 32 is a photomicrograph of the flash area at the edge of the tee flange. The interesting features here are the fragmentation of the surface grains of the adherend and the separations at grain boundaries. This is presumed to have been caused by the very high energy input during the fatigue test.
