USAAEFA PROJECT NO. 80-07

CLIMATIC LABORATORY SURVEY HUGHES YAH-64 HELICOPTER

FINAL REPORT

MARCH 1982

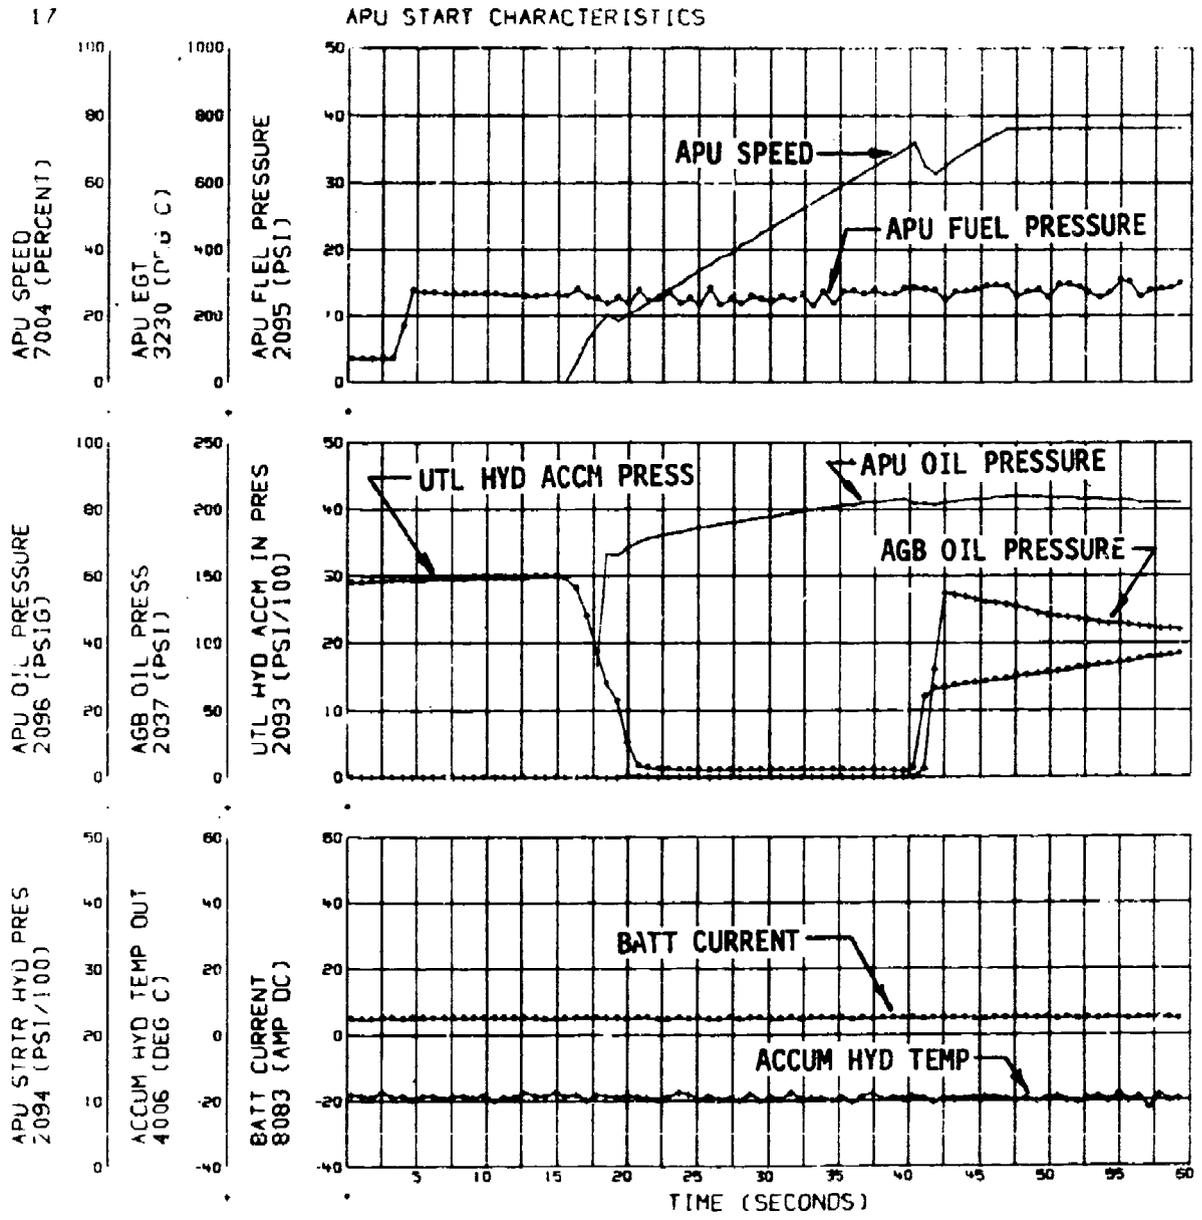
FIGURE 5
APU START CHARACTERISTICS
 APU S/N P113
 YAH-64 USA S/N 74-22249
 CLIMATIC LABORATORY TEMPERATURE -50°F

8. On the first start attempt at -50°F the APU-to-AGB clutch failed (fig 5, app E). The APU achieved operating speed, but could not turn the accessory gearbox. A new clutch was installed and several more start attempts were made. The APU started on each attempt and accelerated to clutch engagement (approximately 60 percent speed). When the clutch engaged, the APU speed decreased to zero and the start sequence was aborted by the APU control unit (fig 6, App E). No problems were encountered at the subsequent 70°F nor $+125^{\circ}\text{F}$ test conditions.

- NOTES:
1. APU SERVICED WITH MIL-L-7808H OIL
 2. HYDRAULIC SYSTEM SERVICED WITH MIL-H-5606H FLUID
 3. JP-4 FUEL UTILIZED
 4. ACCESSORY GEARBOX CLUTCH ENGAGED, THEN FAILED
 5. APU STARTER HYDRAULIC PRESSURE INSTRUMENTATION UNRELIABLE
 6. BATTERY CURRENT INSTRUMENTATION FAILED

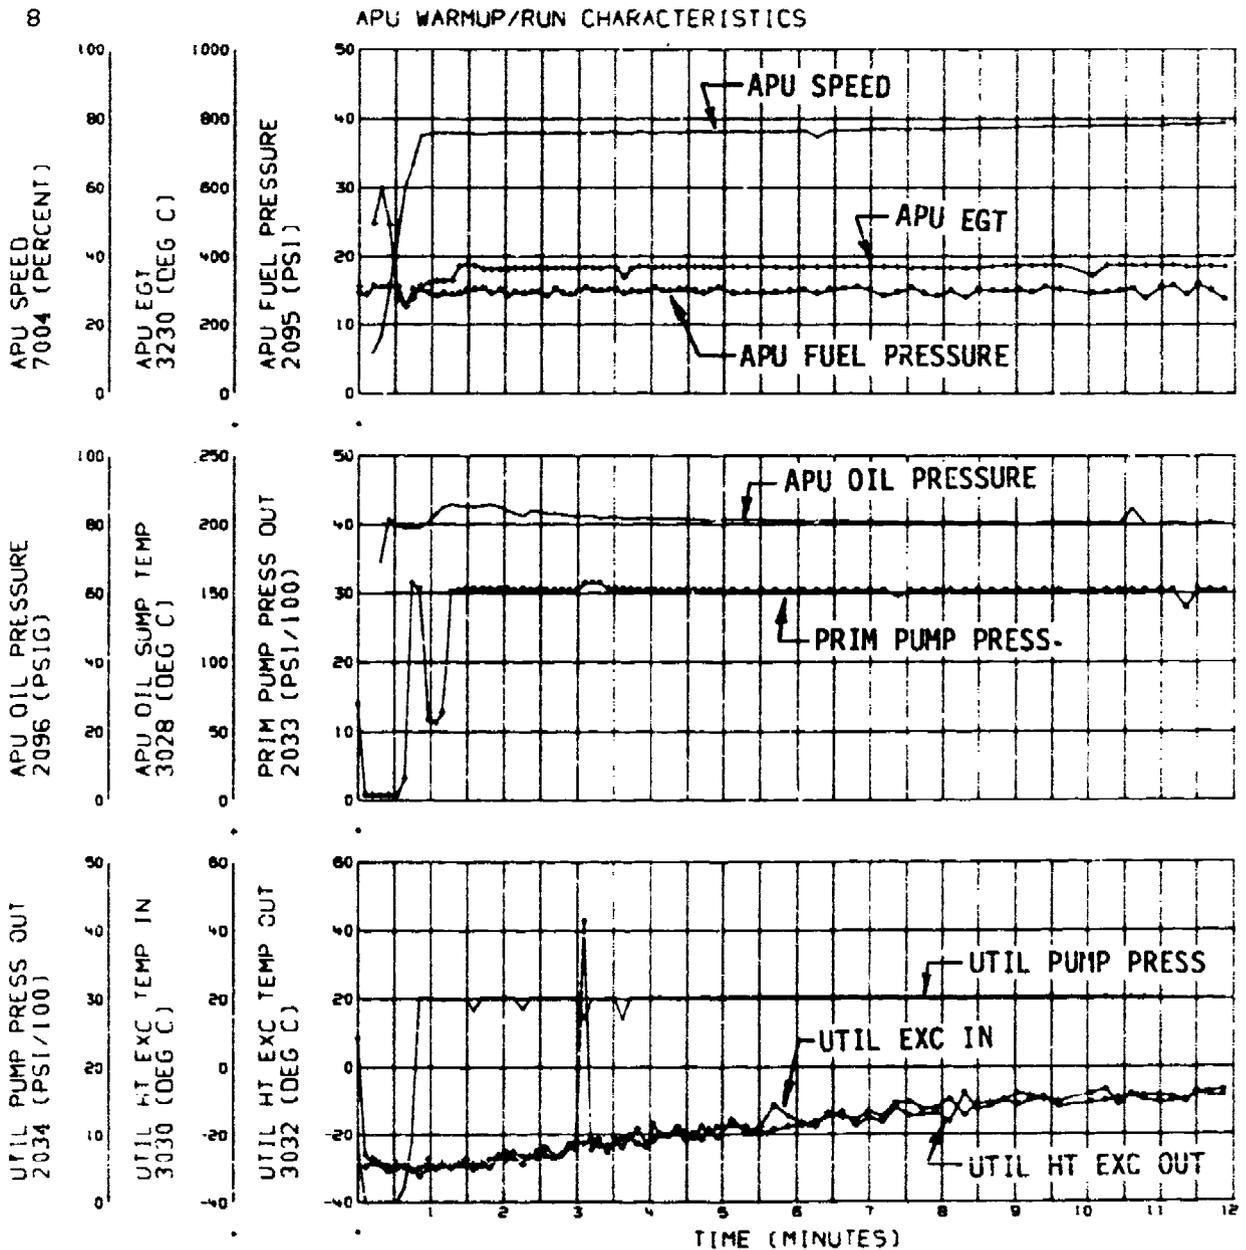
FIGURE 11
APU WARM-UP/RUN CHARACTERISTICS
 APU S/N P113
 YAH-64 USA S/N 74-22249
 CLIMATIC LABORATORY TEMPERATURE -50°F

- NOTES:
1. APU SERVICED WITH MIL-L-7808H OIL
 2. HYDRAULIC SYSTEM SERVICED WITH MIL-H-5606H FLUID
 3. JP-4 FUEL UTILIZED
 4. ACCESSORY GEARBOX CLUTCH ENGAGED THEN FAILED

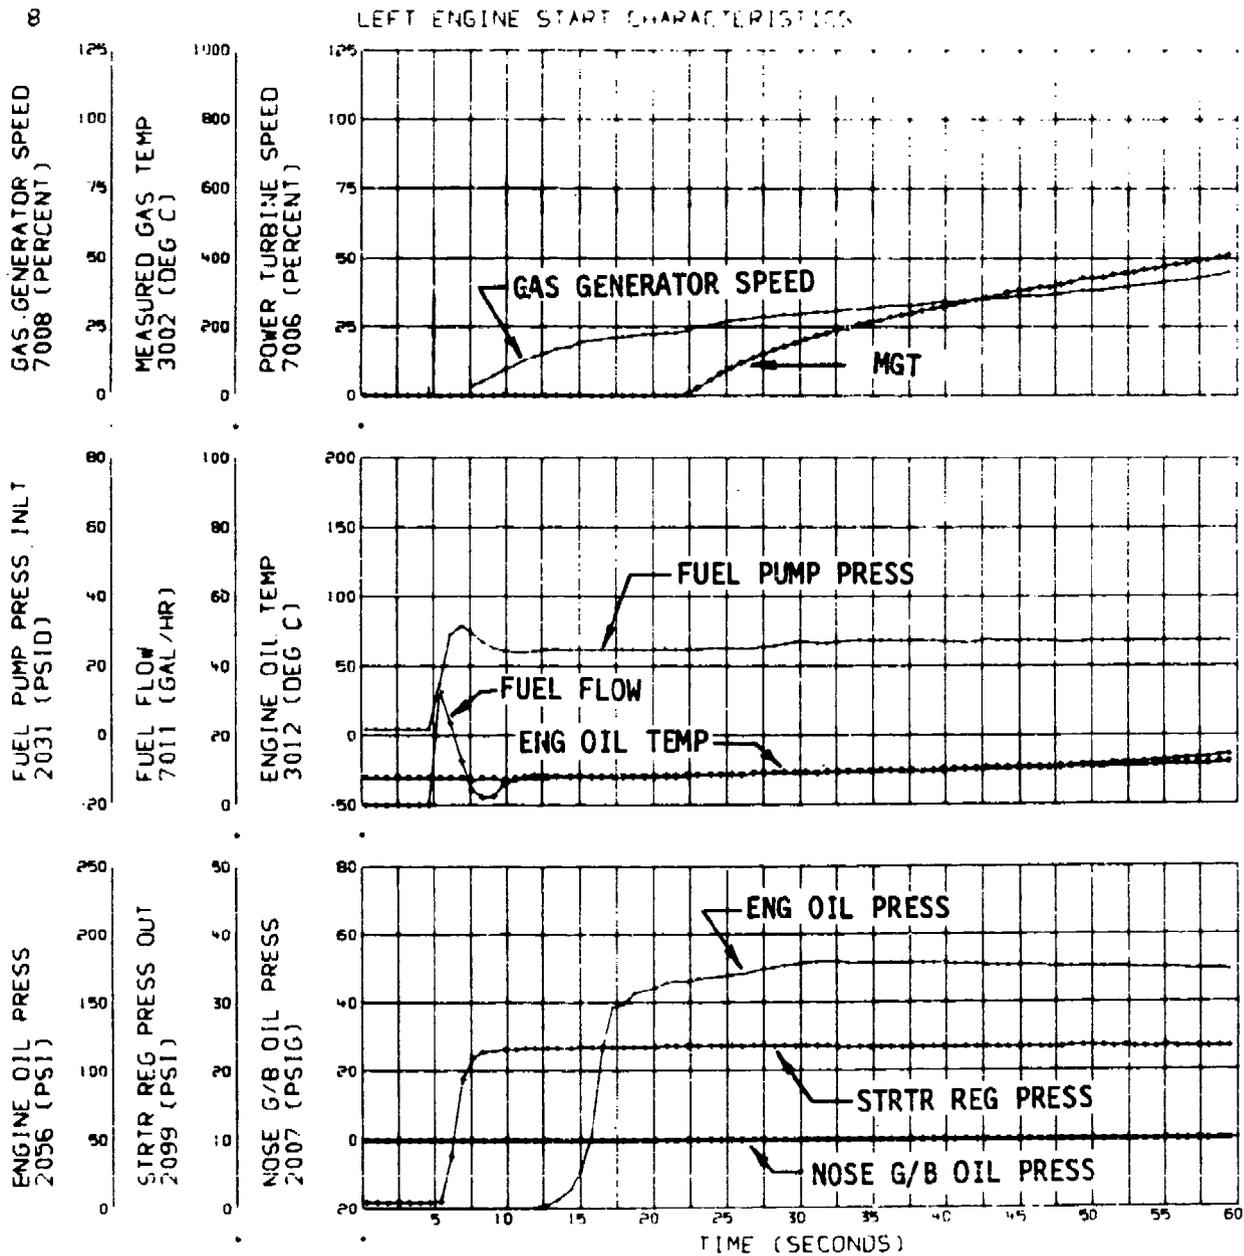
FIGURE 17
NO 1 ENGINE START CHARACTERISTICS
 T700-GE-700R ENGINE S/N 207-263R
 YAH-64 USA S/N 74-22249
 CLIMATIC LABORATORY TEMPERATURE -50°F

14. At -50°F the first several left engine start attempts were unsuccessful (fig 17 app E). The cold weather start procedure which requires cycling the ECL was used during these attempts. Fuel flow to the engine during these attempts was 3 to 4 gallons per hour. Fuel flow during successful starts was 9 to 12 gallons per hour. The engine hydromechanical unit was replaced and subsequent starts were successful.

- NOTES:
1. ENGINE SERVICED WITH MIL-L-7808H OIL
 2. JP-4 FUEL UTILIZED
 3. ENGINE START ATTEMPT ABORTED AFTER TWO MINUTES
 4. PNEUMATIC POWER CART USED FOR START ATTEMPT

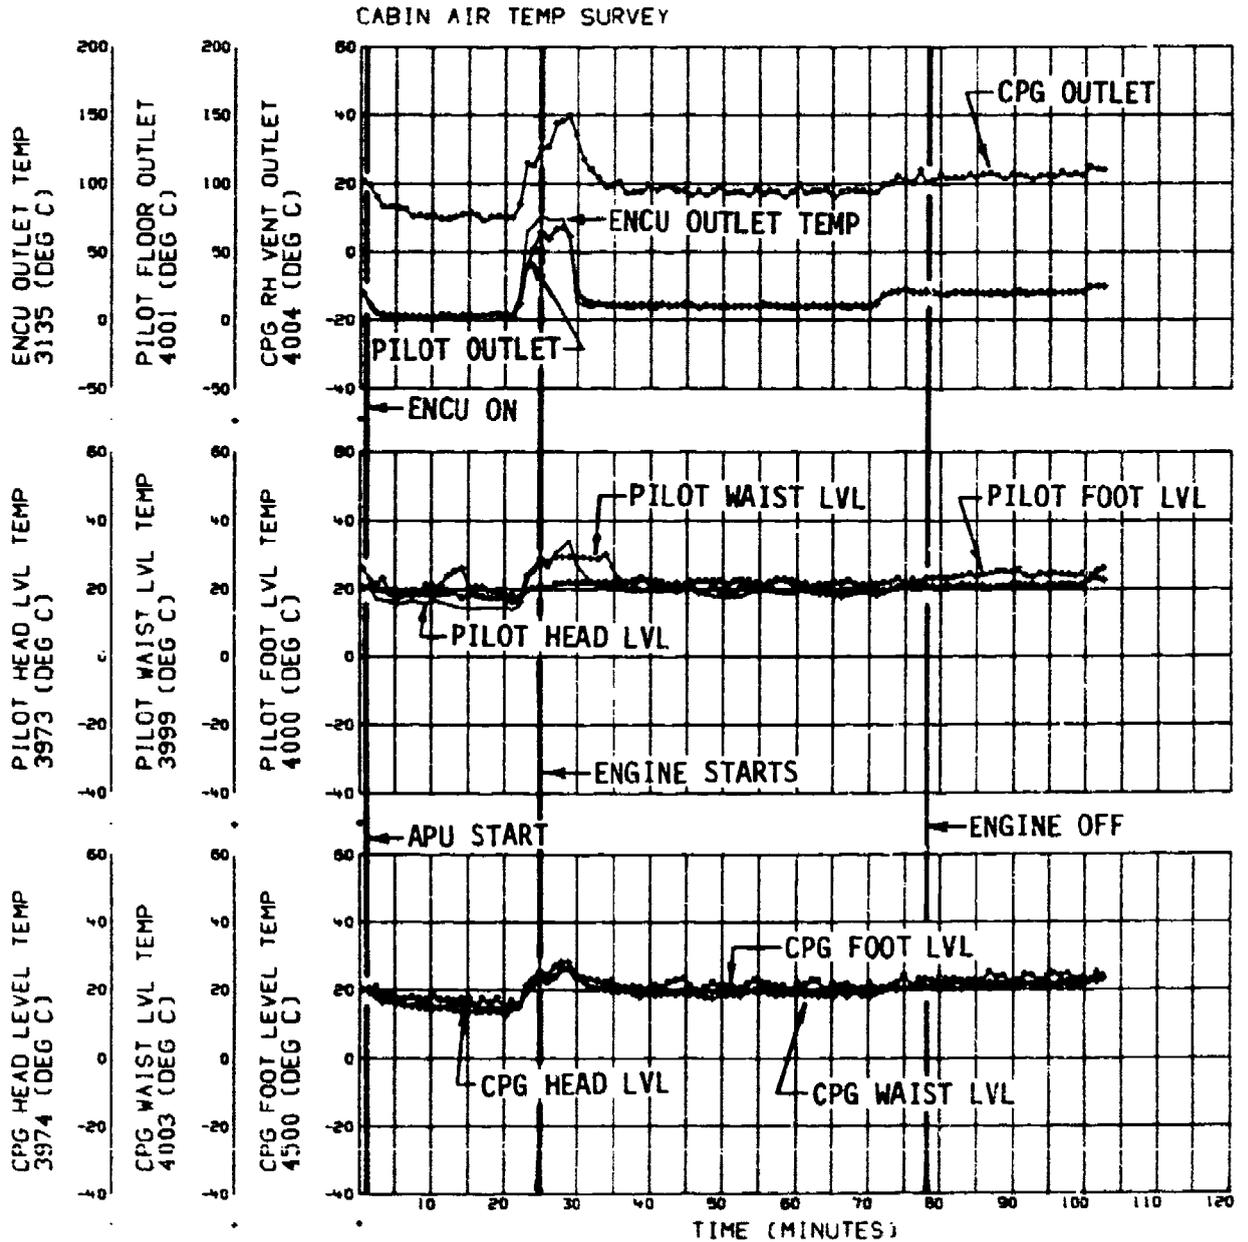
FIGURE 39
CABIN AIR TEMPERATURE SURVEY
YAH-64 USA S/N 74-22249
CLIMATIC LABORATORY TEMPERATURE -25°F

21. The heating operation of the ECS was tested at -25°F (-32°C) and data are presented in figures 39 and 43, appendix E. The ENCU outlet temperature averaged 149°F (65°C) during the test with insignificant duct losses between the ENCU and the pilot station. Between the pilot and CPG outlet, however, the conditioned air temperature dropped by 45°F (25°C). The time to reach the required minimum temperature of 40°F (4°C) at the pilot station was 4 minutes at the waist, 8 minutes at the head, and 28 minutes at the feet. The temperature at the pilot's feet was below freezing for nearly half of the 2 hour mission. The pilot's feet and hands were very uncomfortable during this test. The temperature at the

cyclic grip was 32°F (0°C) as measured with hand-held instrumentation. The waist-level temperature presented in figure 39 (which averaged approximately 70°F) was measured near the left edge of the pilot's seat and had ECS air blowing directly on the sensor. The difference between the pilot head and foot level temperatures averaged 14°F (8°C) and was a maximum of 22°F (12°C). This large temperature gradient was caused mainly by cold ambient air entering the cockpit through the 30 mm weapon turret and holes in the floor around the pedals. Table 3 presents speeds of air blowing up through the holes in the floor as measured with hand-held instrumentation in the aft cockpit. At high power settings, the air speeds increased and produced wind chill effects which added to crew discomfort. The pilot's lower duct outlets being closed also contributed to the temperature difference. The temperatures at the CPG station and at the TAD/PNVS and FABS inlets reached the minimum temperature of 40°F (4°C) in 10 minutes. Temperatures in the CPG cockpit were acceptably uniform during the test.
