## Task Order 2 Enhanced Preliminary Assessment

KAPALAMA MILITARY RESERVATION  
HONOLULU, HAWAII

February 1990

ENHANCED PRELIMINARY ASSESSMENT REPORT

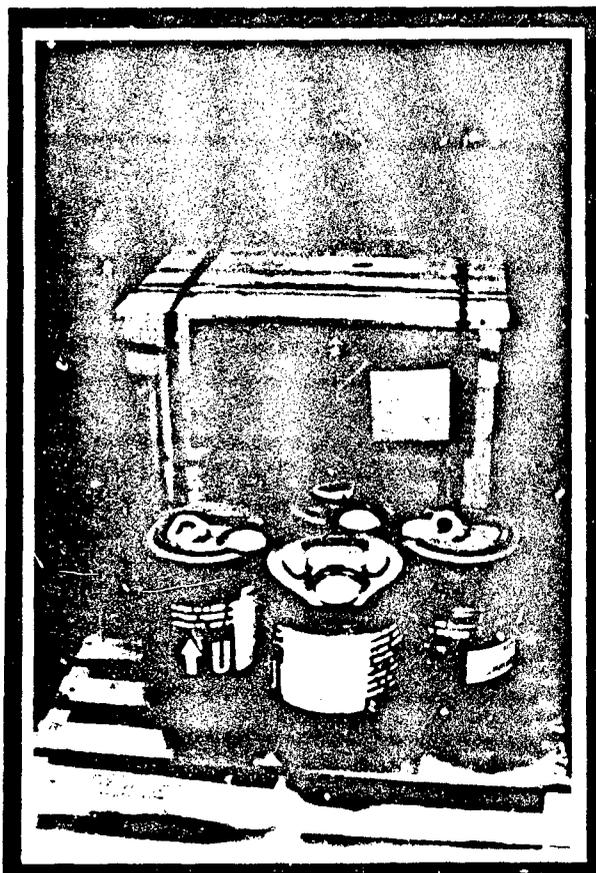
11. Battery Acid

**CONTENTS OF BUILDING 917**

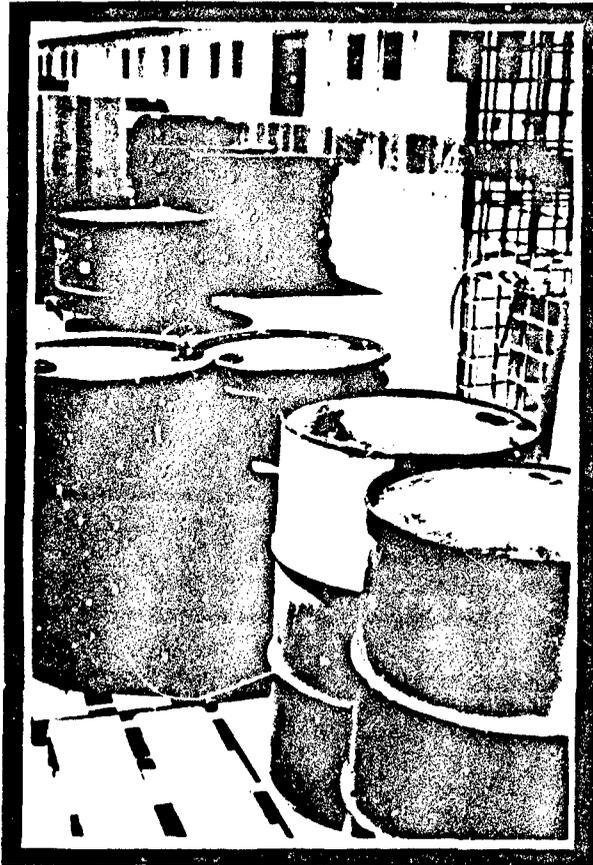
- Building 924 - Canvas Repair Area & Packaging Area - waterproofing with polymer-type water repellents; packaging with isocyanate foam; "waste oil" drums (apparently empty) on pallet outside building.

**29. RUSTED DRUMS OUTSIDE BUILDING 924**

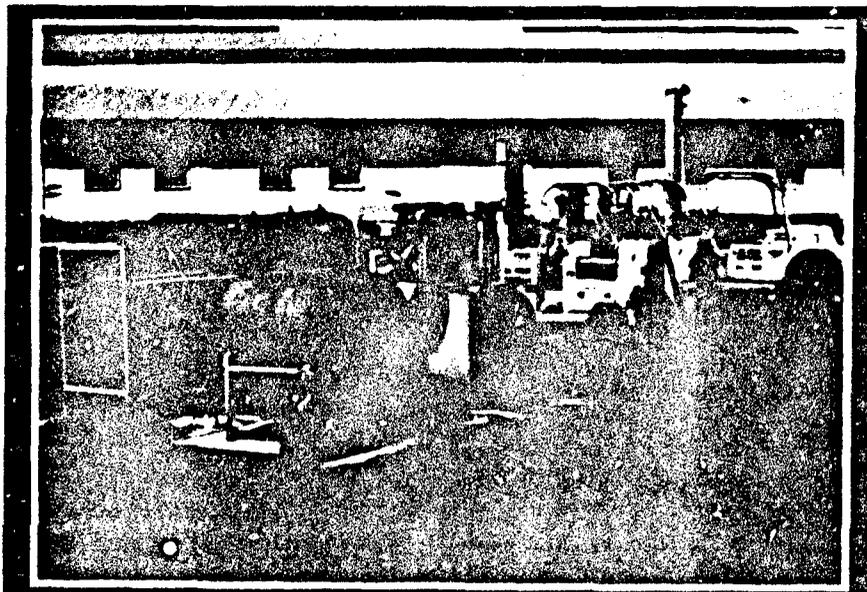
- Building 925 - Maintenance & Repair of Forklifts - oils, greases, solvents, and hydraulic fluids used in the repair and maintenance of forklifts in an area adjacent to the building.

**30. FORK LIFT MAINTENANCE AREA, BUILDING 925**

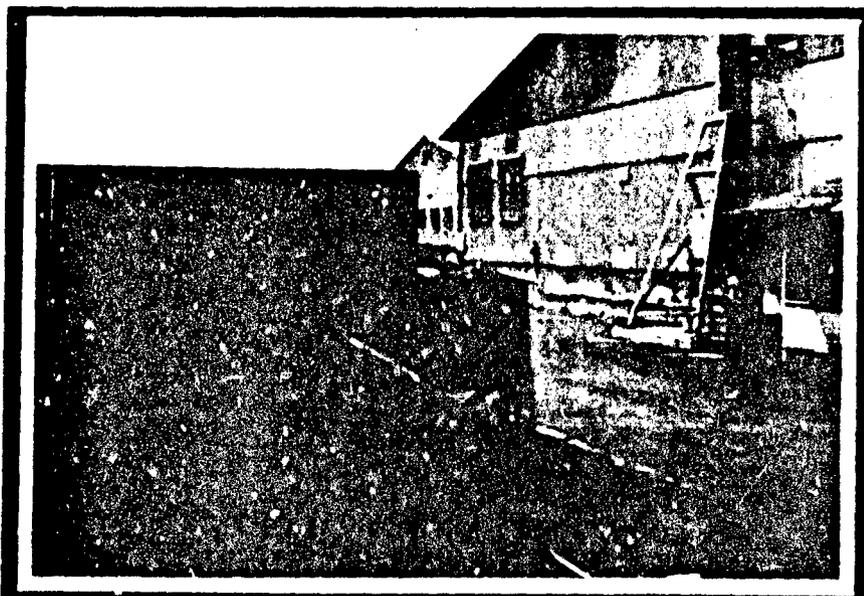
**36. FORMER RADIOACTIVE MATERIAL STORAGE AREA, BUILDING 929-A**

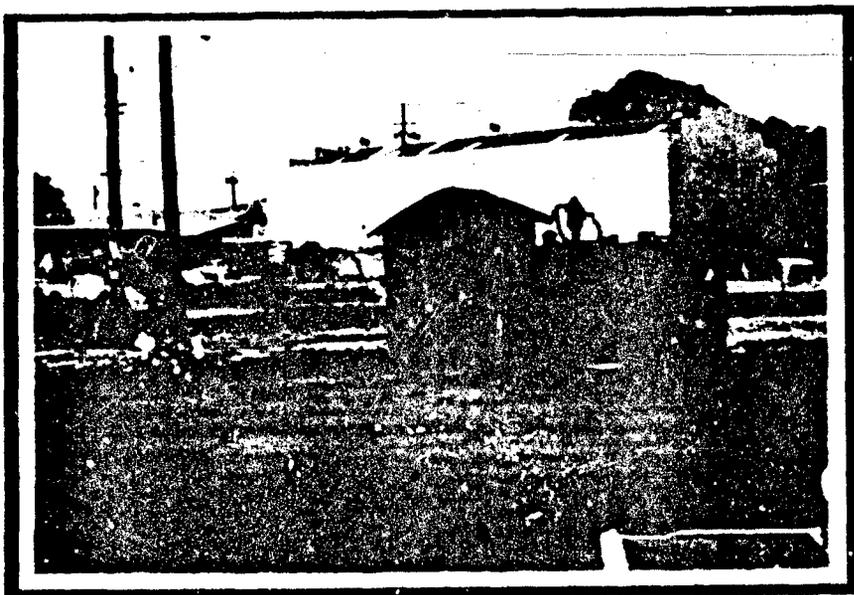
**40. KEROSENE STORAGE TANK**

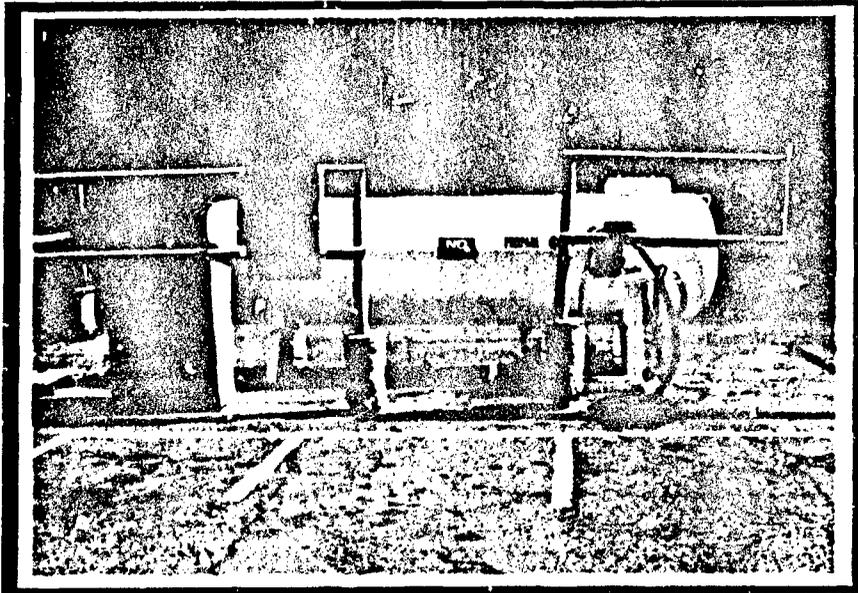
**41. PROPANE STORAGE TANK NEAR BUILDING 925**

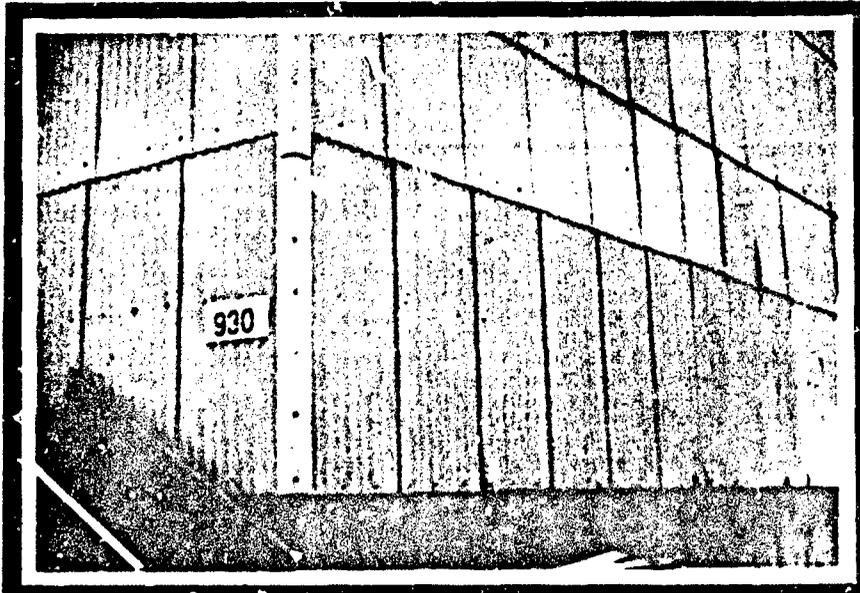
- Asbestos - numerous onsite buildings constructed with Transite siding and other asbestos-containing material. Some siding material is broken along the lower side of buildings.

**42. GENERAL CONDITION OF TRANSITE SIDING**

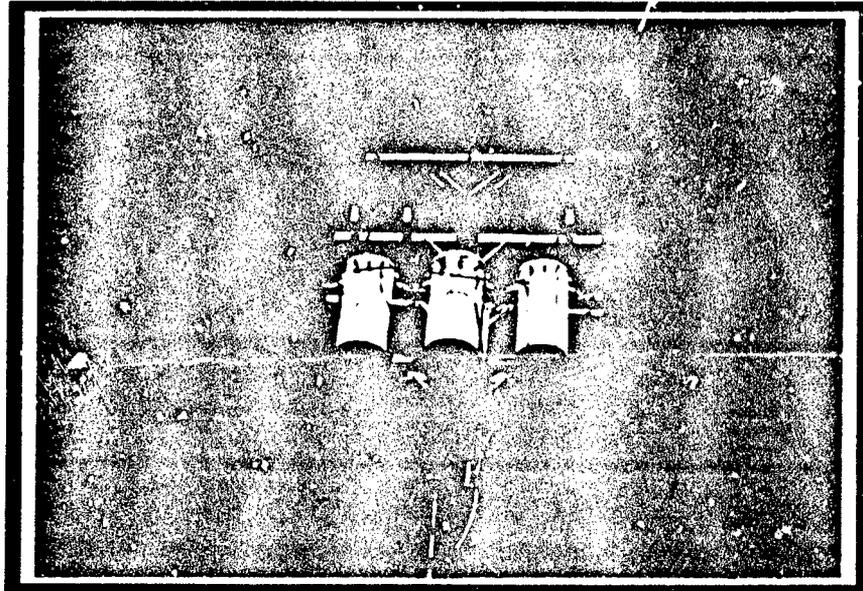
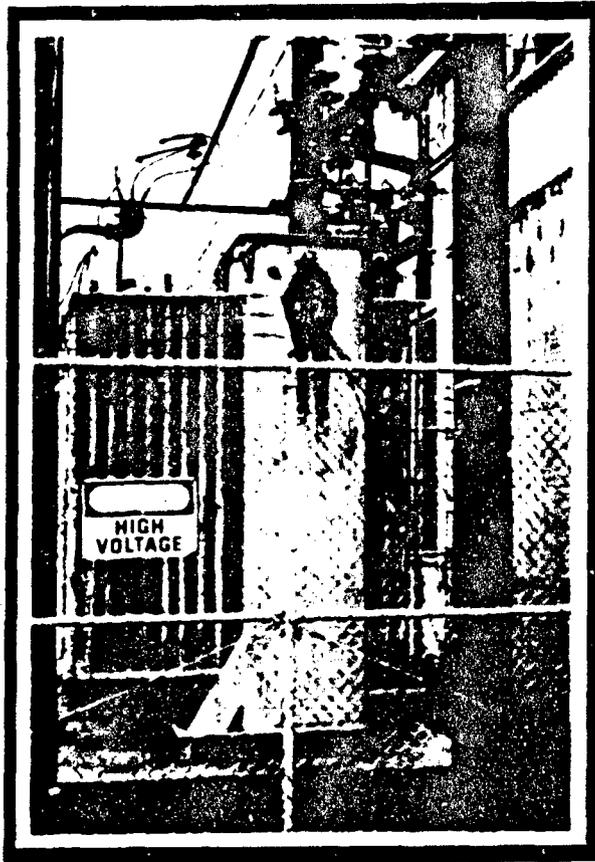
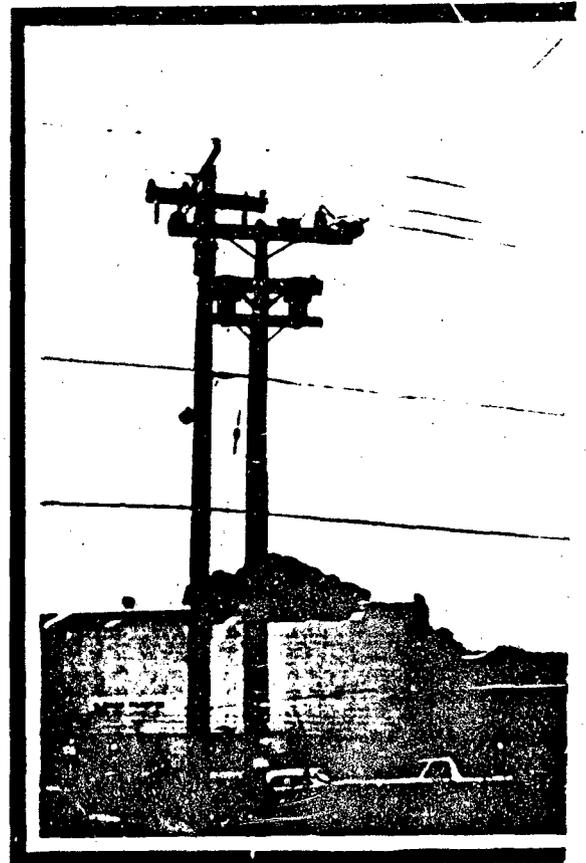
- Transformers - approximately 40 transformers, two pad mounted, the remainder pole mounted. Fluids have not been tested for polychlorinated biphenyls (PCBs) content. Two apparent minor leaks observed.

**TRANSFORMERS**

All transformers on the property potentially contain PCBs and two of them appear to have leaked in the past. An inventory should be made of all transformers remaining on the property (except Phase I), and each transformer should be sampled for PCBs.

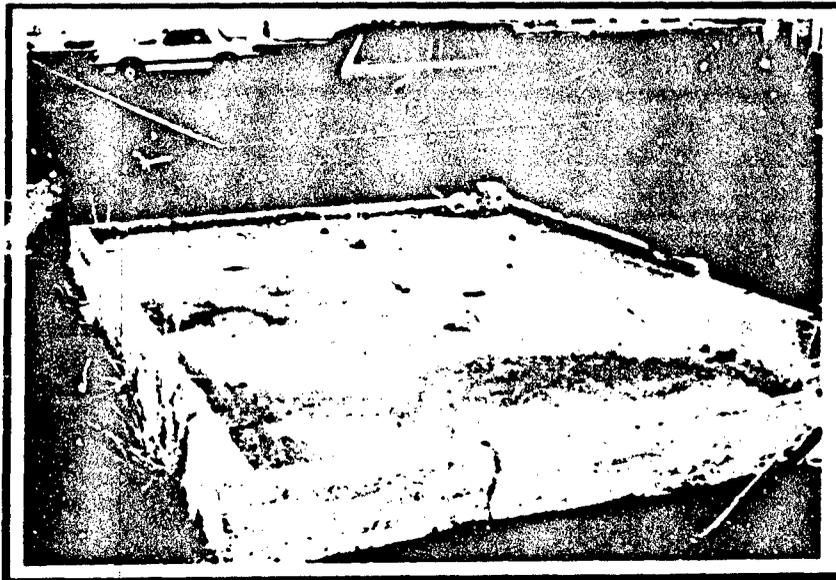
**49. CONCRETE PAD NEAR BUILDING 923**
