DOT/FAA/CT-94/119

Evaluation of Alternative Pavement Marking Materials

January 1995

Final Report

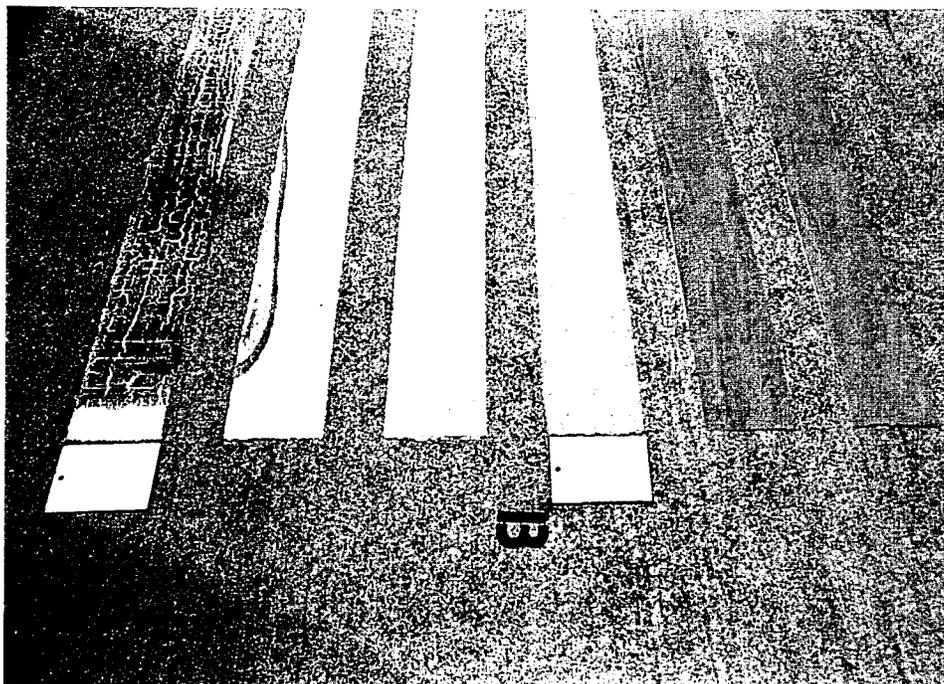
FIGURE A-21. EPOXY NO. 2 - INCOMPLETE HARDENING

The taxiways Bravo and Hotel test stripes were each inspected on a monthly basis. One stripe of epoxy material (Epoxy no. 2, white, non-beaded) was noted to have not completely cured and assumed a blackened appearance. The blackened appearance was a result of the partially cured epoxy collecting the dirt from the main gear of the aircraft and vehicle tires as they passed over the test stripe. One benefit to be mentioned is that the material remained in place even though only partially cured. The test stripe did not delaminate from the concrete surface therefore eliminating the potential for foreign object damage (FOD).

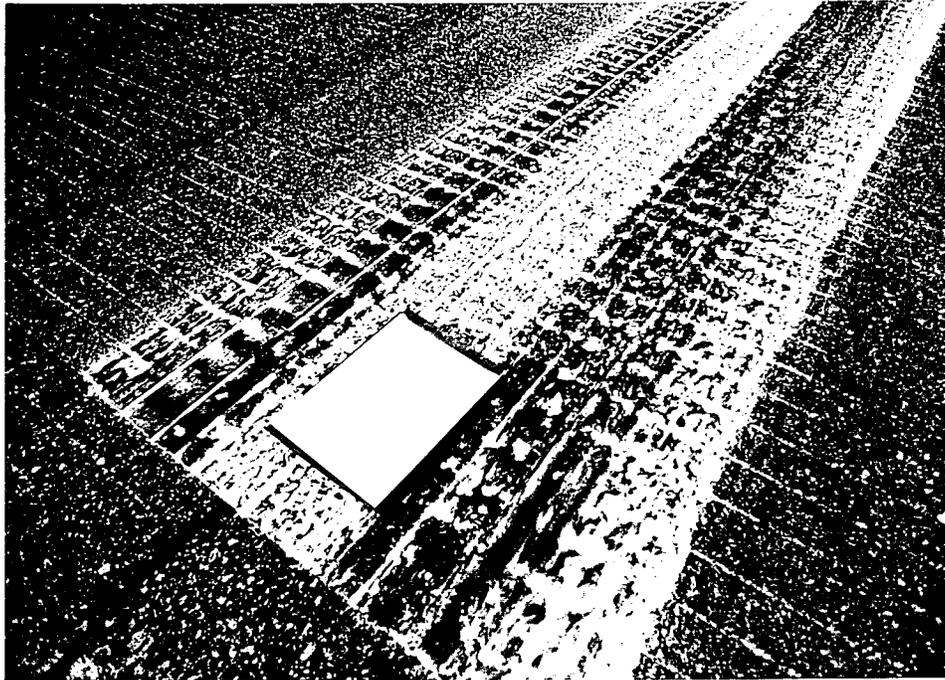
FIGURE A-22. RUBBER ACCUMULATION ON RUNWAY TEST STRIPE

While using silica and/or beads showed higher resistance to rubber buildup, none of the materials totally avoided the problem. In hot climates such as Phoenix, it appears that rubber buildup will occur rapidly regardless of the material type. At such locations the runway pavement markings in the vicinity of the touchdown area need to be painted more often, regardless of the marking material used. Therefore, no benefit is gained by use of more durable materials. It must be noted, however, that the

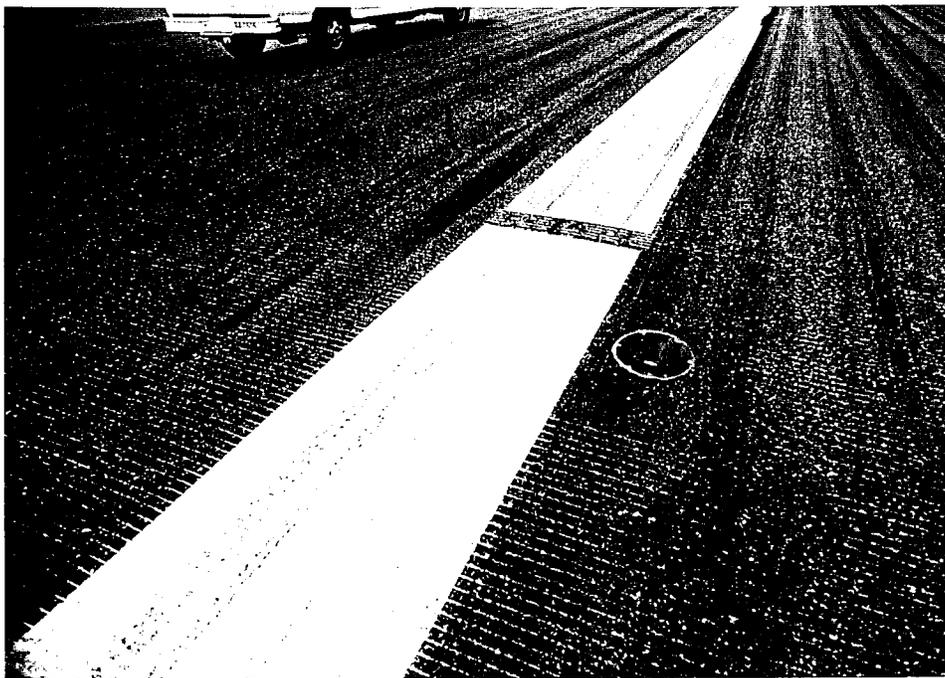
FIGURE A-23. COLOR VARIANCE - ATLANTIC CITY

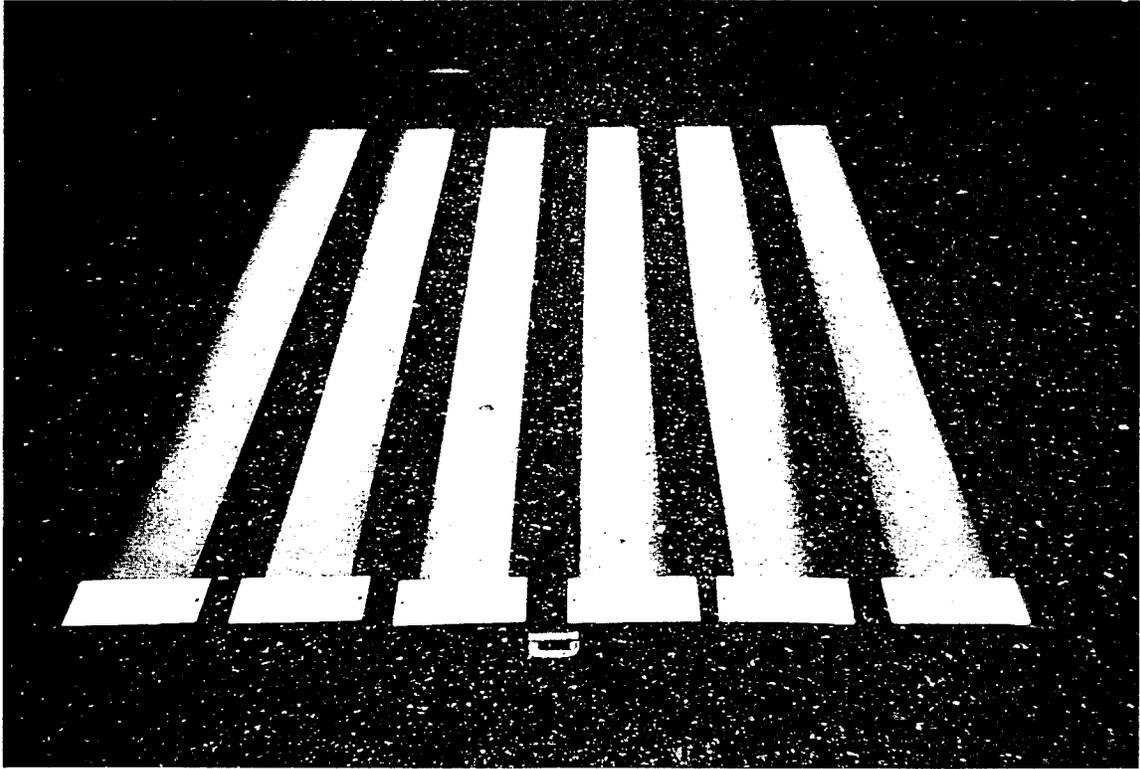
FIGURE A-24. WATER-BORNE DISCOLORATION - ASPHALT SURFACE

At Atlantic City airport the water-borne material no. 2 was found to have developed a rust-colored cast on the runway threshold stripes and on the asphalt taxiway stripes. Since this occurred only on the asphalt pavement surfaces, it was believed that a component in the asphalt mix was interacting with the materials. Use of drawdowns and comparative photographs illustrated the color transformations that occurred. Refer to the appendix for individual comparisons. Overall, the test materials displayed a constancy in color characteristics with the exceptions already noted.

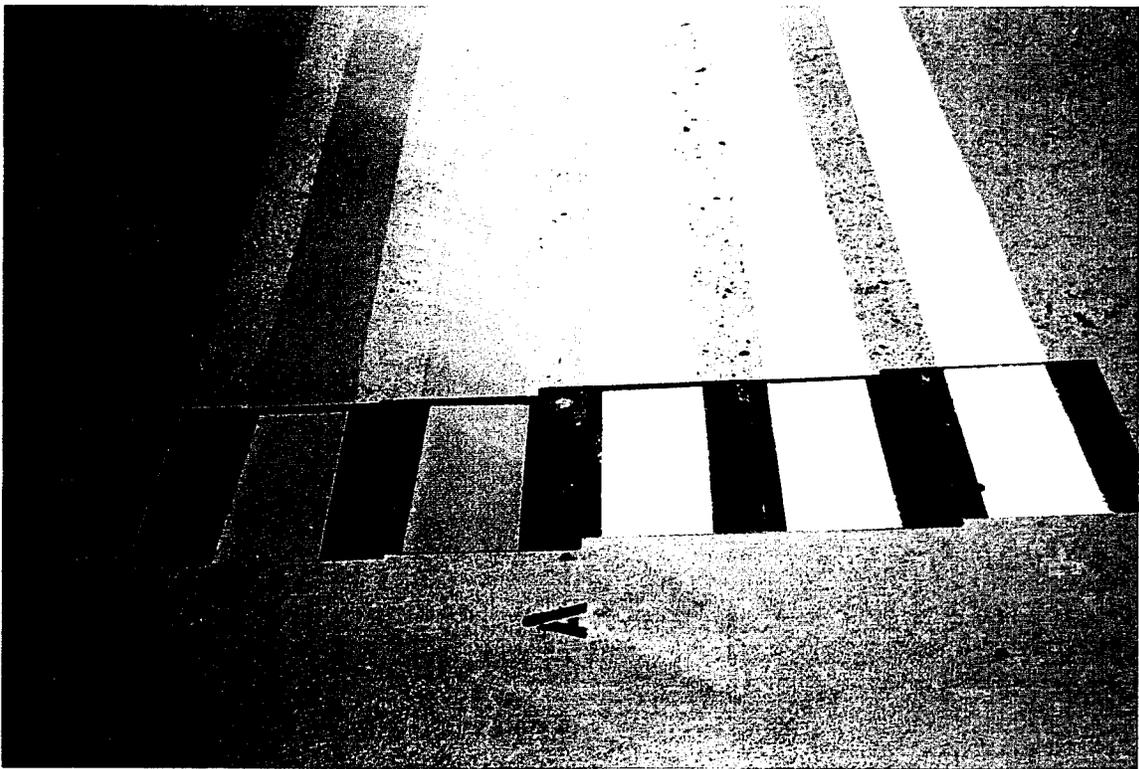
FIGURE A-25. EPOXY NO. 1 DISCOLORATION - CONCRETE SURFACE
