**Loss of Pitch Control During Takeoff  
Air Midwest Flight 5481  
Raytheon (Beechcraft) 1900D, N233YV  
Charlotte, North Carolina  
January 8, 2003**

**Aircraft Accident Report**  
**NTSB/AAR-04/01**

# **Aircraft Accident Report**

**Loss of Pitch Control During Takeoff**

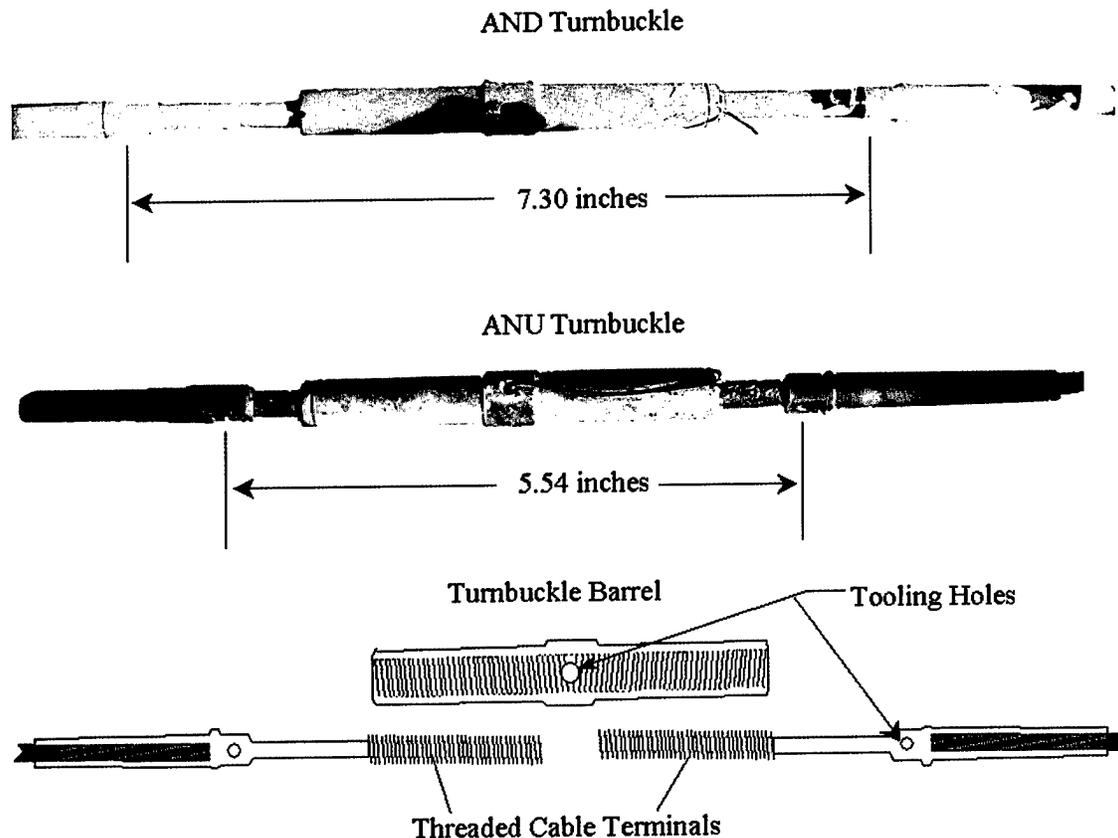
The ANU turnbuckle was almost fully contracted, and the AND turnbuckle was almost fully extended. The measurement from the center of the tooling hole in one threaded cable terminal to the center of the tooling hole in the other cable terminal was 5.54 inches for the ANU turnbuckle and 7.30 inches for the AND turnbuckle. In addition, the AND turnbuckle had one thread visible, and the ANU turnbuckle did not have any threads visible. Figure 6 shows the turnbuckles as found in the wreckage and a drawing that shows a turnbuckle barrel and threaded cable terminals.

**Figure 6.** Turnbuckles as found in the wreckage.

The AND turnbuckle was extended 1.76 inches more than the ANU turnbuckle. After the accident, Air Midwest surveyed its entire fleet of 42 Beech 1900D airplanes, which represented 25 percent of the 164 Beech 1900D airplanes active in the North American fleet. Air Midwest data submitted to the Safety Board indicated that, on average, the AND turnbuckle was extended 0.04 inch less than the ANU turnbuckle.

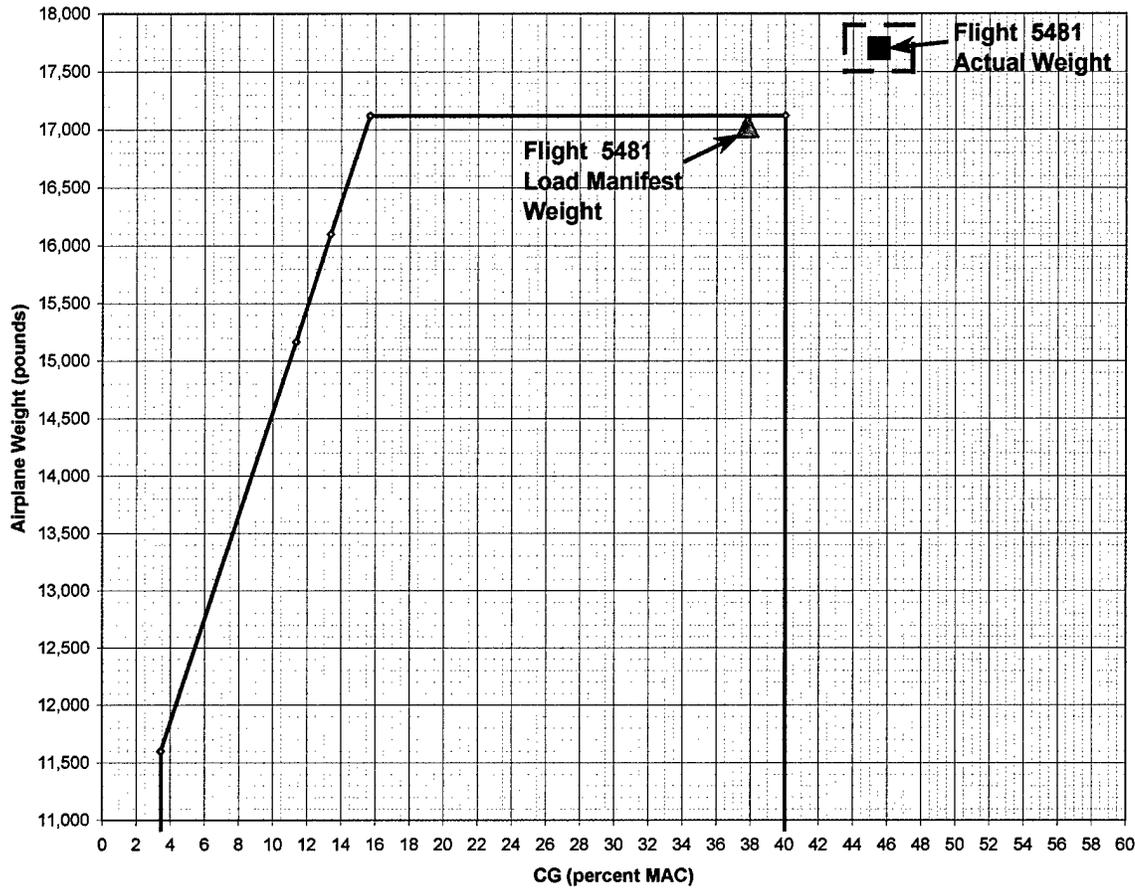
On the basis of these FDR data, radar data, the validated force and moment model, and component weight and location information, the Safety Board determined that the accident airplane had an actual weight of  $17,700 \pm 200$  pounds and an actual CG position of  $45.5 \pm 2$  percent MAC. Figure 7 shows the results of the Board's calculations overlaid on the Beech 1900D weight and CG envelope.

Figure 7. Weight and center of gravity information for flight 5481.

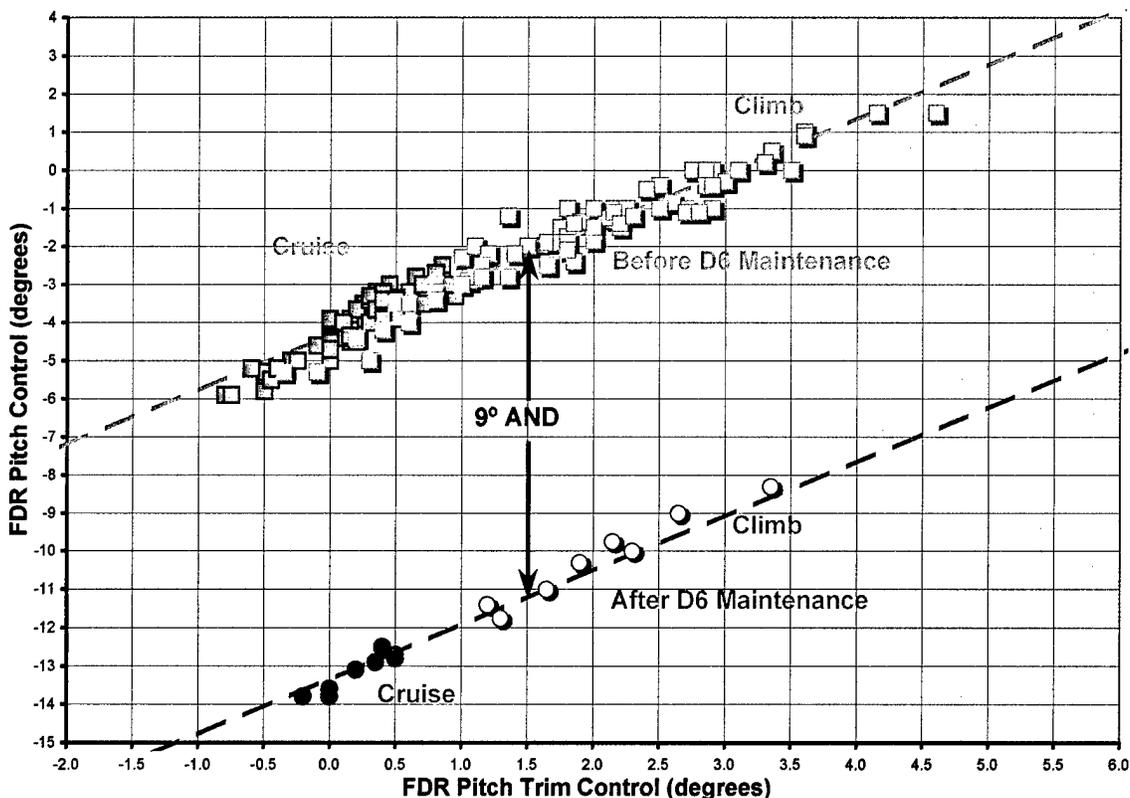
The position of the trim tab is the predominant predictor of elevator position during climb and cruise flight. Figure 8 shows that a strong correlation exists between elevator (FDR pitch control position) and trim tab (FDR pitch trim control) data. The figure shows two distinct data groups: the larger group represents flights before the D6 maintenance check, and the smaller group represents flights after the D6 maintenance check.

**Figure 8.** Flight data recorder pitch control and pitch trim control positions.

The larger group of data shown in figure 8 (that is, the flights before D6 maintenance) compared well with the Beech 1900D flight test certification data, indicating that the pre-maintenance FDR pitch control position data represented the actual elevator position to within about 1°. However, the smaller group of data (that is, the flights

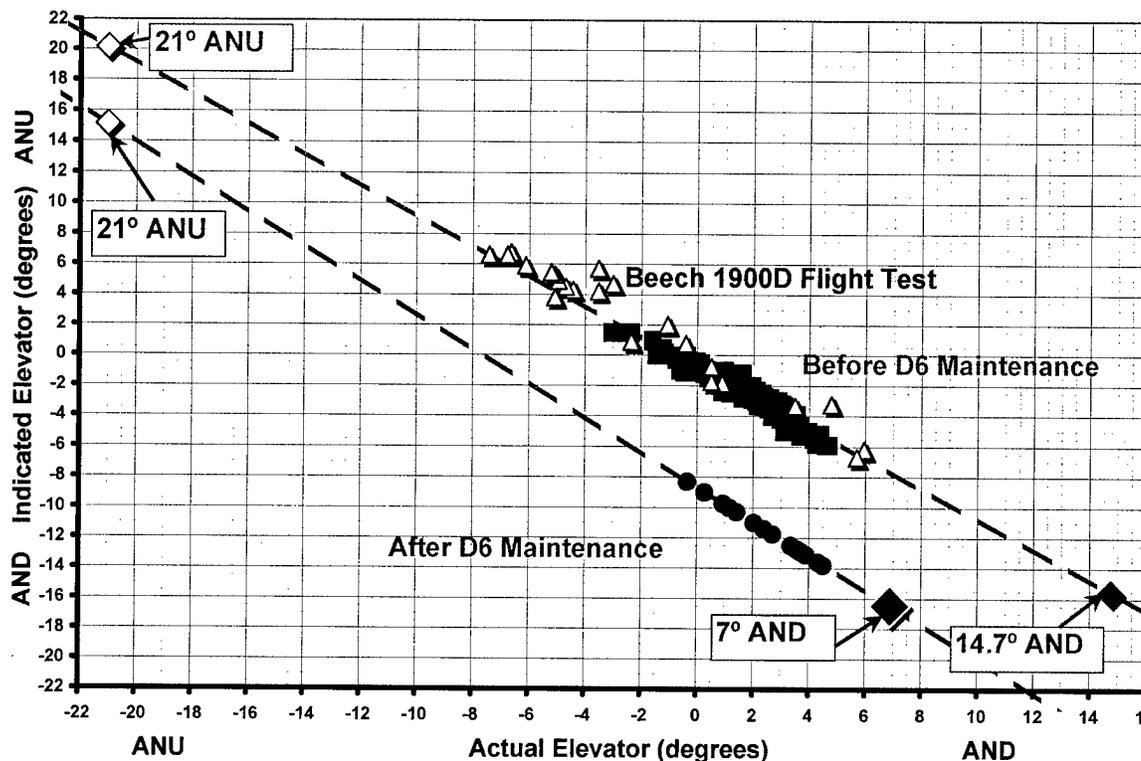
**Figure 9.** Elevator travel available before and after the detail six maintenance check.

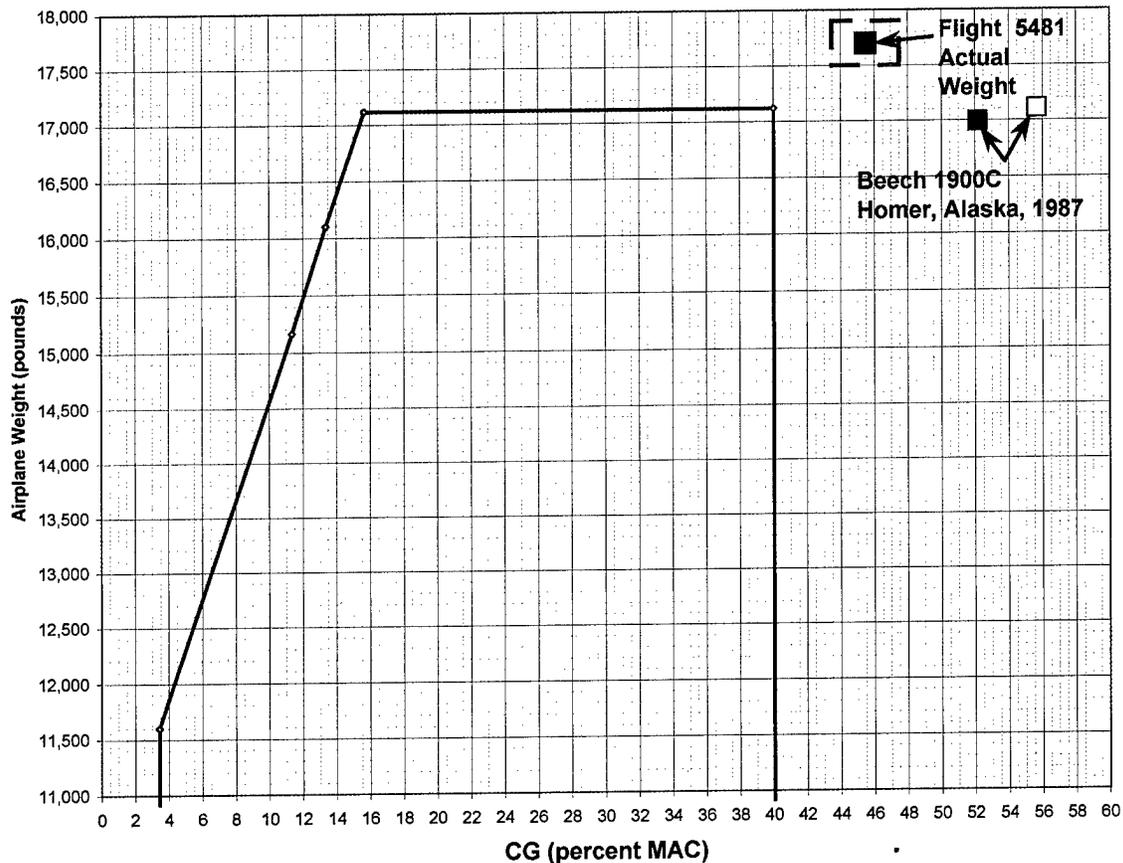
Figure 11 shows flight 5481's weight and CG information compared with that for the flight 103 accident airplane. Two data points in the figure show the CG range for the flight 103 airplane.

**Figure 11.** Flight 5481 weight and center of gravity information compared with flight 103 weight and center of gravity information.
