# Monitoring Morphology and Currents at the Hatteras Breach

## ABSTRACT

On 18 September 2003, Hatteras Island, North Carolina, was breached by Hurricane Isabel about 6 miles northeast of Hatteras Inlet to connect Pamlico Sound with the Atlantic Ocean. The breach occurred at a location of minimum island width and elevation. As part of research on coastal inlets, the new opening was surveyed to provide much-needed data on the hydrodynamic and morphologic evolution of barrier island breaches. Two topographic and shallow water surveys were conducted 10 days apart to capture short-term temporal changes in the breach morphology. Analysis of the survey data indicates rapid morphology change. Ebb and flood shoals formed within 2 weeks of the breach. The main breach channel widened by as much as 125 ft and migrated to the west by as much as 80 ft in the 10 days between surveys. Water levels on both the ocean and sound side of the barrier were also measured. Current velocities were measured with surface drifters and with an ADCP during two field deployments. Maximum current velocities were on the order of 7 ft/sec. The surveys provide quantitative data on the evolution of barrier island br

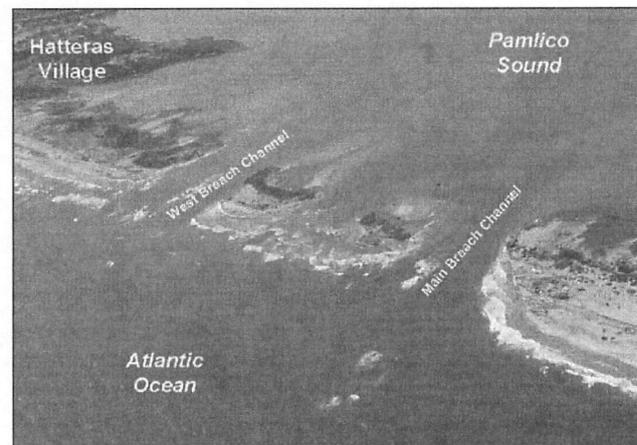
Figure 2. Hatteras breach, 22 September 2003 (USACE Wilmington District photograph).

Wamsley 2003). The Hatteras breach destroyed utility infrastructure and severed North Carolina Highway 12, isolating Hatteras Village from the rest of Hatteras Island. Parking lots and buildings near the breach were also destroyed. Highway 12 is the only transportation route east from the village. Residents were unable to drive to work and home. Businesses at Hatteras Village and on Ocracoke Island experienced loss of tourism revenue because of the restricted access.

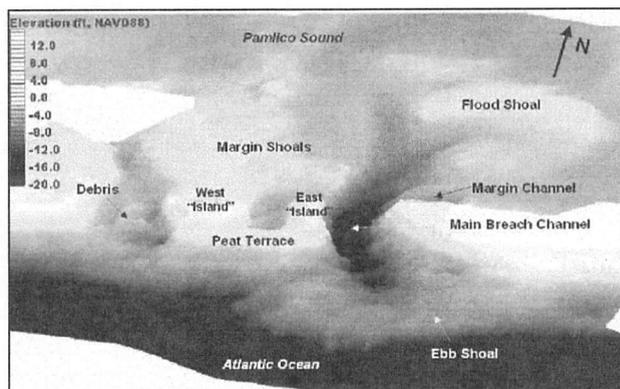
Figure 3. Digital elevation model of Hatteras Breach.

best coverage of the nearshore region just seaward of the breach openings and, combined with the ebb shoal data, provides the most comprehensive data set. Figure 3 is a DEM created for illustrative purposes from Survey 2 data combined with the multi-beam ebb shoal data. Three breach channels, separated by breach islands, are well defined. The breach islands were not washed away because of resistance of peat outcroppings that fronted the islands on the ocean side (Figure 4). The peat acted as an erosion-resistant barrier, revetting the island at this location. The broad peat terrace extended from the eastern most breach island, across the middle breach channel and west breach island (Figure 3).

The flood shoal is readily identifiable in Figure 3. The Survey 1 DEM showed that a flood shoal formed within 2 weeks after the breach opened with the centroid approximately 1,750 ft from Highway 12. The shallowest water over the flood shoal was less than 0.5 ft NAVD88 and had to be surveyed by wading, as depths were too small even for the waverunner system. The second survey showed little growth of the flood shoal. A volumetric analysis indicates that the flood shoal gained on the order of 10,000 cu yd of sand over the 10-day period. A well-defined ebb shoal also formed by 5 October (Figure 3). The ebb shoal extended offshore as far as 1,250 ft from the former location of the highway. Depths over the ebb shoal were 4 to 6 ft NAVD88. Waves were often observed breaking on the ebb shoal.

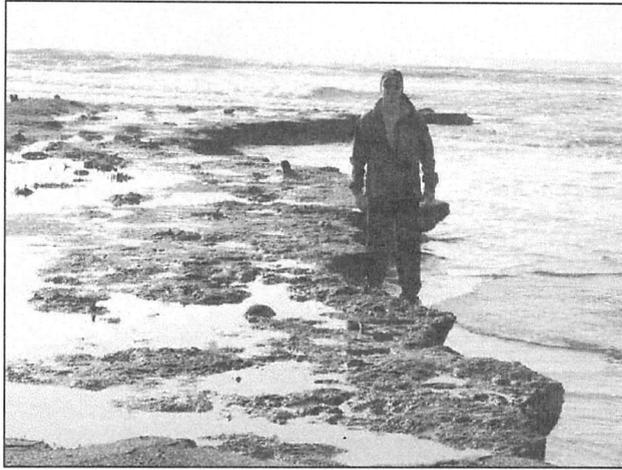
**Figure 4. Western edge of peat terrace, looking southeast. The peat extends approximately 1.5 to 2 ft above the adjacent sandy bottom.**

The peat terrace restricted flow in the middle breach channel, which was about 225 ft wide. Water flowed through the middle channel and over the peat terrace only at higher tide elevations. The restricted flow resulted in little scour of this channel. Maximum depths in the middle channel were about 5 ft NAVD88 (1988 North American Vertical Datum). The west channel was about 350 ft wide and littered with debris (Figure 5). Pilings from the bridge partially constructed in the 1930s extended across the channel on the ocean side. Large chunks of asphalt and roadbed material were visible at lower tide elevations, particularly on the west side of the channel. Near the center of the channel was a peat outcropping with large chunks of asphalt resting on top. The flow through the west channel was somewhat greater than that of the middle channel. Survey 2 maximum

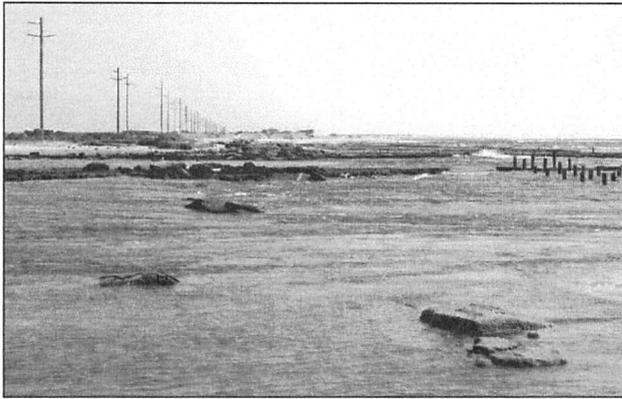
**Figure 5. West breach channel, looking east, 5 October 2003. Note the old bridge pilings on the right and the extensive road debris in the channel.**

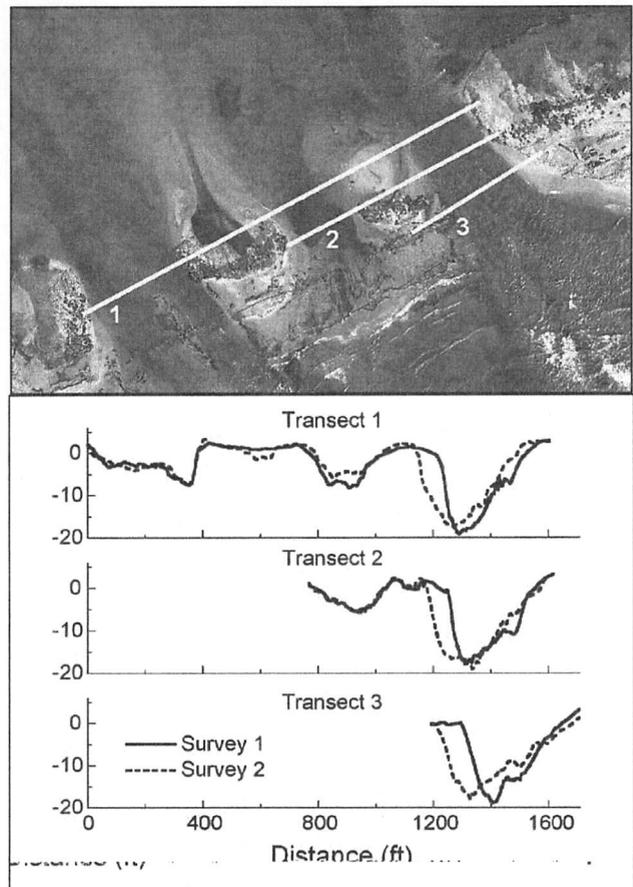
The DEM analysis indicates rapid morphology change. Figure 6 is a comparison plot of breach cross-sections from Surveys 1 and 2. Comparisons are made only where sufficient coverage of the channel was captured by both surveys. Due to debris and wave conditions, the seaward end of the west breach channel was not measured in Survey 1. As Figure 6 shows, there was little change in the west channel, because of the substantial amount of armoring by debris and peat. Flow velocities were significantly weaker than observed in the main channel. The sound end of the

**Figure 6. Comparison of Survey 1 and Survey 2 breach channel cross-sections (North Carolina Department of Transportation (NCDOT) photograph).**

middle channel shoaled approximately 2.5 ft in the 10 days between surveys. The sediment likely originated at the margin shoals on the sound side and could not be flushed out by flow restricted by the peat terrace. The central and seaward portions of the middle channel did not change between Surveys 1 and 2.

The main breach channel experienced the greatest amount of change. Defining breach width as the distance across the channel between the NAVD88 0-contour (which corresponds to +0.44 ft msl), the breach widened by approximately 125 ft on the ocean side, 65 ft through the middle part of the channel, and 25 ft on the sound side. From the center of the barrier toward the sound, the main channel migrated approximately 20 ft to the west over the 10-day period while on the ocean side the channel migrated over 80 ft to the west. The average channel depths were maintained and maximum channel depths generally increased through the middle part of the channel and decreased on the sound side over the 10-day period. The average cross-sectional area of the breach channel increased from 3,400 to 4,000 sq ft.

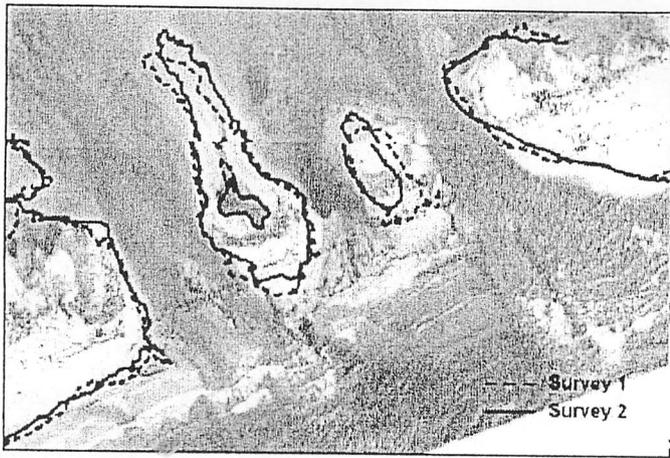
Figure 7. Comparison of the 0-contour (NAVD88). The aerial photograph was taken on 24 September, tide elevation -1.3 ft NAVD88 (NCDOT photograph).

Figure 7 is a comparison of the 0-contour (NAVD88) between Surveys 1 and 2. The recession of both channel banks at the ocean end of the breach is evident. The east bank receded 25 to 45 ft while the west bank moved 40 to 80 ft. On the sound end of the breach channel, the east bank advanced approximately 25 ft, pushing the channel to the west. This end of the channel also continued to widen, however, as the west bank receded about 45 ft.

The prograding shoulder of the barrier island was supplied sediment from the ocean end of the breach bank and the sound side of the barrier island. A strong current was observed in the margin channel on the east side of the breach. Bank erosion was easily observed at this location. As the tide fell, a scarp formed on the sound side of the barrier. During lower tide elevations, the strong flow removed sand from the base of the scarp until a tension crack formed, leading to mass failure. The sandy bank material slumped into the margin channel, moving down the bank slope where the tidal current carried it downstream. At higher tide elevations, the scarp became submerged and was smoothed by the current flow and wave action. Recession of the 0-contour as a result of this process is seen in Figure 7. The maximum shoreline recession measured over the 10-day period at the margin channel was approximately 20 ft.

Figure 7 illustrates the elongation of the margin shoals behind both breach islands. The east island shoal advanced approximately 65 ft. The west island shoal migrated in a

northerly direction and also elongated by approximately 65 ft. The 0-contour on the front side of each island receded. This recession, however, was not from erosion of the peat terrace. The peat terrace elevation was below 0 NAVD88, and the sandy material on top eroded during higher tide elevations.

Figure 7 also shows beach shoreline change within about 500 ft of the breach. On the west side, the beach eroded approximately 35 ft. Sediment supplied by longshore transport

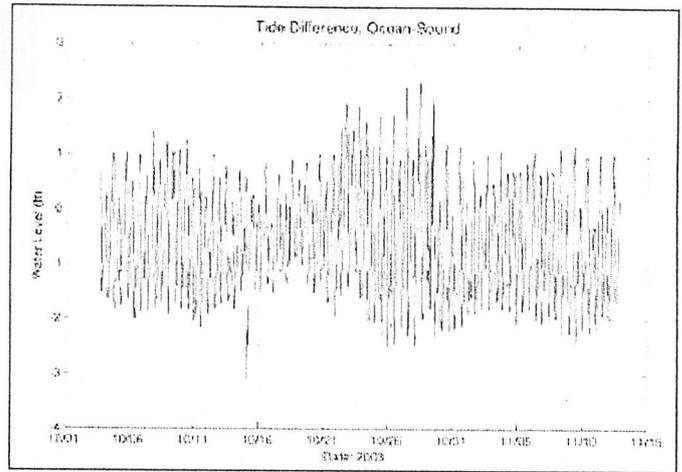
Figure 8. Pamlico Sound and ocean water level difference, 3 October to 12 November 2003.
