MEMORANDUM REPORT ARCCB-MR-00007

**A FRACTOGRAPHIC STUDY OF
A CIRCA AD83 ROMAN NAIL**

**A. A. KAPUSTA
J. H. UNDERWOOD**

MAY 2000

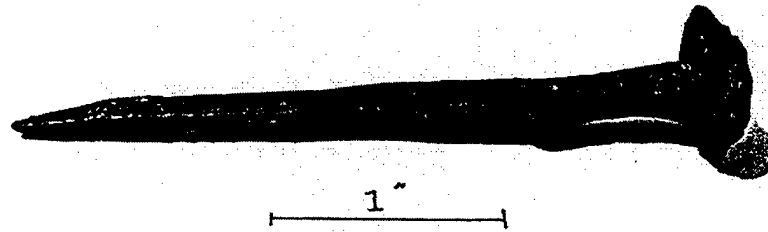
Measuring about 84-mm long with a disk-shaped head, the nail corresponded to one of group "D" as classified in the previous work. Figure 1 shows the as-received nail at 1X magnification, and reveals the roughly rectangular shape of the nail shank and the surprisingly light surface oxide layers discussed in the previous work.

Figure 1. A group "D" nail from the Roman fortress at Inchtuhil (1X).

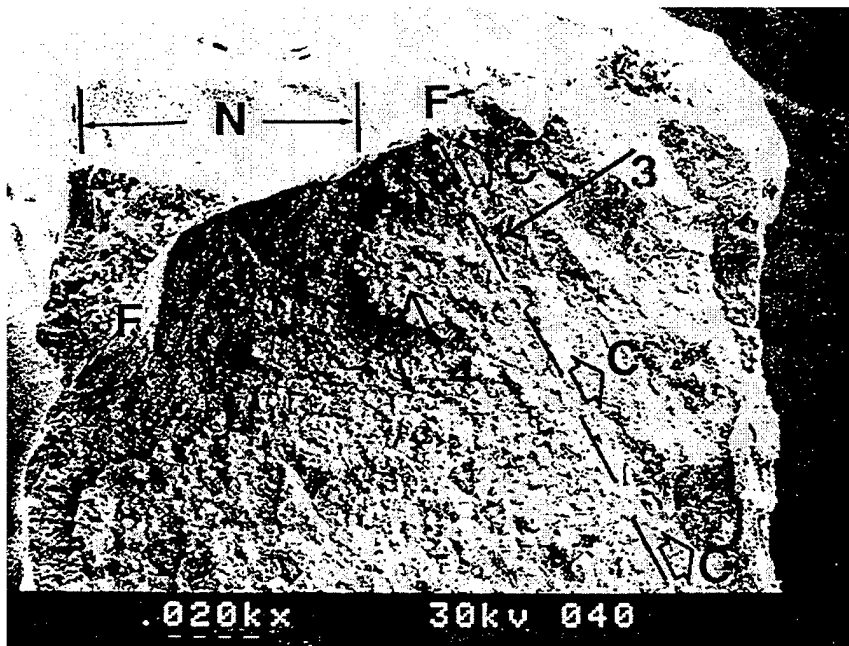
Figure 2 is a view normal to the fracture surface, and it shows that only a small portion of the laboratory-created fracture surface had initiated at the introduced notch, indicated by the letter "N." Most of the fracture had started at a preexisting transverse corner defect, "C." A preexisting longitudinal fissure, "FF," separates the laboratory-created fracture area that initiated at the corner defect and the area that initiated at the introduced notch. The preexisting corner defect and fissure were coated with a black (high-temperature) oxide, and they have a similar appearance to the internal defects seen in a longitudinal metallographic cross section of a group "D" nail shown in Figure 13 of Reference 1. Figures 3 and 4 (from locations shown in Figure 2) are from the oxide covered preexisting corner defect and the "clean" laboratory separation, respectively. The oxide obscures most other features in Figure 3. Figure 4 shows typical low-temperature transgranular cleavage, consistent with cleavage of sound, homogenous steel. Figure 5 is from a region most remote from the crack origin, and again shows transgranular cleavage, and a thin lip of tear dimples, "D."

Figure 2. Transverse fracture surface showing notch, corner defect, and fissure (20X).

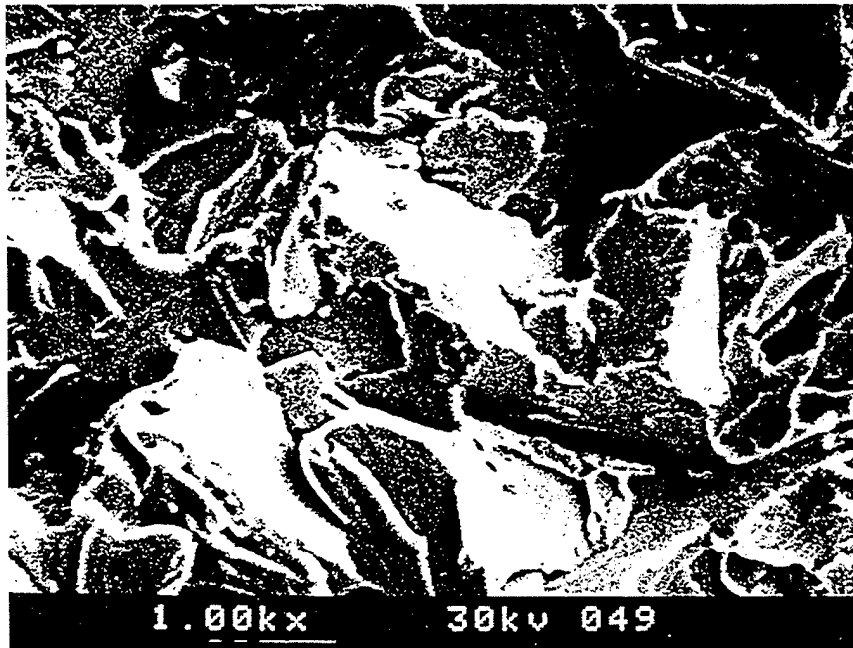
Figure 4. Low-temperature transgranular cleavage near crack origin (1000X).

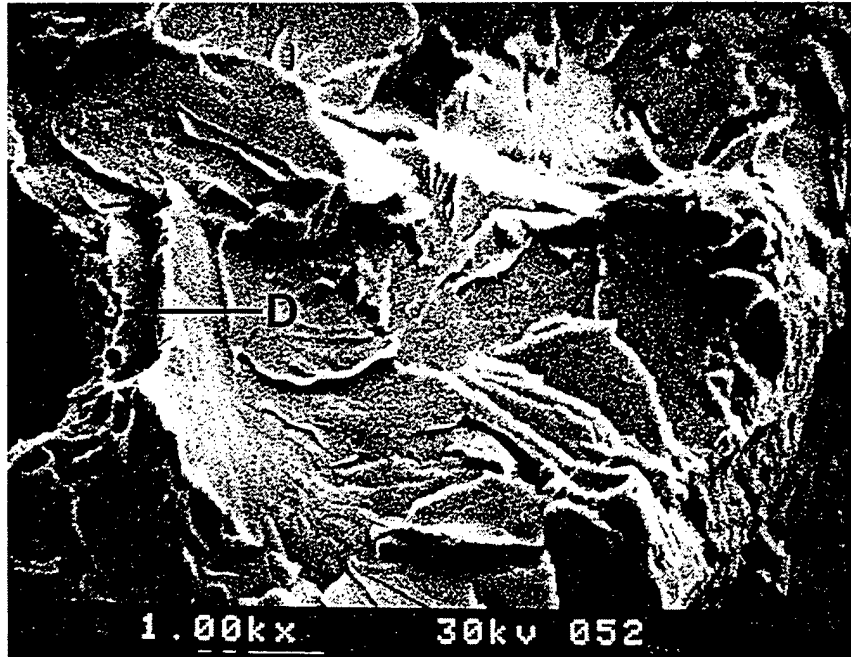
Figure 5. Low-temperature transgranular cleavage remote from crack origin (1000X).

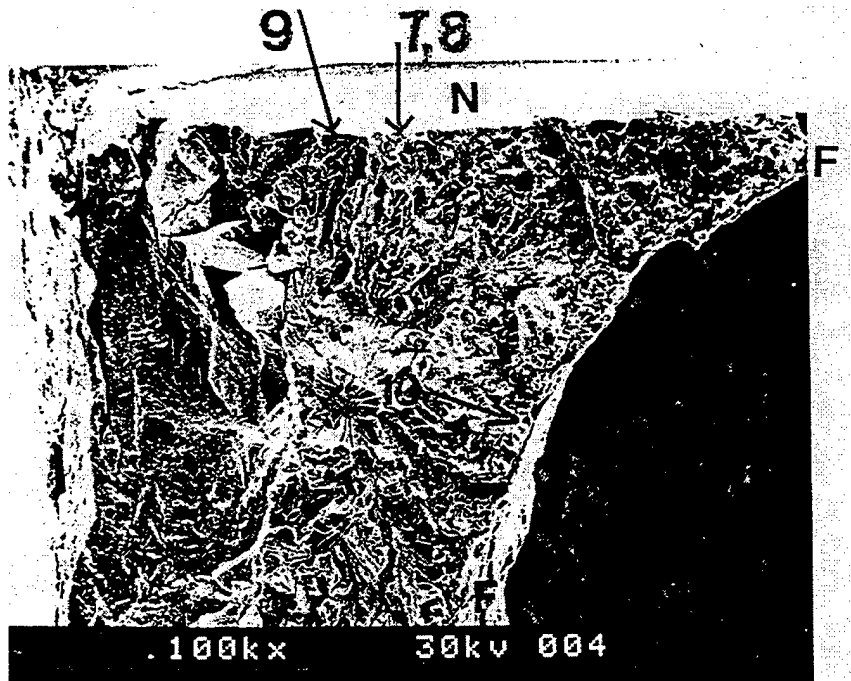
Figures 6 through 10 are from the laboratory-created fracture surface that initiated at the introduced notch, with the locations of Figures 7 through 10 noted in Figure 6. Figures 7 and 8, at 1000X and 5000X, respectively, show areas of transgranular cleavage immediately adjacent to the notch. Figure 9 shows curved river lines, "R," indicative of transgranular cleavage through preexisting cold worked metal adjacent to the notch, while Figure 10 shows oxide, "O," and small voids, "V," associated with the preexisting longitudinal fissure, "FF."

Figure 6. Transverse fracture surface near the laboratory-induced notch (100X).

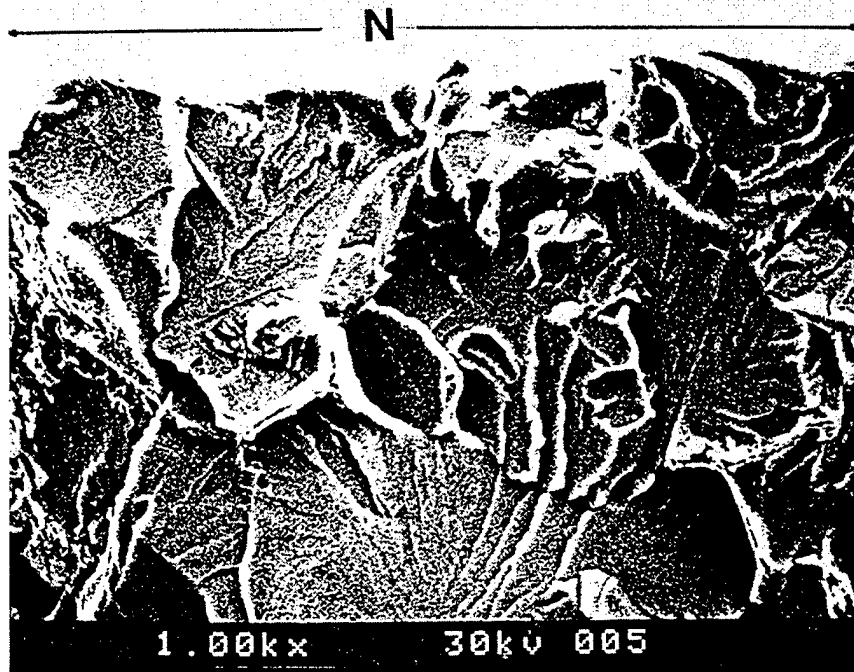
Figure 7. Low-temperature transgranular cleavage adjacent to notch (1000X).

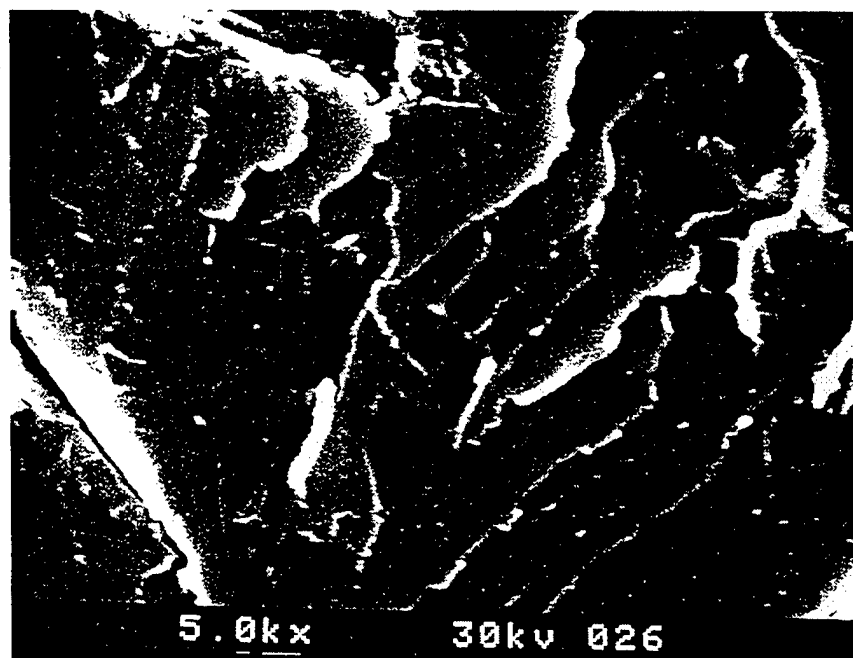
Figure 8. Low-temperature transgranular cleavage adjacent to notch (5000X).

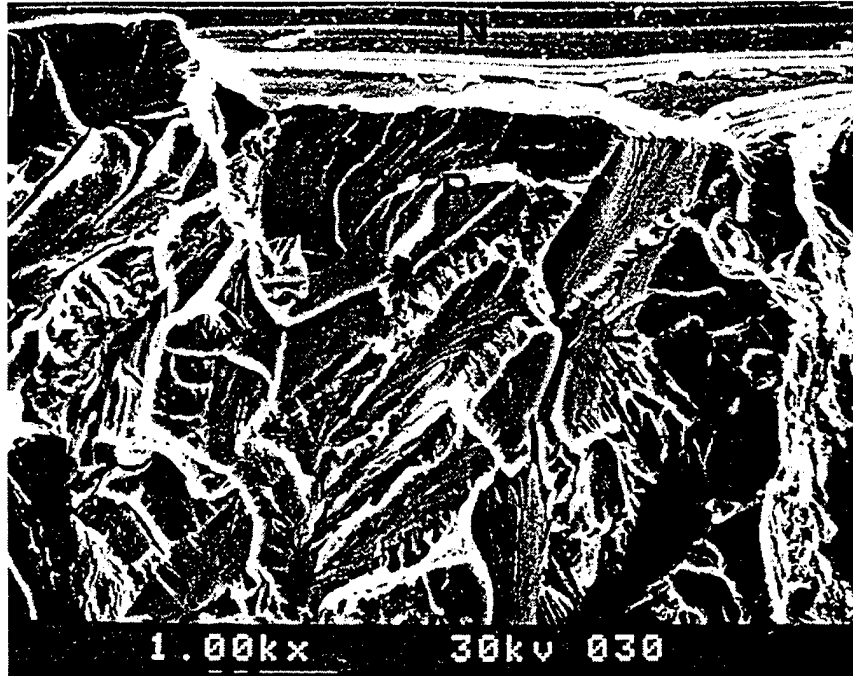
Figure 9. Curved 'river lines' indicating cold-worked metal (1000X).

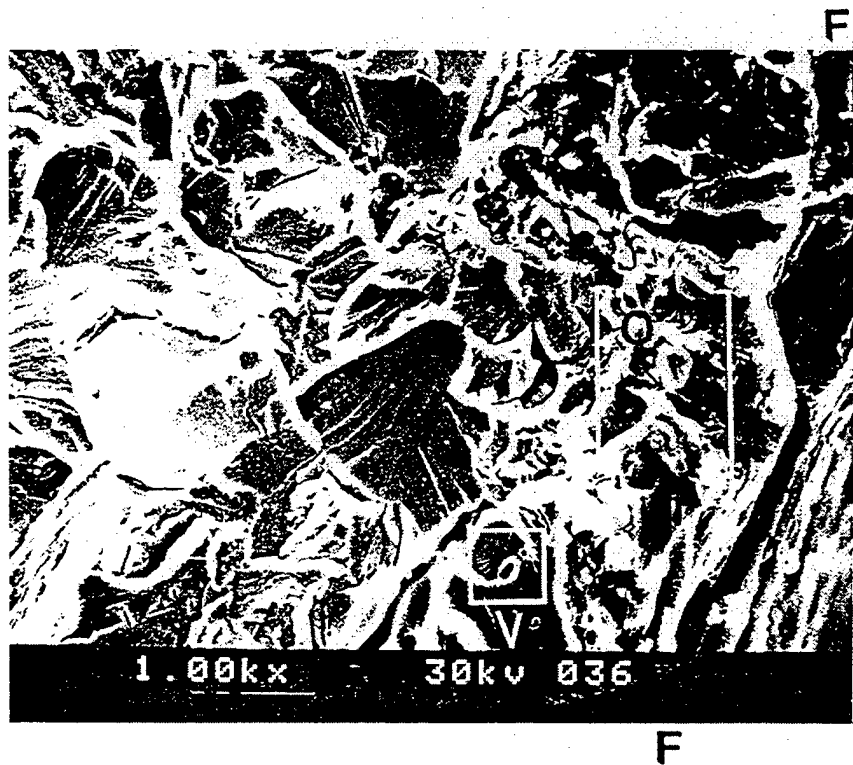
Figure 10. Oxide and voids indicating the preexisting fissure (1000X).
