***SMALL CALIBER AMMUNITION
BRANCH
CAL .50 NO-PRIMER VENT HOLE
EVALUATION TEST***

***PRESENTED BY
MARISEL R. LIPINSKI***

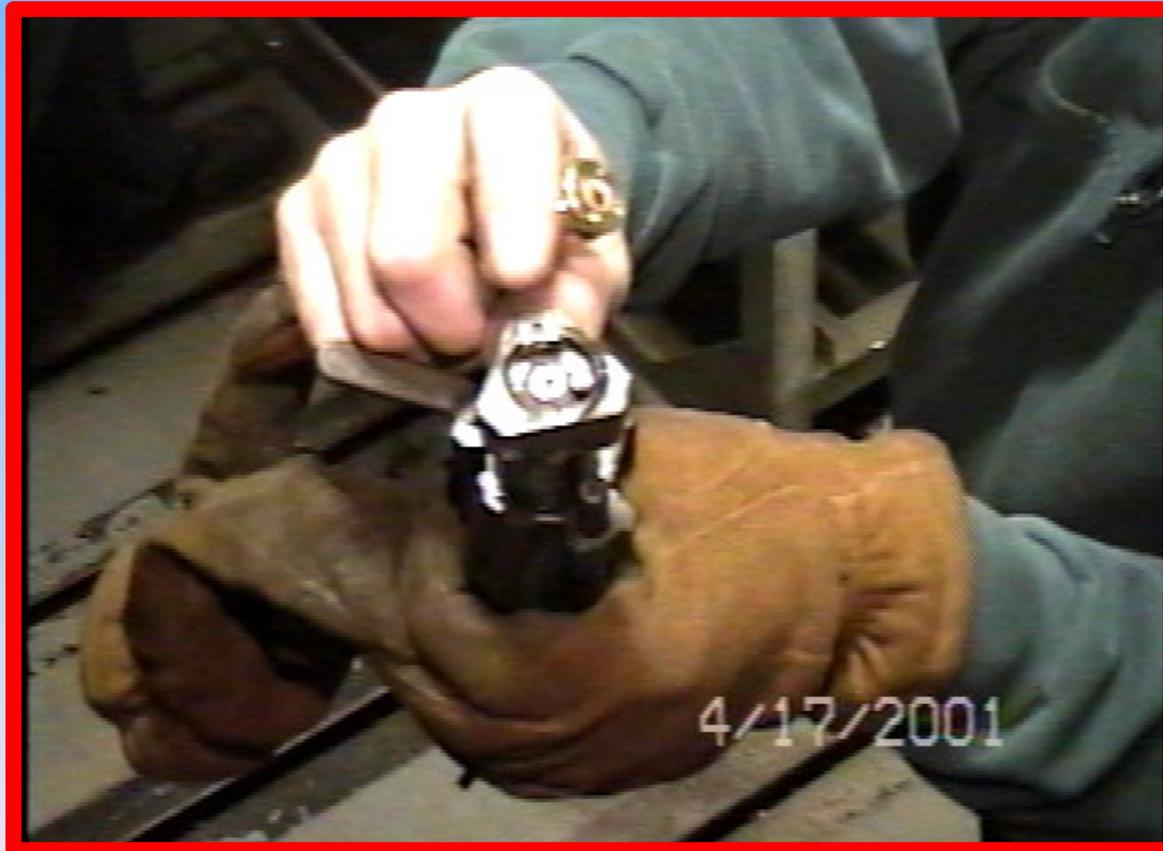
VIDEO CLIP OF BROKEN EJECTOR M82 SNIPER RIFLE

- Round # 1 broke the new ejector spring that had been replaced in the morning
- Round # 3 - The flexible rod provided with the M82 failed to remove a lodged cartridge in less than ten minutes
- Round #11 - the weapon stopped extracting the cartridges
