Bore Evacuator Corrosion on the M284 Cannon Tube

Presentation NDIA Joint Armaments Conference,
Exhibition & Firing Demonstration – Modeling & Simulation
16 May 2012

Dr. Elaine Humiston
US Army Benét Laboratories
1 Buffington Street
Watervliet, NY 12189

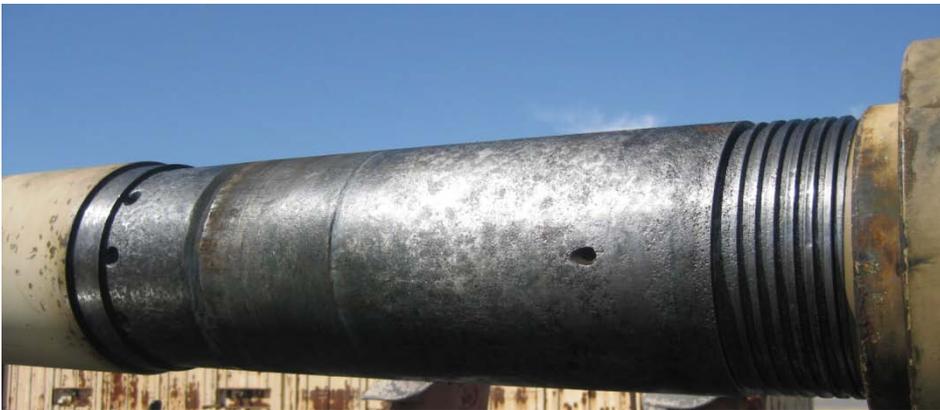
Bore Evacuator Region of Gun Tube

- Issues
 - Evacuator region configuration presented challenges to regular maintenance – not always performed
 - Storage practices have deviated from prescribed procedures resulting in excessive corrosion and pitting of the evacuator region

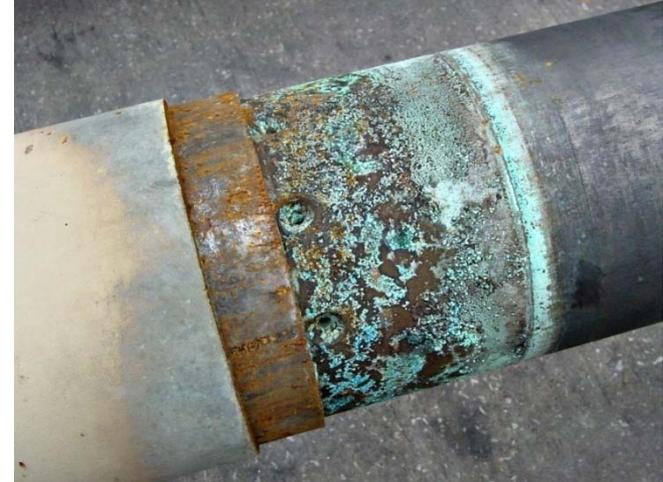
Heavily corroded Tube

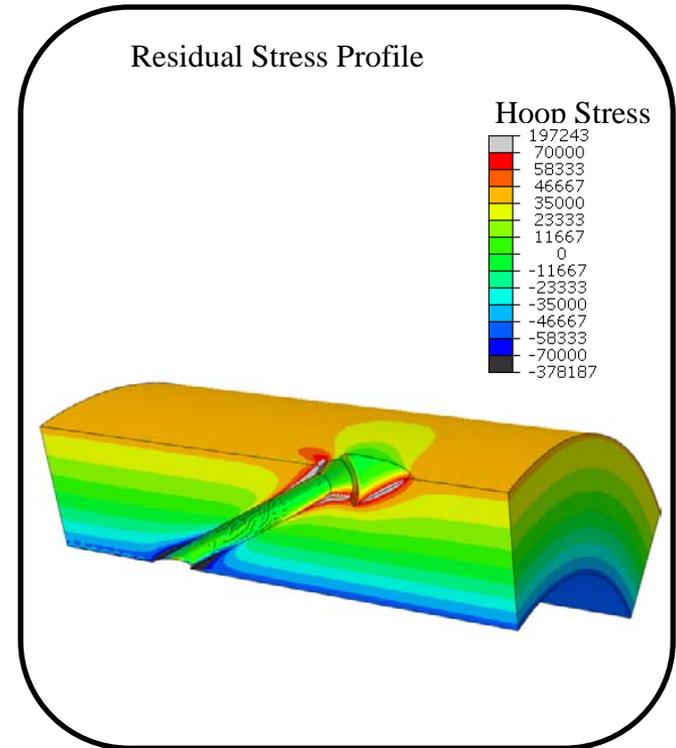
- Findings resulted in a Final Safe Life less than 50% of the original
- Results
 - Tube 1
 - Failure in 30° hole
 - Indications in all 30° holes
 - Tube 2
 - Failure in 30° hole
 - Indications in all 30° and 90° holes
 - 90° holes were not expected to fail (indicate cracking)

Failure cracks

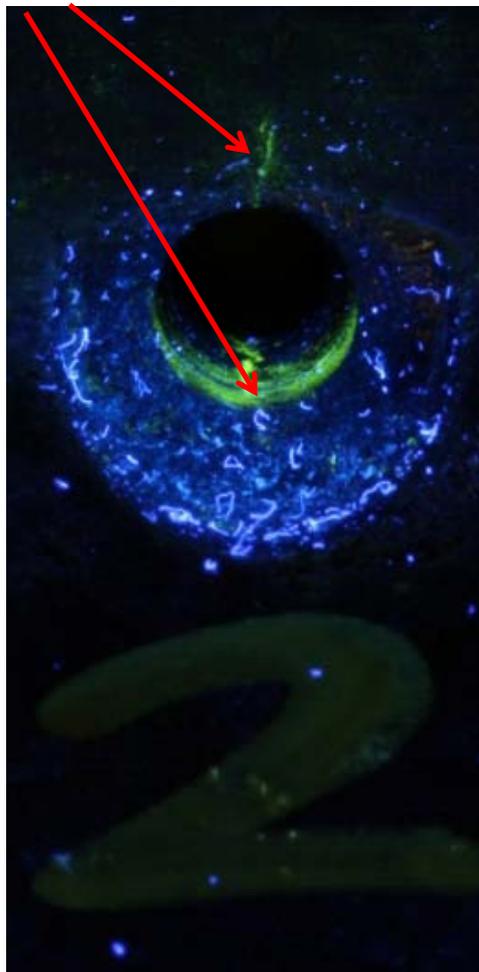
Second fatigue specimen

Indications

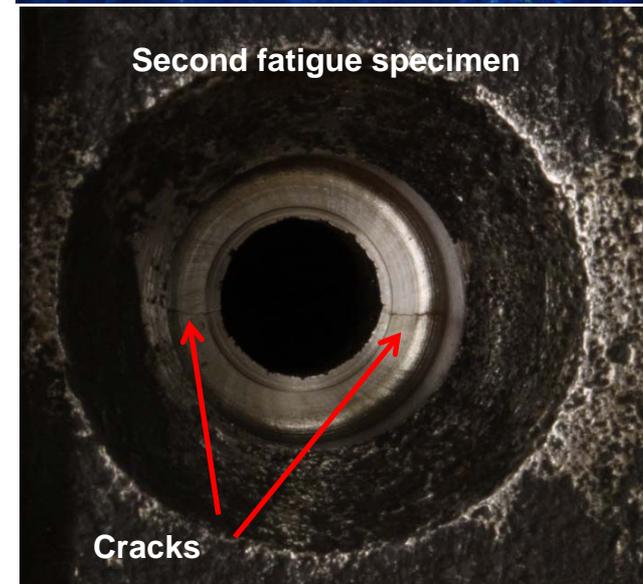
Second fatigue specimen

Cracks

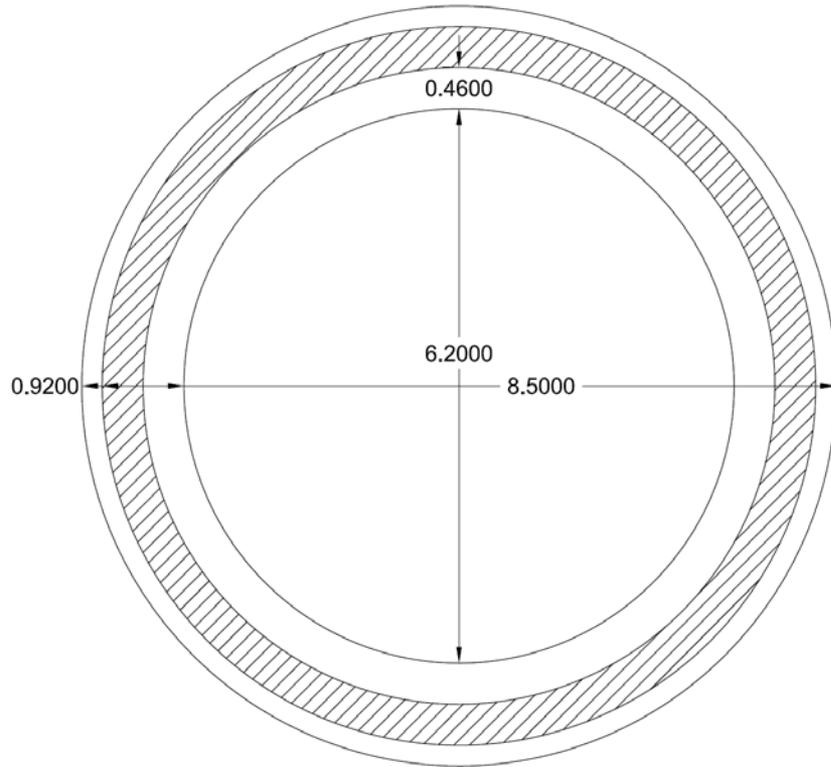
Critical Region

Failure occurred within the predicted region at a corrosion pit with environmental cracking
